**BARN AT TREVOLLARD FARM,
ST VEEP, nr LOSTWITHIEL,
CORNWALL**

PHOTOGRAPHIC SURVEY

January 2012
Report 767

The required photographic survey recorded a redundant barn in the southwest portion of the farmyard at Trevollard prior to proposed conversion to a domestic dwelling. The survey was undertaken to compile a record of the site for posterity.

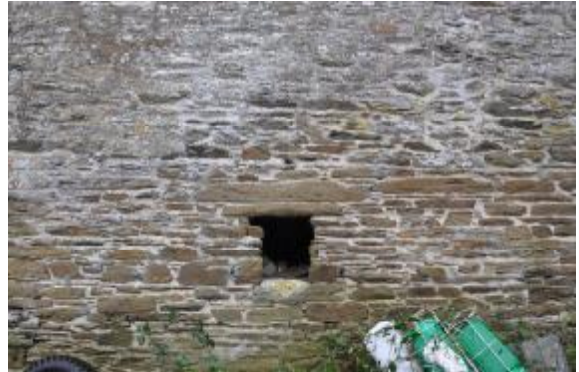
- 4.2.4 This building has undergone four phases of build and several clear changes of use. The original barn may have been single-storey. This is suggested by the change in stonework between the ground floor and first floor (Figure 11, 011). It is probable that this phase had just the one front entrance (D1) and the four loop-hole/arrow-slit ground floor windows (W 2, 3, 8 and 9). In phases 2 and 3, an upper storey and Extension 1 were added which are of the same construction type, suggesting some contemporaneity, although the upper storey pre-dates Extension 1, as Extension 1 is joined to the side of the upper storey. The openings on the first floor appear to be original. Door 2, on the ground floor of Building 1, was inserted to provide access between Building 1 and Extension 1. The horse-whim may have been associated with a change of use which prompted this expansion of the original building. At some point during this time Door 3 (D3) was inserted as access to Building 2.

011: NORTHEAST ELEVATION: DETAIL SHOWING CHANGE IN STONEMWORK BETWEEN UPPER AND LOWER FLOOR

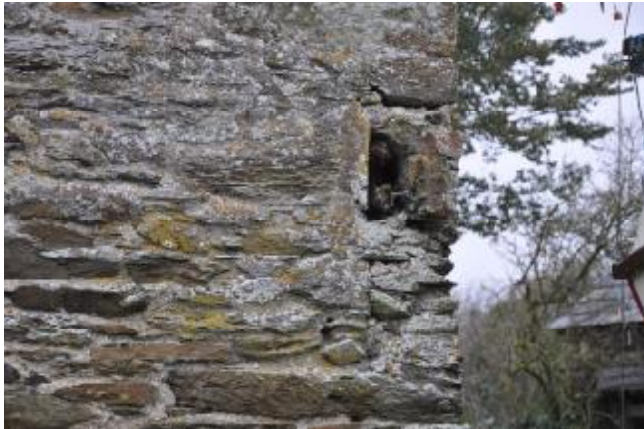
012: NORTHEAST ELEVATION, BUILDING 1: PATCHED 'HOLE'. SW FACING.

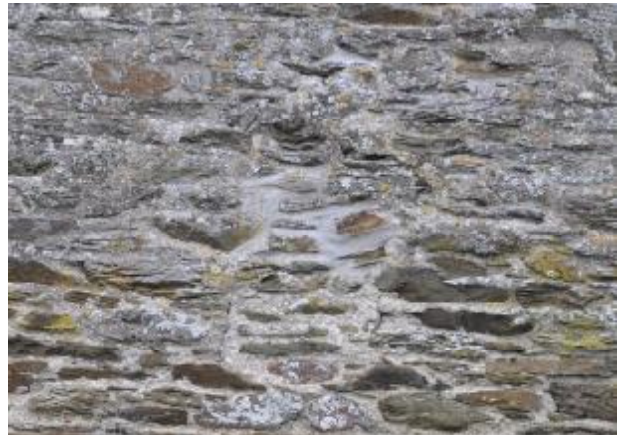
013: NORTHEAST ELEVATION: DETAIL OF PATCHING

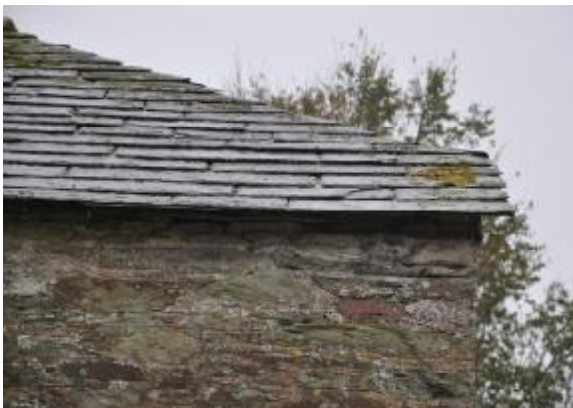
- 4.2.8 The hipped roof is a six bay truss of very basic king post construction which has subsequently been strengthened by hammer beams on the southeast side of the building (Figure 25). Repair in the stonework under the eaves, visible on the external elevations of Building 1, suggests that the roof could have been replaced (Figure 11, 014; Figure 13, 026). The ceiling of the ground floor is divided into three sections.

014: NORTHEAST ELEVATION BUILDING 1: UNDER EAVE AND ROOF DETAIL. SW FACING.

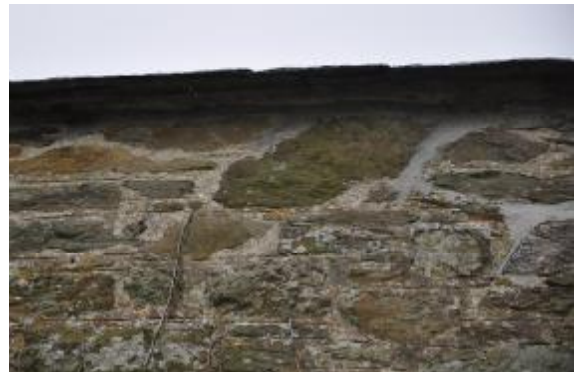
015: NORTHEAST ELEVATION, BUILDING 1: DETAIL OF UNDER EAVE. SW FACING.

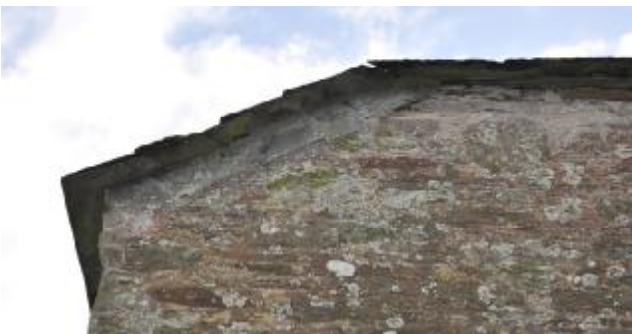
026: NW ELEVATION, BUILDING 1: ROOF DETAIL, SW SIDE.

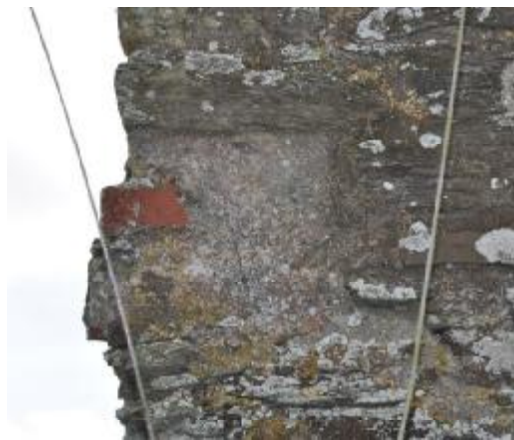
028: NORTHWEST ELEVATION, BUILDING 1: 'HOLE' ON SOUTHWEST CORNER

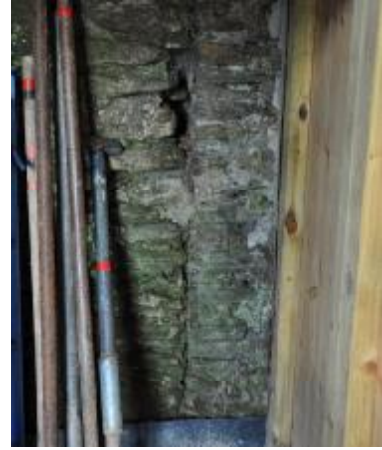
- 4.2.12 Building 2 adjoins the southeast side of Building 1; the northeast wall is butt-jointed to Building 1 (Figure 12, 017) and is therefore later in date. At the time of the survey the roof covering had been removed (the slate tiles were stacked inside the building) although the modern rafters remained. The original building had two floors, as indicated by the holes for the joists in the brick work (Figure 23, 081). The roof-line showed some repair and concrete mortar, which could suggest the upper walls had been slighted; if not, the upper floor of this building had a very low ceiling at its southeast end. In addition, window 13 is unusually close to the wall plate, which forms its lintel.

072: BUILDING 2: SE ELEVATION, BUTT JOINT, NW FACING.
