THE BULL HOTEL,
99 MAIN ROAD,
HOCKLEY,
ESSEX

HISTORIC BUILDING RECORDING

**THE BULL HOTEL,
99 MAIN ROAD,
HOCKLEY,
ESSEX, SS5 4RN**

**Report No. 1273
December 2018**

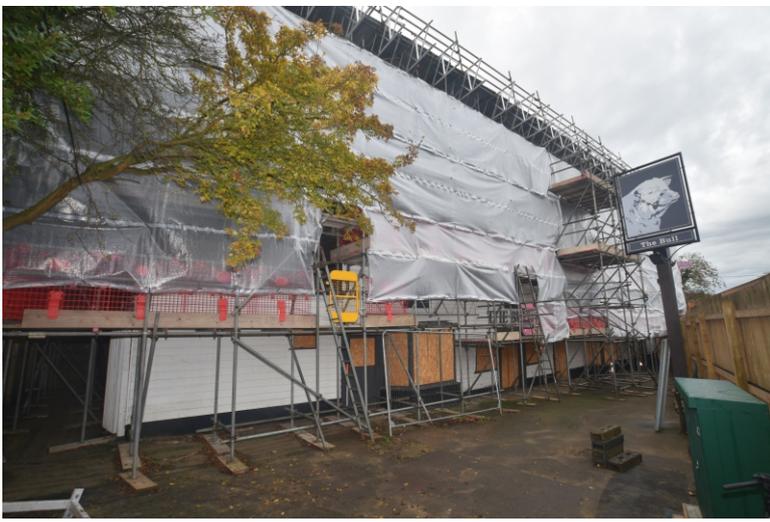
Plate 1: The front elevation of the Bull Hotel with scaffolding and sheeting cover

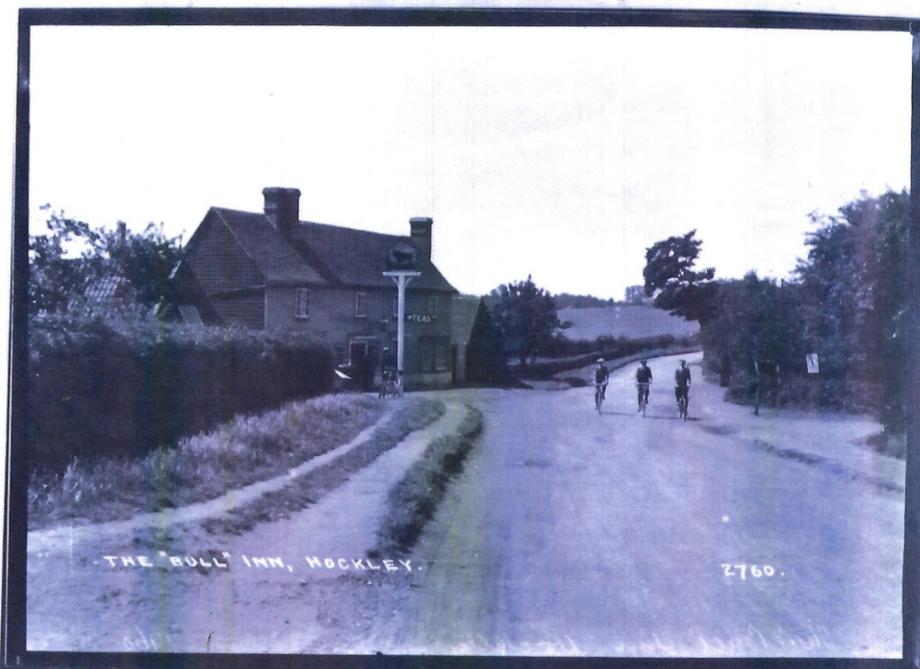
Plate 3: The Bull in 1925

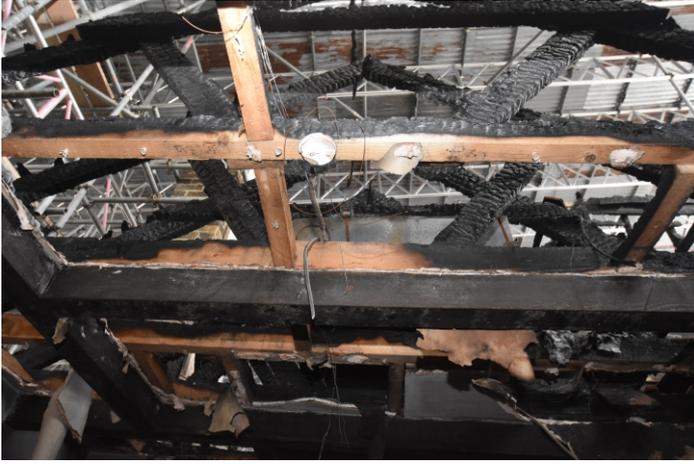
Plate 6: Room A truss

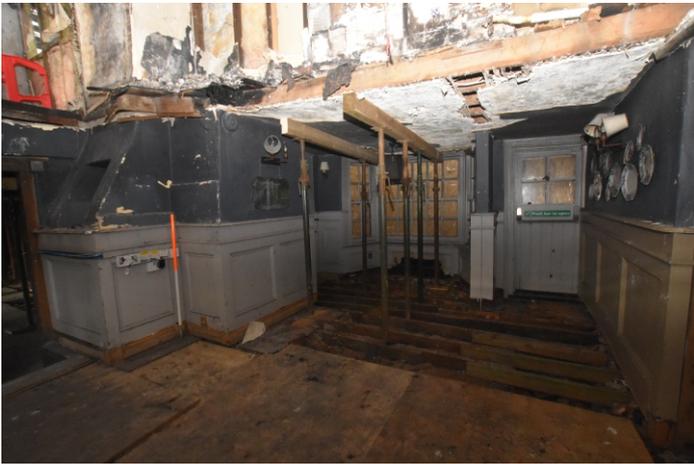
Plate 8: Room B looking to front

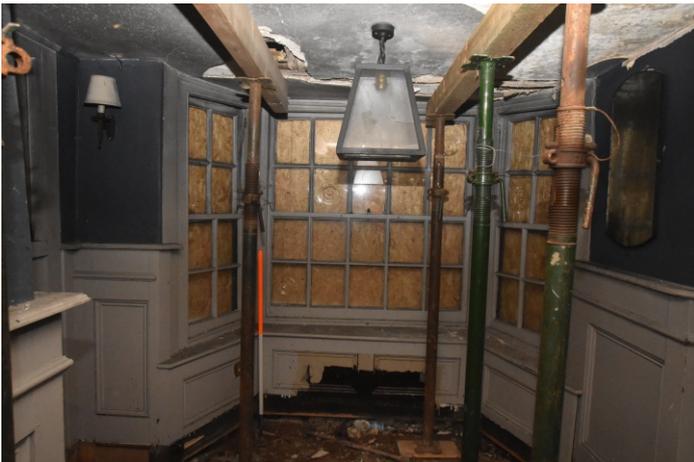
Plate 9: Room B, bay window

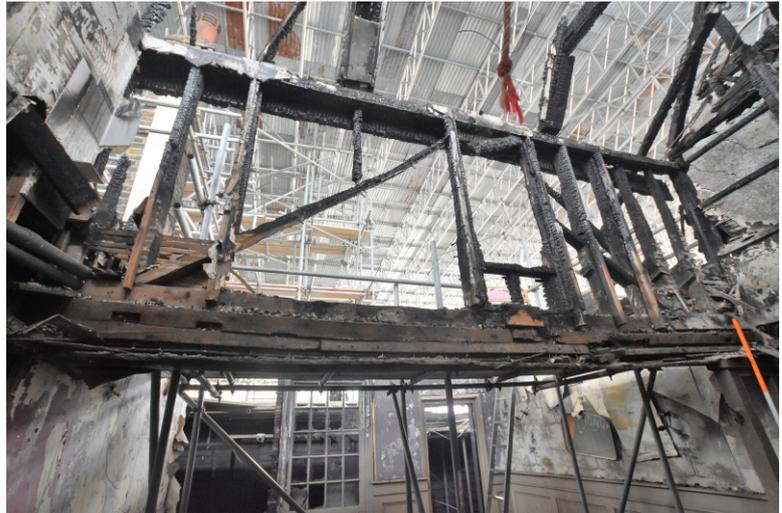
Plate 12: Room C, with rear wall of BB above, beam marking the position of the original rear wall of The Bull

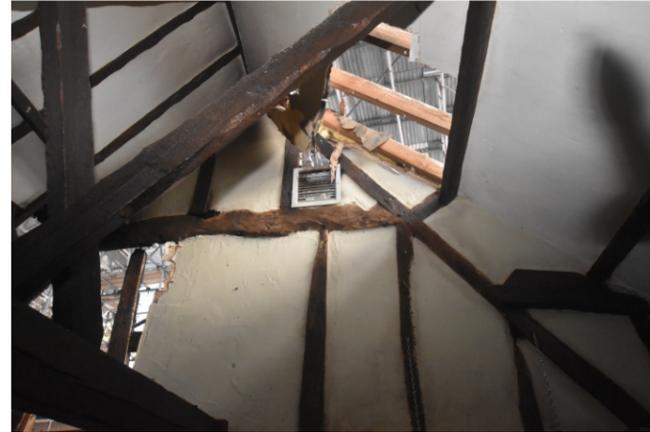
- original purlins are missing in the rear bay, but a 'v-shaped' cut-out in the timber in the rear wall shows the position of the original purlin (Plate 36).

Plate 36: Room I rear wall, purlin with a 'V-shaped' cut-out showing the position of the original purlin

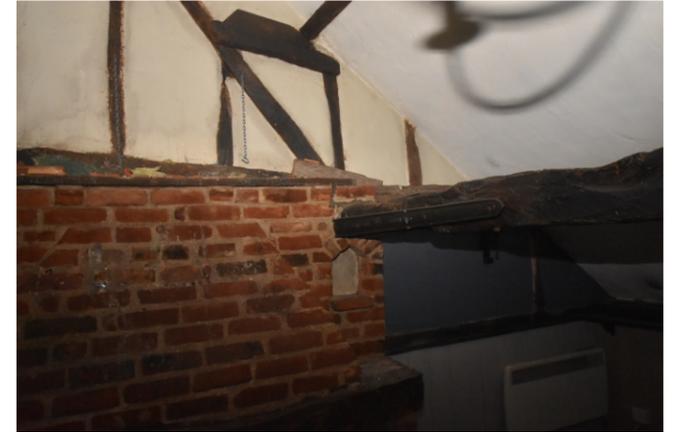
Plate 37: Room I, beam intruding into the fireplace

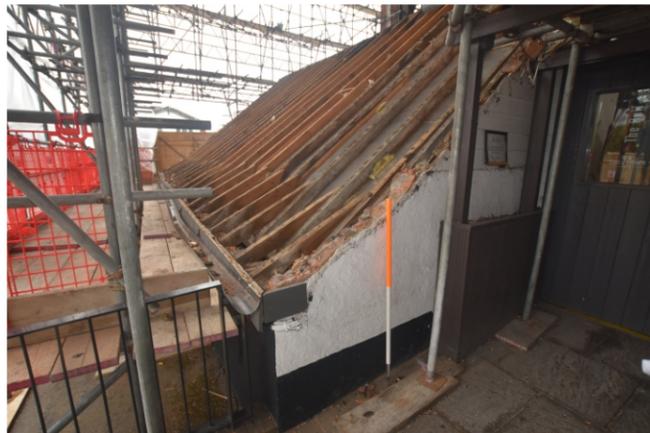
- 8.9.5 The roof is a modern replacement with plasterboard and insulation in-filling. The rafters to right (Plate 38) are modern and to left (Plate 39) modern rafters are nailed to the outside edges of late 19thearly/20th century rafters. To right 19th/20th century rafters 'float' below the ceiling level and rest on a longitudinal timber supported by posts.

Plate 38: Room I external roof to right

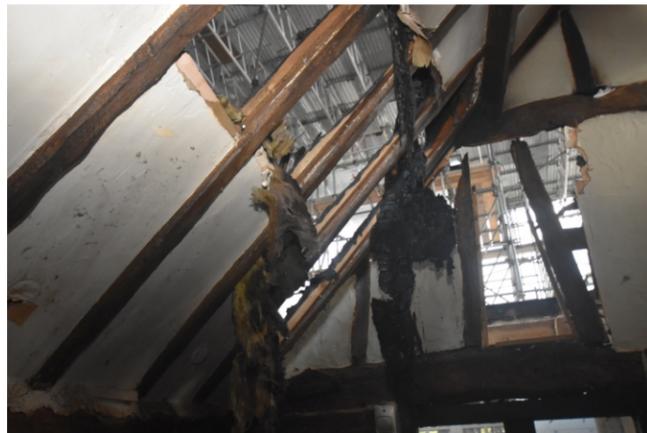
Plate 39: Room I roof to left

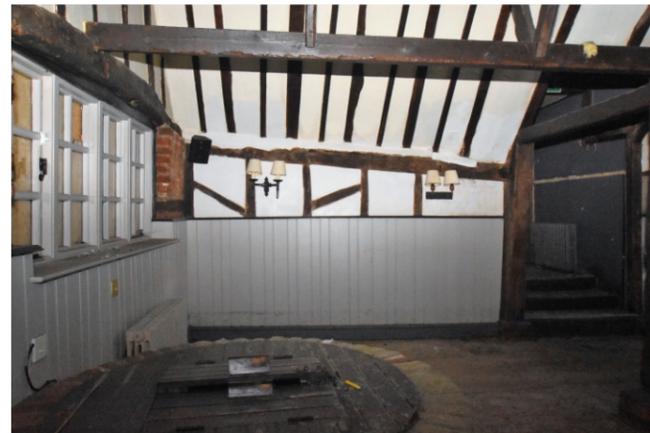
- 8.9.6 The walls are all wood panelled to dado height, excepting to left of the fireplace. The walls to rear and left (Plate 40) have timber and plaster infill above the panelling. There are some genuinely older timbers, probably 17th century in date, in the rear wall and possibly also in the wall to left. The infill, however, certainly to the rear where it is exposed, is modern plasterboard and insulation. The wall to right is probably a mid-late 20th century construction. The wall to front is timber with later brick infill above panelling and below the wall plate. Above the wall plate is timber with plaster infill. It is possible the timbers in this wall are original. The red brick is set in Flemish bond with thick joints re-pointed with a cementitious mortar. The floor of the structure is modern concrete.

Plate 40: Room I wall to front left

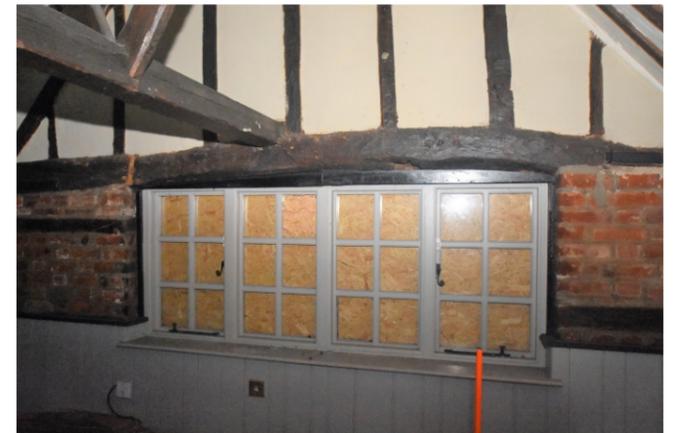
- 8.9.7 The window to front (Plate 41) has replaced double doors which are visible on a photograph of a few years after c. 1910 (Plate 2). The casement window has four lights, six panes per light. The flanking lights open and have iron fittings. The style of the window suggests a mid-20th century date. There is an opening in the rear wall styled as a door, but which appears to be fixed. This is a modern insert.

Plate 41: Room I window to front

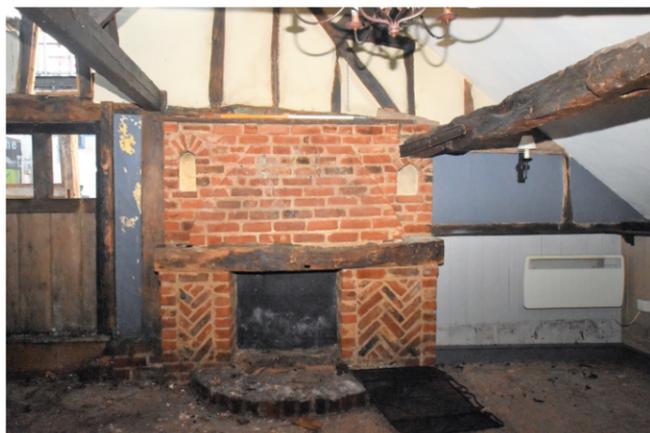
- 8.9.8 The large brick fireplace set into the rear wall is a feature of the room (Plate 42). It has a thick wood lintel, herringbone pattern on the 'pilasters' and two asymmetrical blind, arched niches above. The hearth is stone. The fire would have vented out through a flue in the rear wall and a modern one is still present. It appears to pre-date the aisle, considering how the longitudinal beam of the aisle structure penetrates the brickwork of the fireplace. However, there are a number of indications that the fireplace may post-date the aisle. Map evidence suggests that the barn was extended to the rear between 1967 and 1972 (Figures 10 and 11), the rear bay of the truss has been altered and the style of the fireplace with a smaller niche to right to fit around a beam, all indicate a late 20th century date.

Plate 42: Room I fireplace to rear

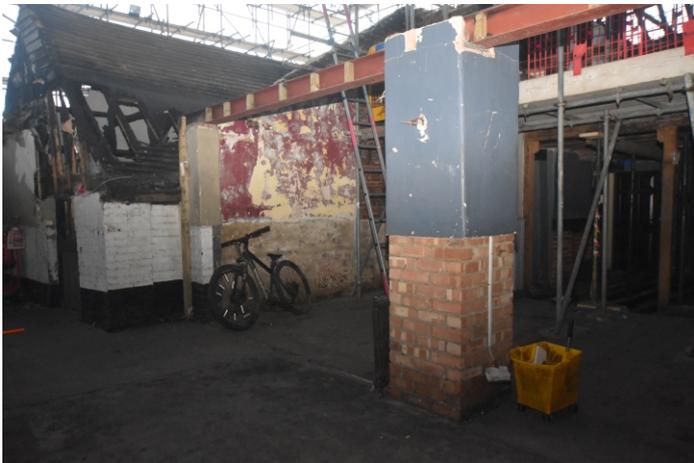
- 8.10.2 The wall to right (Plates 46 and 47) abuts Room I and extends to left at roof height to abut the rear right corner of Room EE. It is constructed of brown yellow brick set in Flemish bond with a reddish lime mortar. At ground level the internal face of the wall is covered with two layers of plaster, the outer a modern 'skim'. The wall to left, up which the staircase ran, comprises timber frame with lath and plaster infill supported on a wooden sill over at least four courses of red brick foundation (Plate 48). Above the timber frame, at a height of 1.7m and to roof height, the wall is red brick set in Stretcher bond with integral horizontal timbers every few courses (Plate 49). This wall is bonded to a modern breezeblock wall to front and a modern brick wall to rear.

Plate 46: Room J wall to right

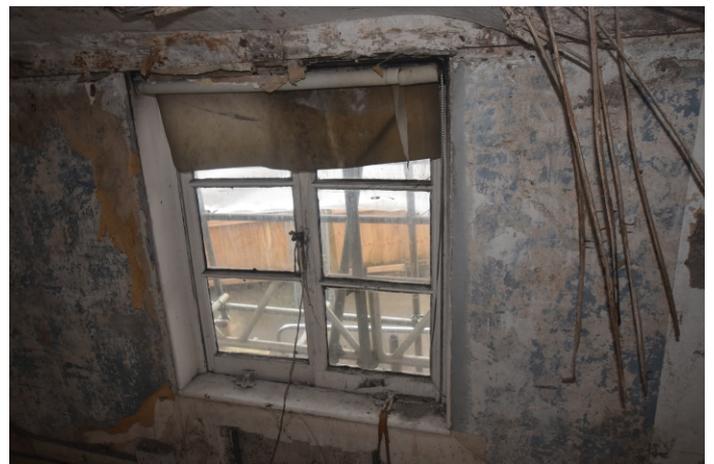
Plate 61: First Floor window detail

- 8.16 Each front room has a central window of the same type (Plate 61). The windows are two-light wood casements with three panes in each light, without a central mullion. The fittings are iron. The glass, where it remained, appeared to be modern and the windows are of likely 19th century date.

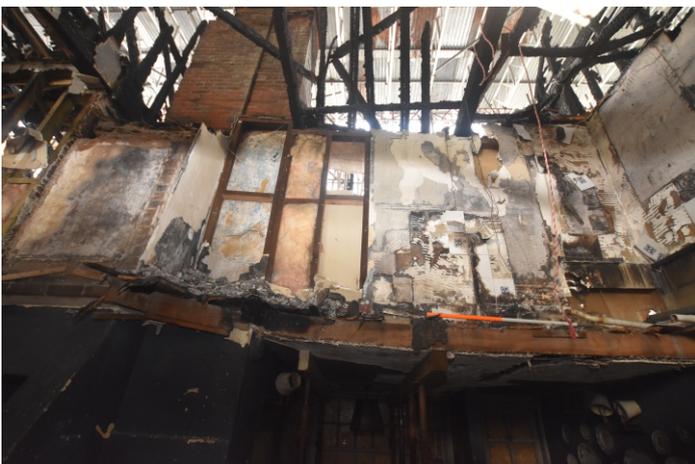
Plate 62: First Floor Room BB, wall to front

- 8.17 The front wall to Room BB (Plate 62) appears to comprise a modern stud wall, therefore, it is likely that Rooms BB and FF were originally a single space. The wall to left appears to have the same construction type, but this is presumably attached to the 17th century external framing.

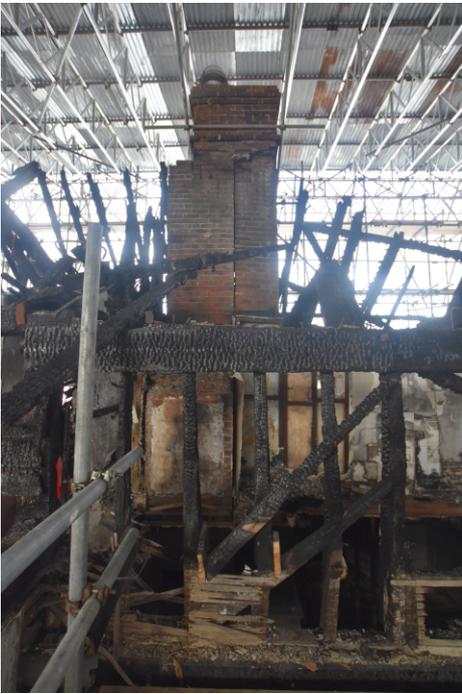
Plate 63: Chimney stack to left

8.18.1 The historic core of the Bull has two red brick stacks set a-symmetrically. The stack to left (Plate 63) is a large structure with two flues and a single chimney pot. It provided heat to the rooms to left on the ground floor and the larger first floor room to left (CC). It is likely that the stack is contemporary with the building of the structure. The stack to right (Plate 64) is an end stack which services Rooms E and EE. Map evidence suggests that it may have been added to the complex between 1840 and 1874.
