**BARNs AT BRICKBARNs FARM
MASHBURY ROAD
CHIGNALL ST JAMES
ESSEX**

LEVEL 1 HISTORIC BUILDING RECORD

Report no. 2440

July 2011

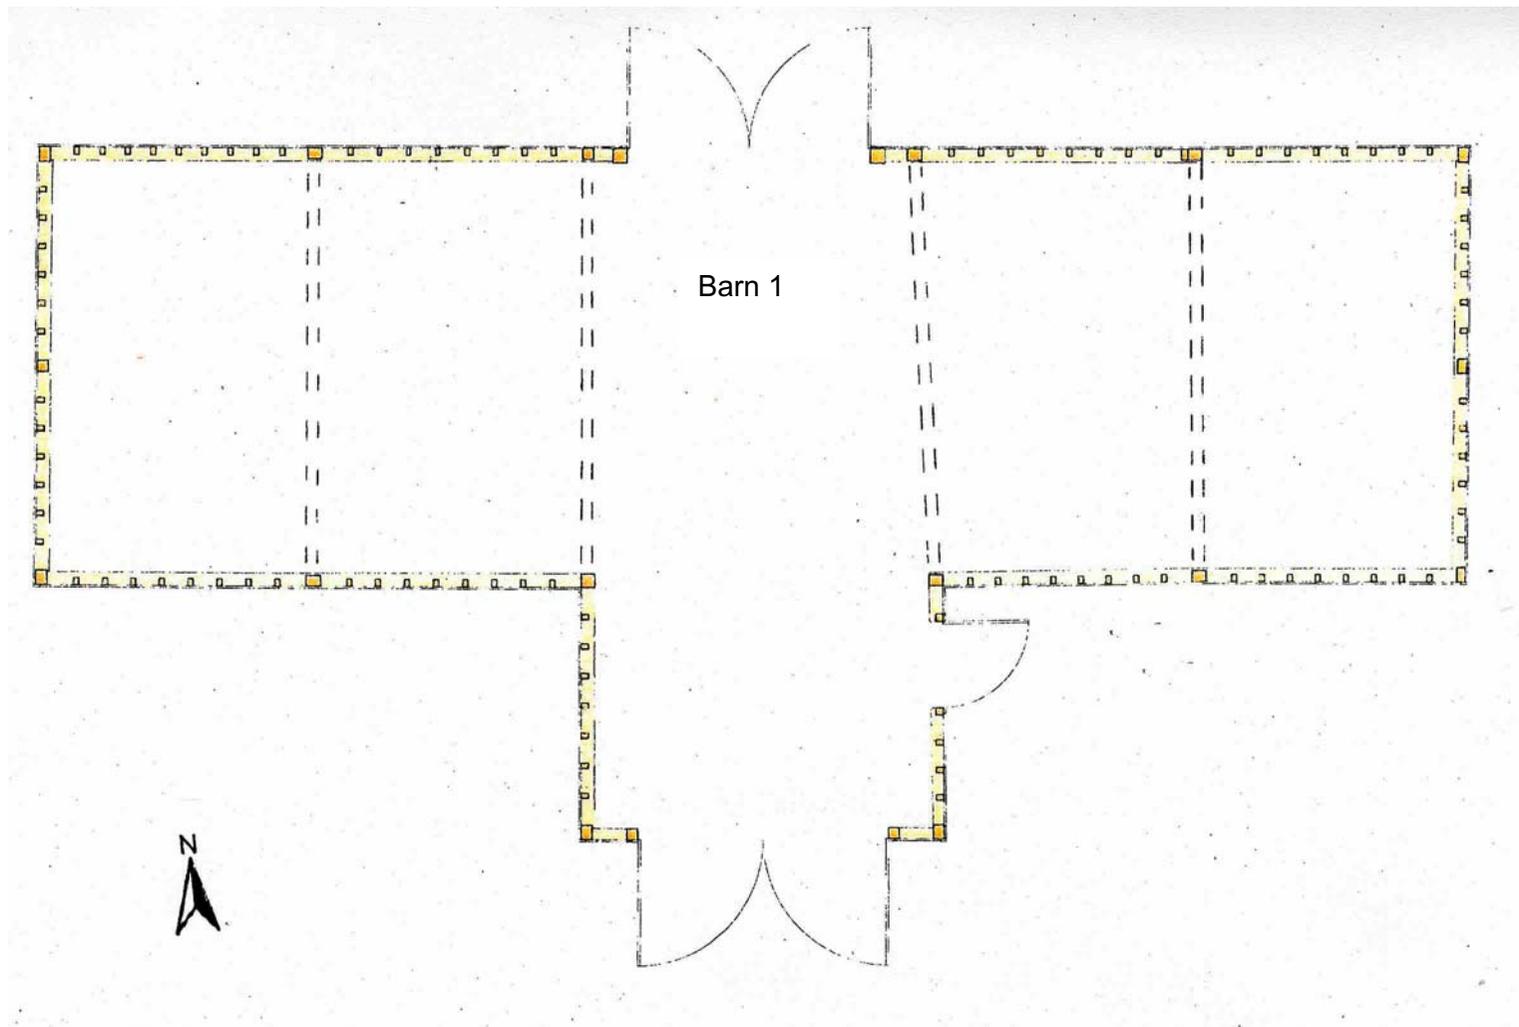
Fig. 2 Plan of timber barn (scale 1:100)

The interior (plate 3) is laid out over five bays, most of which are fairly regular at 3.5m wide, apart from the midstrey, which is canted to the east due to the cart doors being slightly out of line (fig. 2). The modern concrete floor has been recently removed, exposing natural clay deposits below.
