**HISTORIC BUILDING RECORDING OF BARN & OUTBUILDINGS
AT
LITTLE WARLEY HALL FARM
LITTLE WARLEY
ESSEX**

February 2007

FAU Project No.: 1709

Site Code: WARW 06

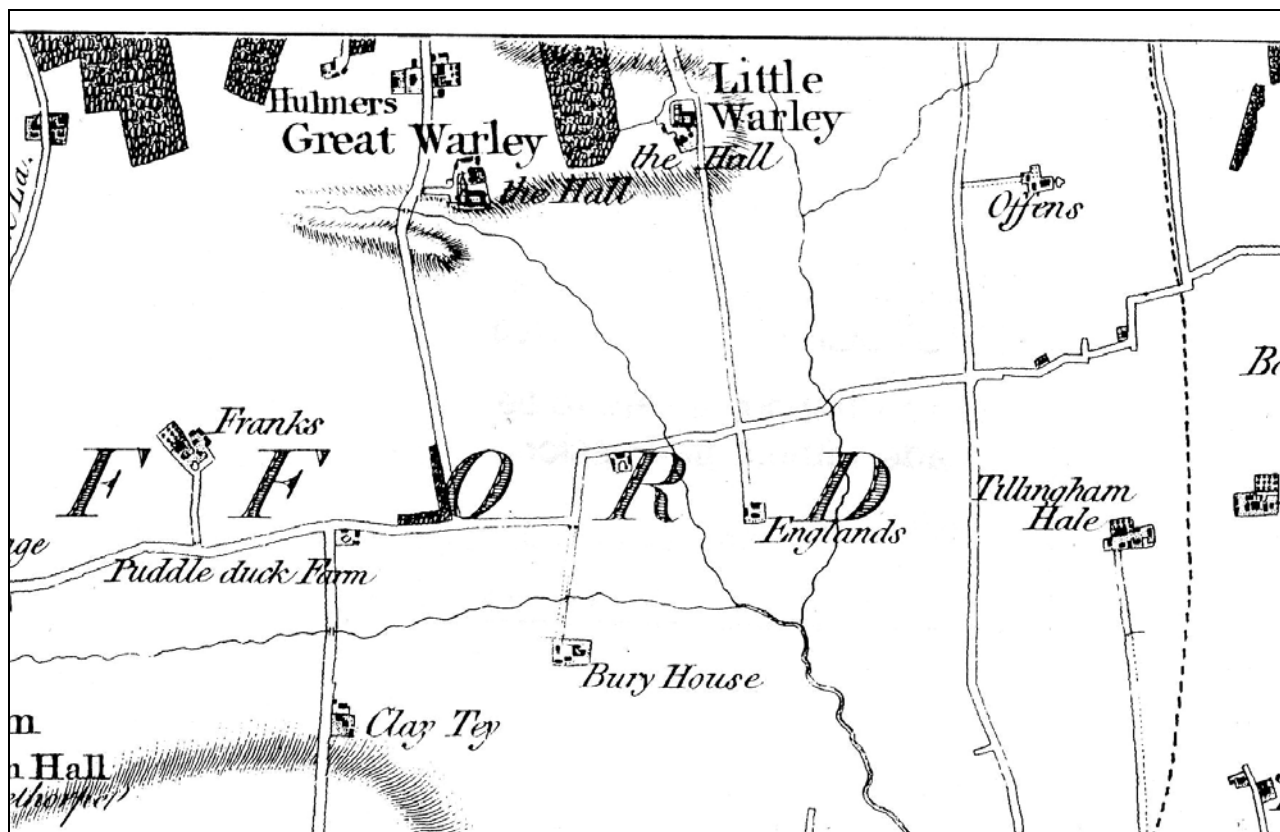
Fig. 2 Chapman & Andre map, 1777 (plate 22)

The barn is described as 16th/17th-century in the brief (HEM 2006) and has several post-medieval characteristics. It could be contemporary with the building of the hall in the early 16th-century or later works in the 17th-century (listedbuildingsonline 2007). It is first shown, in isolation, on Chapman and Andre's map of 1777 (fig.2).

The barn is clearly the oldest and most architecturally interesting of the group and is the main subject of the survey. 18th-century mapping (fig. 2) shows it standing on its own to the north-west of the hall. In the 19th-century farm it was the dominant component of the north-western yard, with easy access from the fields at harvest time. Since the 1950s the structure has been somewhat engulfed by stables and associated structures of varying architectural merit. The reasoning behind their refurbishment/removal in the new development, put simply, is to re-expose the original building and enhance its landscape setting (Clarke 2006).

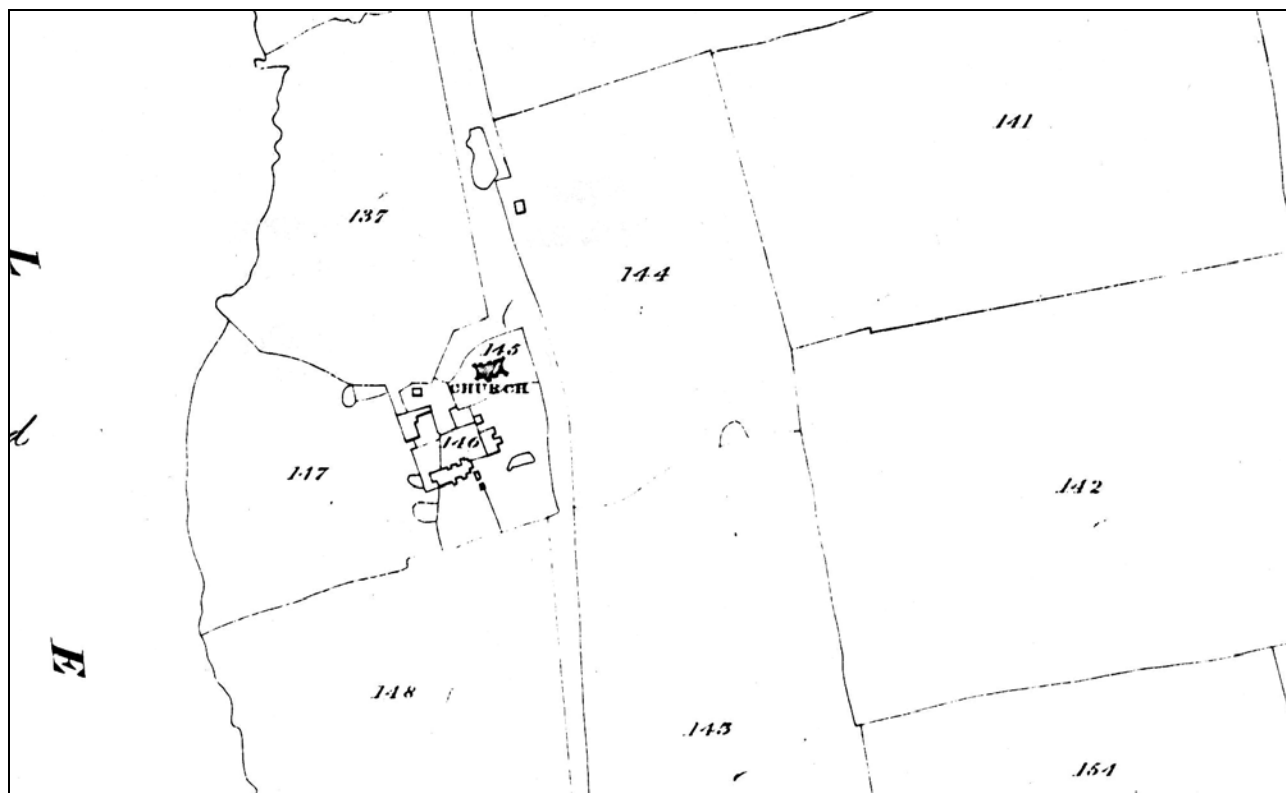
Fig. 3 Tithe map of Little Warley, 1838 (D/CT 38B)

Little Warley tithe map of 1838 (D/CT 38B, fig.3) depicts a narrow range along the north end of the barn (cattle shed?) forming an L-shape, the other barn and an unidentified building (since removed) in the north-east corner. It is hard from the map to decipher the precise layout of the barn and other buildings that appear to adhere to it. The tithe award (D/CT 38A) gives the owner of the hall as Charles Winn, and John Parson the occupier. Plot 146 is described as 'the homestead', but individual structures are not named. Plot 147 to the rear of the barn is referred to as 'barn meadow'. In all the holding amounts to around 100 acres; a high proportion of which is arable land (73 acres). Winn owned much of the western side of the parish. Clearly a large landowning family, George Winn, perhaps Charles' father, had sold Warley Common for the East India Company barracks in 1805 and built Warley Lodge c.1820.

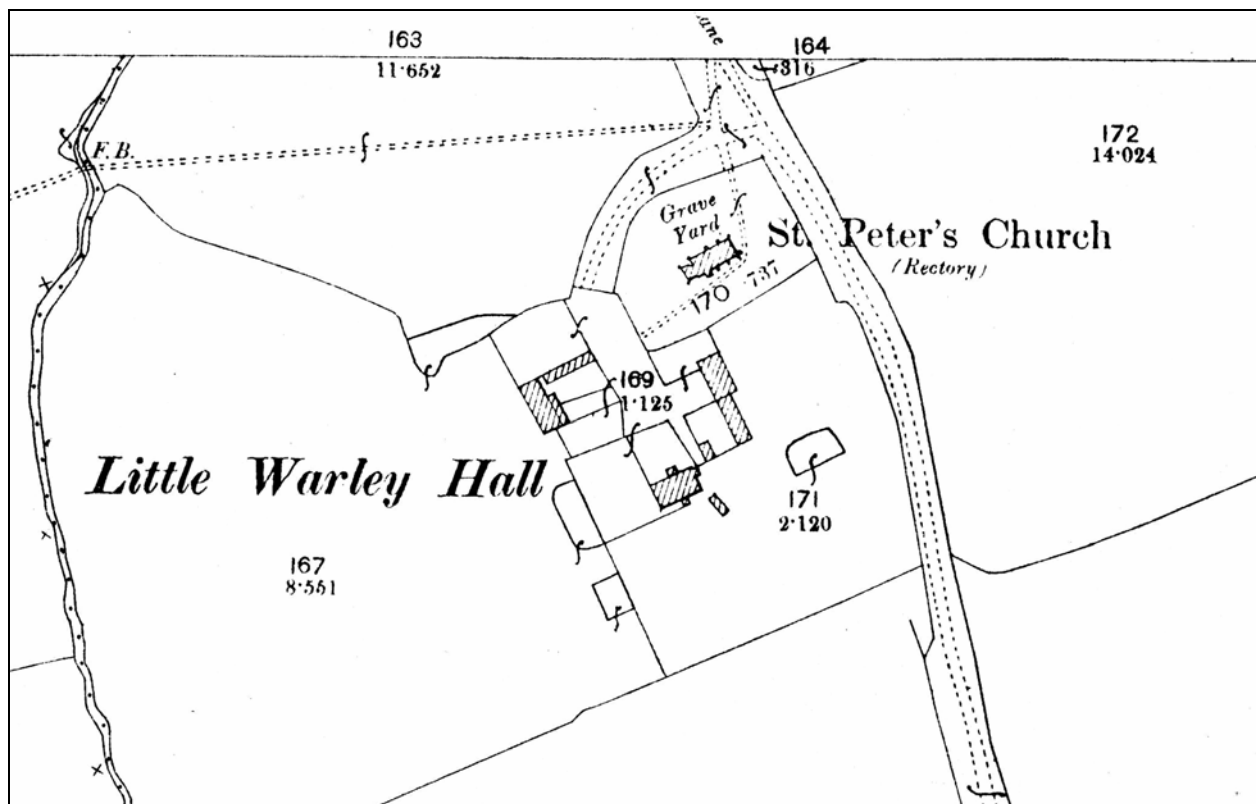
Fig. 4 Second Edition 25" OS map, 1896, (sheet 75.3)

fig.4, the second edition OS map published in 1896. Both maps show separate yards either side of the drive to the hall that now form the eastern paddock (fig.1).

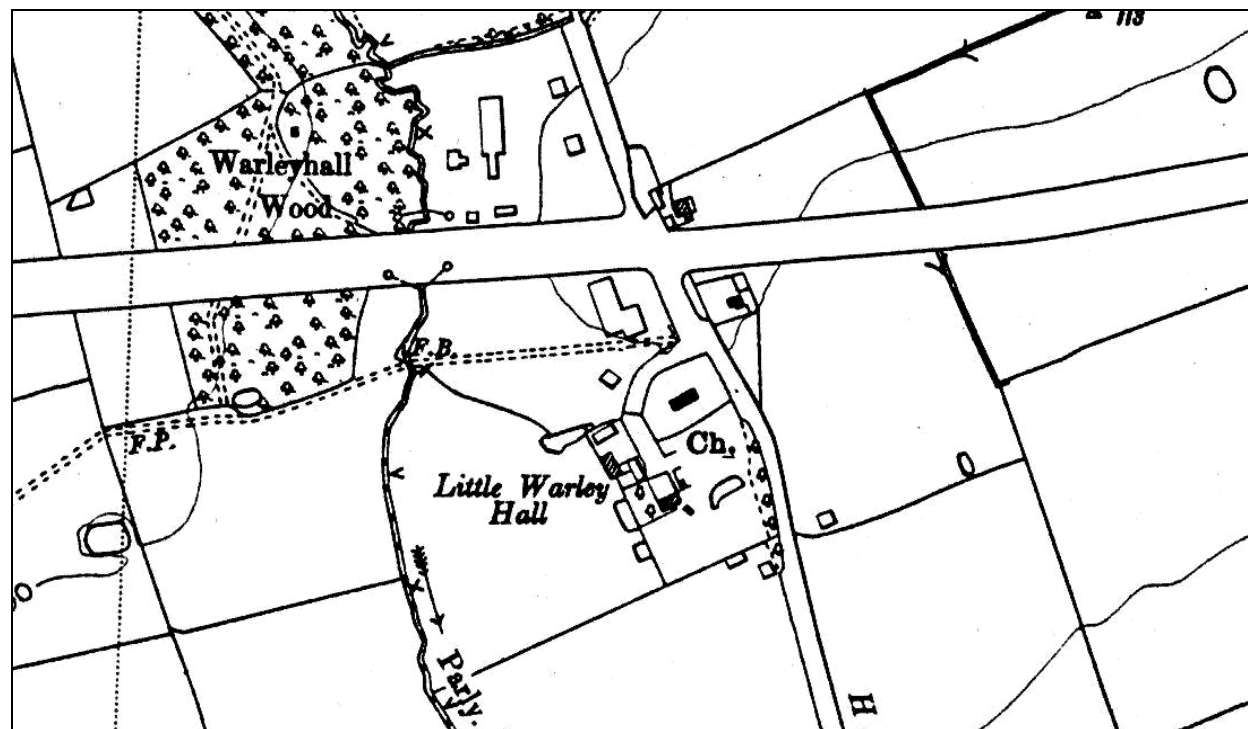
Fig. 5 New series OS map (third revision), 1938

The farm was compulsory purchased by Essex County Council in 1919 (VCHE 1978) and continued to be rented out to tenant farmers as before. The same L-shaped layout continued and is replicated on the 1921 OS map, again with further slight divisions (not shown). By the 1938 OS map (fig.5), the barn has become the only early building left standing, and other structures have been added. These are likely to have been associated with a dairy herd of 12 cows (Mr. Stockley pers. comm.).

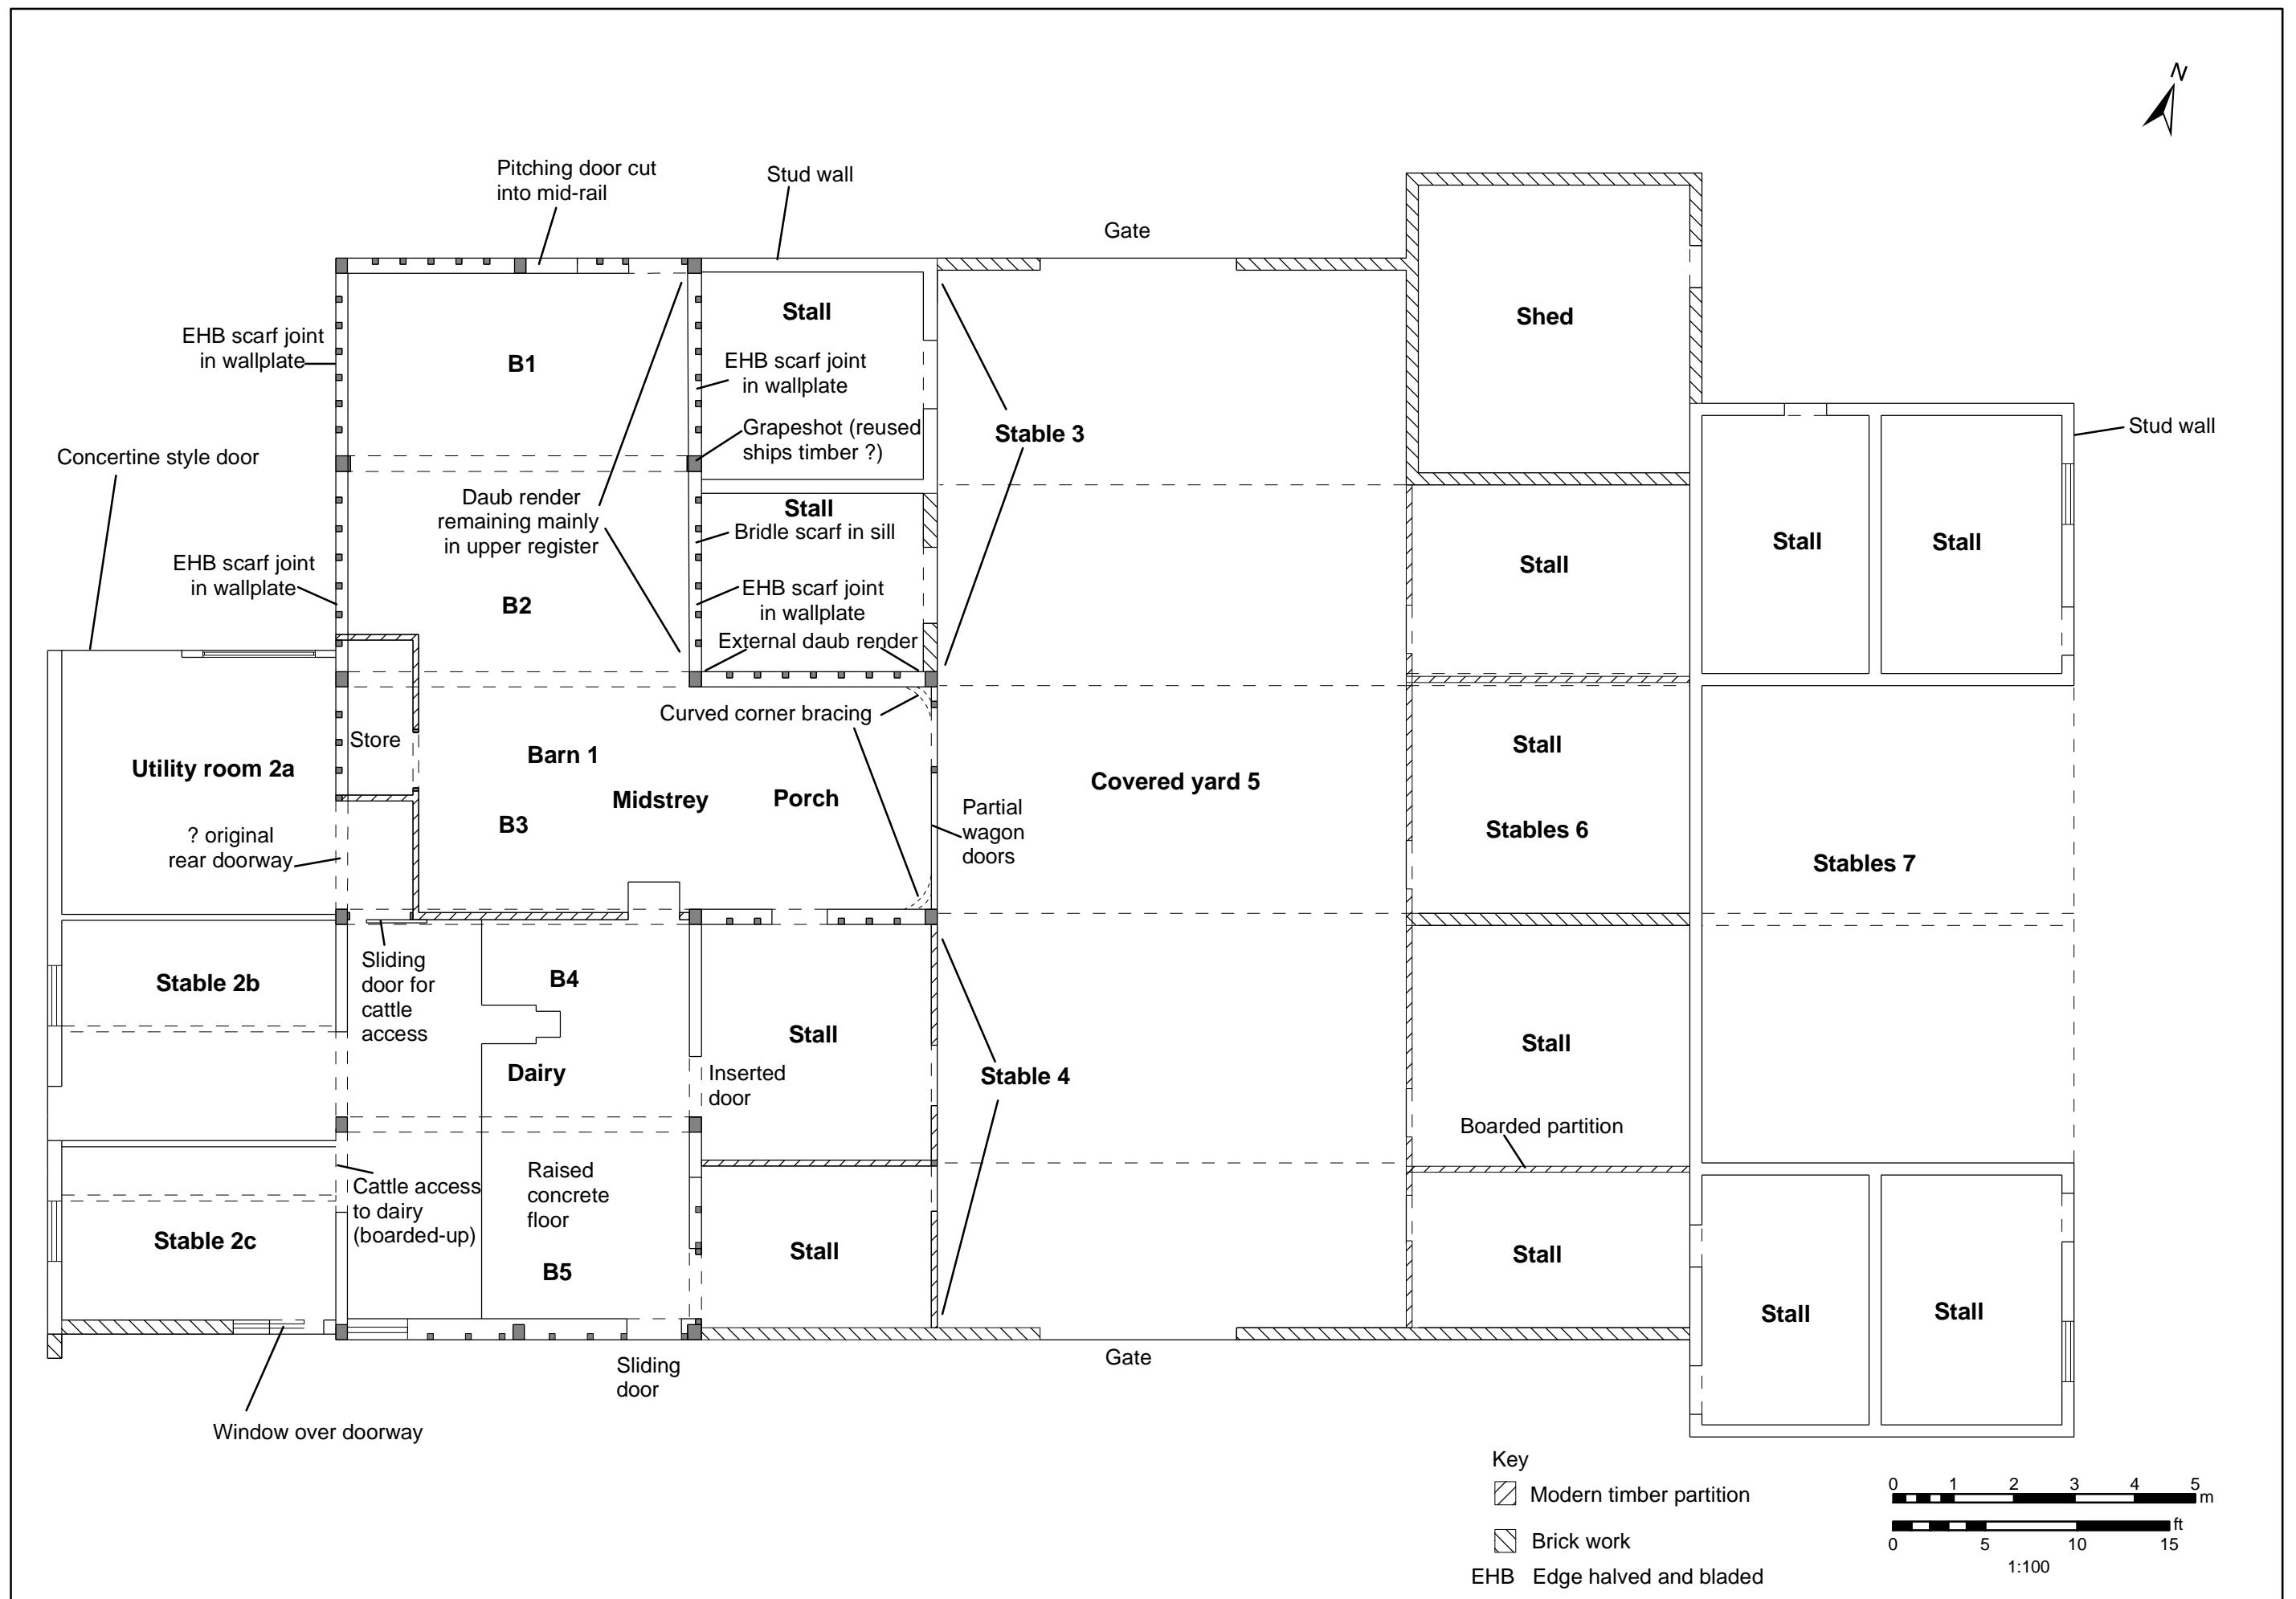
Fig.6. Ground floor plan of barn and stables

is the 'pitching door', where hay or straw could be pitched into the barn from a cart outside (Peters 2003) to fill the final bay (fig.6, plate 3).

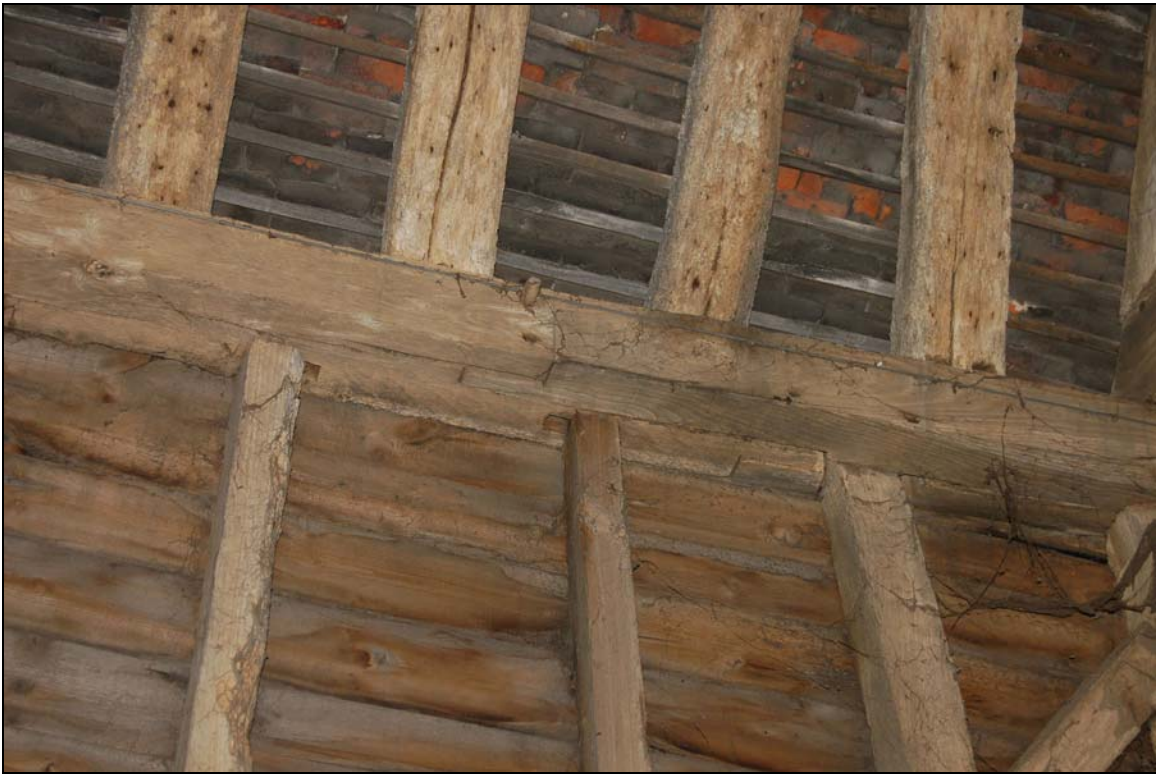
Plate 10 Typical edge-halved and bladed scarf joint in wall plate

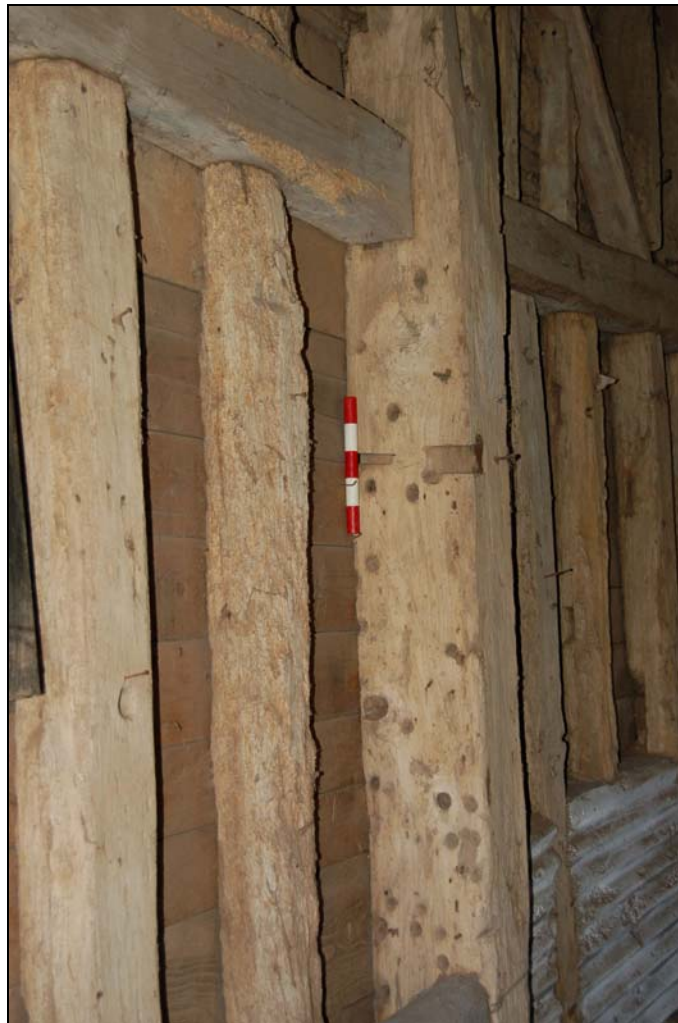
Plate 12 Possible reused ship's timber

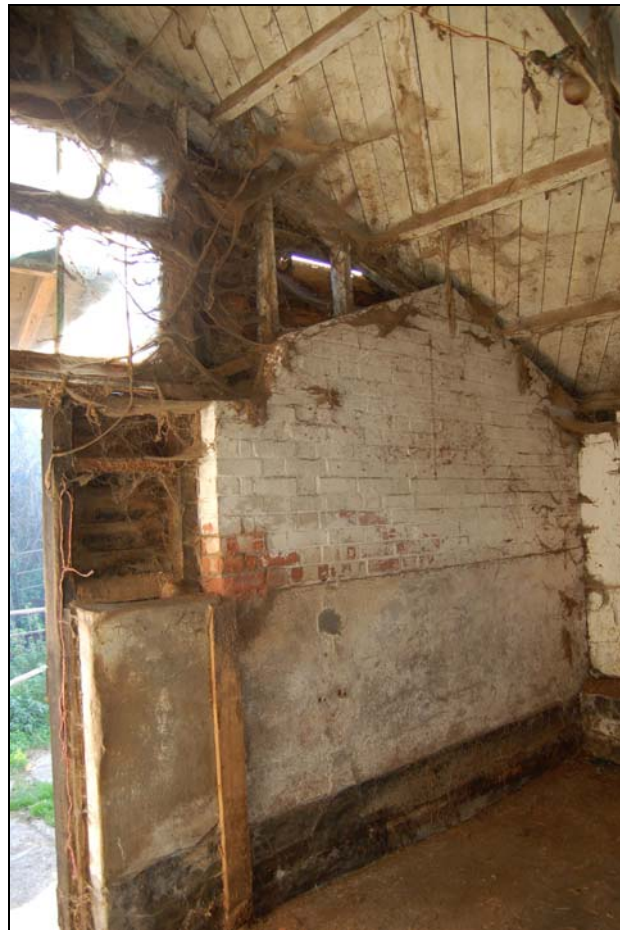
Plate 20 Gable to earlier brick structure preserved within south wall of Stable 2c

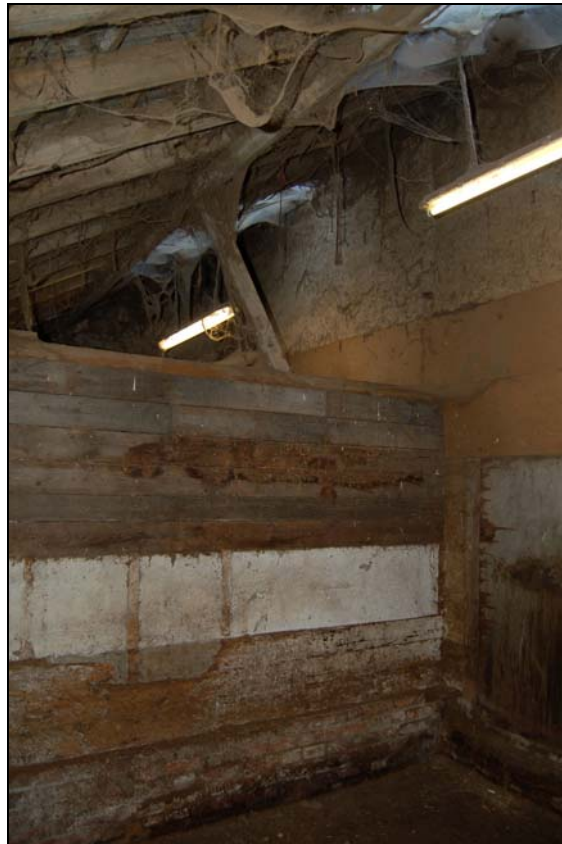
Plate 22 Interior of Stables 3 showing external daub render to Barn

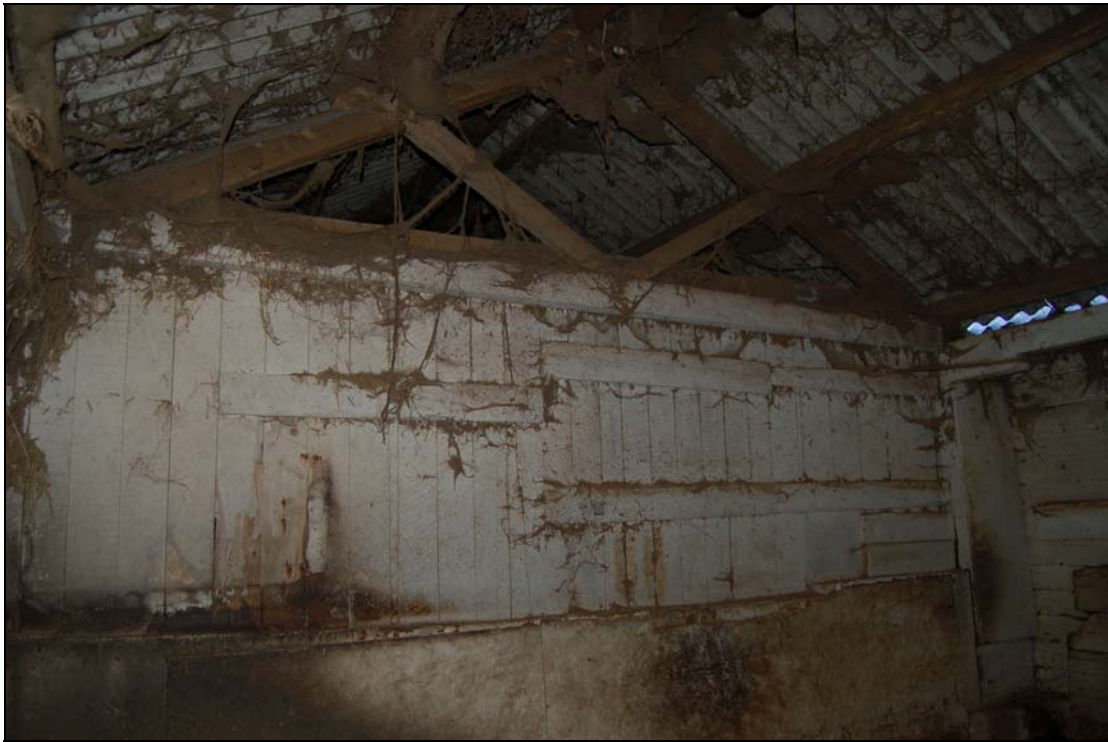
Plate 26 Reused partition inside Stables 6
