**STOKES HALL, ALTHORNE, ESSEX
HISTORIC BUILDING RECORDING
AND ARCHAEOLOGICAL MONITORING**

February 2007

STOKES HALL, ALTHORNE, ESSEX
HISTORIC BUILDING RECORDING
AND ARCHAEOLOGICAL MONITORING

FAU Project No.: 1620

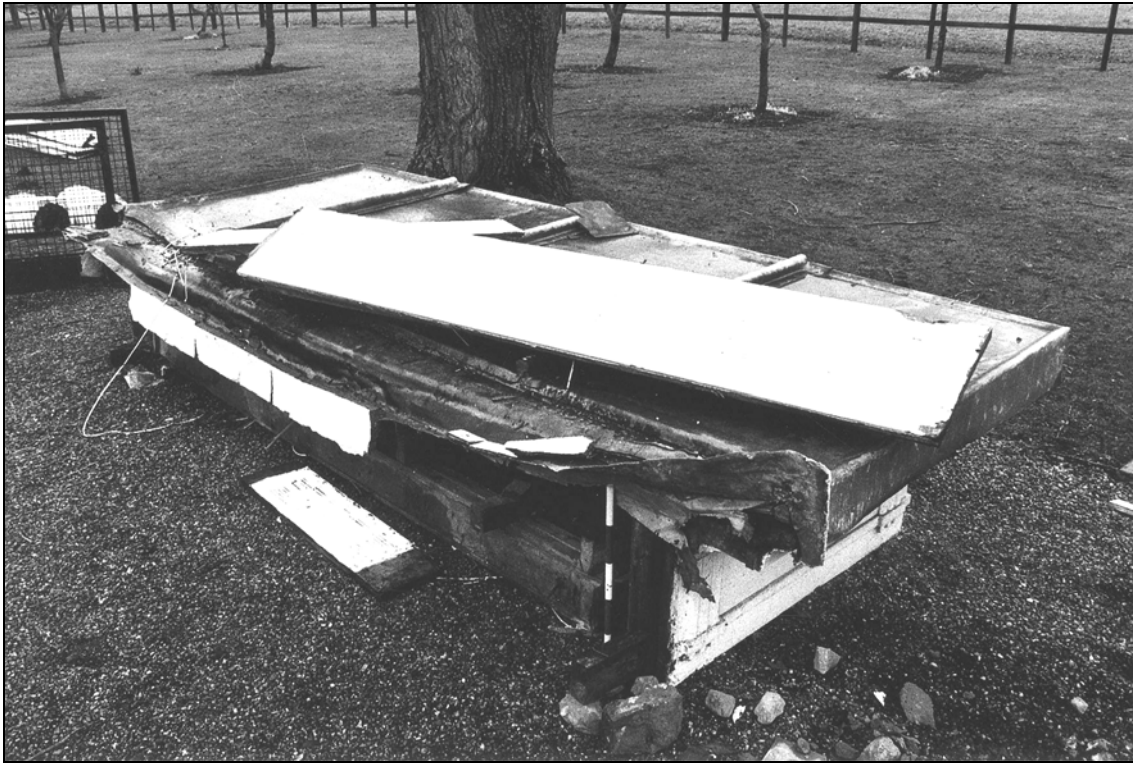
Plate 3 Removed portico

The main entrance is set centrally to the front, with low steps leading to a paved area that lines this side of the house. The 19th-century portico and front door have been removed, and the scar to the former pilasters and entablature are clearly visible, as are the mortice holes that fixed the structure to the wall (plates 1 & 2). After dismantling, the portico was put to one side and recorded photographically during the survey (plate 3). It was noted that the timber columns at the front of the feature were fluted and had stucco bases to add weight. They stood in line with the wall pilasters, two each side of the entrance. Mortice holes indicate their positions in the paving.
