**HISTORIC BUILDING RECORDING OF BARN & OUTBUILDINGS
AT
CHURCH FARM, ALRESFORD
ESSEX**

HISTORIC BUILDING RECORDING OF BARN & OUTBUILDINGS
AT
CHURCH FARM, ALRESFORD
ESSEX

Document Ref.	1721rep
Report Issue Date	16th March 2007
Circulation	Mr. E. Daniels
	ECC Historic Environment Management
	Essex Historic Environment Record

FAU Project No.: 1721

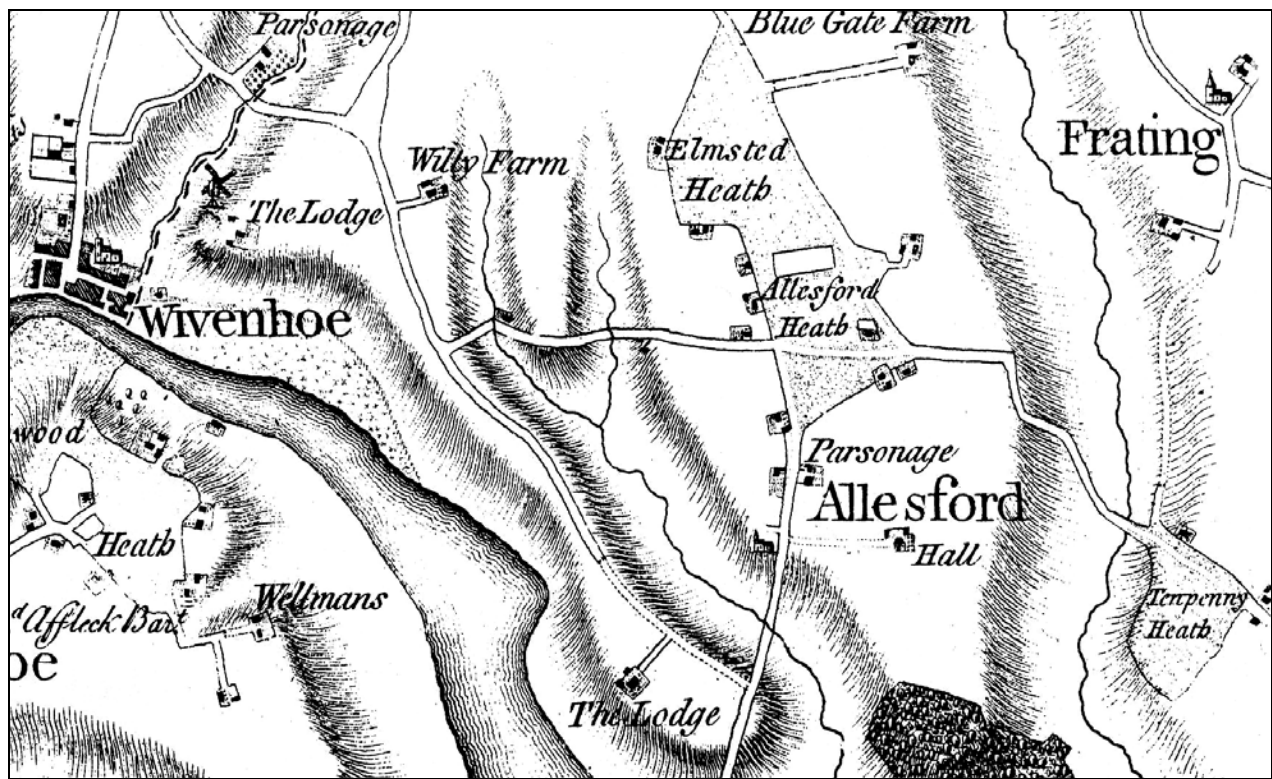
Fig. 2 Chapman & Andre map of Essex, 1777 (plate 9)

Chapman and Andre's map of Essex, 1777, (fig.2) is the earliest surviving cartographic record studied and appears to show an earlier, pre-improvement, farmstead. It shows a plot with two buildings at the base of the fork in the road in the same place where Church Farm is now located. Although lacking the detail to accurately identify the structures, they are in roughly the correct positions to be the barn (though drawn with porch to the west) and a farmhouse, the forerunner of the existing house.

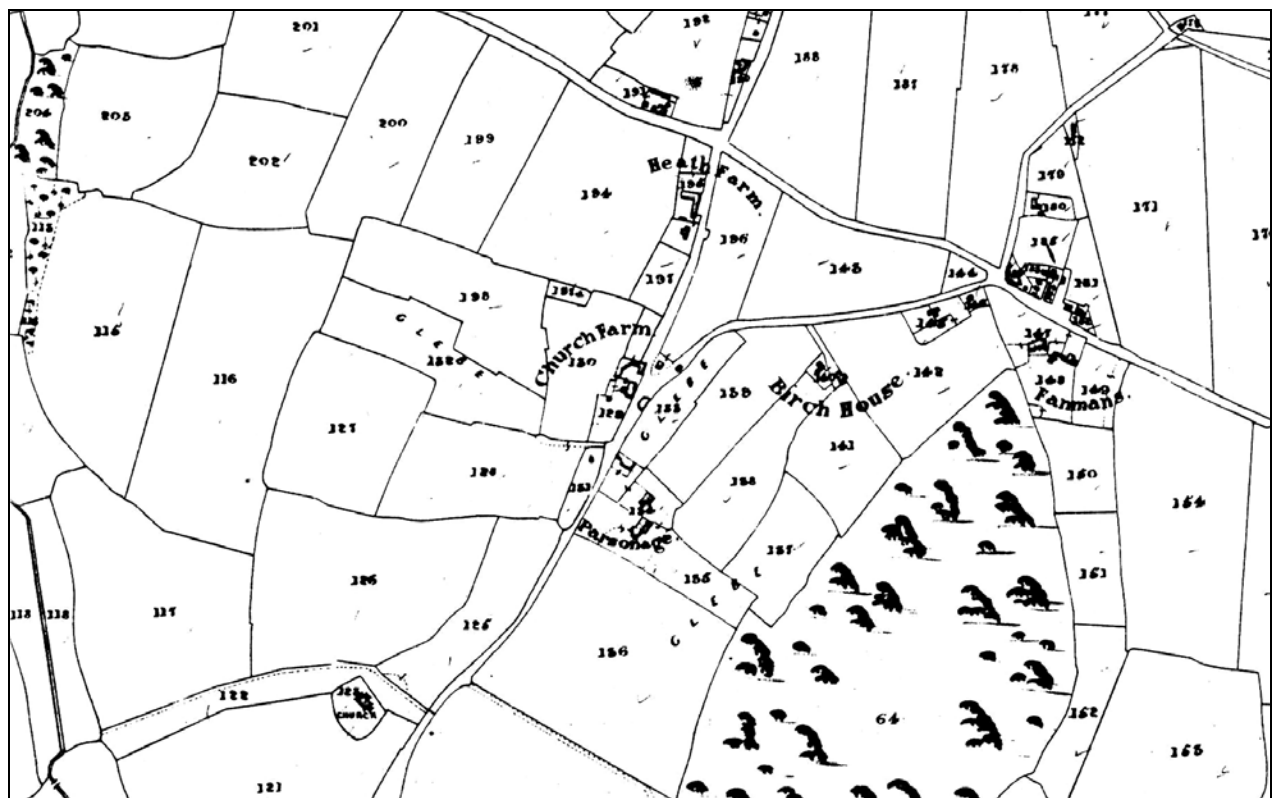
Fig. 3 Allesford tithe map, 1839 (D/CT 4B)

Alresford tithe map of 1839 (fig.3) clearly indicates Church Farm and shows the barn, with cowhouse 6 extending southwards and an L-shaped building to the east (fig.3). This later structure was lost when the farm was improved in the mid-19th-century and cowhouse 5 now stands on much of its footprint. At this stage, the barn extension and other structures

The accompanying *tithe award* (ERO D/CT 4A) lists a small farm of c.25 acres owned by George Higginbotham and Sarah Schofield and rented to Joseph Barton. The land is predominantly to the south of the farmstead and it is likely that grazing pasture is included as plot 209 in the award; 'the homestead' (fig.3).

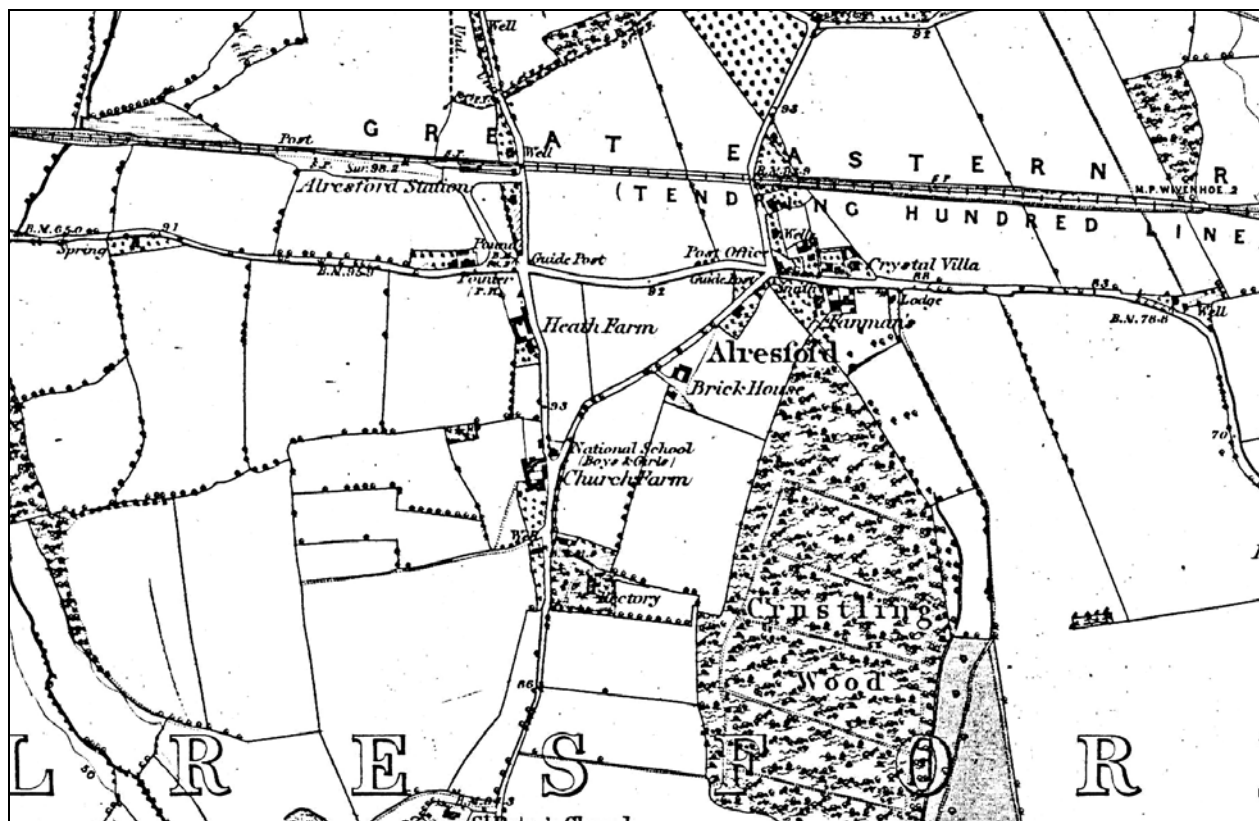
Fig. 4 First Edition 6" OS map, 1879 (sheet 37)

The *first edition Ordnance Survey map of 1879* (fig.4) shows that the farm was improved in the 'high farming' era between 1839 and 1879. By 1879, the granary, cowhouse 5, wagon house/stables 7 and the farmhouse have been built, representing much of the existing layout. An extension was made to the house around the end of cowhouse 6, possibly a utility range (dairy, etc.), that was recently lost to the modern extension (fig.1). A pigsty, no longer standing, has been built beside the wagon lodge, seen in better detail in the following OS map. The same is true for a shelter shed built against the road in the northern pasture (fig. 5). Two yards are present at this point. The pole barn, built much later, is the only structure not part of this group. A deed studied from the same year (ERO D/DB T1301) gives the holding as 120 acres, a five-fold increase in land in the from the date of tithe map 40 years before. Although the exact proportions of arable and grazing land are unclear, this increase may account for the improvements carried out at this stage, i.e. building of the granary and barn extension and remodelling of the cowhouses.

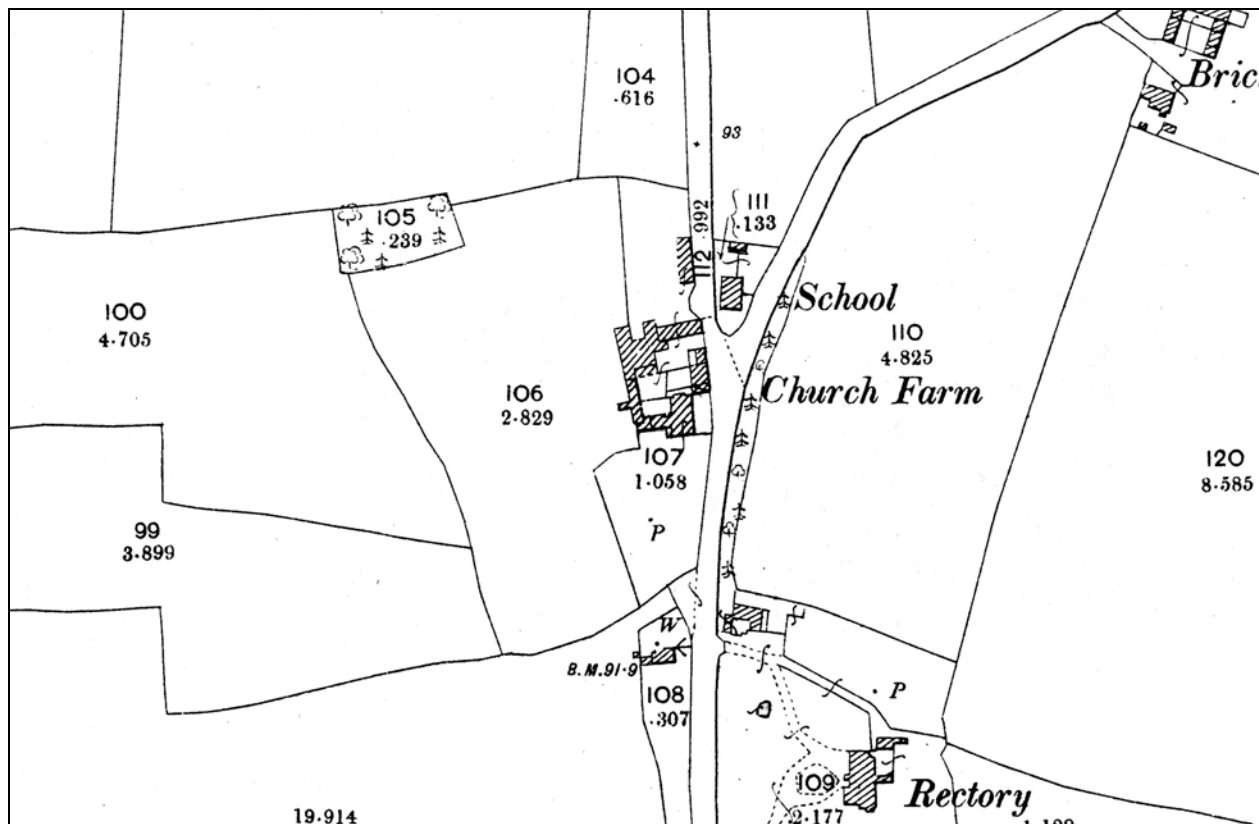
Fig. 5 Second Edition 25" OS map, 1897 (sheet 37.3)

The *second edition OS map of 1897* (fig. 5) shows little in the way of change but is important in understanding how the farmyard worked. It shows three main yards. The southern yard defines the service/utility areas to the house. The central yard, divided into three was for cattle (left) and for horses and wagons to manoeuvre (right). The area in front of the store within Building 7 is enclosed. The third (north) yard serves cowhouse 5, with cart access to barn and granary, and a small yard encloses the pigsties. An open-sided shed is attached to the stables on the south side of loose box 2, linking to the north end of cowhouse 6. There is also a structure on the east side of the granary, covering part of the cowhouse (fig.5). Both of these structures are no longer standing, but evidence for the shed was recorded in the survey.

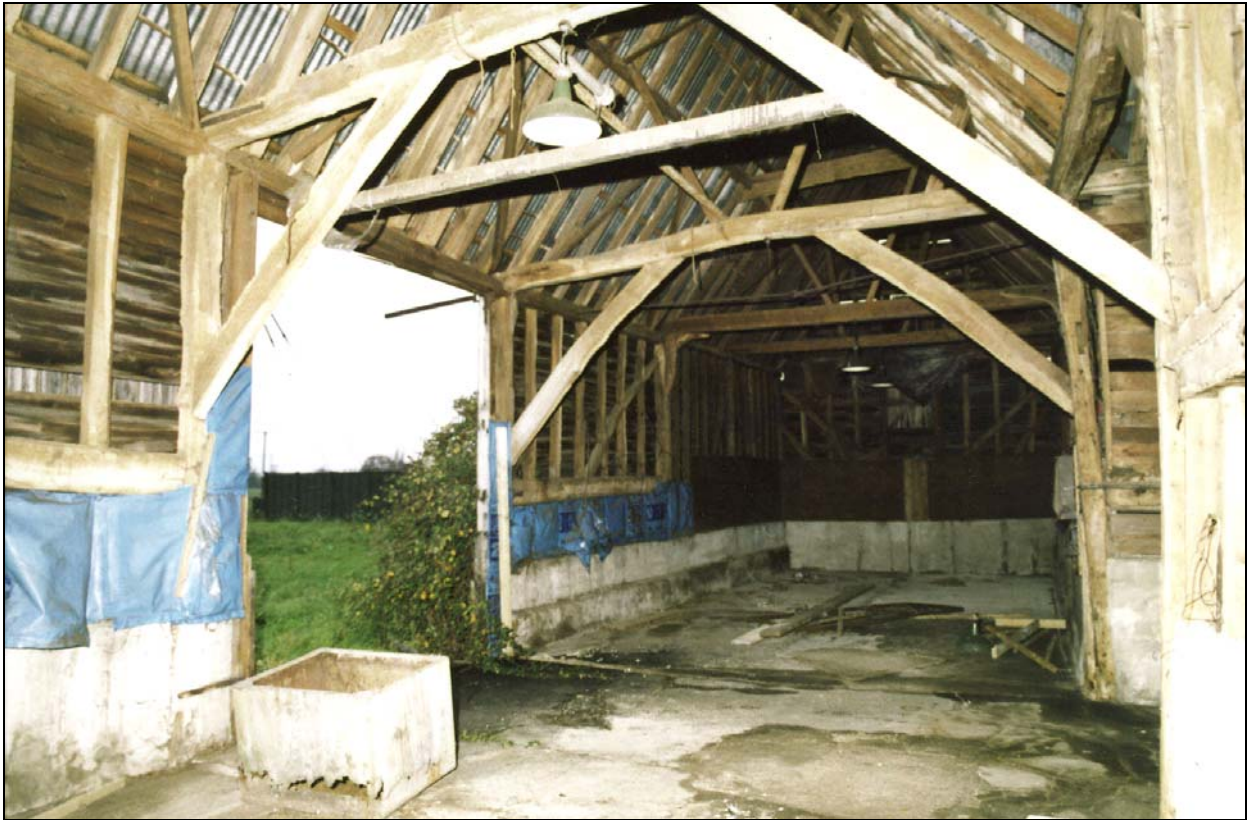
Plate 7 Barn interior viewed to rebuilt north end

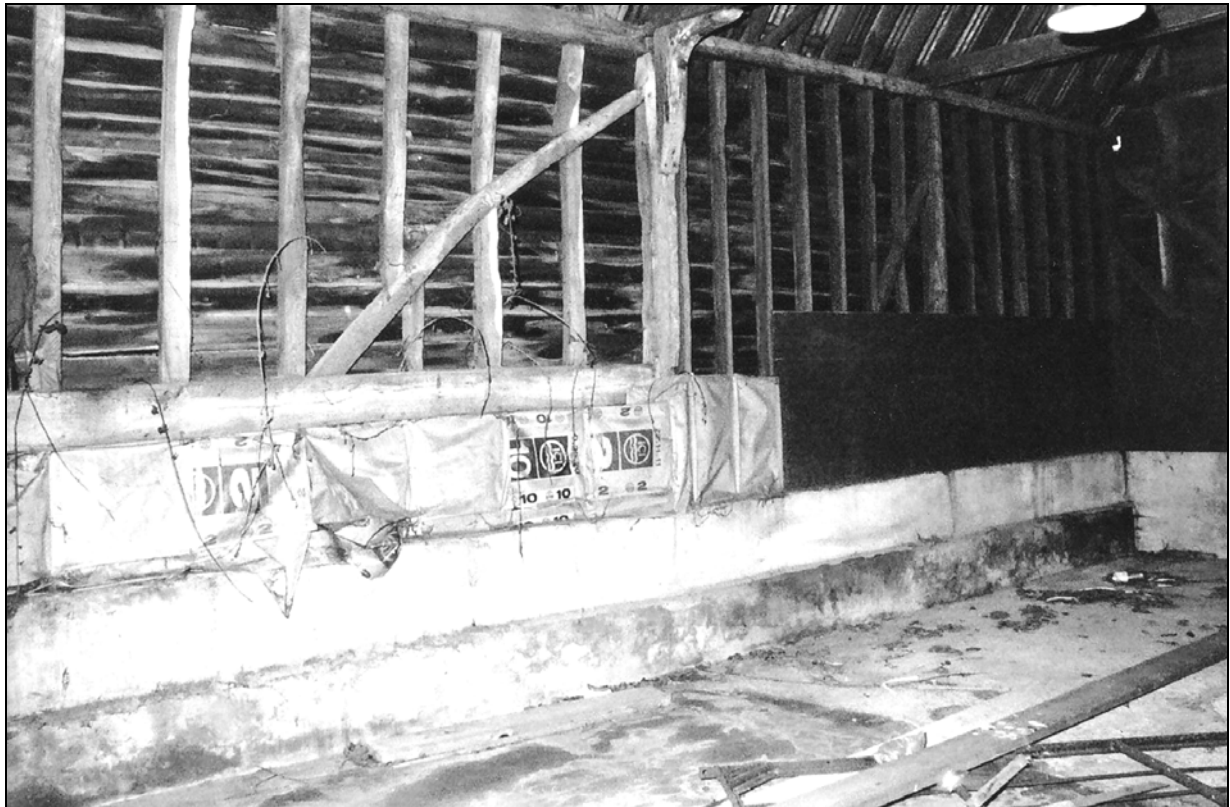
Plate 8 Comparison of primary and secondary builds in barn

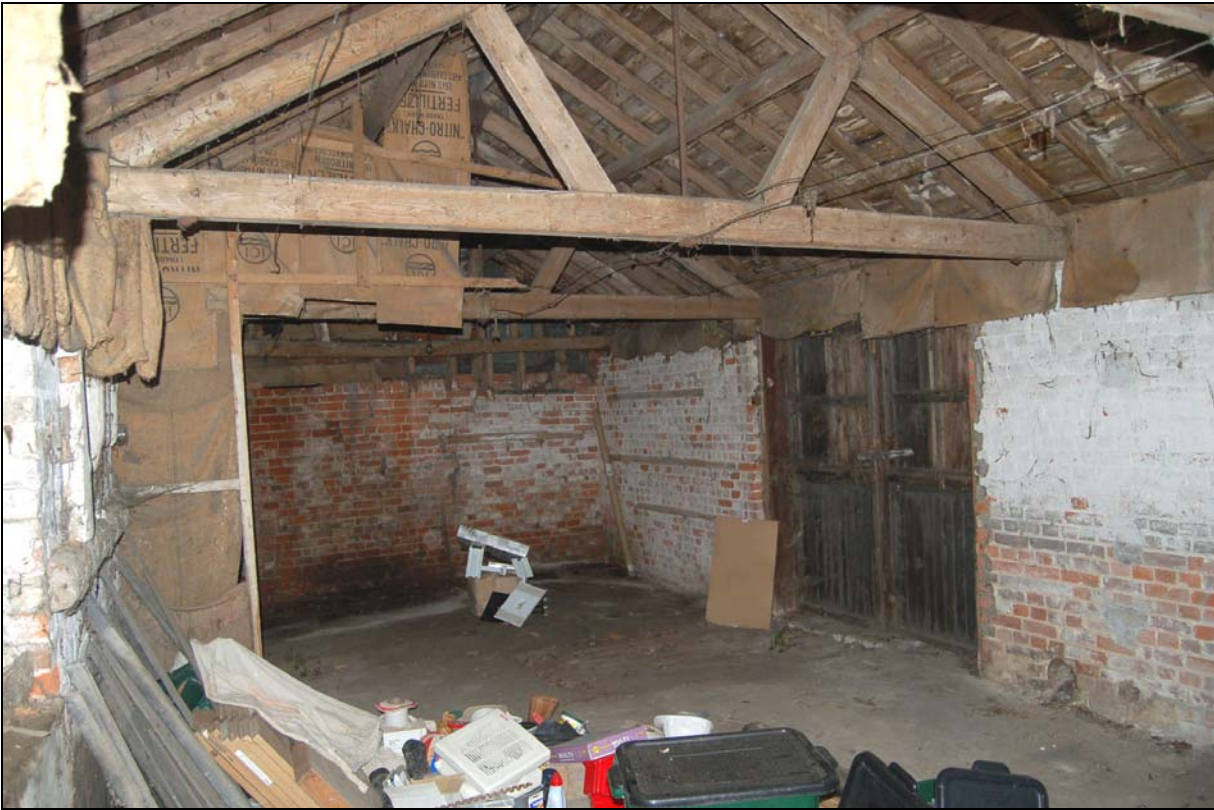
Plate 19 Interior of cowhouse 5 showing exposed brick floor by cow doors

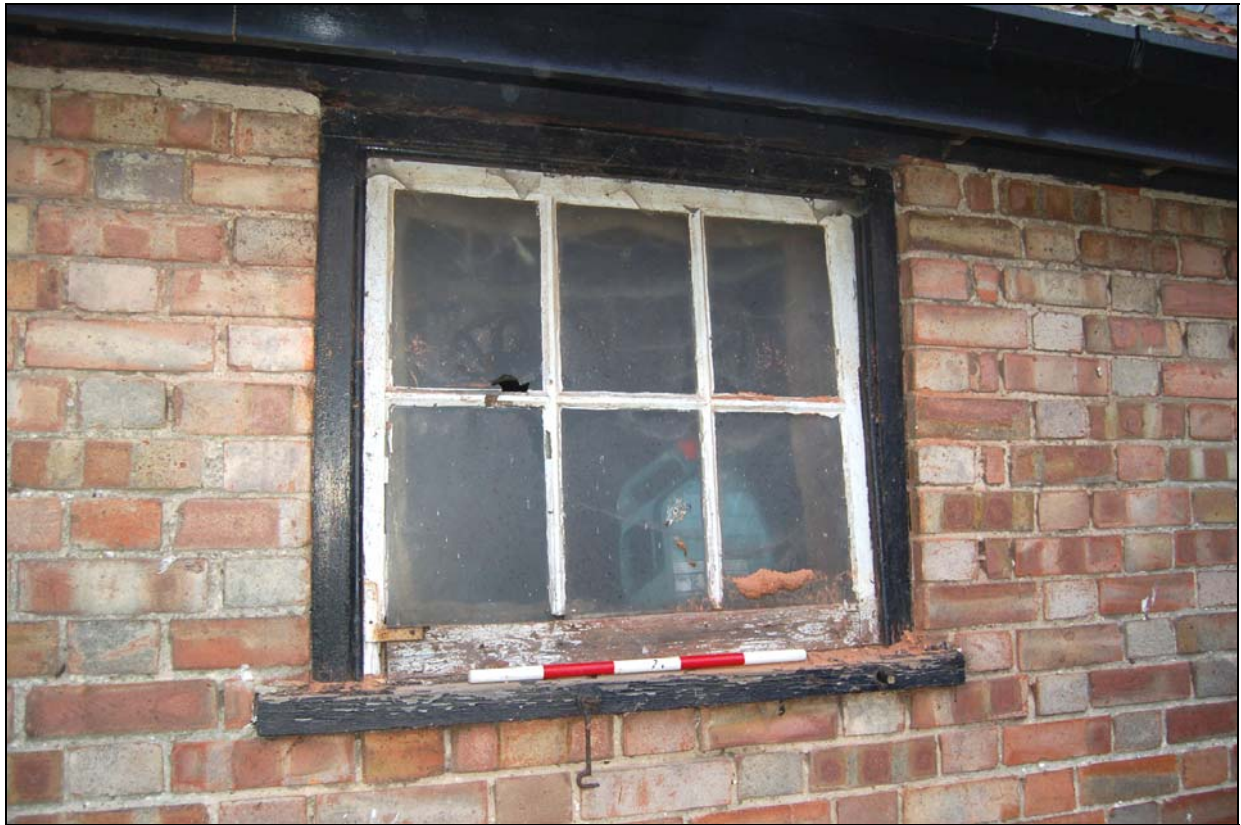
Plate 22 Typical cowhouse 6 window set within later brickwork
