**BARN AND OUTBUILDINGS ADJACENT TO THE TOWER ARMS
SOUTH WEALD
ESSEX**

**HISTORIC BUILDING RECORDING AND ARCHAEOLOGICAL
MONITORING**

Field Archaeology Unit

June 2007

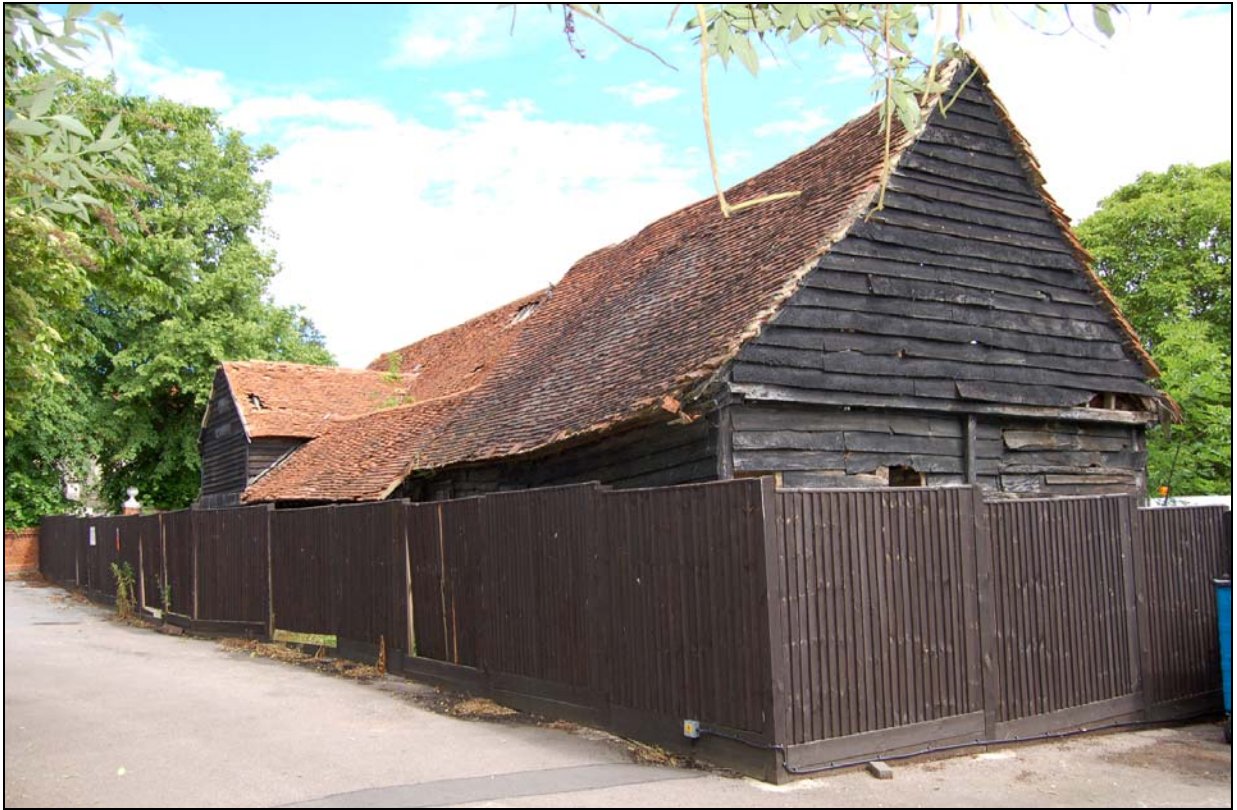
From the 19th-century maps, the byre formerly had a smaller structure built onto its south end, that was removed in the 20th-century. An external mid post and wall plate, both machine-sawn, remain on the south end to show the building as a late 19th-century addition rather than contemporary with the byre (plate 13).

Plate 13 Byre and other buildings viewed from south

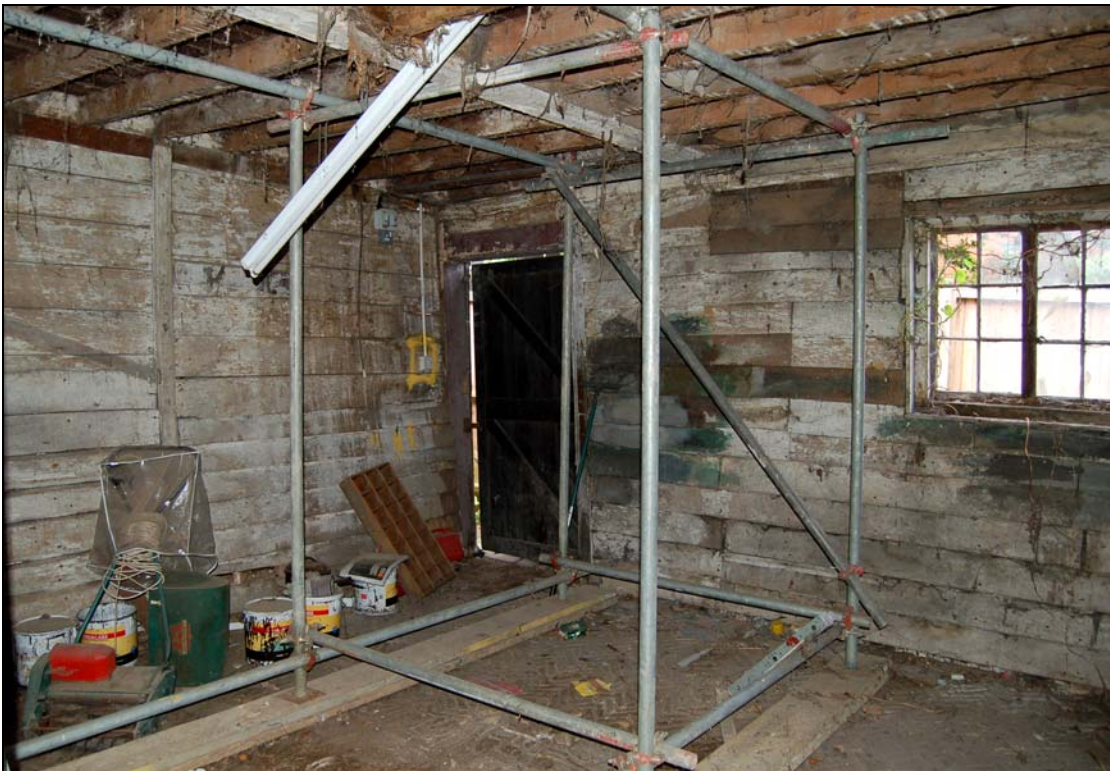
Entry to the tackroom is solely from the west (pub) side through a ledged and battened door. Beside it is a pair of six-pane ovolo moulded casement windows of likely 19th or early 20th-century date (plate 16). Entry into the byre side is either side of the south-east corner. Both doors are missing, but it is plain the south door is a later insertion (fig. 6). A third connects between byre and lean-to which, judging from its waney timberwork, is contemporary with the barn (18th-century). Otherwise, apart from some dishevelled clapboard, the elevations are fairly bland. It is difficult to deduce how light got inside this part of the building. There are no windows except on the east side, where there is an opening and ledge in the studwork (fig.10). This was found beneath the later boarding during the survey and is likely to be contemporary with the first phase of the structure, but was not seen inside because of the internal boarding (plate 20).

Plate 16 Tackroom interior viewed from north-east

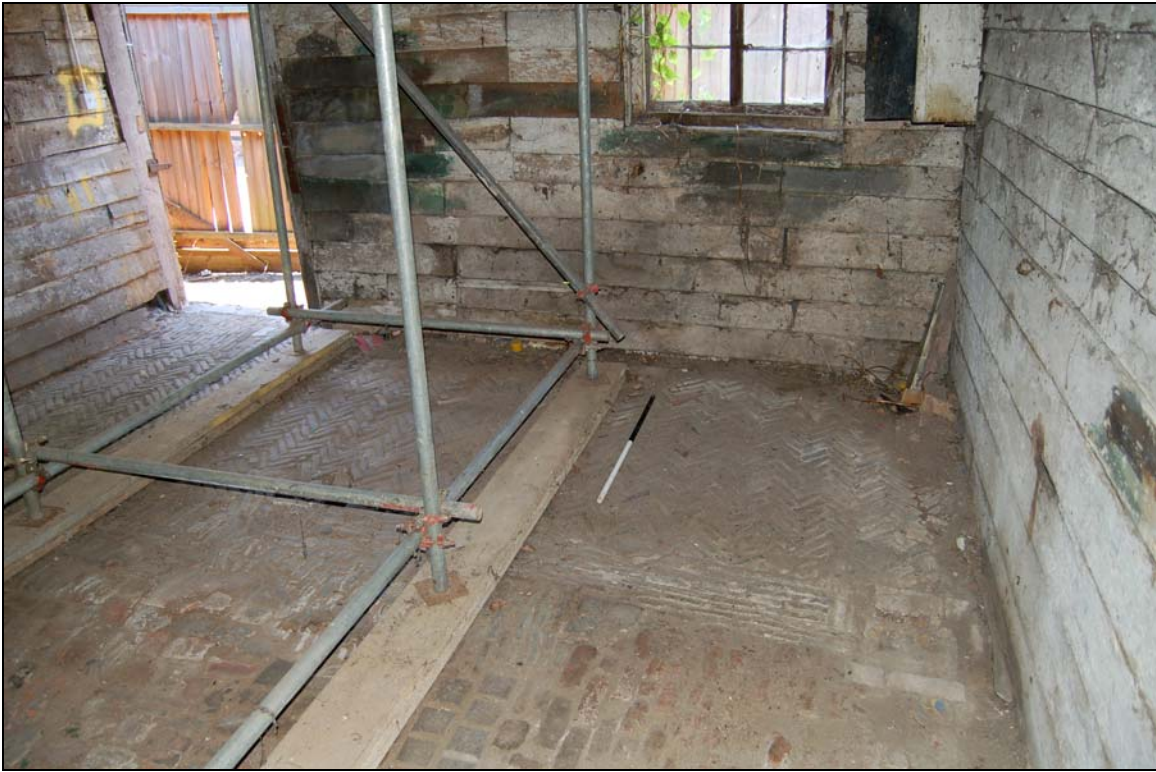
The tackroom is the larger of the two bays (9 x 10m) encased in limewashed horizontal clapboard and moulded cornice (plates 17 & 18). A partial cement render covers the east side. A worn herringbone floor, comprised of floor bricks with 4 x 16cm dimensions, fills the area to the west of a shallow brick-lined gully that leads to a now-blocked drain by the north wall (fig. 6, plate 17), an indication this was used as a stable before it became the tackroom. On the other side, the floor is more random, with floor bricks, half bricks, stone fragments and 4" granite setts arranged in no particular pattern (plate 17). The north side holds what may be a modern low wooden trough frame, more likely for goats than horses. The ceiling joists are straight machine-sawn timbers, showing a later insertion. Nail holes in the joists show where a lath and plaster ceiling was removed, presenting, along with the moulded cornice partly-surviving on the north wall (plate 18, left), a more decorative area.

Plate 17 Herringbone floor in tackroom, viewed from north-east

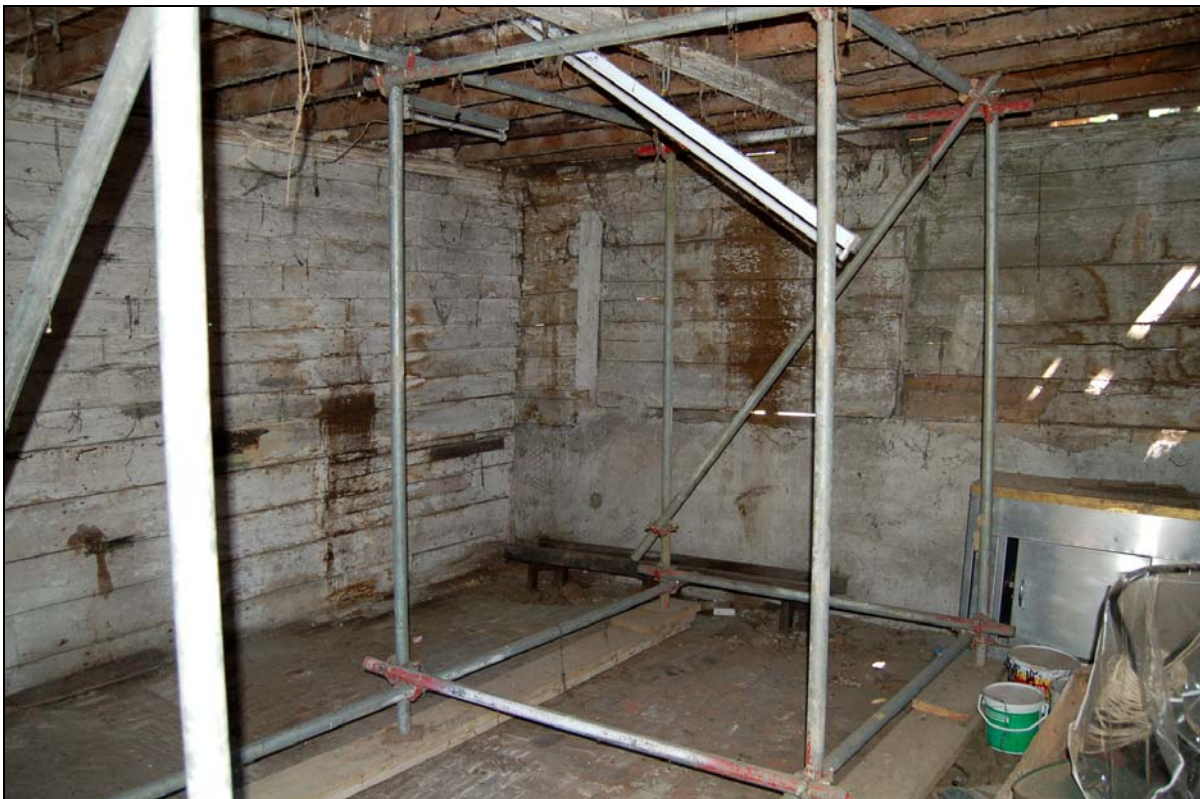
Plate 18 Tackroom interior viewed from south-west

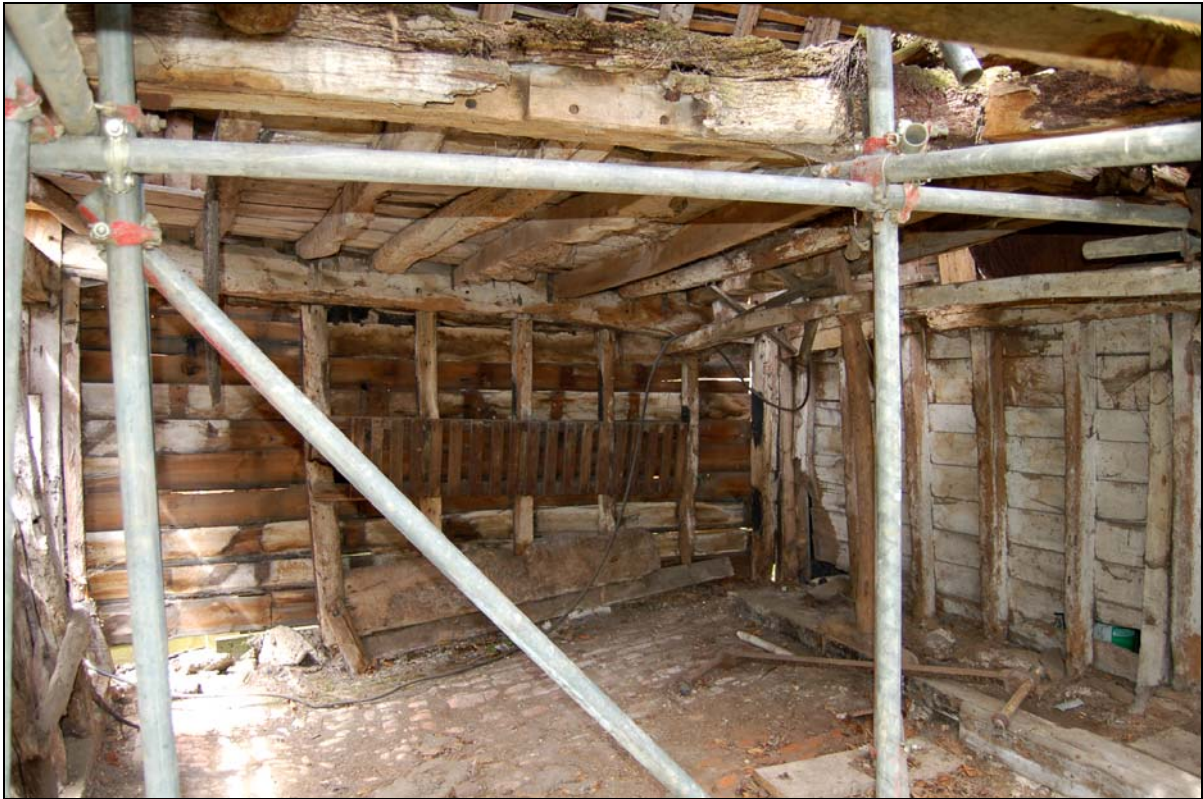
Internally the ground floor of the byre shows clear evidence of its former use. Identical bricks are used to create a hard-wearing floor, arranged in approximate lines north to south, end to end and rather worn through use (plate 19). Lower areas of walling are boarded to prevent damage and there is a gated holding pen in the north-east corner, screened-off by a studwork screen contemporary with the partition build, but not intact. Above there is a gap in the ceiling for ladder access to a hay loft above. Hay could be dropped by two drop zones to the animals below on opposite sides to supply animals in separate pens (fig.6). The first floor is lain on ?nailed wooden clamps, and is likely to be an original feature. A roughly-chamfered 20cm² heavy bridging joist (plate 19) spans the room from north to south onto which floor joists are pegged and jointed with bare-faced soffit tenon with housed shoulder jointing. Most of the joists are fairly waney and some have bark on and would probably be plastered over if this were a house of the same date. The floorboards are sturdy 9" oak.

Plate 19 Ground floor of byre, west wall and partition

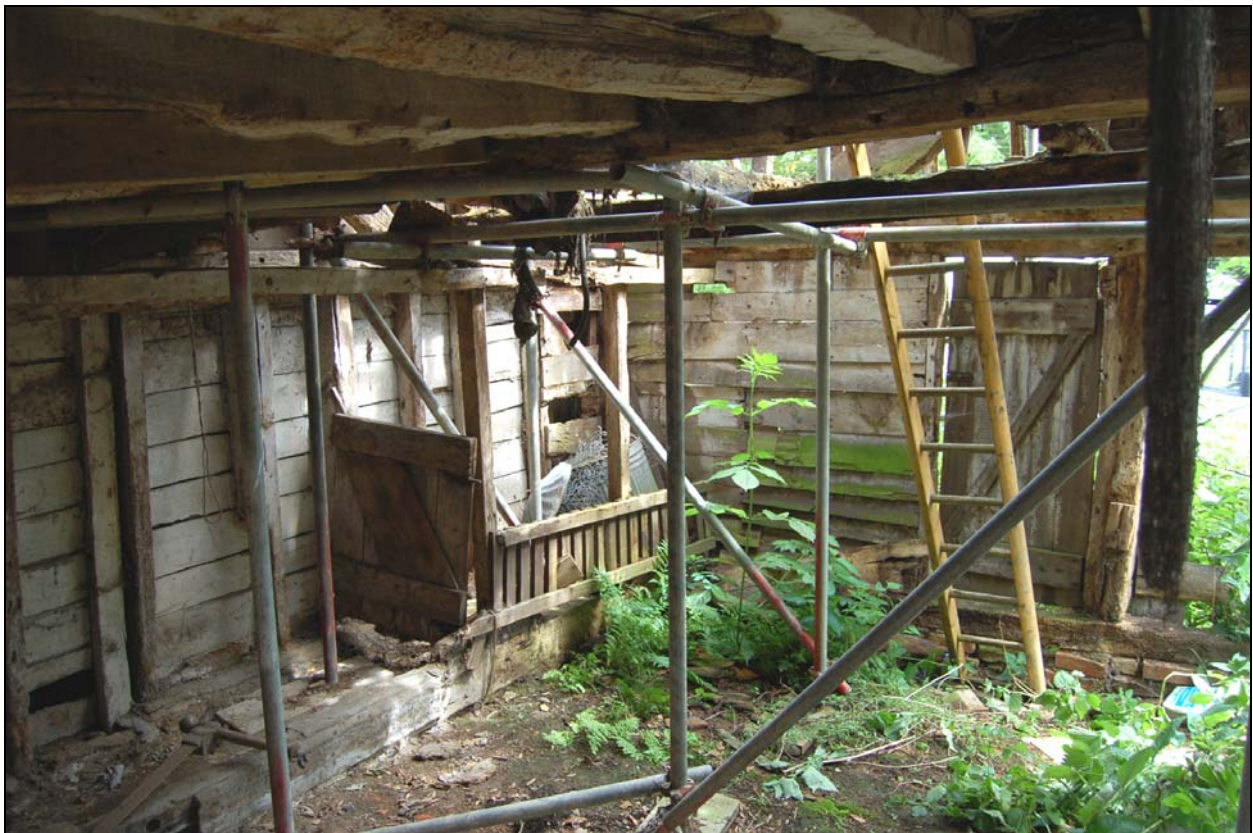
Plate 20 Ground floor of byre, showing pen in north-east corner

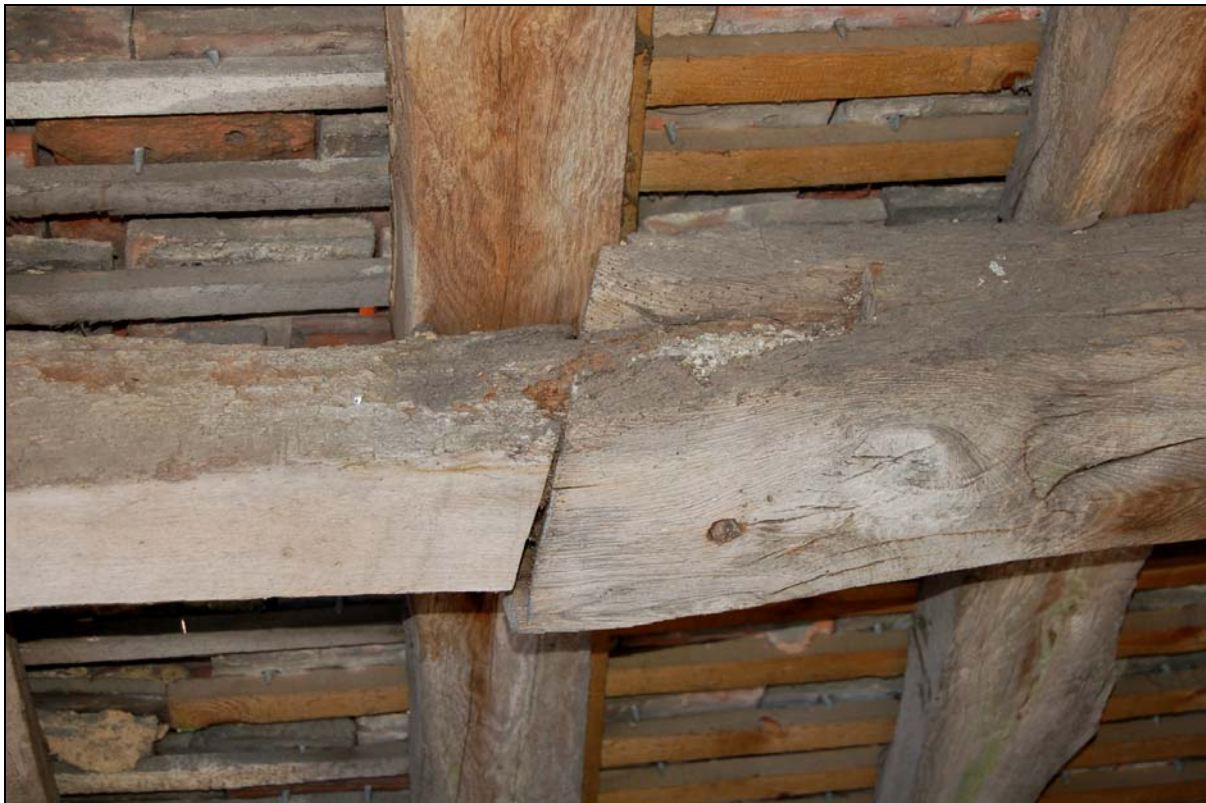
Plate 24 Purlin with bridle scarf with squinted abutments in roof of byre
