**HISTORIC BUILDING RECORDING OF BARN & OUTBUILDINGS
AT
WALNUT TREE FARM, FANNER'S GREEN
GREAT WALTHAM
ESSEX**

Essex County Council

Field Archaeology Unit

September 2007

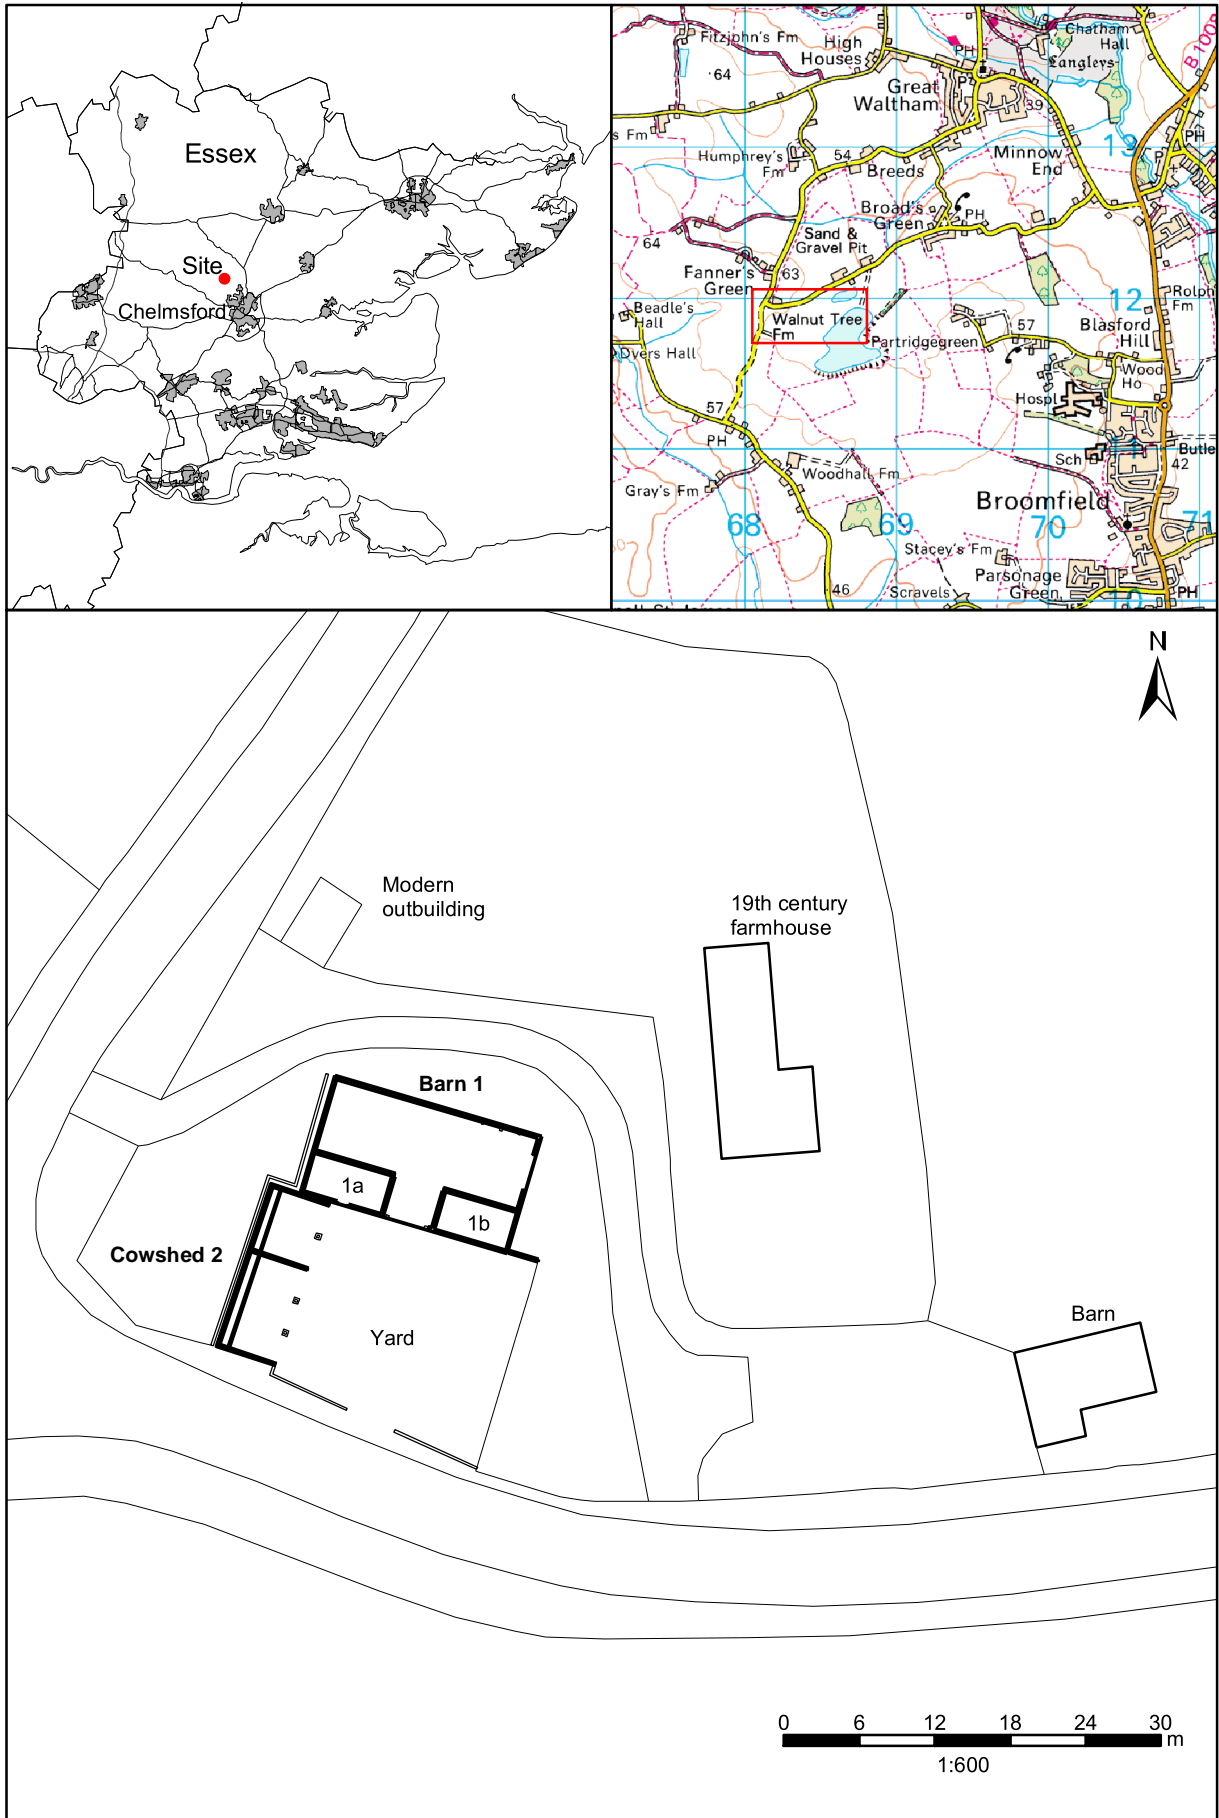
Fig.1. Location and block plan

Walnut Tree Farm stands at the intersection of two minor roads to the south of Fanner's Green, a small hamlet approximately 2km south-west of Great Waltham. The farm has undergone many changes during the past two centuries and currently only the barn and cowshed remain. Together they form an L-shaped block facing the road (fig.1), with a dirt

The farm remained on the same layout up to the 1950s at least. At some stage after, the buildings around the north yard were demolished to expand the garden. A circuitous trackway was laid across the middle of the old yard (fig.1). Cattle were kept in the barn in the 1970s. In recent years the building to the east of the southern yard was pulled down (J. Mitson pers. comm.).

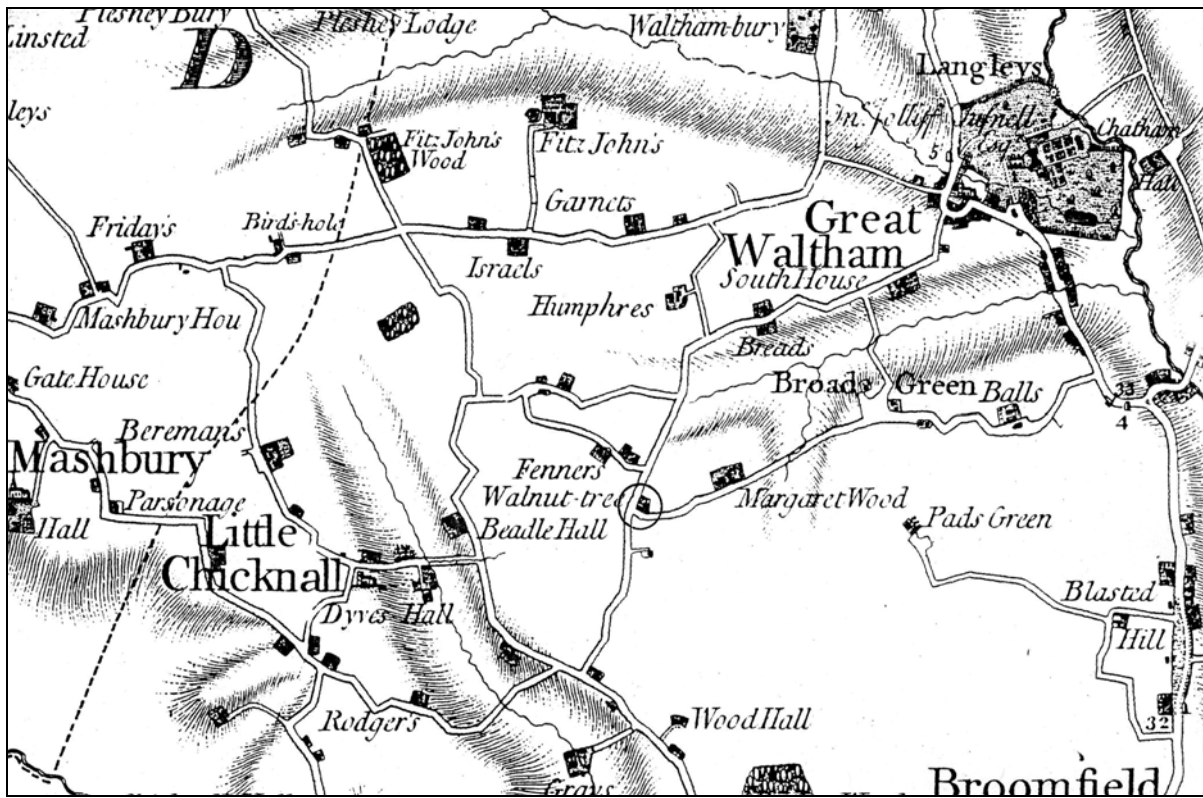
Fig. 2 Chapman & Andre map, 1777

Fenners and Walnut Tree Farms are indicated on Chapman and Andre's map of 1777 (fig.2). Buildings are shown within a square plot on the road junction, but the detail is insufficient to identify coherent structures.

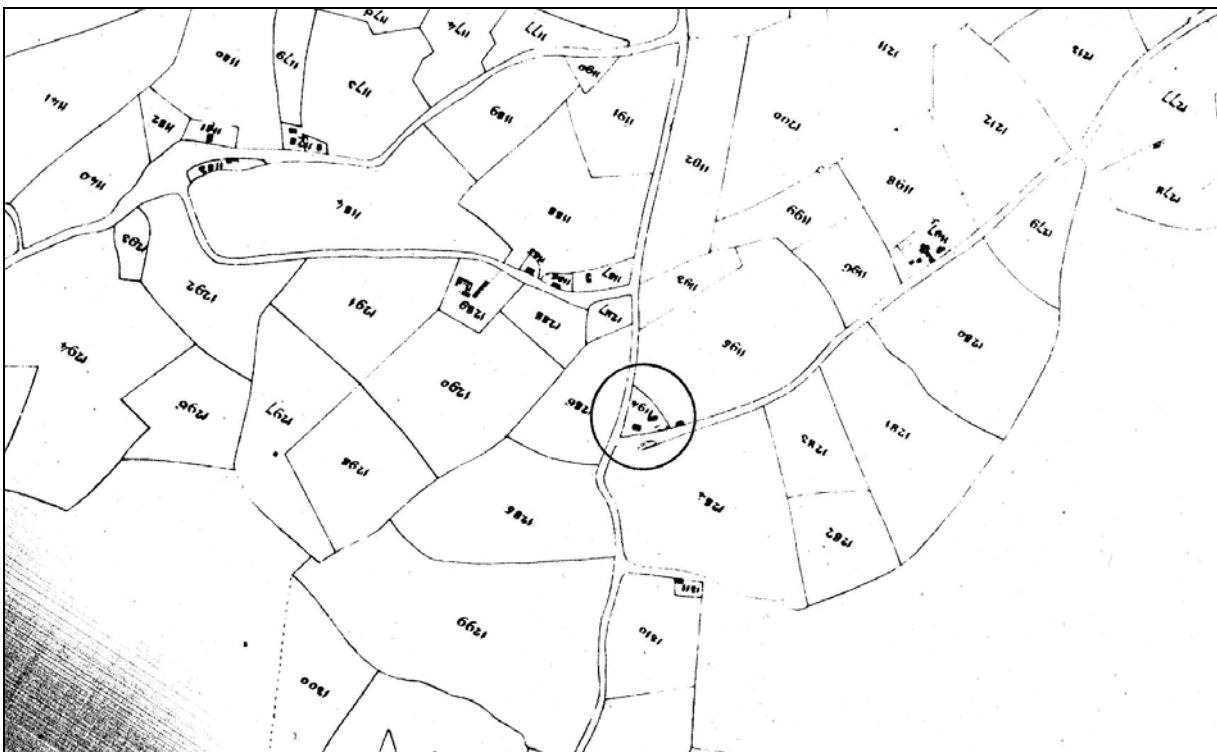
Fig. 3 Tithe map of Great Waltham, 1840 (re-oriented to north)

Great Waltham tithe map of 1840 (D/CT 379B) shows little agricultural improvement in the first part of the 19th-century. It basically shows the post-medieval farmstead from 1777 in greater detail. Curiously, the tithe map is drawn to the south-east, so it has been re-orientated to rough north in this report (fig.3). The map depicts two structures within the same roadside plot. One is clearly the barn, while the other is likely to be the original farmhouse. Another structure stands to the east, a small barn that stands outside the development area and is owned by the farmhouse. Two ponds are situated either side of the road.

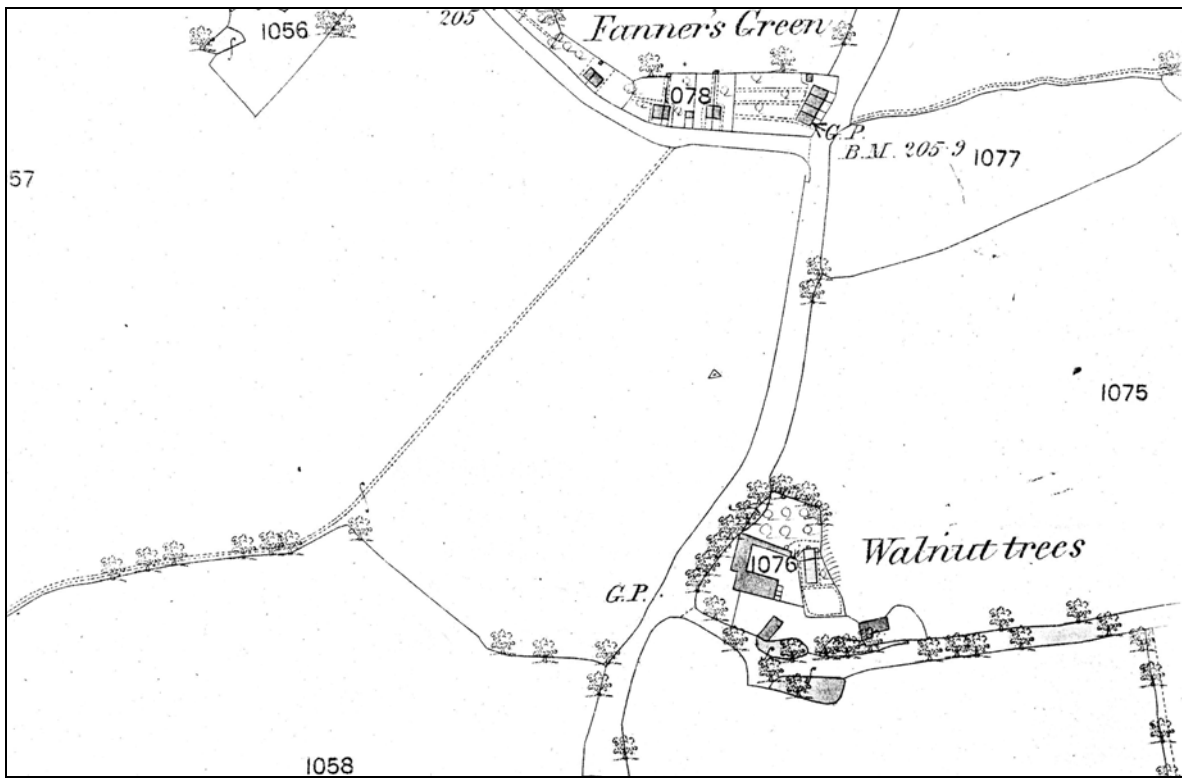
Fig. 4 First edition 25" OS map, 1875

Between 1840 and 1875, the publication date of the first edition OS map (fig.4), the farm has undergone improvement from the scattered farmstead into a planned courtyard layout. The barn has been retained, forming the southern end of the yard, with pens added to the east end, probably sties for the pigs, close to the house. Either a cow or cart shed is added on the west side of the yard, as it is shown open-sided on the succeeding map (fig.5). A thin linear range lies on the north side of the yard, whose function is not known. The farmhouse has been rebuilt on the east side of the yard within its own garden and orchard (fig.4). A second, southern yard is partly defined by walls extending from the front of the barn and structure set askew to the rest.

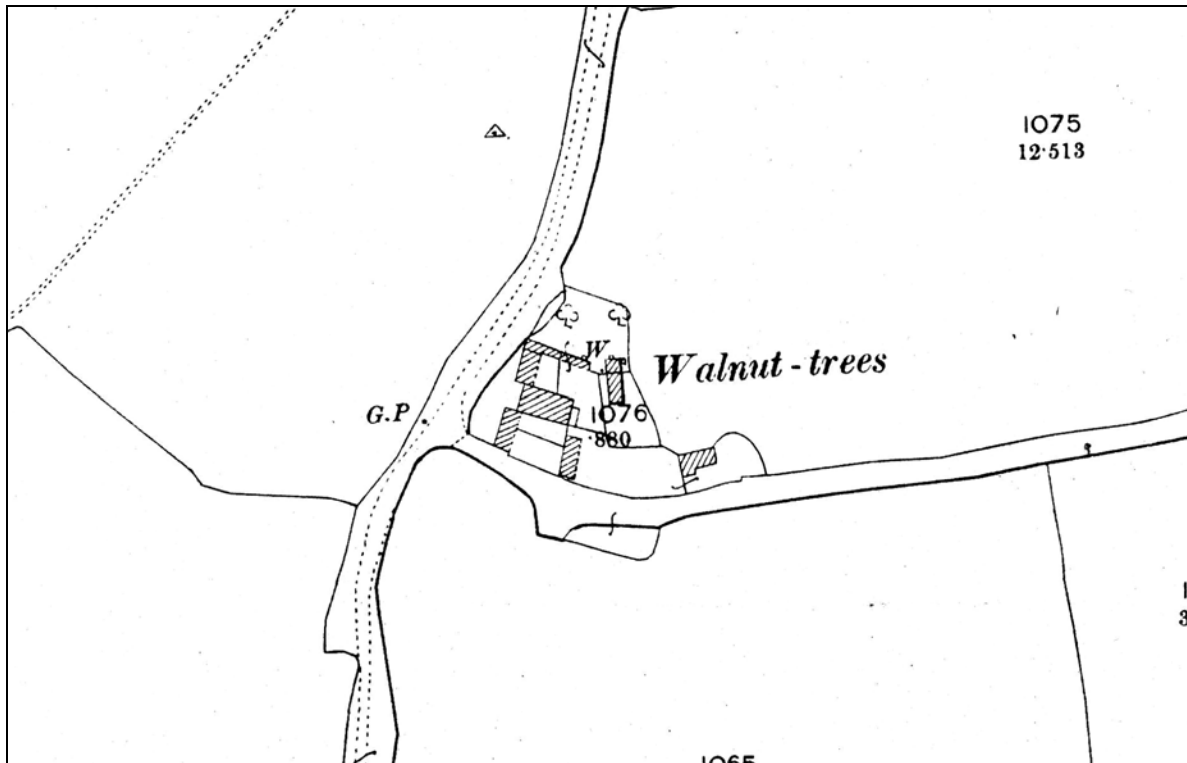
Fig. 5 Second edition 25" OS map, 1996

The second edition OS map published in 1895 shows the southern yard bordered by ranges to the west (existing cow shed) and east and by the road to the south (fig.5). The yard is divided into two, to divide the livestock, perhaps young cattle from the rest of the herd. The eastern structure is partly open to the rear.

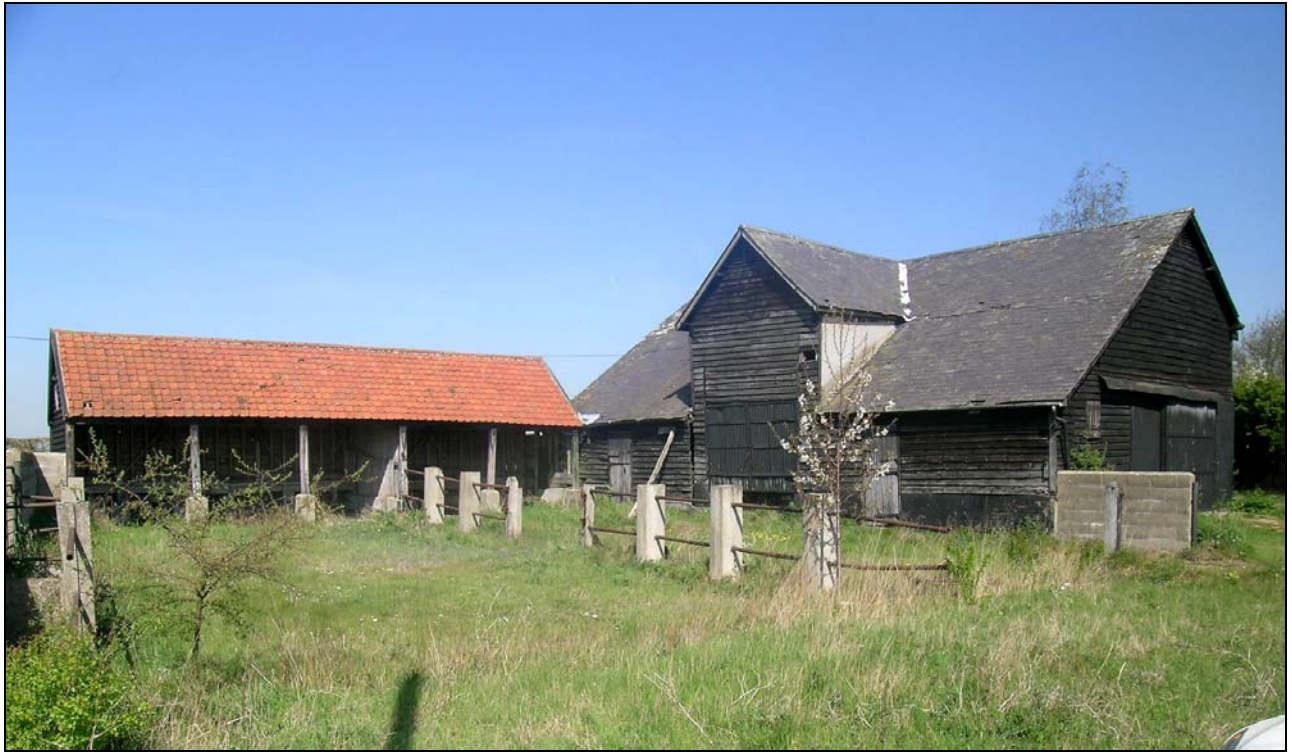
track leading around the back of the barn, linking to the road on the other side. The 19th-century farmhouse and a second barn (also 18th-century) to the east are in separate ownership and outside the development area. Modern concrete and rolled iron fencing divides a grassed-over cobbled yard and provides a boundary wall to the road (plate 1). A low concrete wall separates the structures and hardstanding on the west side.

Plate 1 Farm group viewed across yard to north-west

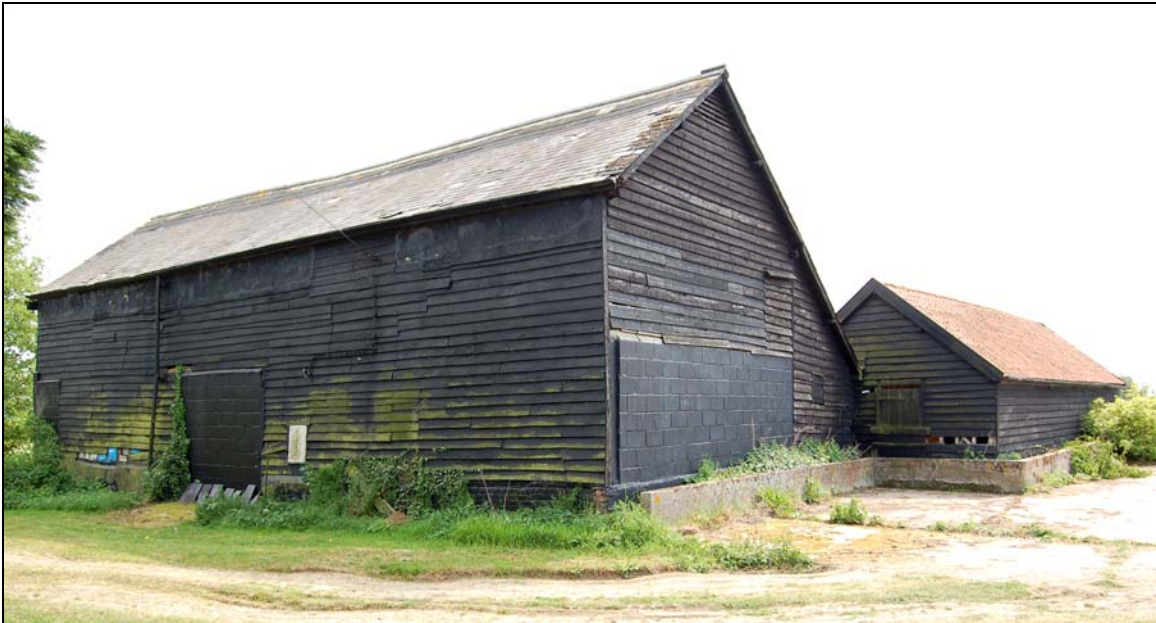
Plate 6 Rear of barn & cowshed viewed to south-east

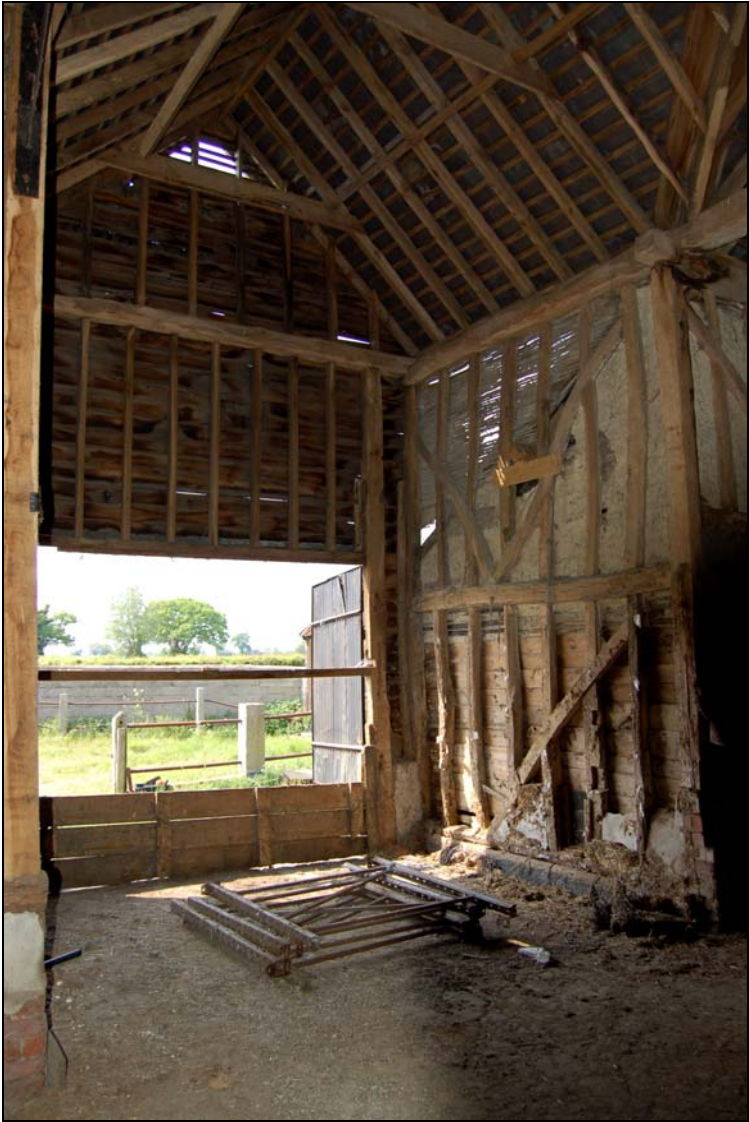
Plate 9 Interior of porch

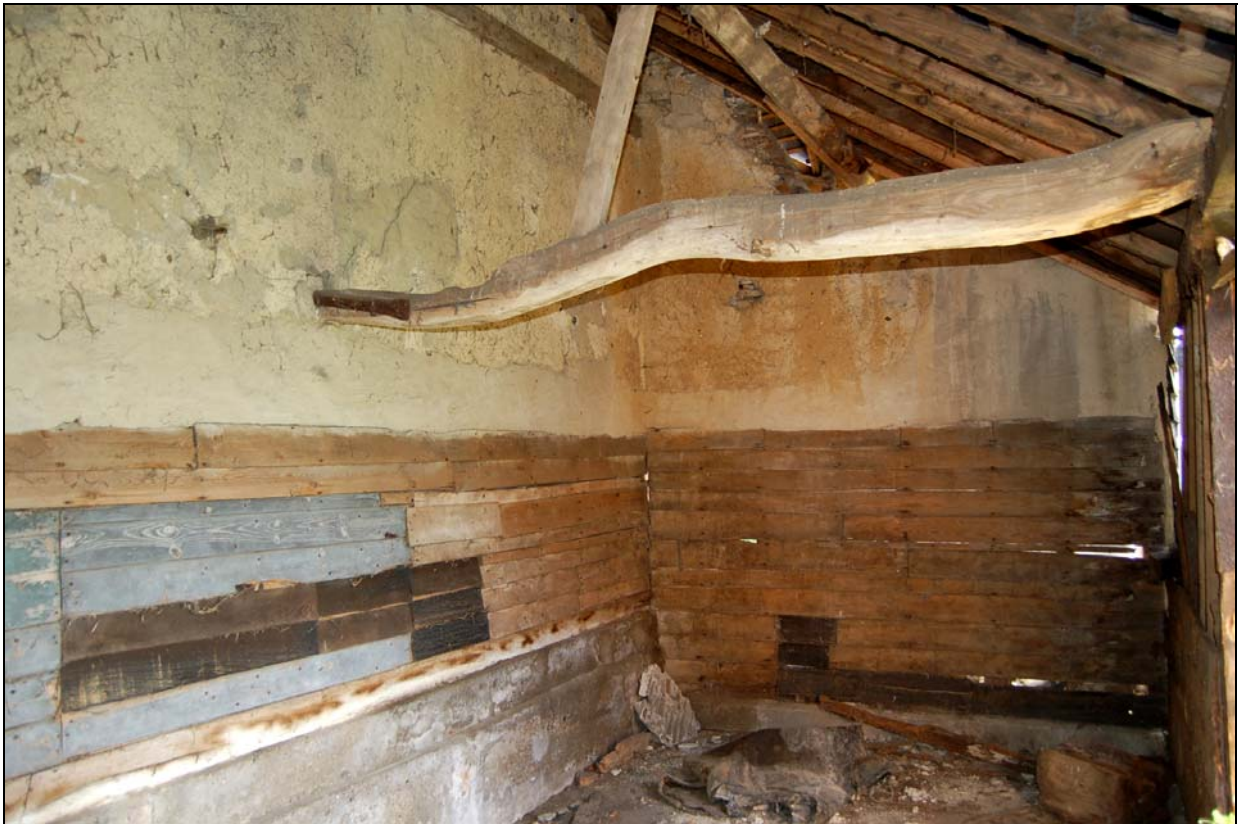
Plate 12 External walls of barn & porch viewed from interior of loose box 1a
