**HISTORIC BUILDING RECORDING
AT GRAYS FARM, GRAYS LANE
WETHERSFIELD
ESSEX**

Document Ref.	1742rep
Report Issue Date	21st September 2007
Circulation	Mr. D. Butler
	ECC Historic Environment Management
	Essex Historic Environment Record

FAU Project No.: 1742

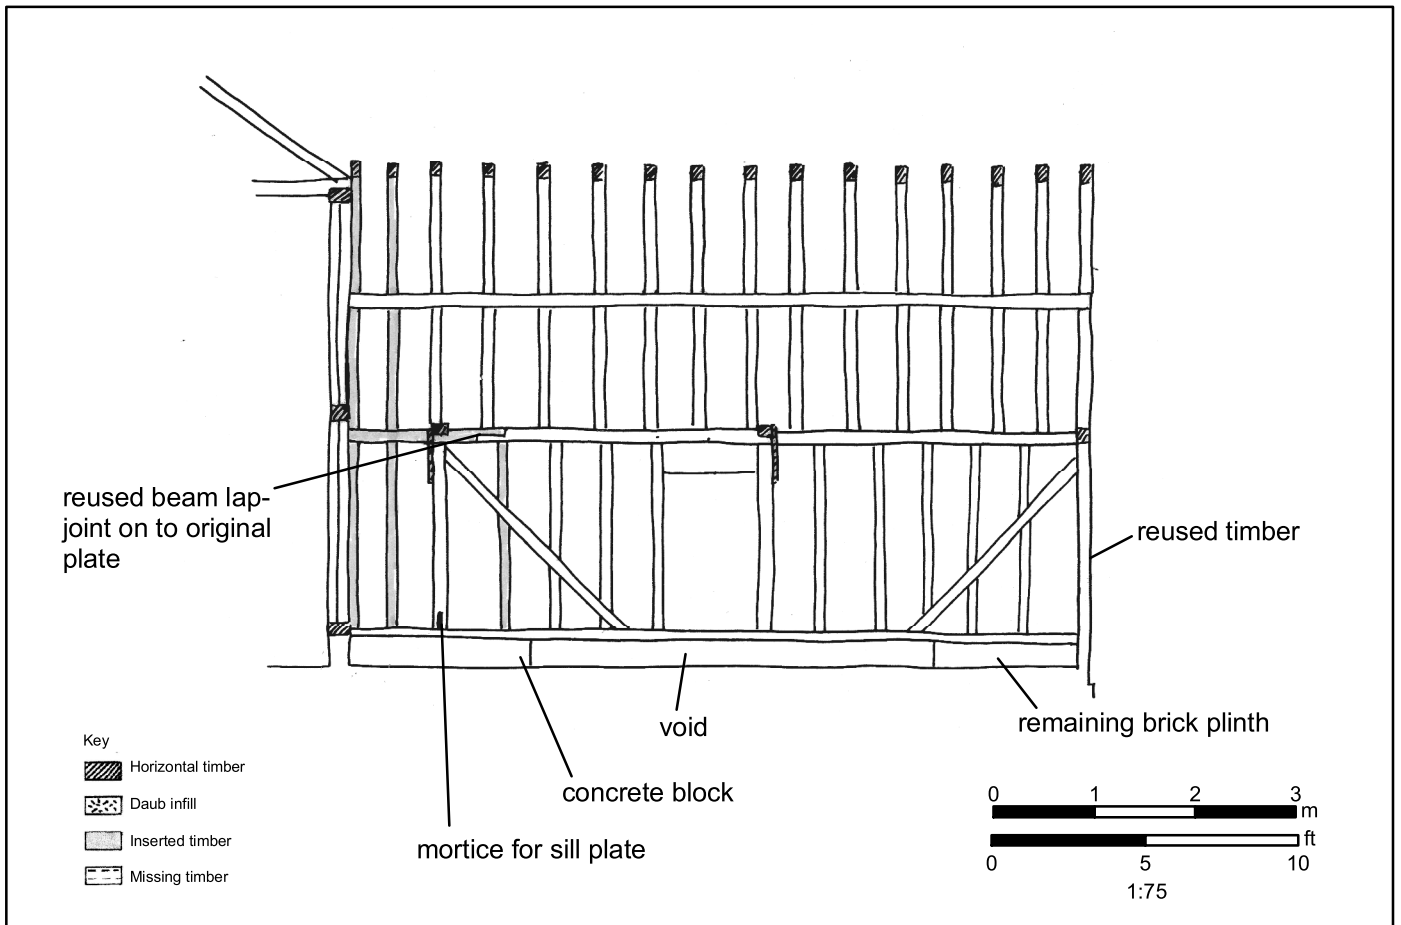
Fig.9a. North wall of byre

In terms of condition, the byre has suffered more than the barn, but not irreparably so. In particular, the north side, facing onto the yard is in poor condition, with the frame exposed and brick plinth either missing or replaced by concrete blockwork (fig. 9a, plate 19). The latter is also true of the east elevation. Its weatherboarding, which is the same as that on the barn, has faded on all sides. Decrepit wall plates and posts from the southern range adhere to the east end (plate 20).

The studwork is similar in scantling to the barn, at c.10cm². Average spacing between the studs is 40-50cm, though slightly narrower on the north side. Each is tenoned to the wall plates and rests on a narrow 10cm-wide sill that only survives on the south side. The studs are tenoned into the plates, rather than lapped and nailed to the outside of the wall plate like many in the barn. On the north and east sides the ends of the studs have rotted with the sill plate (plate 23). Wall plates and posts are c.18cm² and the former roughly chamfered. The wall plate and post on the east gable wall are the only reused timbers (fig.9a & 9b). No carpenter's marks were observed.

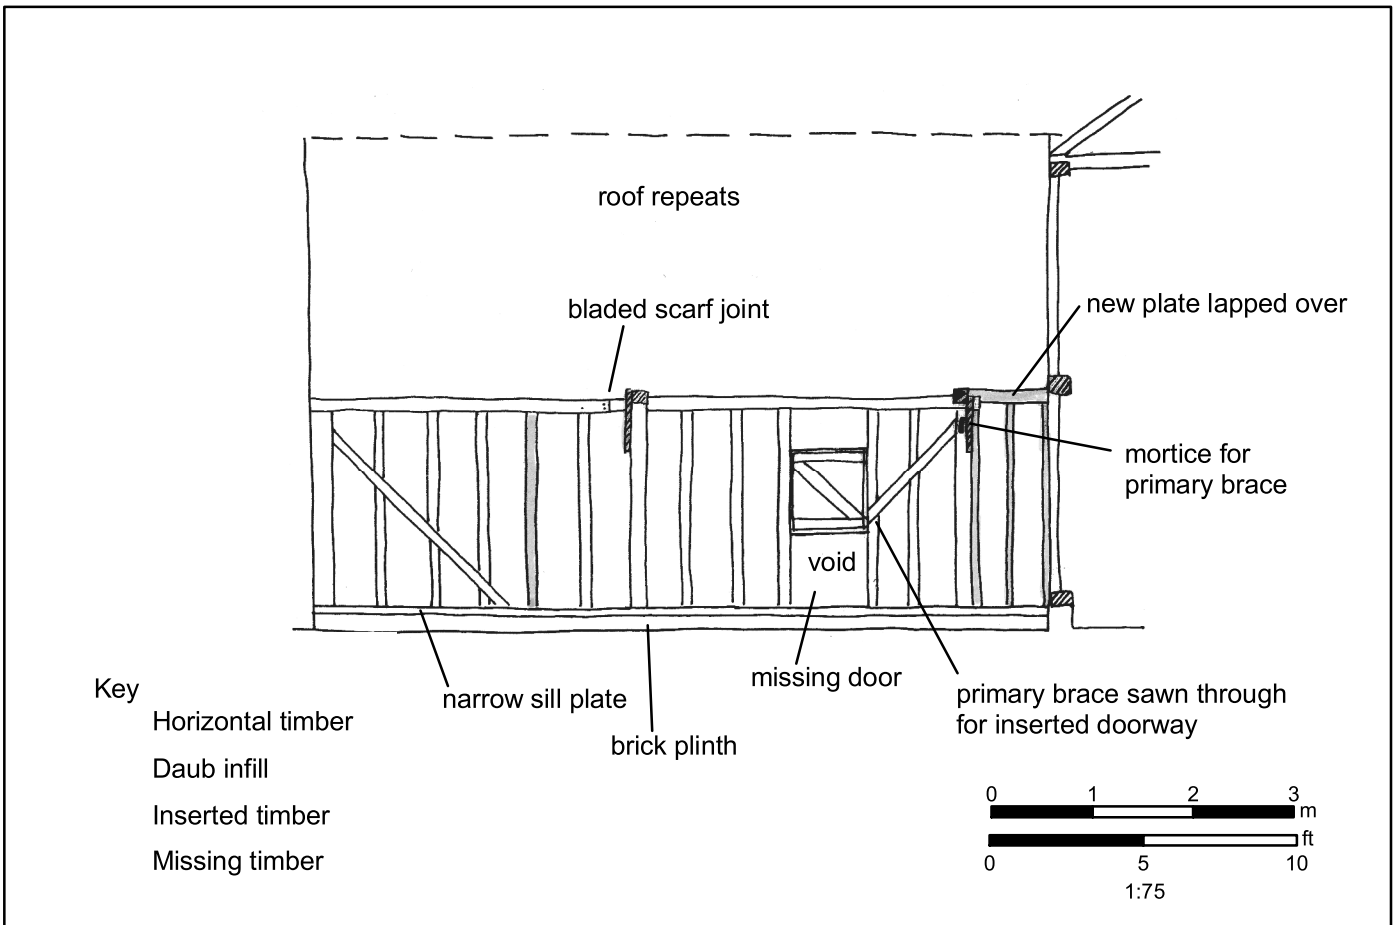
Fig.9c. South wall of byre

Of the three elevations, the best preserved side is the south elevation (plate 1). The main feature of this is the upper part of a half-heck door (fig.9c) with plain original strap hinges

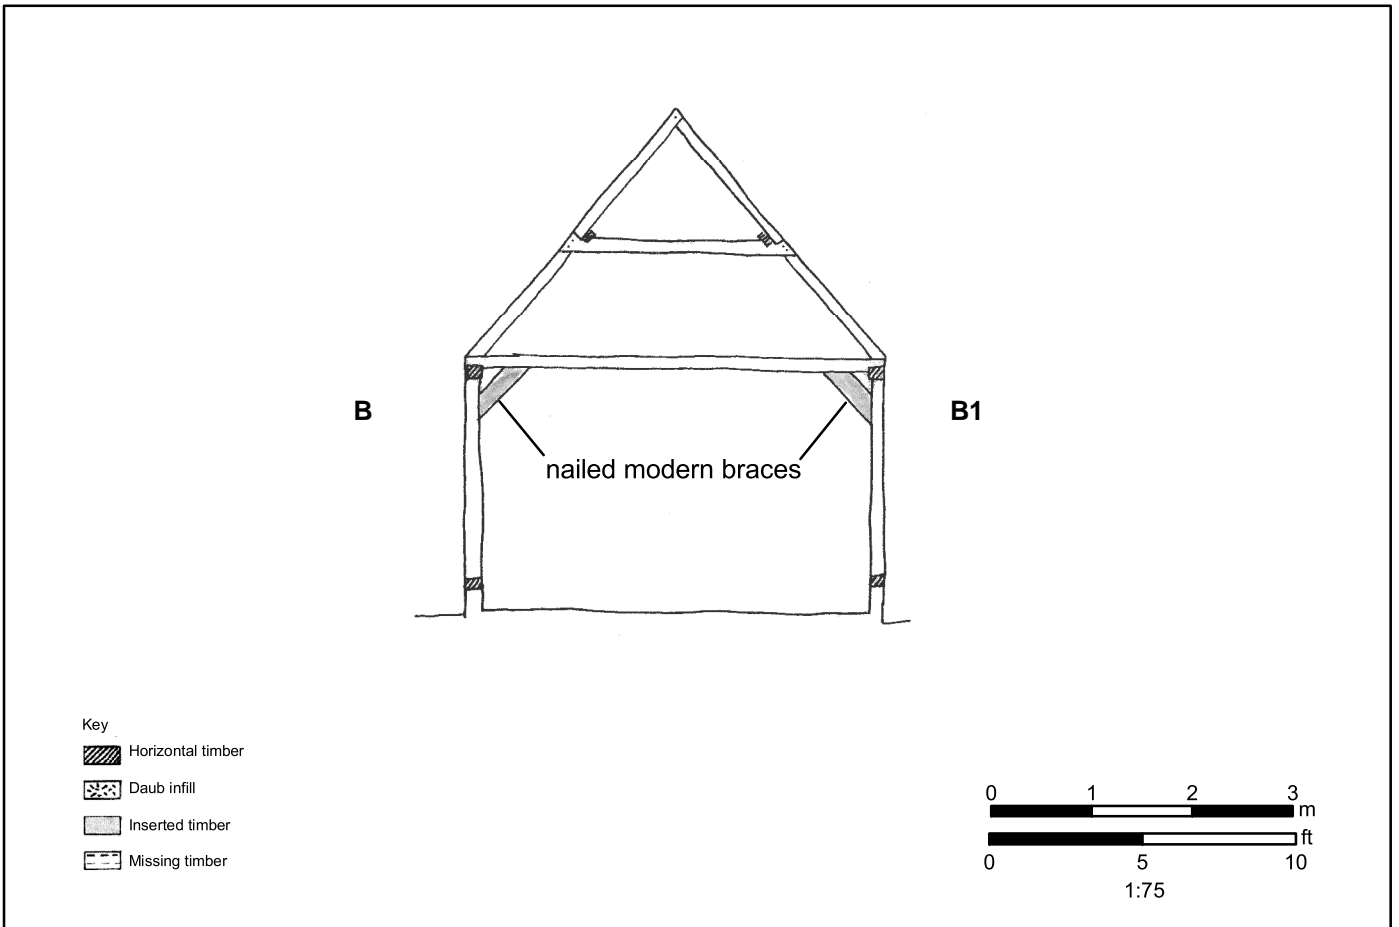
Fig.10. Section B-B1 through byre

Inside (plates 21 & 22), the layout is divided into two c.3m-wide bays, with a further 1m extension on the west side, created in the 19th-century when the byre was extended to the barn. To enable this, the end stud wall was removed, short sections of wall plate lap-scarfed onto the ends of the longitudinal plates (figs.9a & 9c) and a new end plate fitted on the west side. The extension was made from machine-sawn timbers in the walls and roof. Wide brackets were nailed onto the trusses, made from 2 inch planking (fig.10). The bay posts are original and the southern one retains a primary brace mortice (plate 23).

The roof (plate 24) is original and has suffered from little or no alteration. It is a pegged collar purlin type (fig.10), with the purlins splay-scarfed and nailed together. Flooring is in concrete.

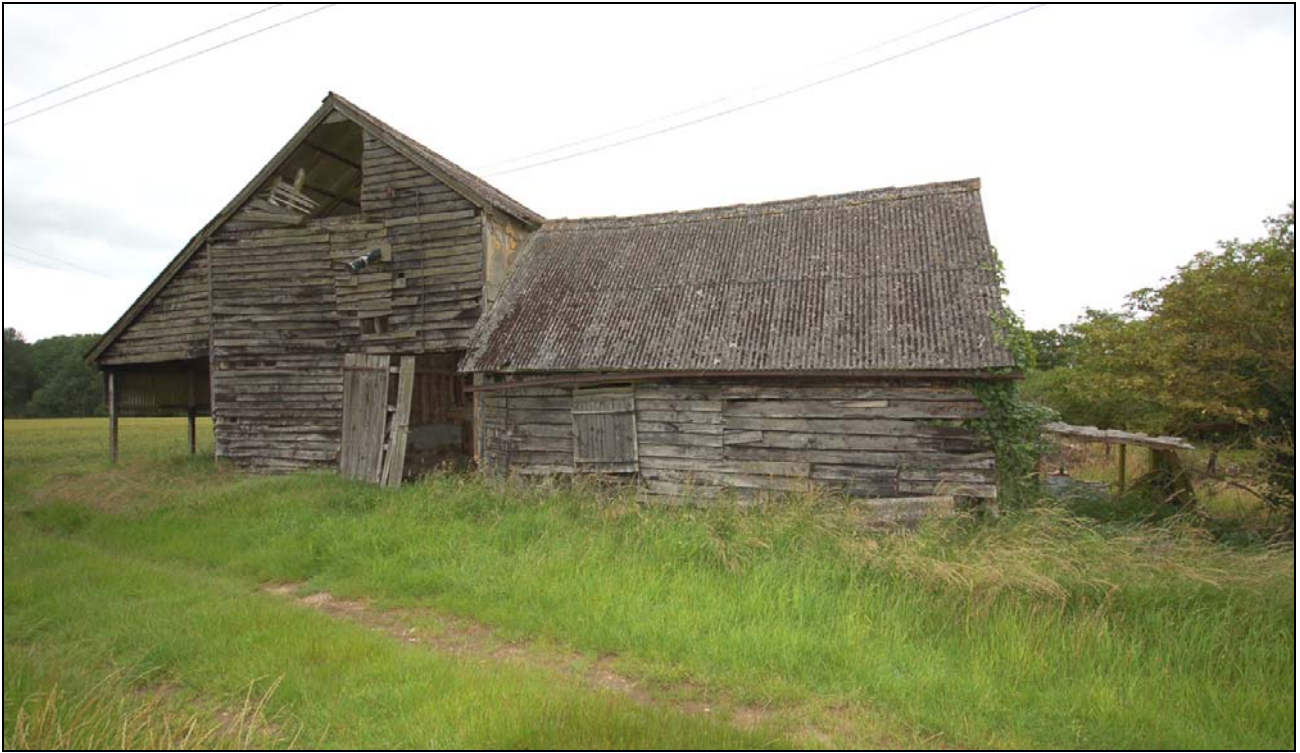
Plate 1 South elevation of barn and byre

As the byre is set slightly further to the south than the barn, the byre extension on this side is set at an angle (fig.6). A vertical wall scar is clearly seen toward the left (plate 1) where short 7 inch cladding has been nailed to the in-filled machine-sawn frame. On the opposite end of the byre, the wall plate to the removed south range is suspended in the air (plate 1). On the east gable of the byre, the wall scar to the same structure, with its lower roof pitch (plate 20) indicates the range was roofed in more durable materials than thatch. Indeed, a pile of pantiles lying within the confines of the building proves this. An owl hole exists in the apex of the roof.

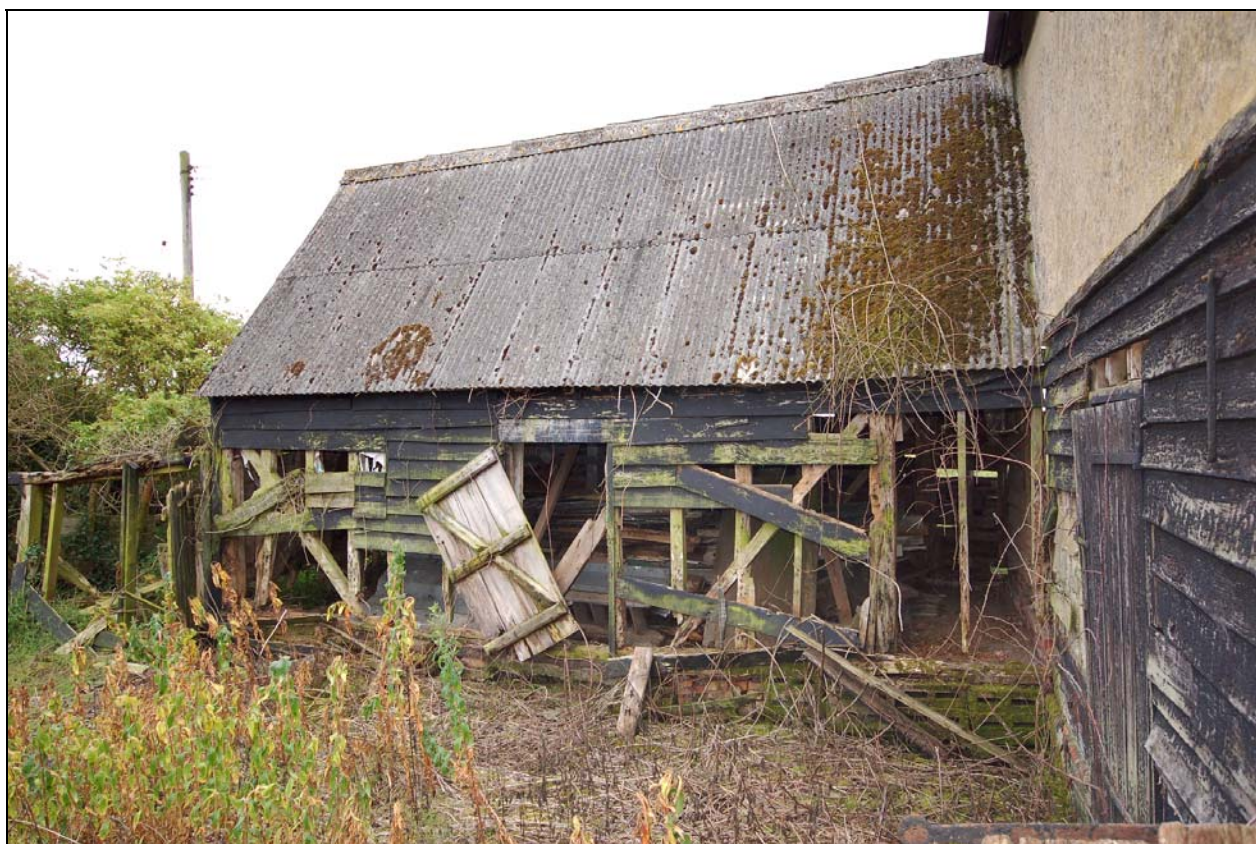
Plate 19 North elevation of byre

The north elevation faces onto the yard. As has already been stated, it is in a poor state. At least half of the cladding has fallen away from the frame and parts of the plinth have rolled and been replaced or else left void. The central ledge and batten doorway is hanging off its hinges (plate 20).
