**UNWINS FARM BARN, SPAINS HALL ROAD  
FINCHINGFIELD  
ESSEX**

**HISTORIC BUILDING RECORD**

**Essex County Council**  
Field Archaeology Unit

**August 2008**

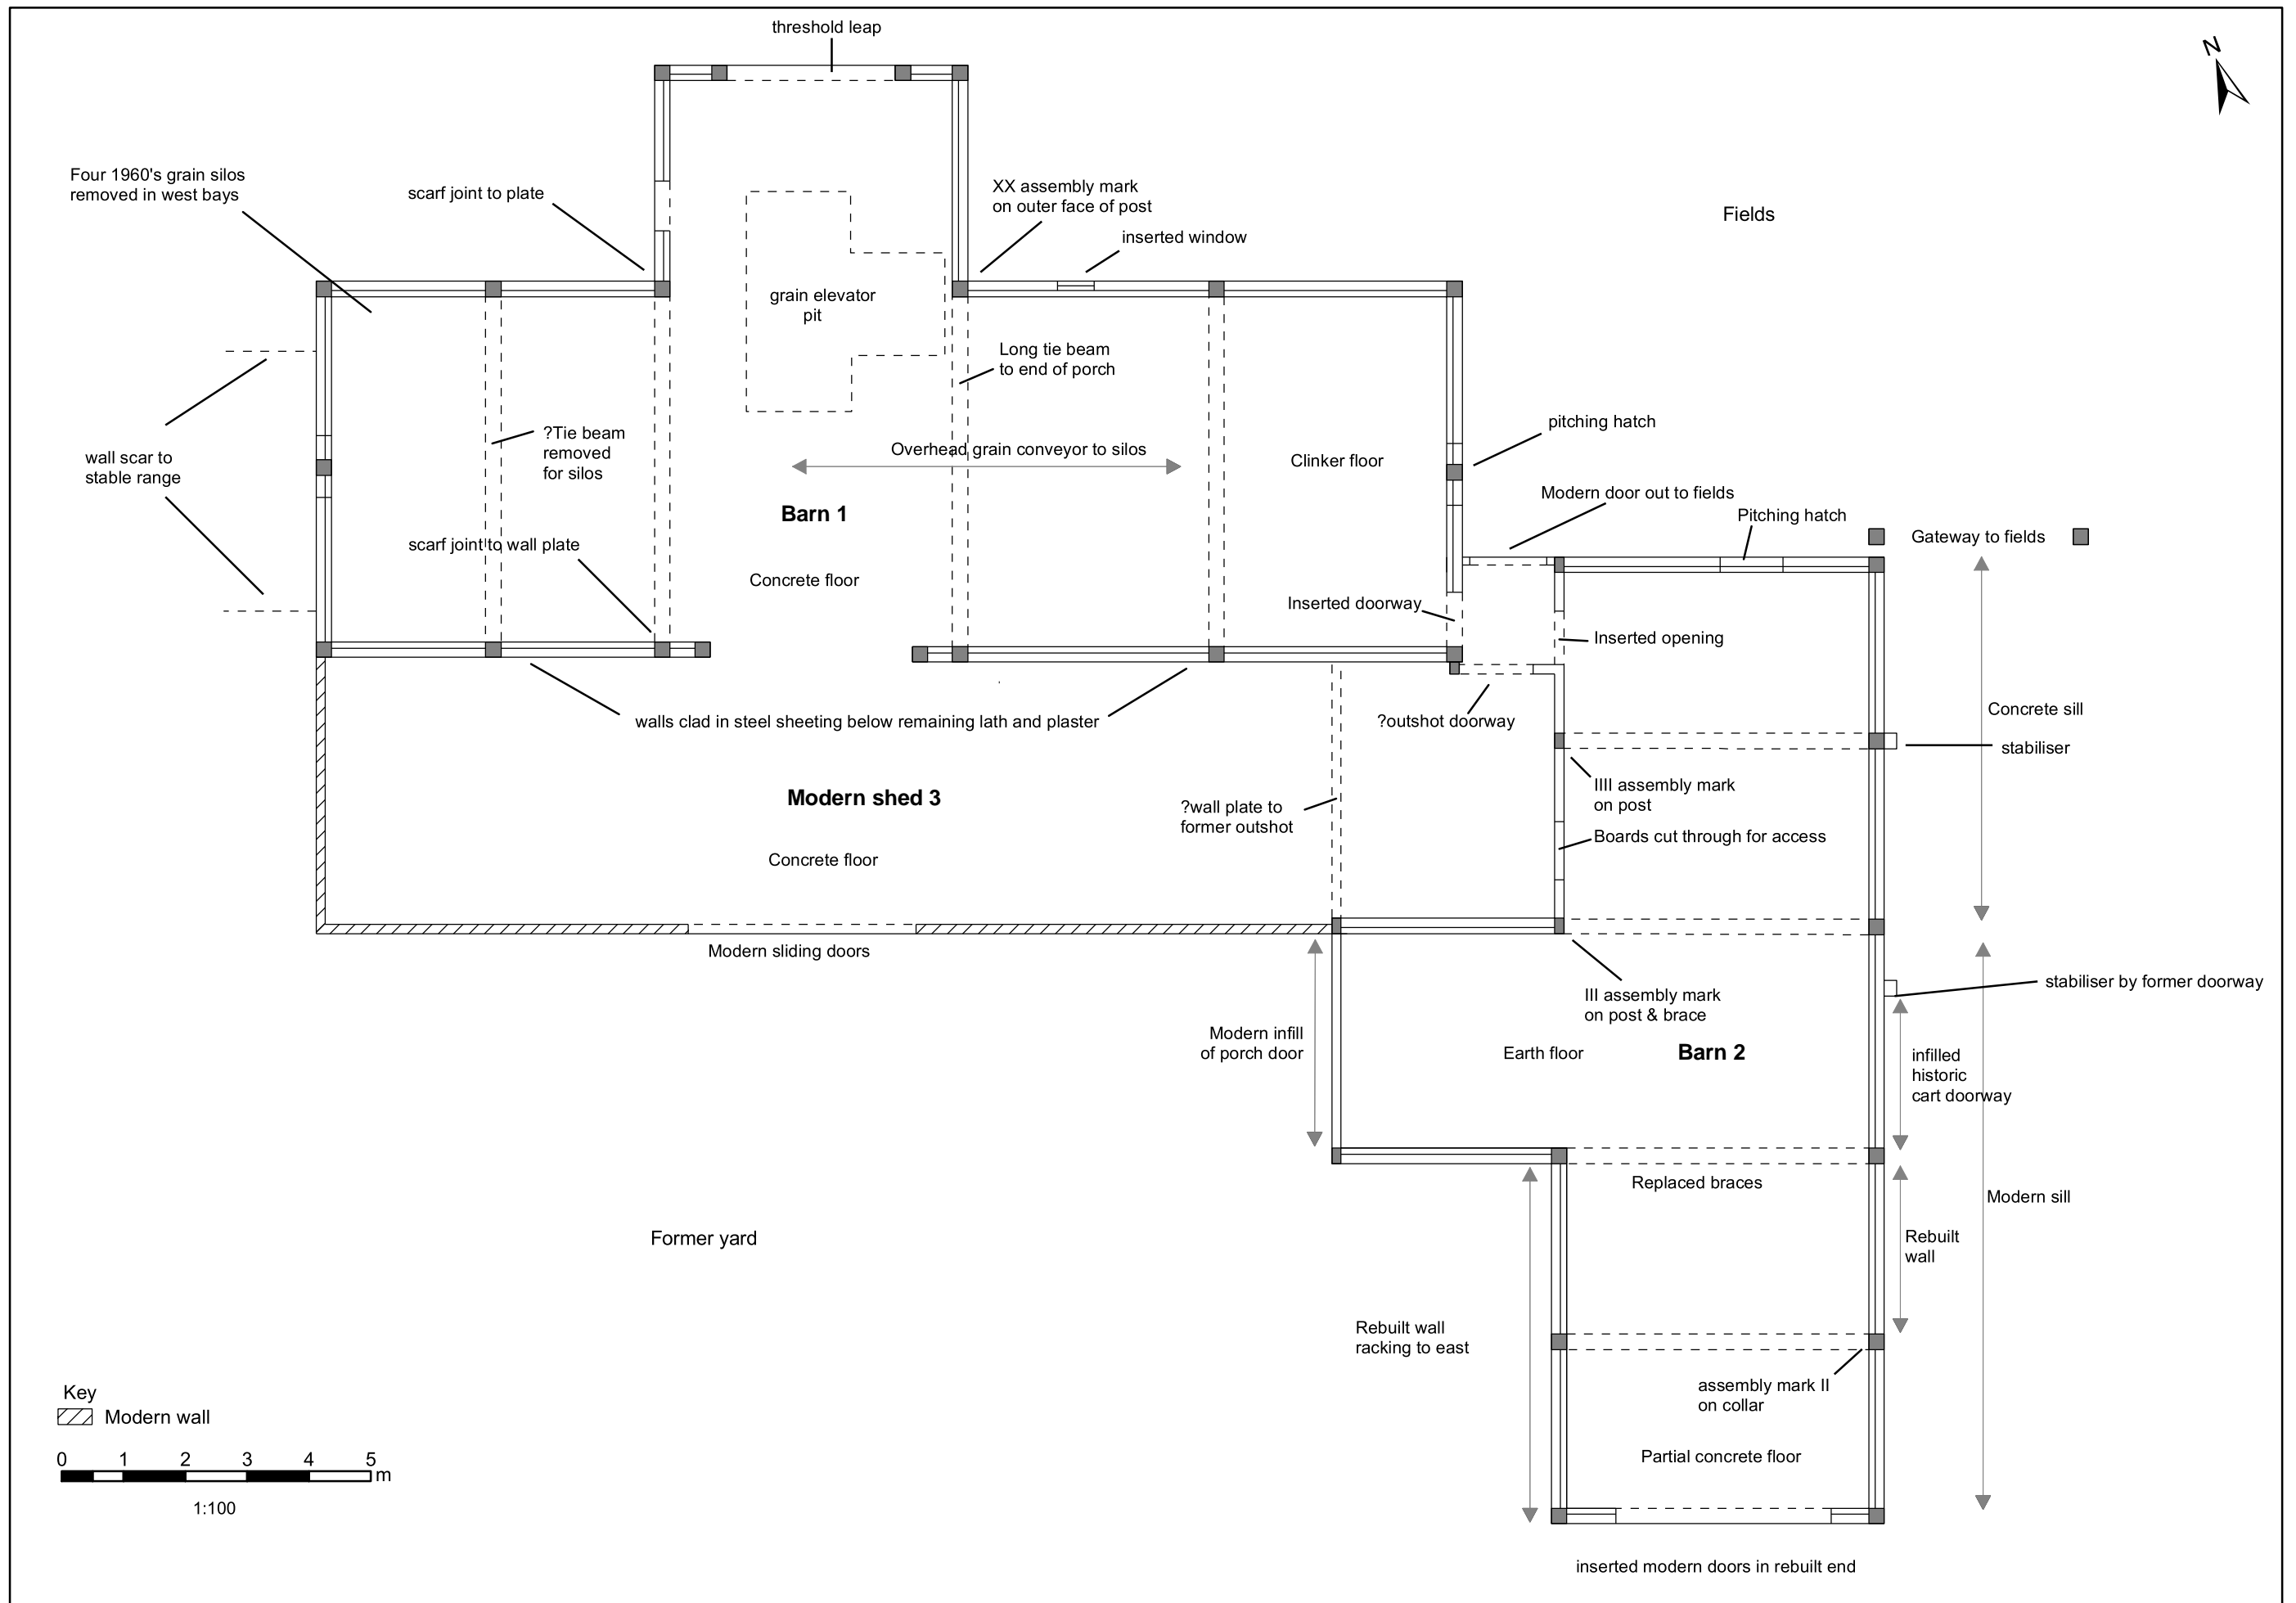
Fig.5 Plan of surviving structures

Parts of the eastern elevation have been re-clad in steel sheeting over the existing weatherboard (plate 14). Wooden stabilisers are original features fitted between the two north bays and one side of the filled-in former low cart door (fig.5). Stabilisers prevented damage by livestock and are often found on shelter shed posts. In this context, they suggest that cattle were being herded behind the barn and through the gateway to the north (fig.5).

The northern gable is virtually indistinguishable because of the surrounding vegetation (plate 14). Steel sheeting clads much of the elevation up to the eaves and the boards above are greenish in hue from damp and lack of sunlight. An off-centre pitching hatch has been retained, though it is better seen from the inside (fig.5, plate 15). Any evidence for a pitching hatch on the southern gable was lost in the rebuild.

Trusses in barn 2 are formed by jowled bay posts and slightly curved braces (plate 17), very different to the plain knee-braced ones seen in barn 1. The jowls are fairly crude, mainly 'gunstock' types (plate 18). Bay posts and rails are slightly narrower than the main barn at c.18 x 12cm, although the rails have the same slightly cambered appearance. Bracing remains to most of the trusses, double-pegged to ties and posts. The wall plates are in shorter, mainly one-bay lengths, connected by edge-halved and bladed scarf joints immediately above or close to the heads of the bay posts (fig.5, plate 18).

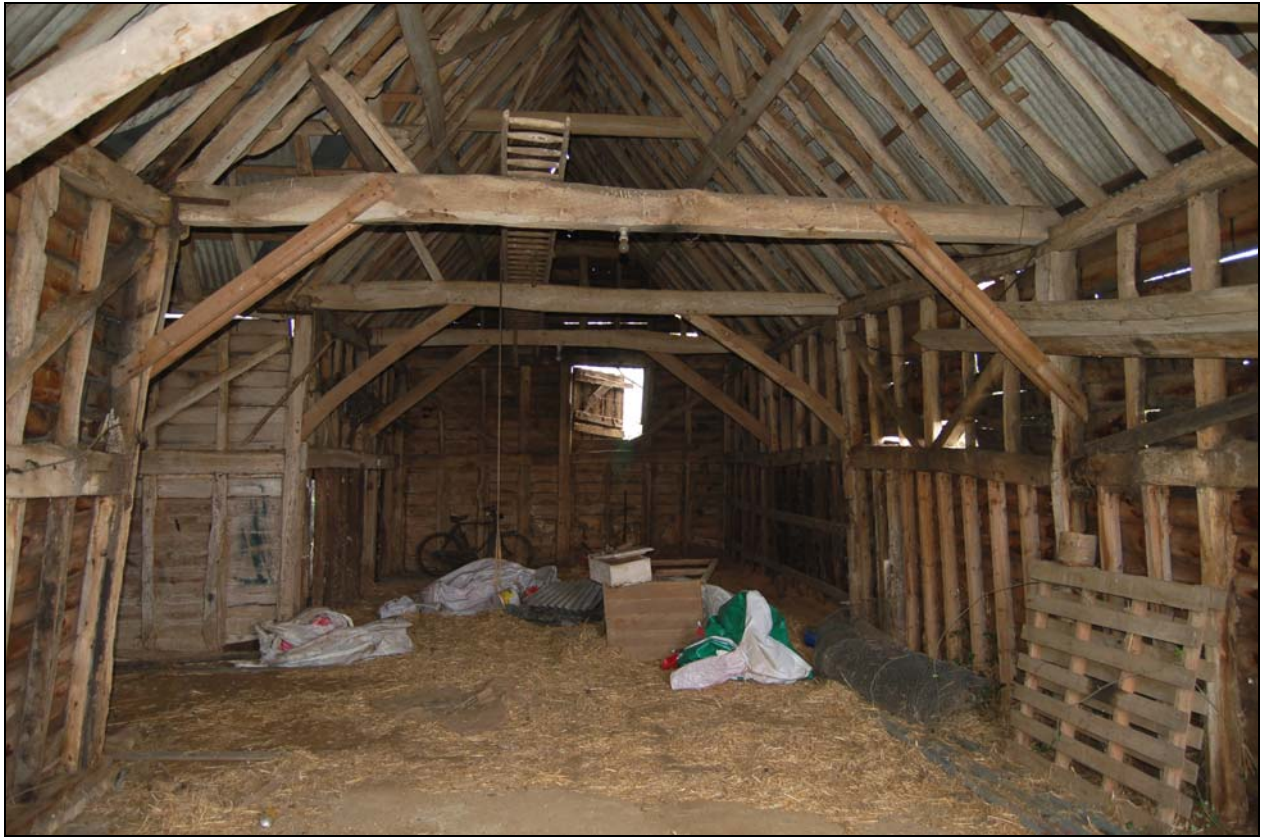
The interior (plates 15 & 16) comprises five bays, two either side of a central midstrey on a symmetrical layout. The bays are regular in size at around 2.8m, with the wider midstrey (at 3.5m) to admit carts. The smaller size would be more suited to a hay or animal feed barn. The floor is partly made of concrete and partly unmade of earth and straw. Prior to the survey the interior's lower register had been lined out in corrugated tin sheeting, which when removed exposed chaff between the studs.

Plate 15 Interior of barn 2 viewed from south

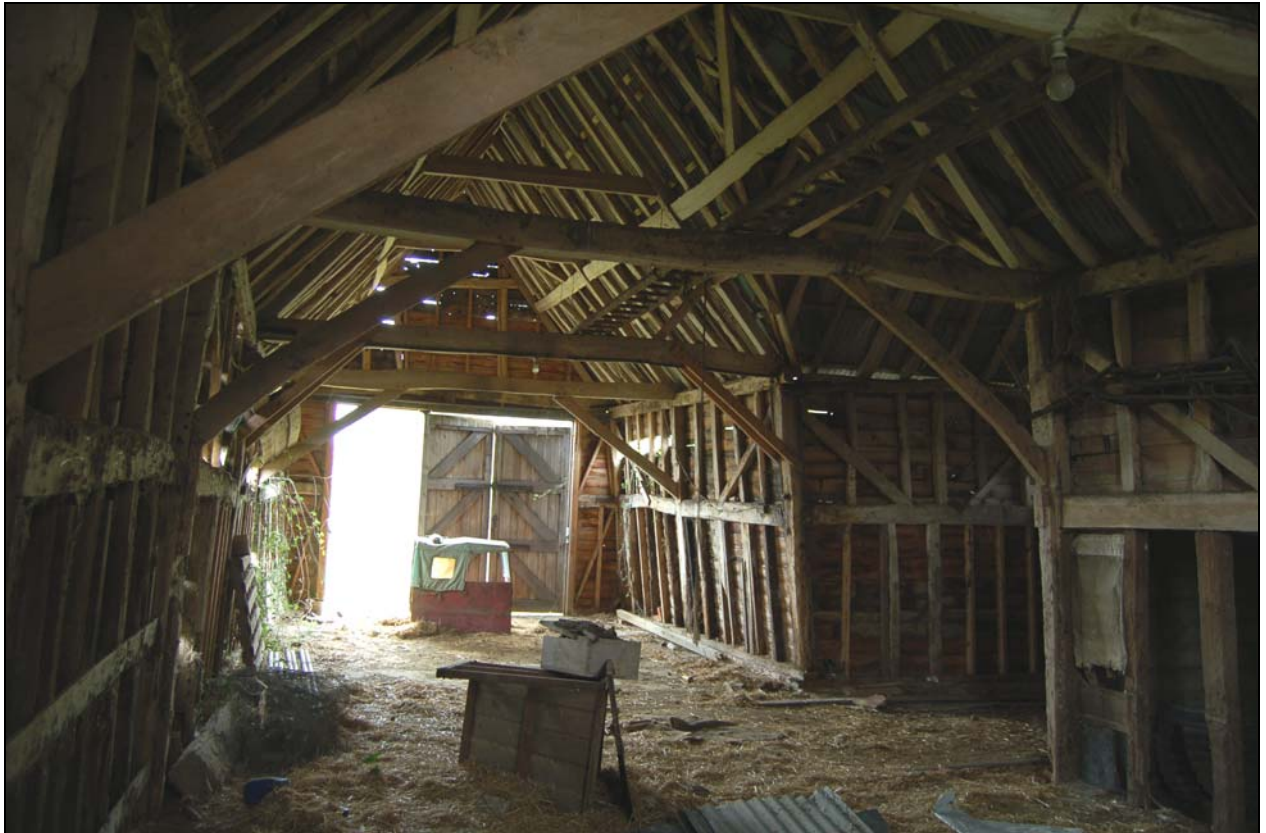
Roof trusses have high pegged collars to each of the bays and pegged rafters at the apex (plate 16). Timber struts have been nailed between tie beam and rafter either side of the midstrey, like in barn 1. Otherwise, most of the timbers are original, including the butt-purlin roof, which is slightly cruder than the other barn. Here the purlins are single-pegged to the principle rafters but unlike barn 1 have a roughly triangular profile. The common rafters are nailed to the purlins rather than pegged. Many of the old hand-cut thatch battens remain in the roof (plate 20) while there is wind bracing at irregular intervals, not just the ends. The porch is built in the same manner.

Plate 16 Interior of barn 2 viewed from north

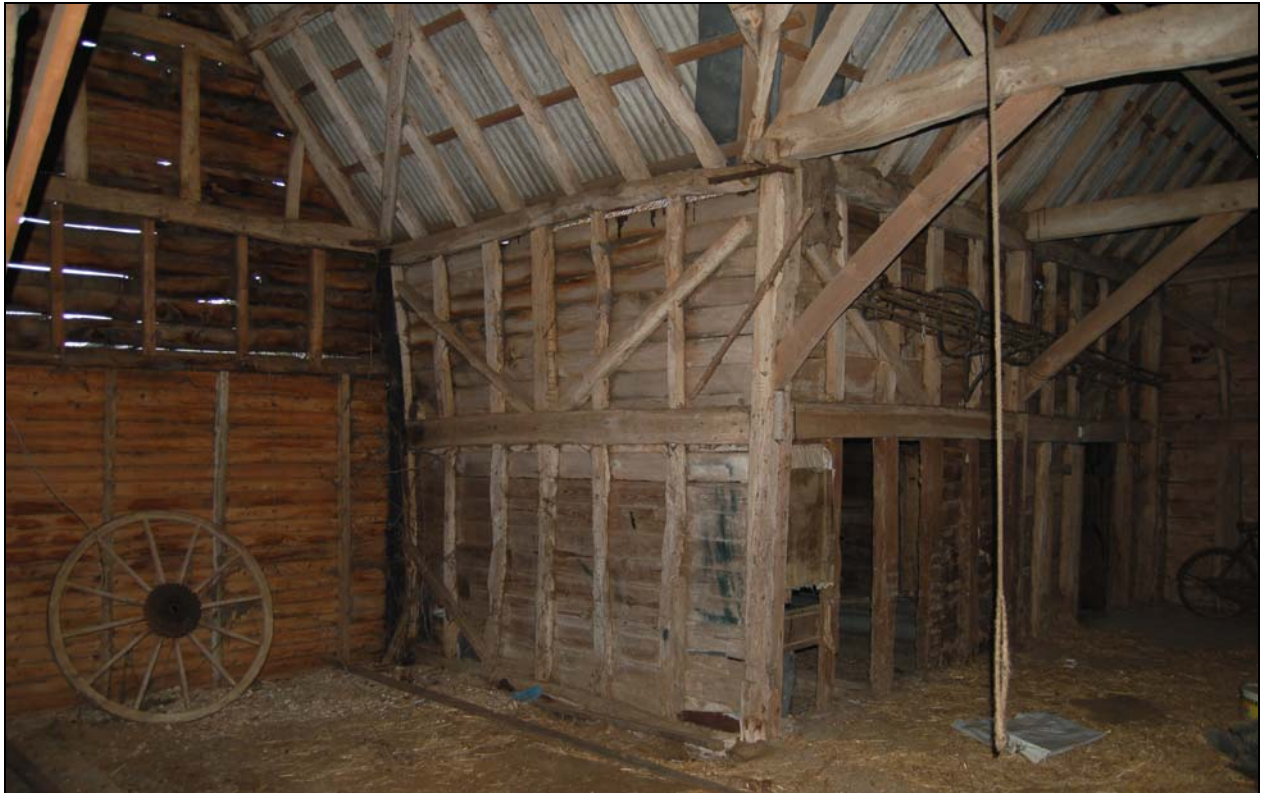
Plate 17 In-filled former cart doorway to barn 2 porch

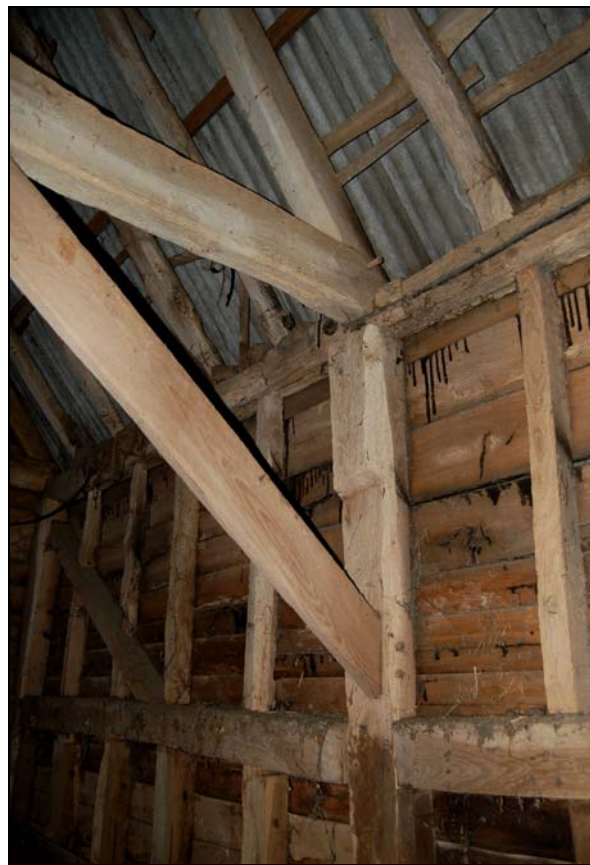
Plate 18 Detail of typical gunstock jowl and bracing in barn 2
