**ROE GREEN HOUSE, ROE GREEN
SANDON
HERTFORDSHIRE**

HISTORIC BUILDING RECORD & ARCHAEOLOGICAL MONITORING

December 2008

Document Ref.	1788rep
Report Issue Date	19th December 2008
Circulation	Mrs Lizzy Rudd
	Herts CC County Historic Environment Unit
	Herts Historic Environment Record

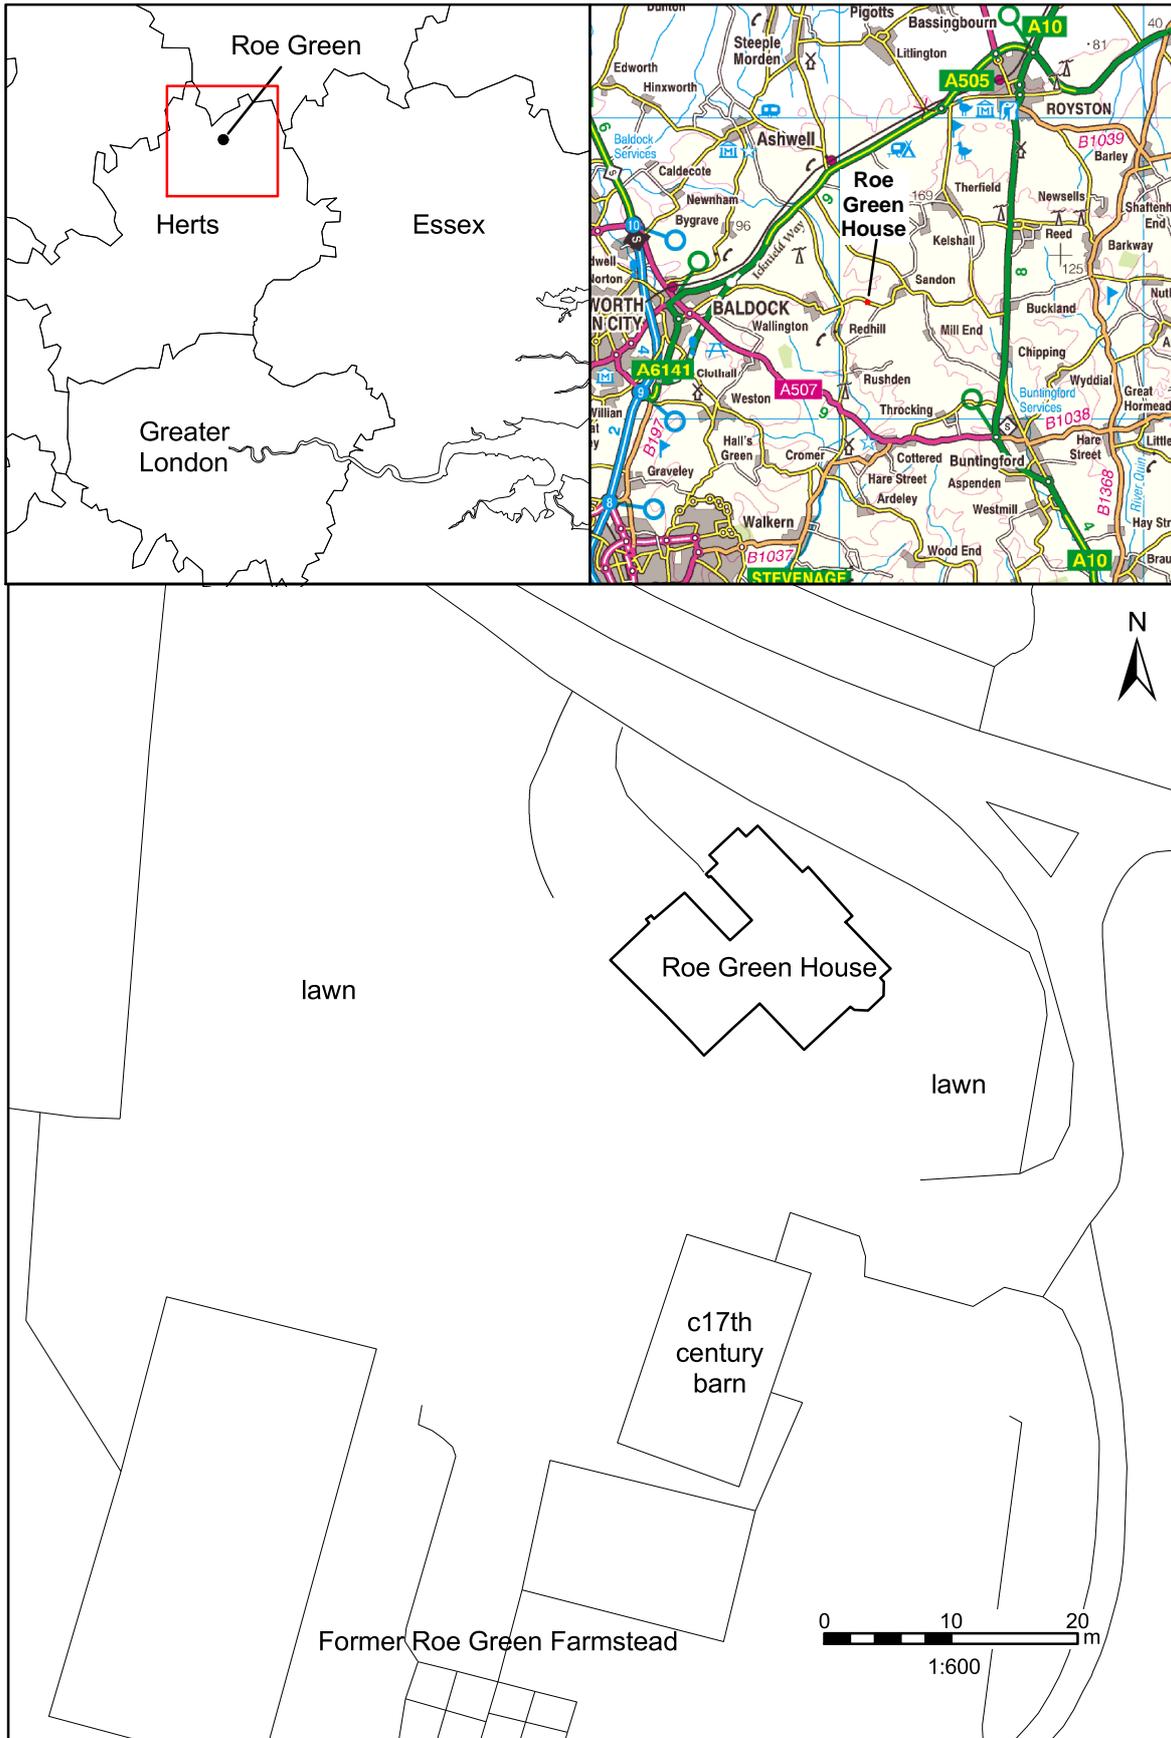
Fig.1. Site location and block plan

Roe Green is a hamlet within the parish of Sandon situated along a minor road at TL 3095 3389, to the west of the A10 Buckland turning (fig. 1). Roe Green House is the Grade II-listed former farmhouse to Roe Green Farm, which lies to the south. It is now in separate ownership and was undergoing refurbishment at the same time as the house.

The house (LBS 162408) occupies an irregular plot with extensive lawns and driveway to the west (fig.1). The main core of the house is timber-framed on a north-east to south-west alignment, with later brick-built additions producing an irregular plan form (fig.1). It is fully-furnished and used as a family home.

Roe Green House is a complex mixture of styles and materials reflecting its long past. The plan form comprises a three-bay timber central range with a three-bay cross-wing at the north-east and single range at the opposite end, with brick-built additions (fig. 1). It appears to have been built as two storeys, rather than as a hall house, with an attic added later. The roofs are predominantly pegtiled (except for the kitchen, which is slate).

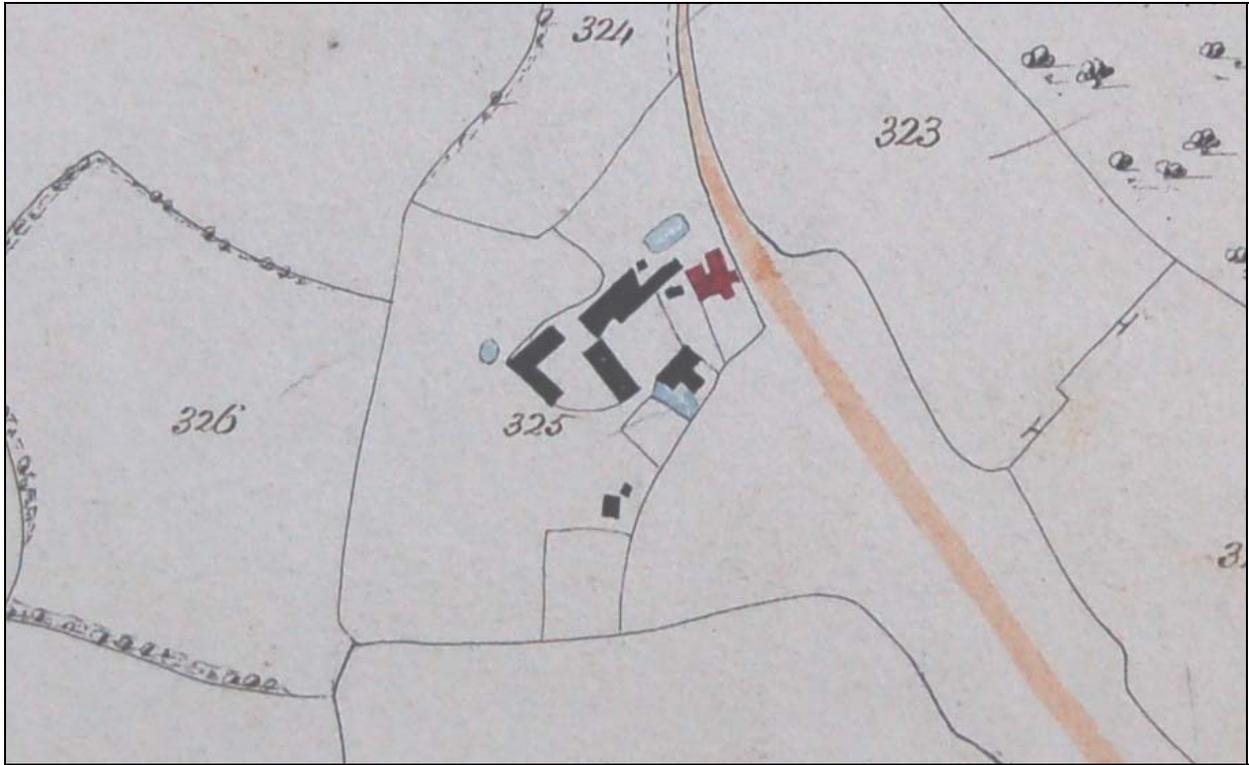
Fig.2 Extract from 1841 Sandon tithe map (DSA 490/2)

19th century maps show the house as it appears today, with farm buildings to the south (figs.2 & 3). 'Roegreen Farm' comprises the farmhouse, or 'homestead' (CRO DSA4 90/1) with a yard to the south which is open to the north and bordered on two sides by barns (fig.3). In 1841 (Sandon tithe award, DSA4 90/1) the farm was owned by the Fordham family, lords of the manor of Royston (Kelly's Directory 1851), and occupied by one of the family, John. The main barn to the west is a large aisled grade II-listed barn, presently undergoing conversion. It is dated from the list description to the 17th or 18th century (LBS 162408), which seems rather conservative given the barn contains the same jowled posts and a queen strut roof that would easily fit in with the early parts of the house (i.e. c.1580-1620).

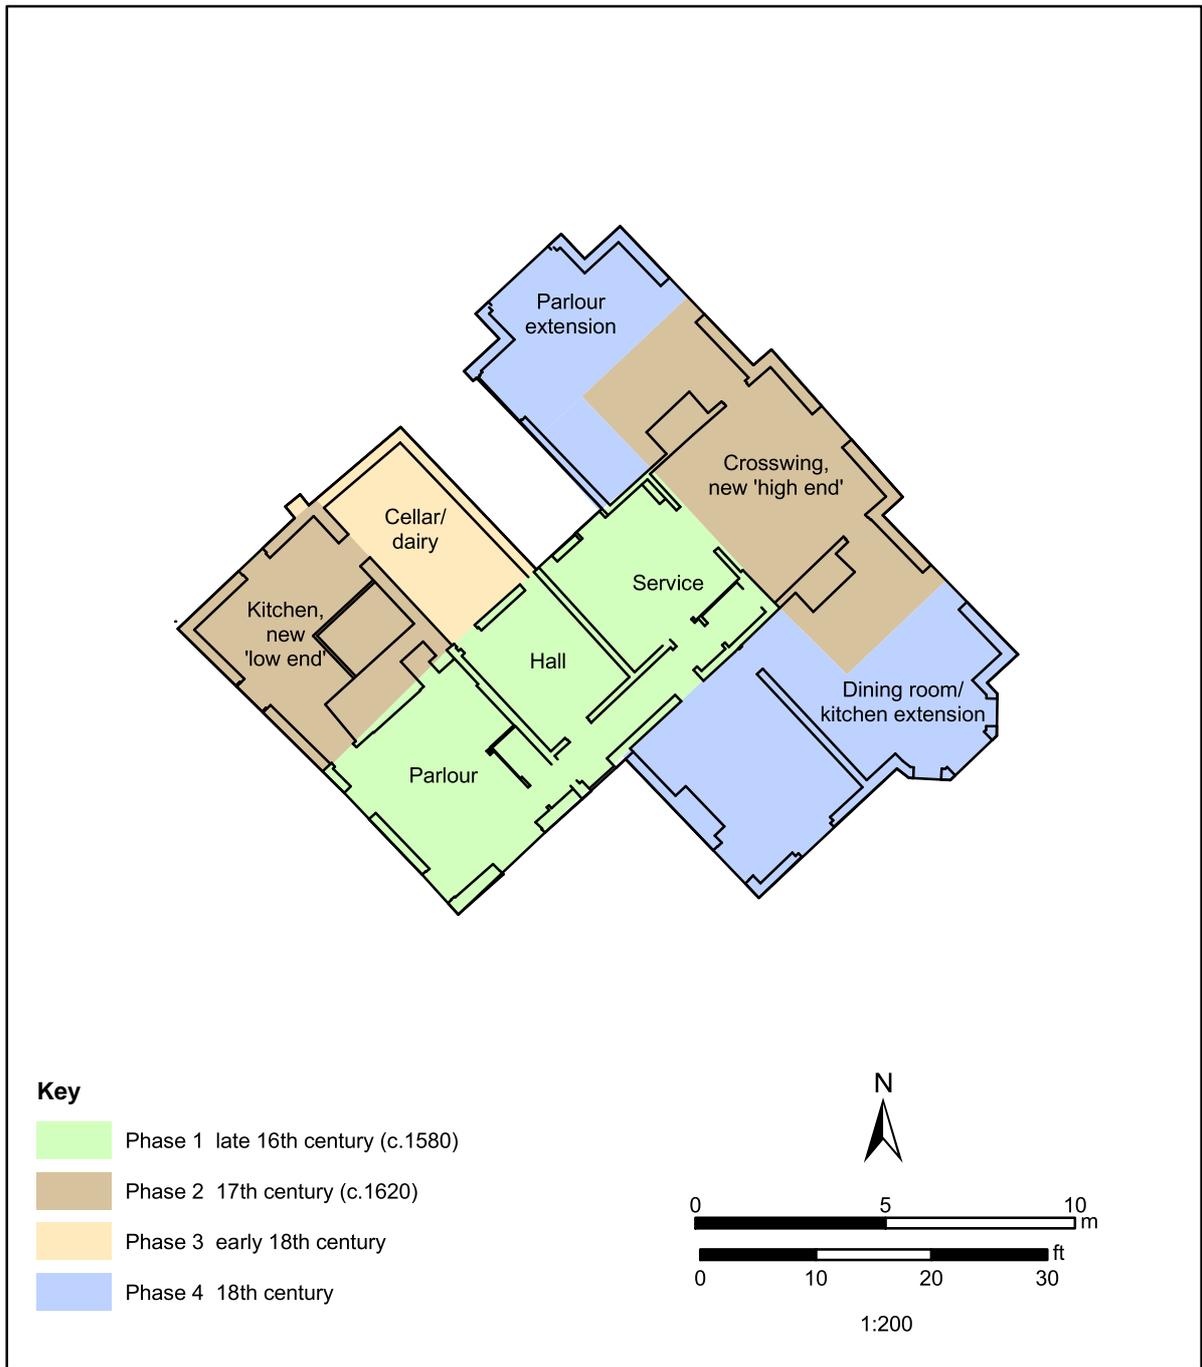
Fig.4. Phase plan

The findings of this report are based on the results of Adrian Gibson's preliminary work and the current survey. In addition, cartographic and documentary research was undertaken at the County Records Office, Hertford, which provided information on the development of Roe Green Farm in the Victorian era but little of value for the main subject of this study, the house. The suggested development of the structure is summarised below and the main building phases identified in figure 4. Subsequent paragraphs deal with the farmstead and later developments.
