**HISTORIC BUILDING RECORDING & ARCHAEOLOGICAL
MONITORING ON FARM BUILDINGS AT FYFIELD HALL
WILLINGDALE ROAD, FYFIELD
ESSEX**

May 2009

Prepared By: Andrew Letch Position: Project Officer	Signature: Date: 14th May 2009
Approved By: Patrick Allen Position: Project Manager	Signature: Date: 14th May 2009

Document Ref.	1889rep
Report Issue Date	14th May 2009
Circulation	Integra Group Ltd
	ECC Historic Environment Management
	Essex Historic Environment Record

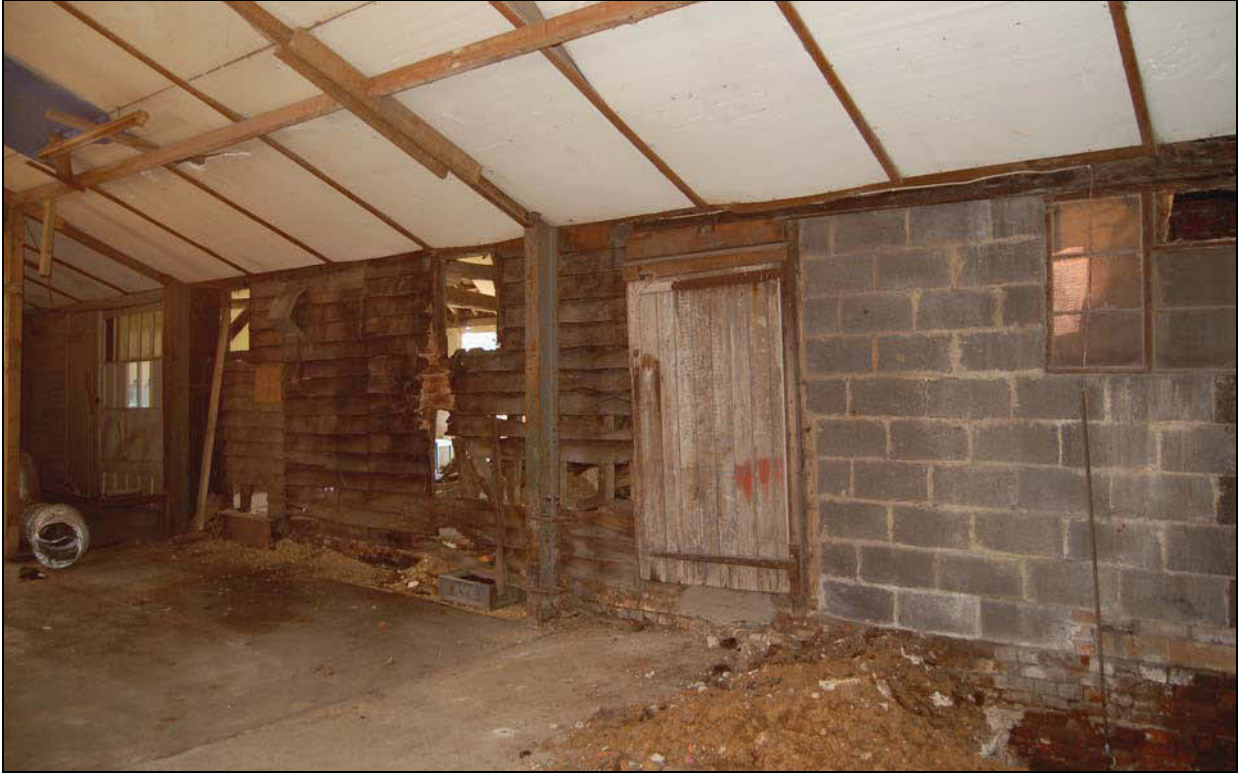
Plate 31 East wall of Shed 7 viewed inside Workshop 10

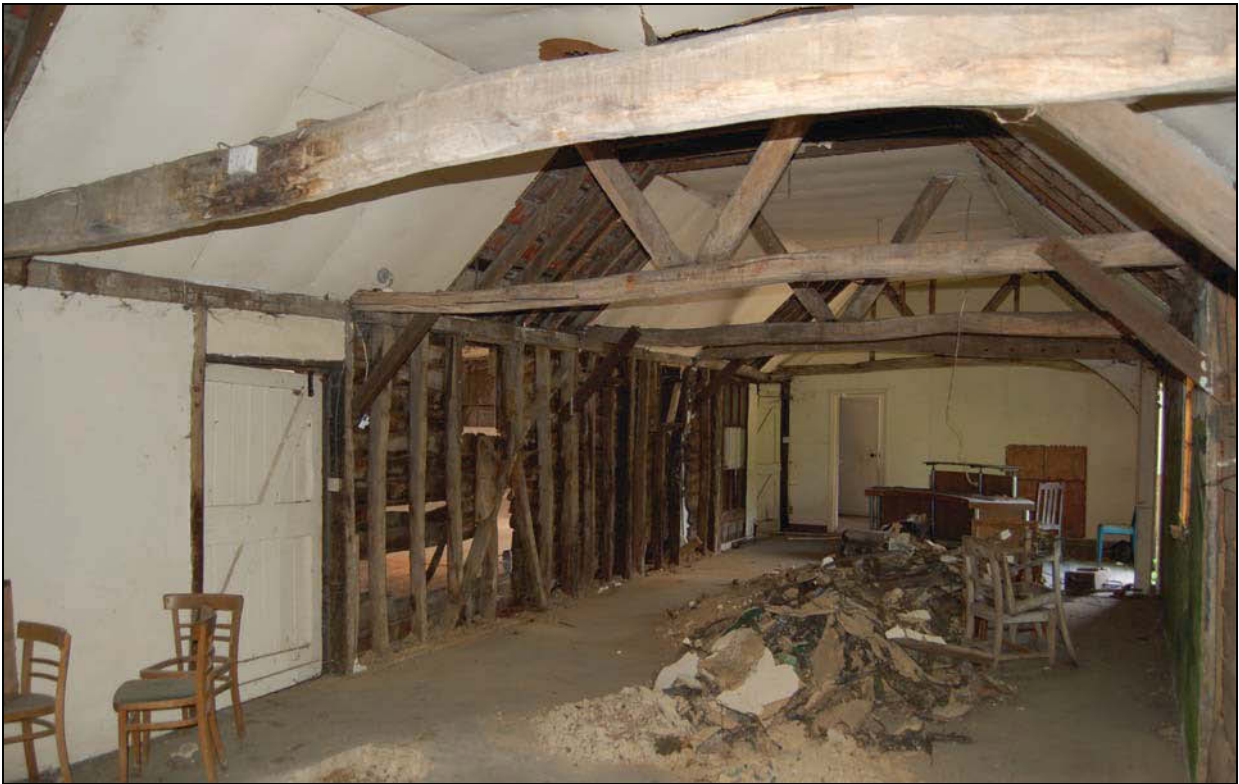
Internally there are six tie beams, corresponding to five bays, within the main 'Hall' area (plates 32 & 33), labelled in figure 15 as T1-T6. The layout of the south end has been partitioned to provide cooking, ?meeting and toilet facilities and a false ceiling inserted that obscures the other tie beams and evidence of any earlier partitions at this end. Although the south end wall is gone, a boxed beam at this end indicates the extent of the original building (fig. 15), making a further three bays and bringing the original length to eight

Plate 32 Interior of Shed 7 viewed to south-east

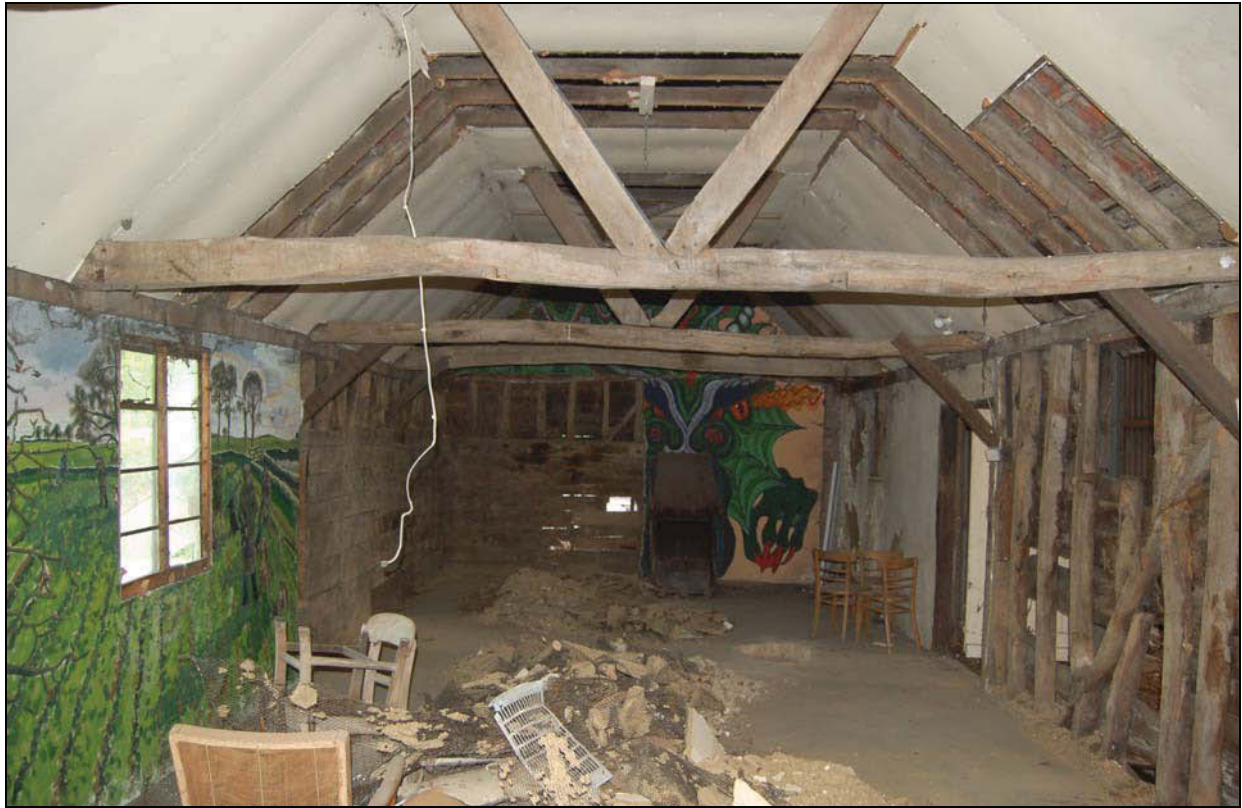
Timber framing is consistently primary-braced in quite thin timbers, the same throughout. The wall plates are connected by face halved and bladed scarf joints positioned mid-way between the trusses. Studwork is occasionally pegged to the plates. Much of the west side that has been infilled was probably built open-sided, with the two north bays boarded-out (plate 33) as a loose box. The roof purlins are clasped by the purlins on each truss.

Plate 33 Interior of Shed 7 viewed to north end

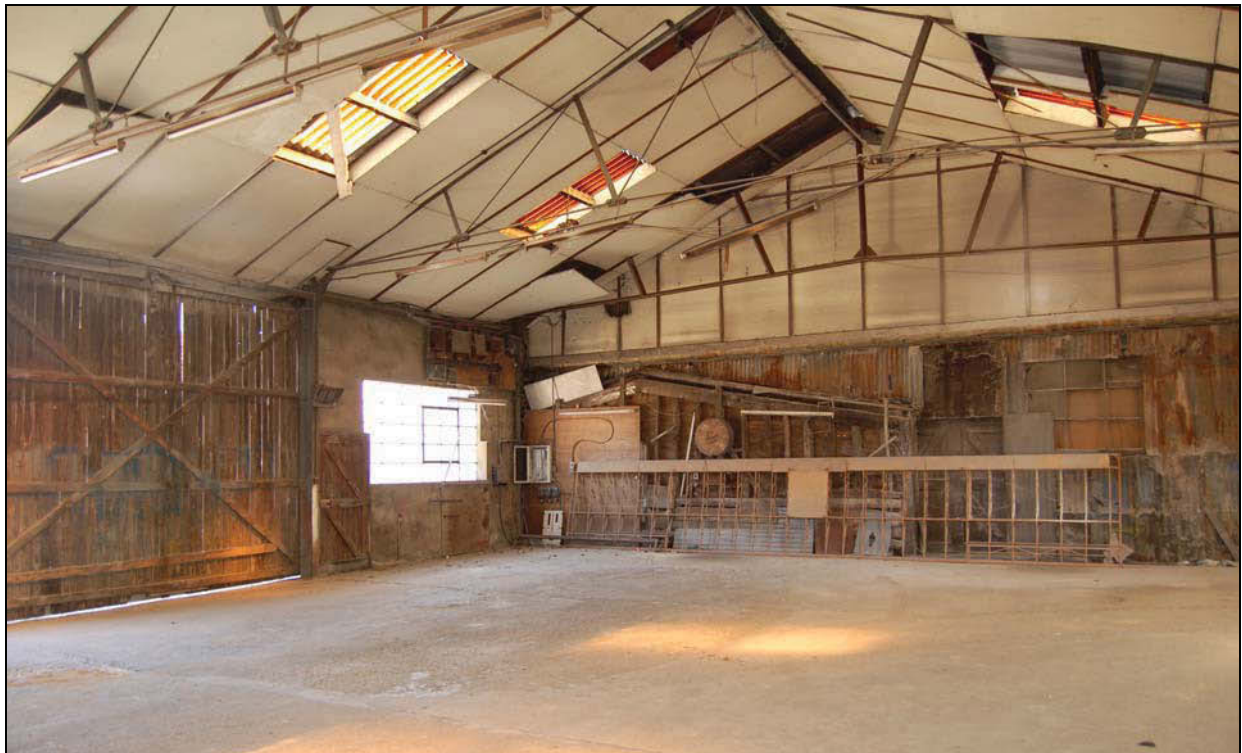
The structure is constructed entirely in modern materials: blockwork and corrugated iron walls and corrugated asbestos sheeting to the roof, supported on angled iron roof trusses. However, the southern wall of Building 10 incorporates the remnants of the mid 19th century cattle shed seen in figure 6 and other historic maps, whose other side can be seen inside Vehicle Store 11 (plate 34).

Plate 34 South wall of former cattle shed incorporated in south wall of Workshop 10

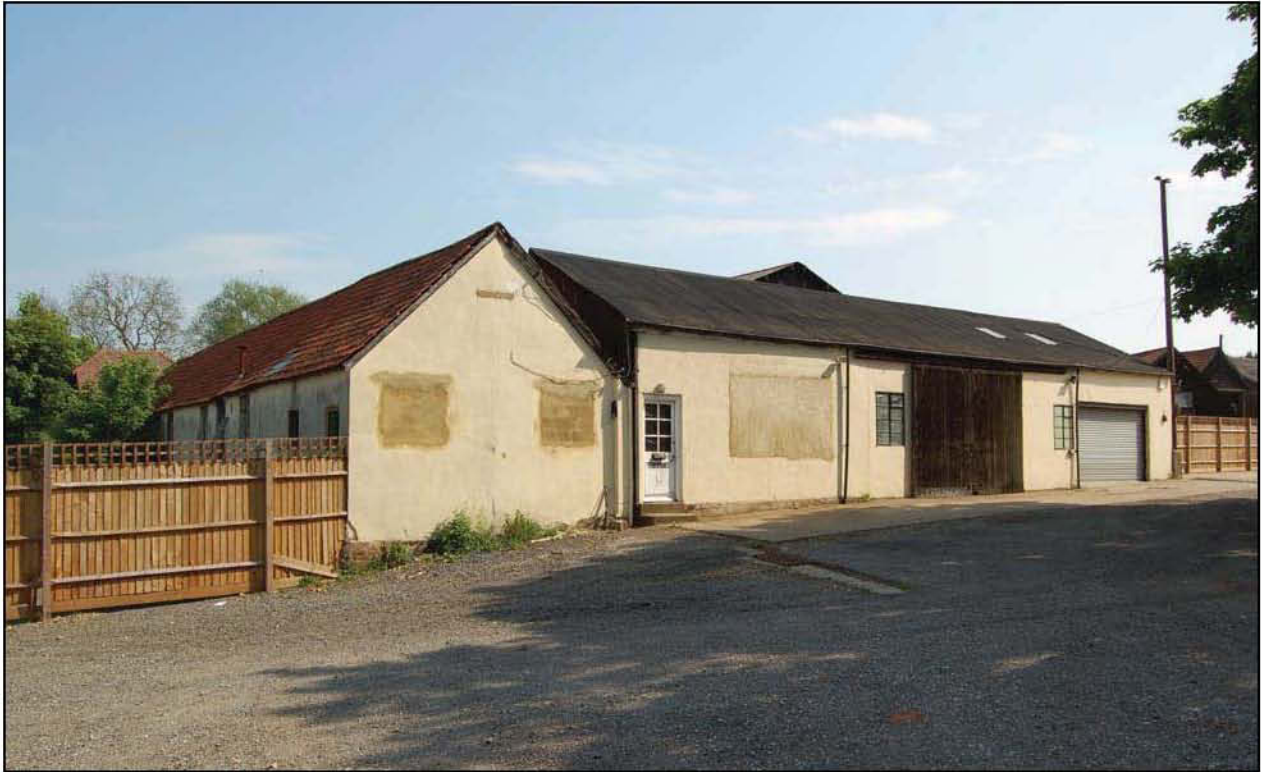
This building comprises a semi-industrial building of post-1960s construction partly used as the farm office and partly for private use by the Hall. Externally it is gable both ends with a cement rendered exterior and metal casement windows matching the appearance of buildings 7 and 8 (plate 35). Inside, an angle-iron frame supports the corrugated iron roof and the southern end of an earlier shed can be seen.

Plate 35 Farm Offices and Vehicle Store 8 and 11

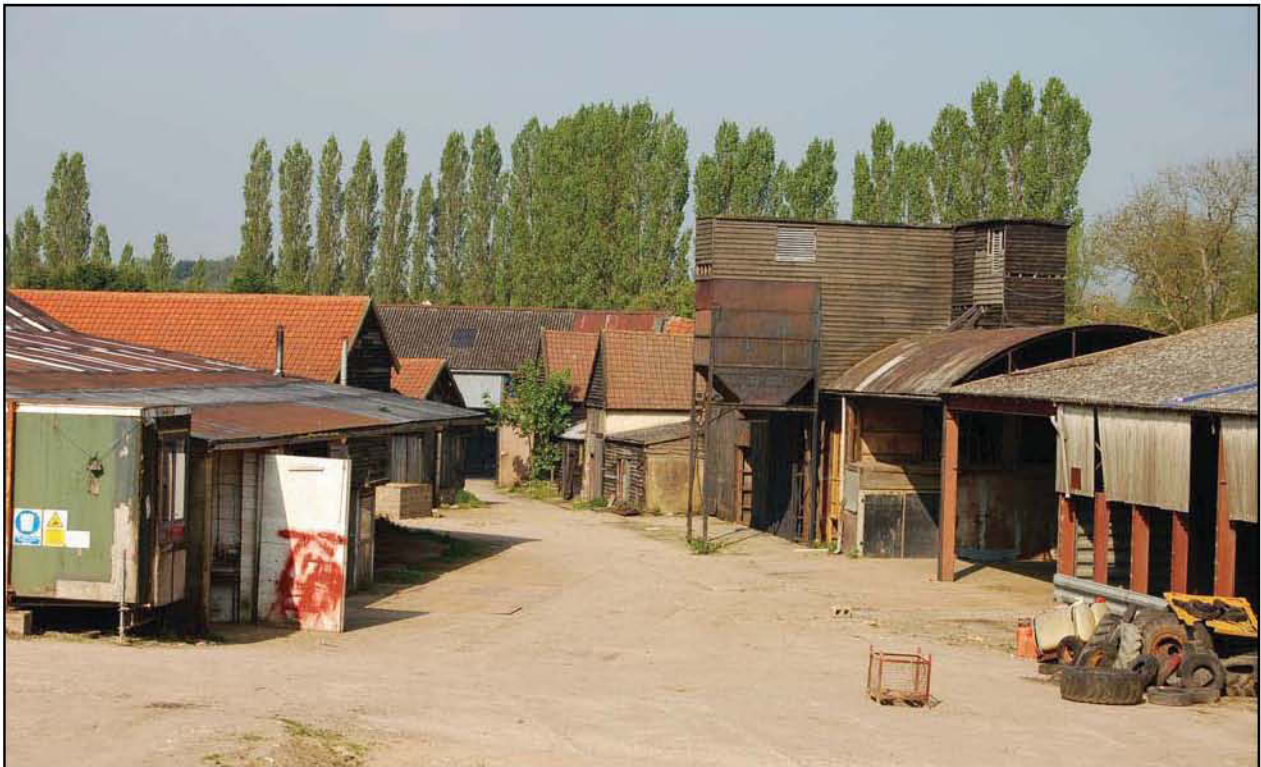
A modern, square double-pile large agricultural building latterly used by Johnstrutt (sic) to design and build pre-fabricated buildings, built from concrete, weatherboard and corrugated iron sheeting (plate 36).

An extensive modern grain store built from corrugated asbestos on a pre-fabricated steel frame (plate 36).

Plate 36 View of yard from east
