THE KING WILLIAM PUBLIC HOUSE CHURCH STREET BOCKING ESSEX

LEVEL II HISTORIC BUILDING RECORD

October 2009

Document Ref.	1979rep
Report Issue Date	9th October 2009
Circulation	Mr John Whitehead on behalf of
	Cambrils Ltd
	ECC Historic Environment Management
	Essex Historic Environment Record

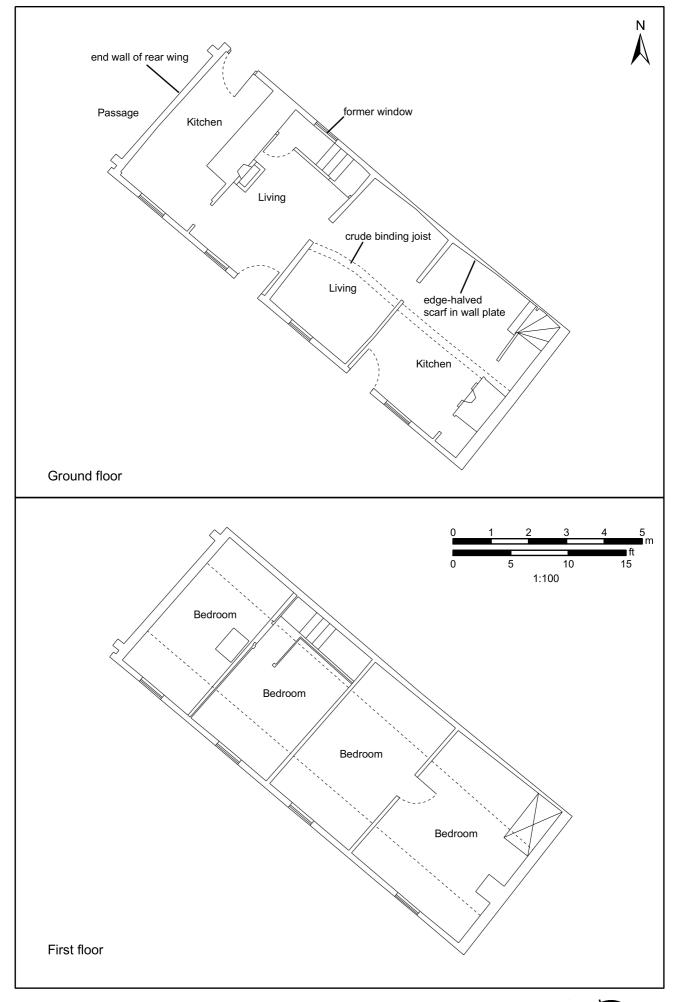
Fig.7. Cottage floor plans

The opposing long elevation and the south-east gable are pictured in plate 21, undergoing conversion. The existing floor plans show no openings at the back apart from a single doorway at the north-west end (fig. 7).

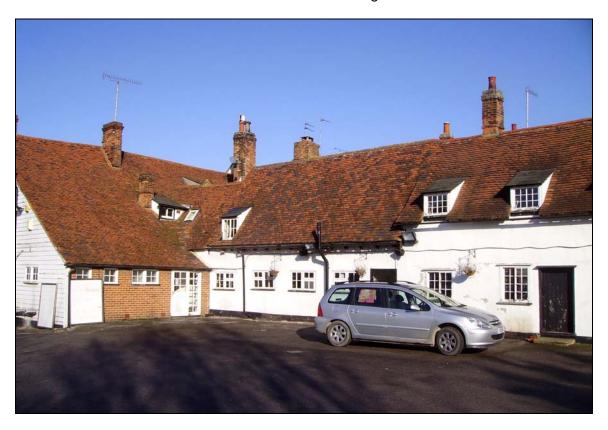
Photographs supplied by the architect prior to conversion show the south-west elevation, a low-roofed rendered building with modern windows similar in style to the cottage next door (plate 16), which is divided and a passage at the south-eastern end, providing access to the rear of the pub. There are no windows at first floor level, except for a dormer window at the north-west end which is within the 18th century part (3), against the roofline of the older building (plate 16). The original south-east gable survives, in 18th-century refurbished form, as the adjoining wall to cottage 5 on the far side of the passageway where the jowled bay posts remain and identical wind bracing to the inside (plate 17). The upper part of the opposite gable wall partly survives inside the public house (plate 18) and is described in section 5.2.2 below. The long elevation to the north-east was removed when the modern corridor was added, leaving only the bay posts.

Plate 16 Rear of public house before conversion

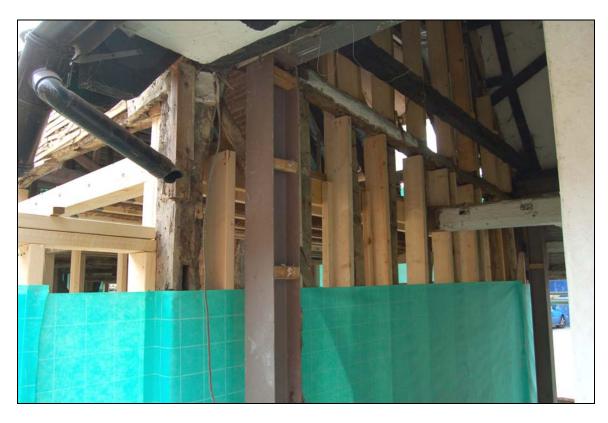
The collar purlin roof remains, wind braced at both ends, but additional collars have been nailed between the purlins for effect and to hold up the plasterboard panels (plates 17 & 19), which meant the roof structure could not be properly investigated.

Plate 17 Jowled corner post and rebuilt end wall of former rear wing

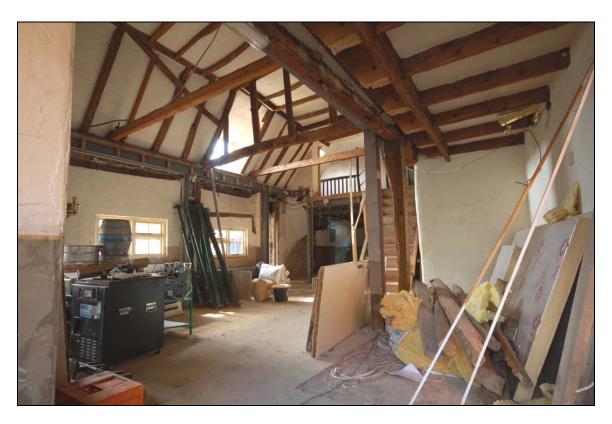
An internal steel frame now supports the timber main frame which comprises six jowled bay posts, similar to those in the main structure, plus wall plates. The wall plates show sockets for three widely-spaced studs at 0.75m intervals (plate 19). Only one original tie beam remains, on the south-east bay. This has been dropped from the top of the post and bolted further down to accommodate the 18th century floor over this bay, represented by an inserted bridging joist, waney-timbered partition and remains of a former doorway (plate 18, fig. 5).

Plate 19 Removed north-east wall of rear wing

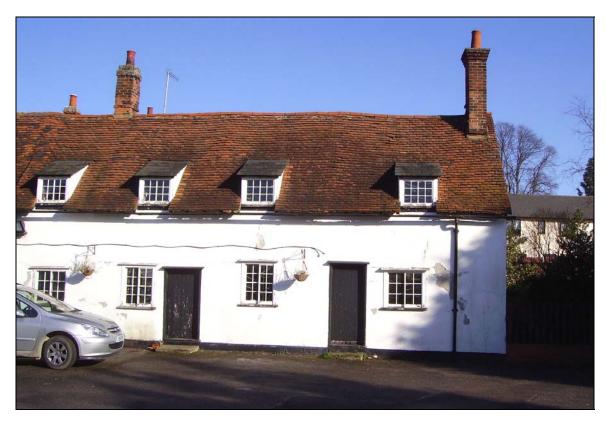
A range of two 18th century timber-framed and plastered cottages adjoins the rear wing on the south-east side of the passage. Conversion was at an advanced stage here, but photographs of the front elevation were supplied by the architect and are included in the report. Plate 20 shows four casement windows and two boarded doors that light the ground floor kitchens and living areas. The roof is tiled and gabled either end with two plain chimney stacks, one per cottage. Four sloping slate roofed dormers light the two bedrooms of each cottage.

Plate 20 Cottages before refurbishment

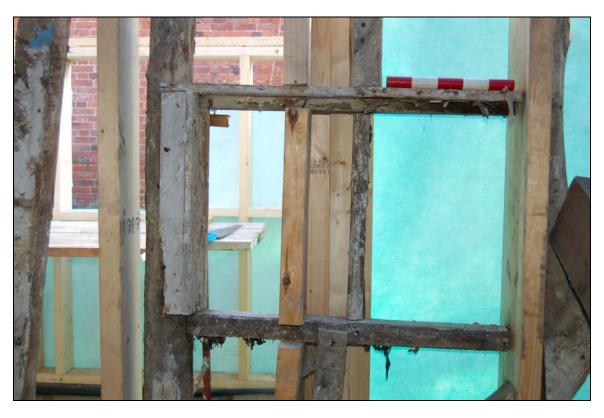
Plate 24 Remains of 18th-century window on north-east wall

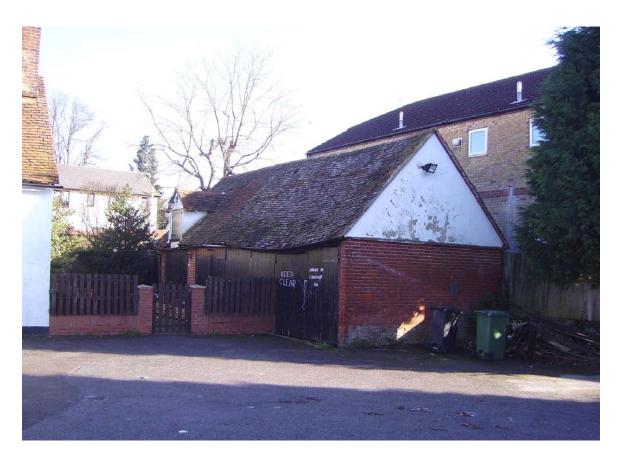
The coach house is brick-built in Flemish bond with plastered gables and a tiled roof (plate 25) and is probably contemporary with the formation of the inn. There are four coach doors at the front, the first of which, to the north-west (left in plate 25) has a gabled taking-in door supplying an internal loft. No record was made of the interior which was in an advanced stage of conversion at the time of the survey.

Plate 25 Coach house before conversion
