**BAKERS FARM, ROMAN ROAD
MOUNTNESSING
ESSEX**

HISTORIC BUILDING RECORD

Revision 1

October 2009

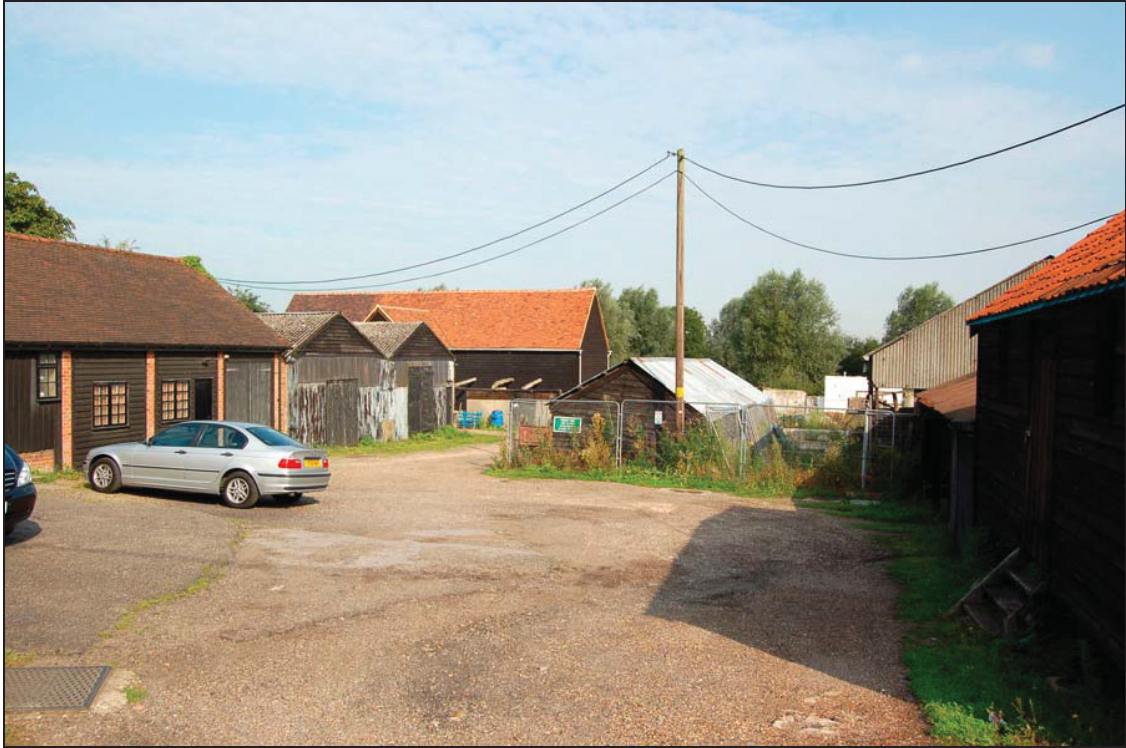
Plate 1 Farmyard viewed to north-west

Bakers Farm lies in the historic centre of Mountnessing, a small village spread out along the B1002 Roman Road between Ingatestone and Brentwood (TL 6282 9758). The yard (plate 1) is on a north-west to south-east alignment with easy access from the main road. To the rear is open ground and the river.

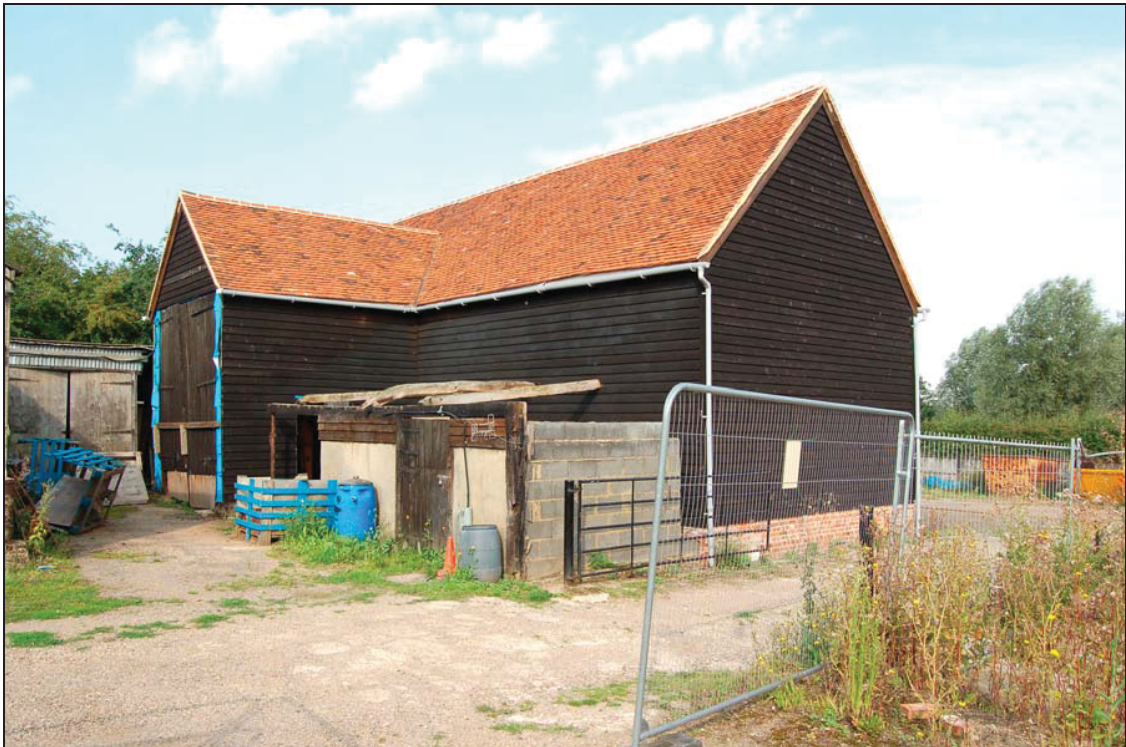
Plate 2 Barn viewed to west

The barn (plate 2) was described during the survey as a good example of an Essex threshing barn of c.1800 date (E. Watkin pers. comm.). It is located at the north-west end of the farm on a south-west to north-east alignment with full gables at either end and a porch to the south-east. It is five bays in length with dimensions of 18.8 x 6.2m (fig. 5).

The barn today is clad in new softwood feather-edged boarding with a tiled roof and English-bonded red brick plinth. Originally it was clad in elm. Most of the original doors have been retained (plate 2).

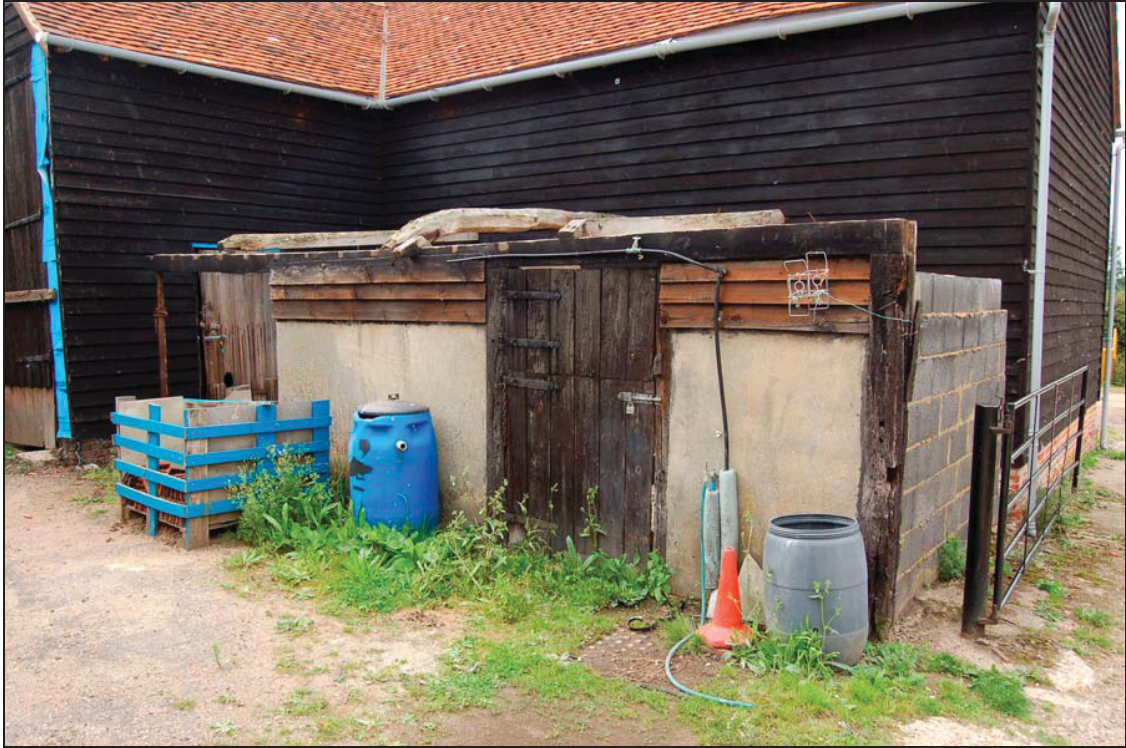
Plate 3 Outbuilding attached to barn

The barn is shown in its refurbished state in plate 2. The old cart doors to the porch have been retained, and a side door, which has a wooden latch (plate 3). The timber lean-to (1a) is probably contemporary but in a dilapidated state, without a roof. It retains partial framing and a half-heck door (plate 3).

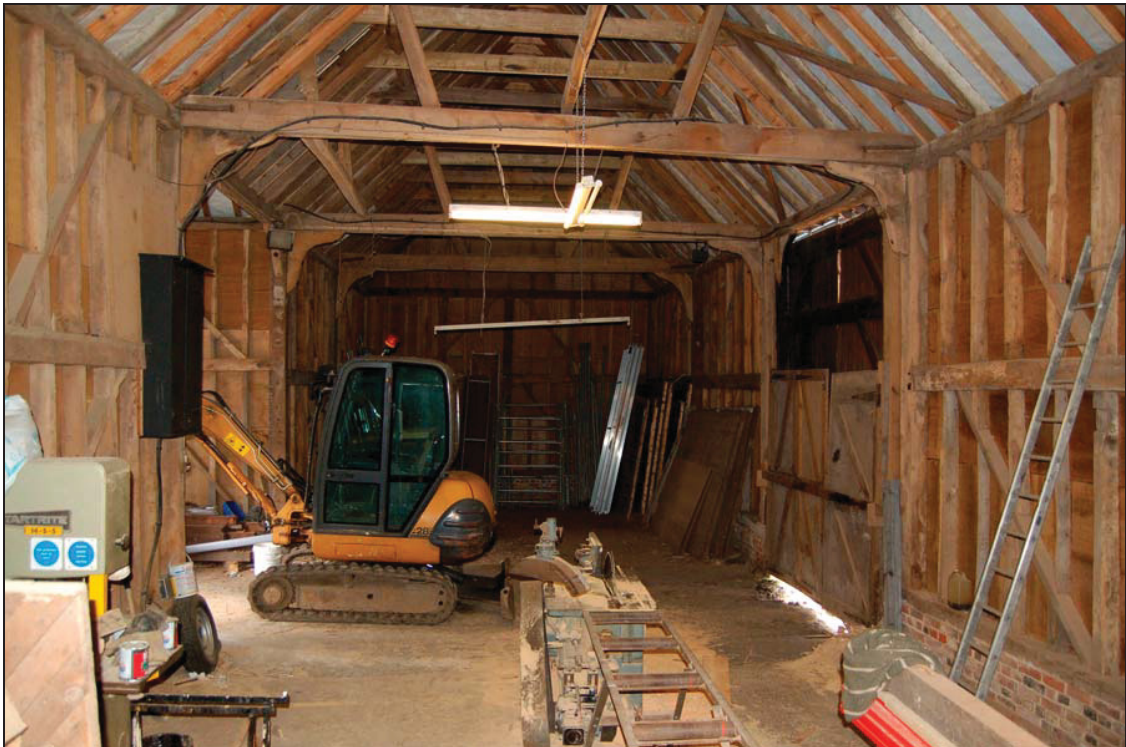
Plate 4 Refurbished barn interior viewed to south-west

Inside, the main framing is primarily in elm with knee-braced tie beams and raking struts supporting a trenched collar purlin roof (plate 4, fig. 7). The primary-braced frame employed many reused timbers as studs (Watkin 2005), some of which have been replaced. The roof was re-built after WWII. The concrete floor dates to previous use and there are no remains of a threshing floor.

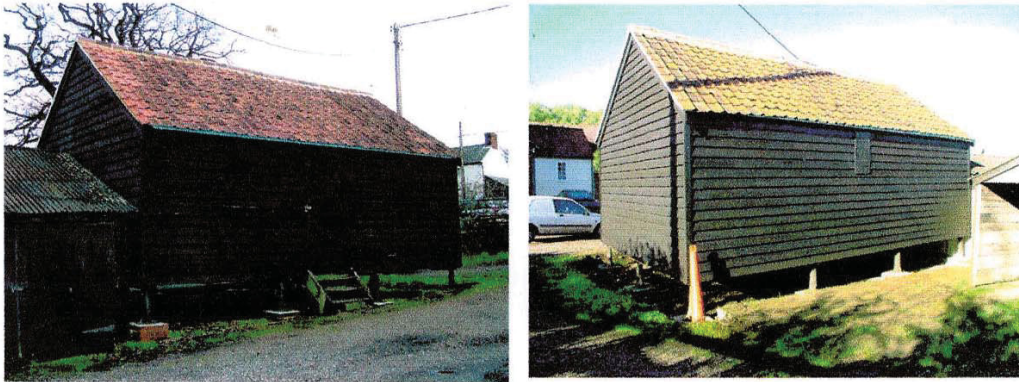
The main concerns are the failure of the joisting system as the reused timbers contained mortices and failure has resulted at these points. The ground level has built-up over the staddles at the SE and general repairs are required to the boarding, rainwater collection and ridge. There is no threat to the structural integrity of the building and the repair schedule will rectify any problems of water ingress.
