**ROLLS FARM BARN, HASTINGWOOD ROAD
MAGDALEN LAVER
ESSEX**

HISTORIC BUILDING RECORD

December 2009

Document Ref.	1948rep
Report Issue Date	22nd December 2009
Circulation	Mrs R. Padfield
	ECC Historic Environment Management
	Essex Historic Environment Record

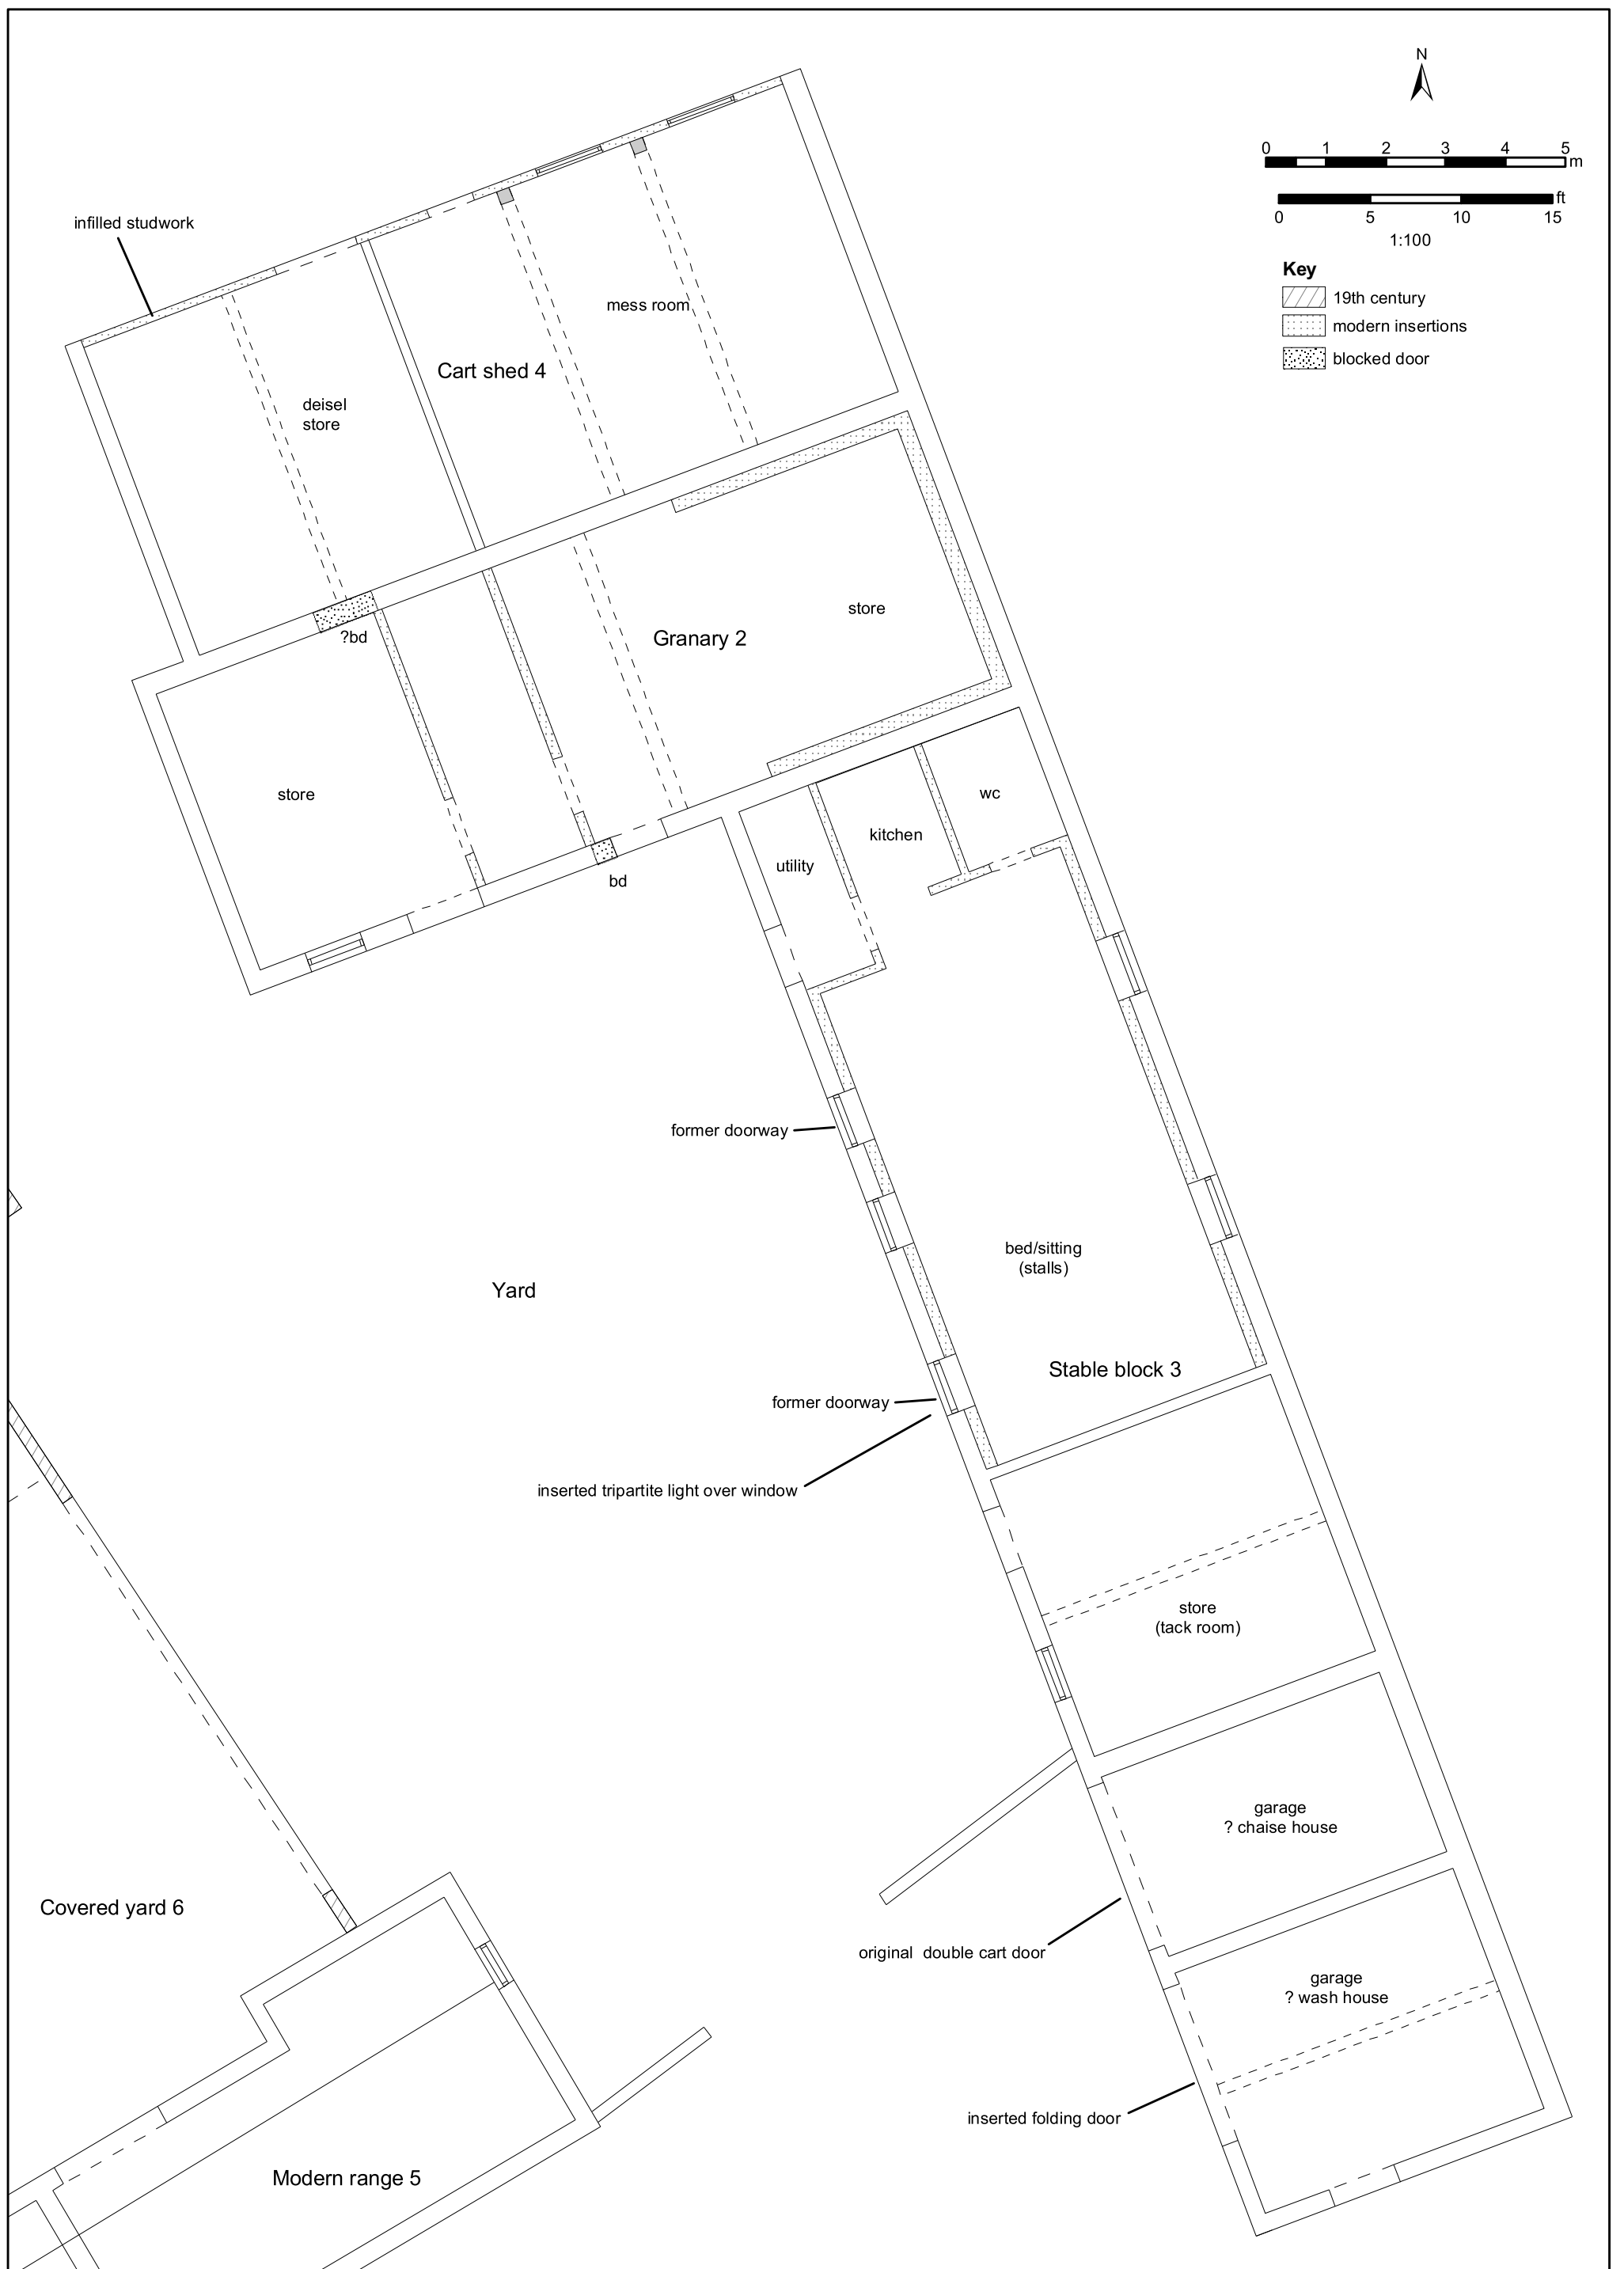
Fig.8. Plan of eastern range (buildings 2, 3 and 4)

The western elevation faces onto the old yard and retains much of its character. At the northern end is the only remaining wide stable doorway, formerly one of three, which is of the same ledged, braced and battened form as the granary (plate 17). The other two doorways have been partially blocked to accommodate windows (fig. 8). All the old openings (probably slatted vents or a combination of vents and windows) are replaced with modern windows along the entire range (plate 17), but their cambered brick arches remain. A wide, fixed tripartite window has been inserted at the south end of the former stalls (fig. 8).

Another ledged, braced and battened door provides entry into the tack room, positioned further along the main elevation, on the north side of the yard wall (fig. 8). Beyond the yard, and also the development area, are service buildings relating to the farmhouse. The first is a probable chaise house, with its own double doorway for cart access. Chaise houses were often found close to the house, where the family's carriage would be kept, commonly a small two-wheeled carriage called a chaise, usually with a folding canopy (Proctor 1985). Next to it appears to be a former wash house, suggested by chimney for an old copper, though the copper is no longer present. Folding garage doors have been inserted at the front, now largely hidden behind the flower bed (plate 14). Both these areas are referred to as garages in figure 8. The eastern elevation finishes in a hipped slate roof and plain chimney on the south end. Entry into the washhouse from the house is at the south end (fig. 8)

The diesel store is separate to the mess room and was only partially accessed but the southern wall shows a possible blocked doorway into the granary, underneath the truss (fig. 8, plate 24).

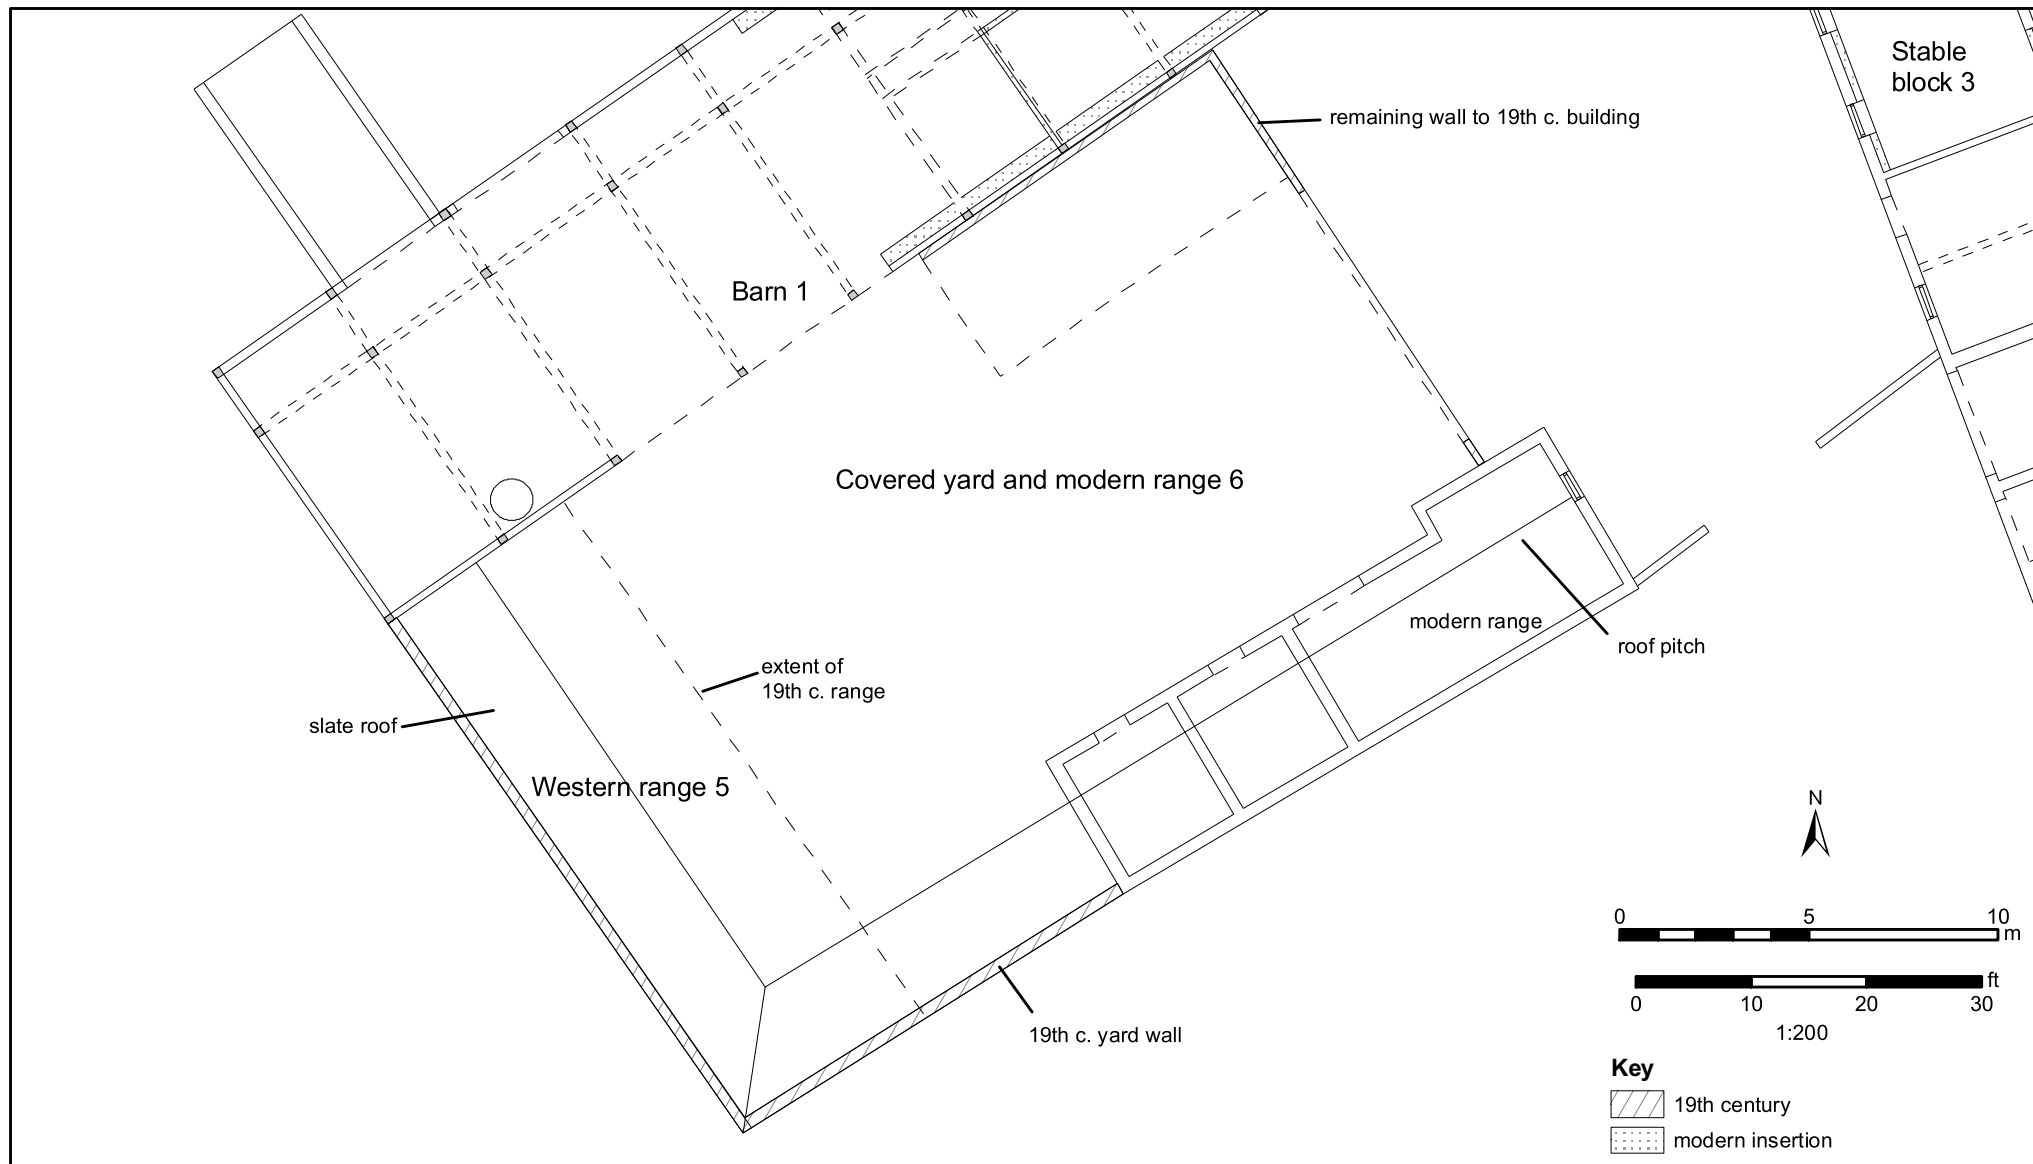
Fig.9. Plan of western range 5 and covered yard 6

Unfortunately, most of the range was lost when the yard was covered over in the modern period. Only the outer wall remains and the western side of the roof, as the expansive roof of the modern yard is built off the ridge (fig. 9). The extent of the range has been extrapolated from old maps and a roof scar against the south wall of the barn.

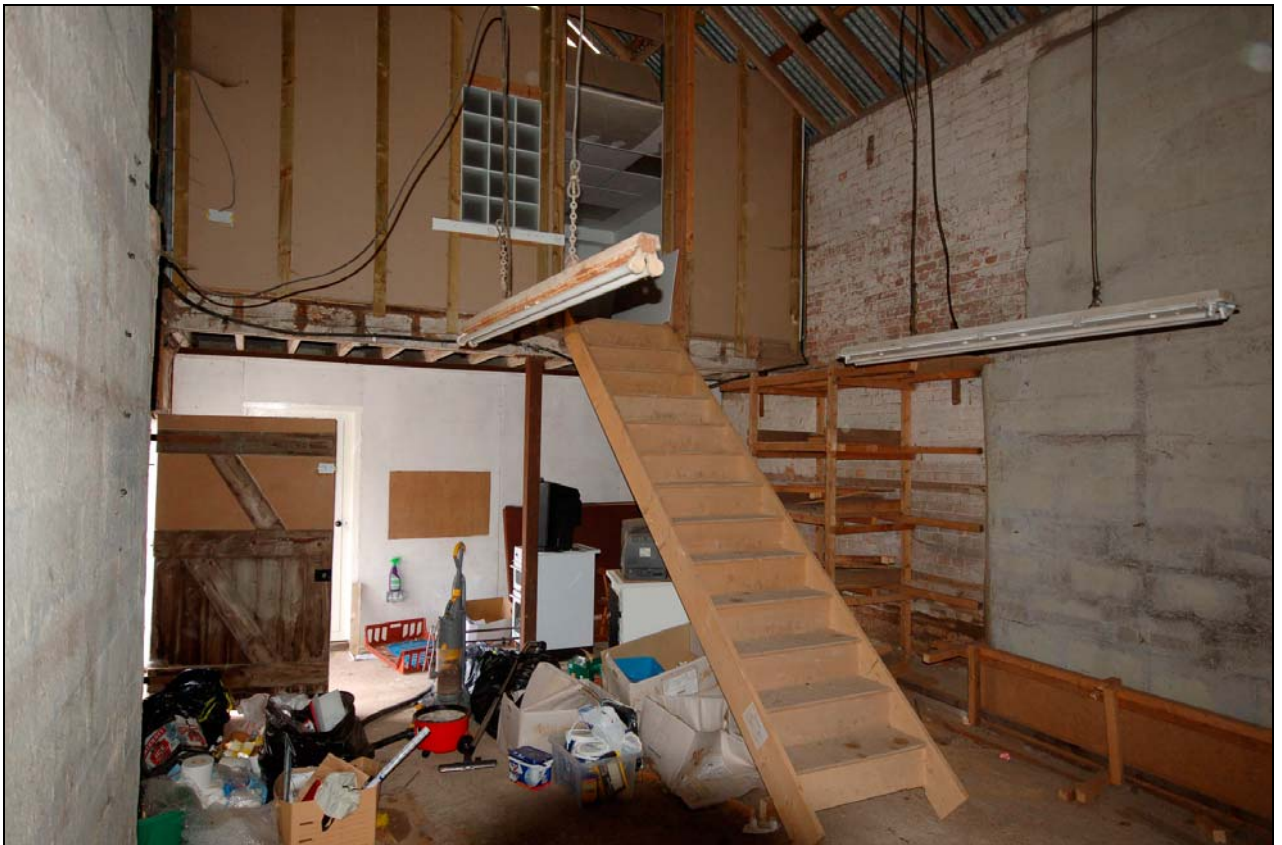
Plate 16 Interior of granary viewed to west

The western part of the ground floor has been refurbished for storage purposes and the floor above is now a self-contained flat, entered by a new stair cut into the former floor above the eastern part (plate 16). The surrounding walls are lined with concrete blockwork and racking and the floor is also of concrete. The walls are white-washed below a collar purlin roof, partly-rebuilt with modern machine-sawn timbers.

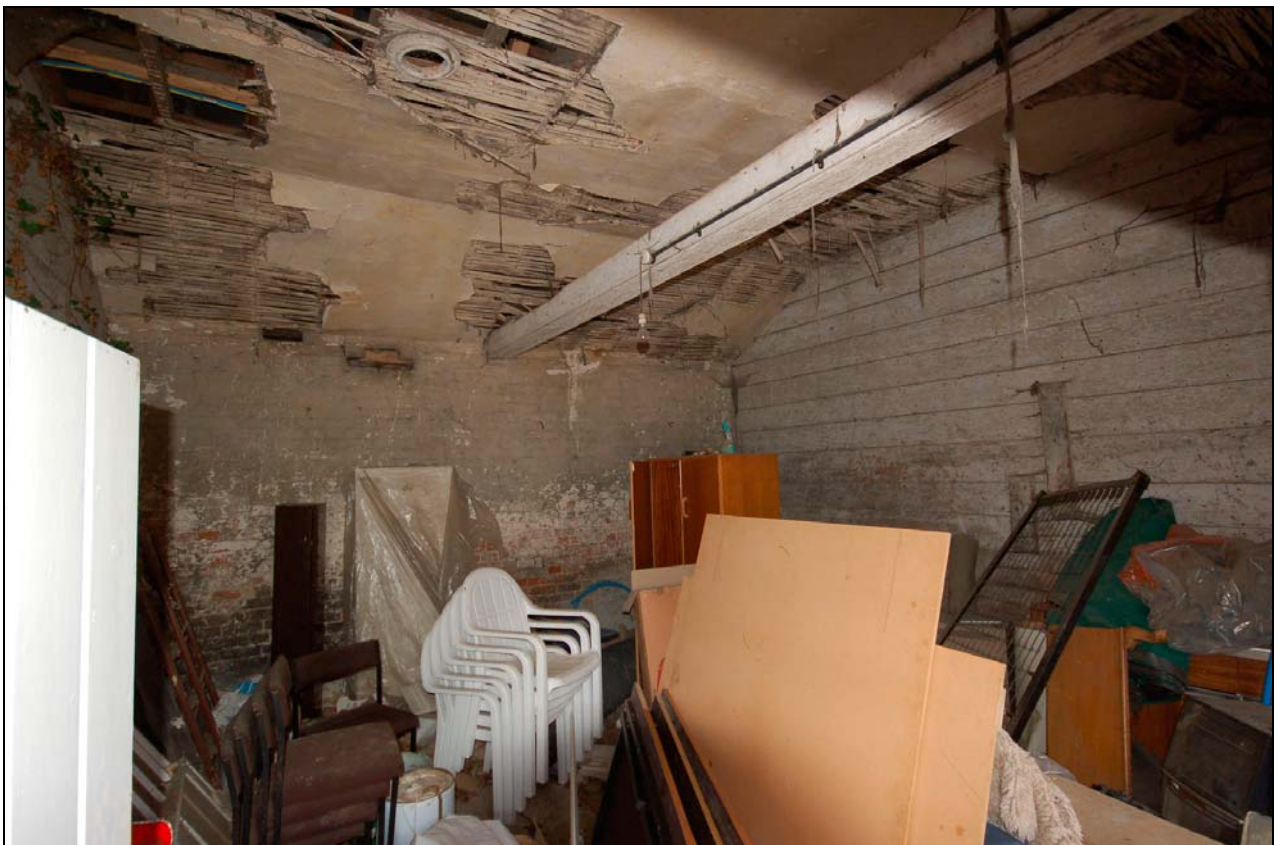
Plate 20 Interior of tackroom

ceiling with the remains of a moulded ceiling vent (plate 21). A painted beam with beaded corners divides the room in two (plate 20). The internal walls are boarded and the northern wall contains four harness racks.

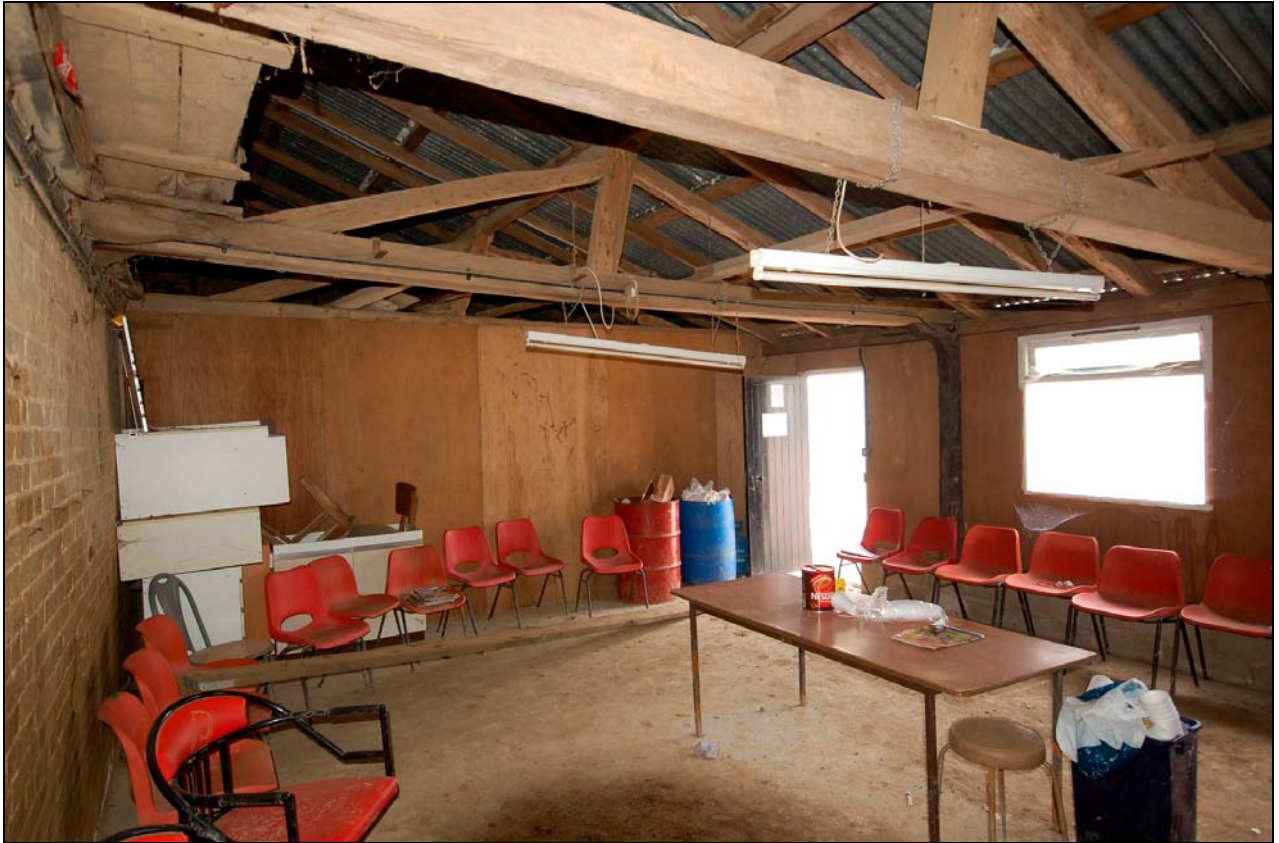
Plate 23 Mess room inside former cart shed

Inside are five bays, defined by heavy 5 inch thick softwood trusses laid over the brick wall at the back and 7 inch thick posts at the front (plate 23). The bays are quite narrow, at up to 2.5m wide, and the mess room and store areas are separated by a modern partition on the line of the second and third truss from the west (fig. 8). Each truss comprises a beam with a short raking strut pegged centrally that cups the purlin in the roof (plate 23 & 24). The struts are strengthened either side by diagonal braces that could have supported a much heavier roof.
