**THE PLANTATION, MILL ROAD  
STOCK, ESSEX**

**LEVEL II HISTORIC BUILDING RECORD**

**May 2010**

**FAU Project No.:** 2178

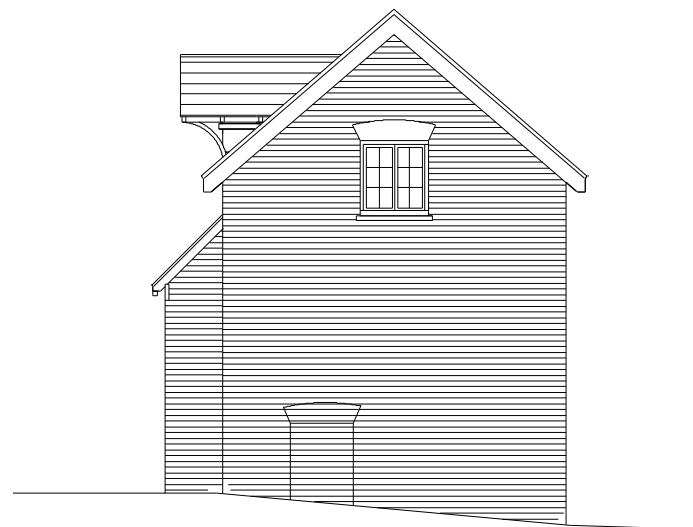
c) South elevation

The gables have horizontal sliding sashes high up at either end to light the hay loft (figs 9b & c); the south-facing one of which is replaced. At ground floor level on the south side is a blocked segmental-arched aperture that was likely associated with a machine pit inside the first stall (fig. 10a) and the line of an old rainwater pipe can be seen running into the tank on the south-west corner (plate 28).

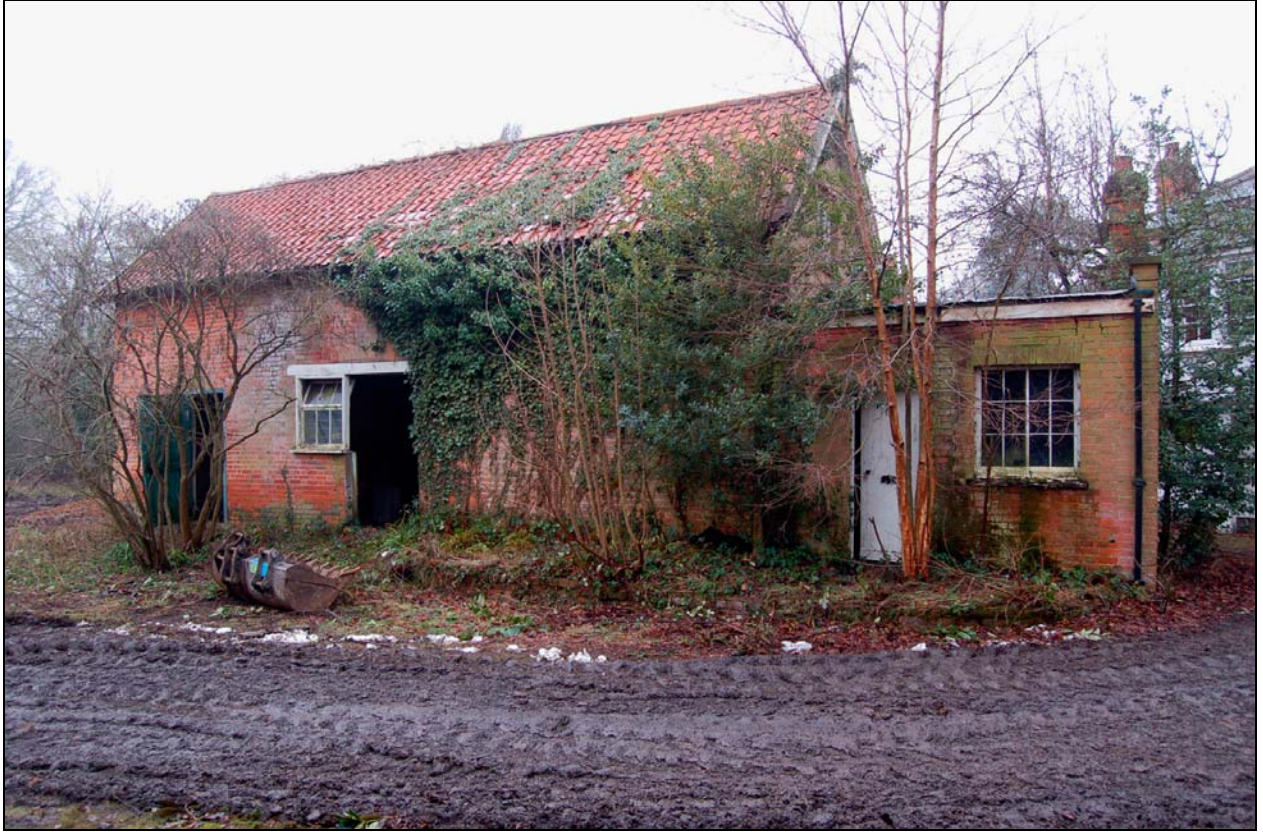
Plate 27 East elevation of stable

This elevation faces onto the present driveway off Mill Road (fig. 1). The main stable range has two entry points into the stalls. The first, on the southern end retains its green boarded and ledged door, while the second door is lost. The doorway into the second stall has a segmental brick arch over the top, lacking on the first stall, and a vented window next to it (fig. 9a, plate 27). At the north end is the groom's quarters: a flat roofed extension with a door containing a letterbox and a horizontal-sliding sash window beside it (plate 27). Both windows have flat heads, which are a phase 3 characteristic (fig. 6).

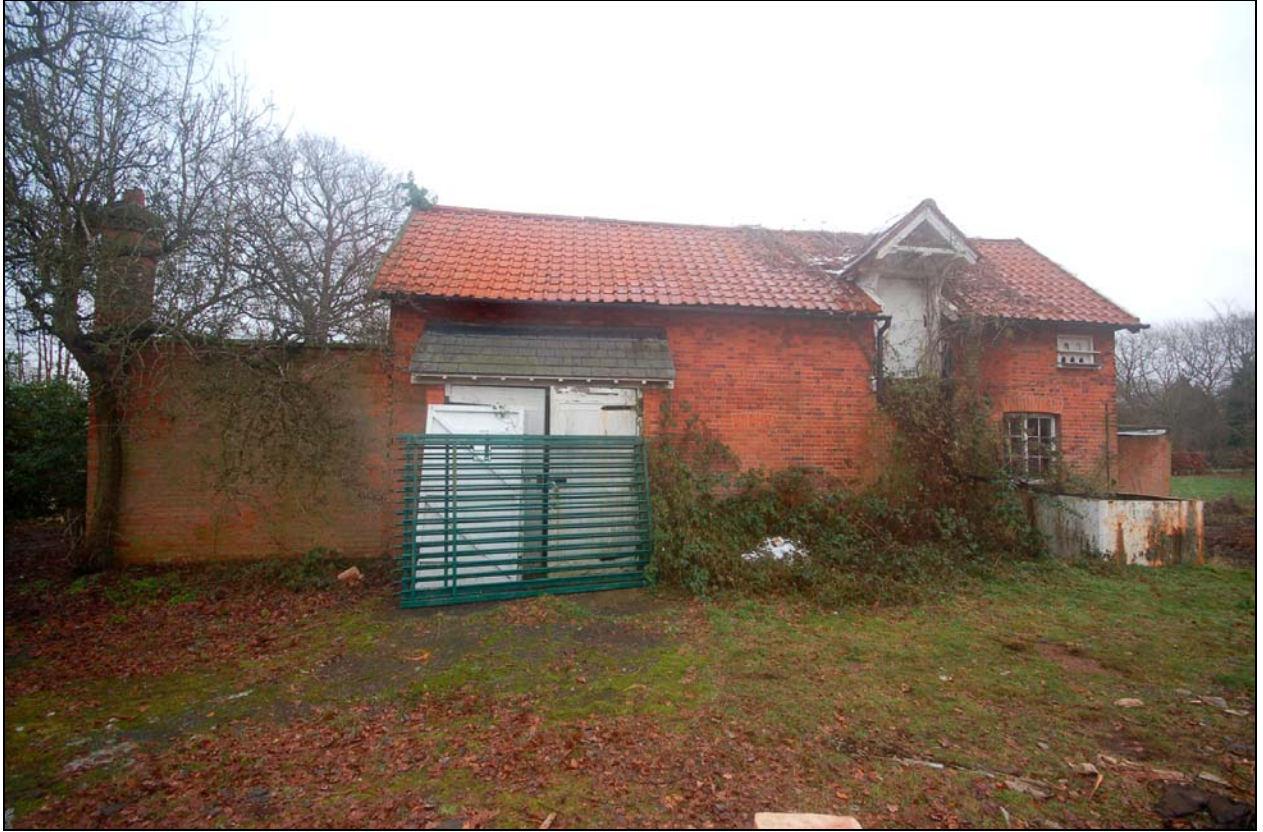
Plate 29 West elevation of stable

A short slate-covered porch extends from the coach house that holds a pair of ledged and braced doors providing plenty of room and height for carriages. Away to the north is the join for the flat-roofed extension, which was well stitched-in but has started to come adrift (plate 29). Beyond this is a blocked window in the extension (fig. 10a).

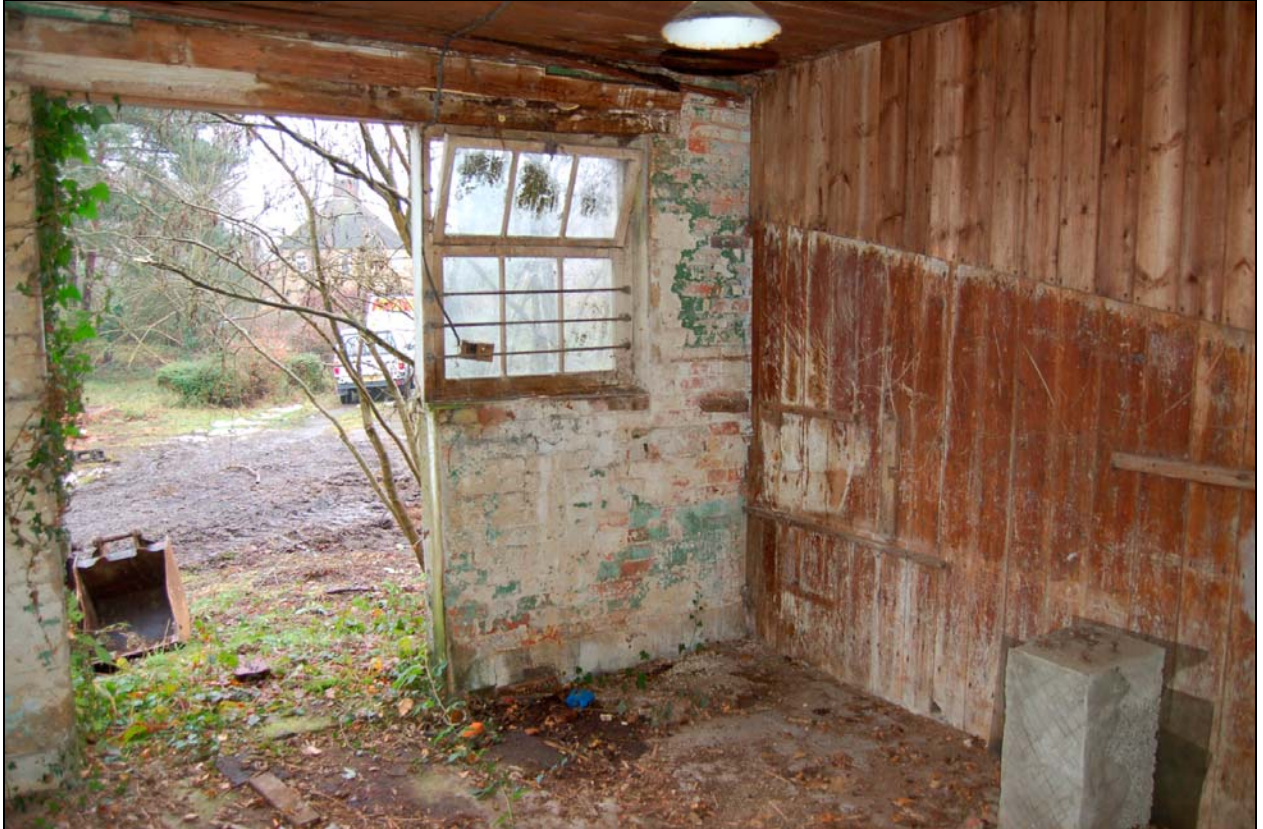
Plate 30 South stall

Two stalls are entered from the east, separated by a boarded wooden divider. The ceilings are also boarded and the walls formerly painted green, a typical utilitarian colour of the time. The **southern stall** retains original 4" square stable setts and part of an old gas mantle, a pre-electricity lighting fixture. There is a third partition in the south stall, where an engine and running gear were located, perhaps for a feed-mixing machine. All that remains today is the machine pit, housing the flywheel, and a concrete engine base associated with a low arched aperture in the wall, currently blocked (fig. 10a). The **northern stall** (plate 30) retains original fixtures to a higher degree in the form of an intact cast iron hay-feeder and complete gas mantle at the west end (plate 31). The original floor has been concreted over.
