**HISTORIC BUILDING SURVEY OF
HULL'S MILL FARM, HULL'S MILL LANE
GREAT MAPLESTEAD
ESSEX**

June 2010

HISTORIC BUILDING SURVEY

FAU Project No.: 2182

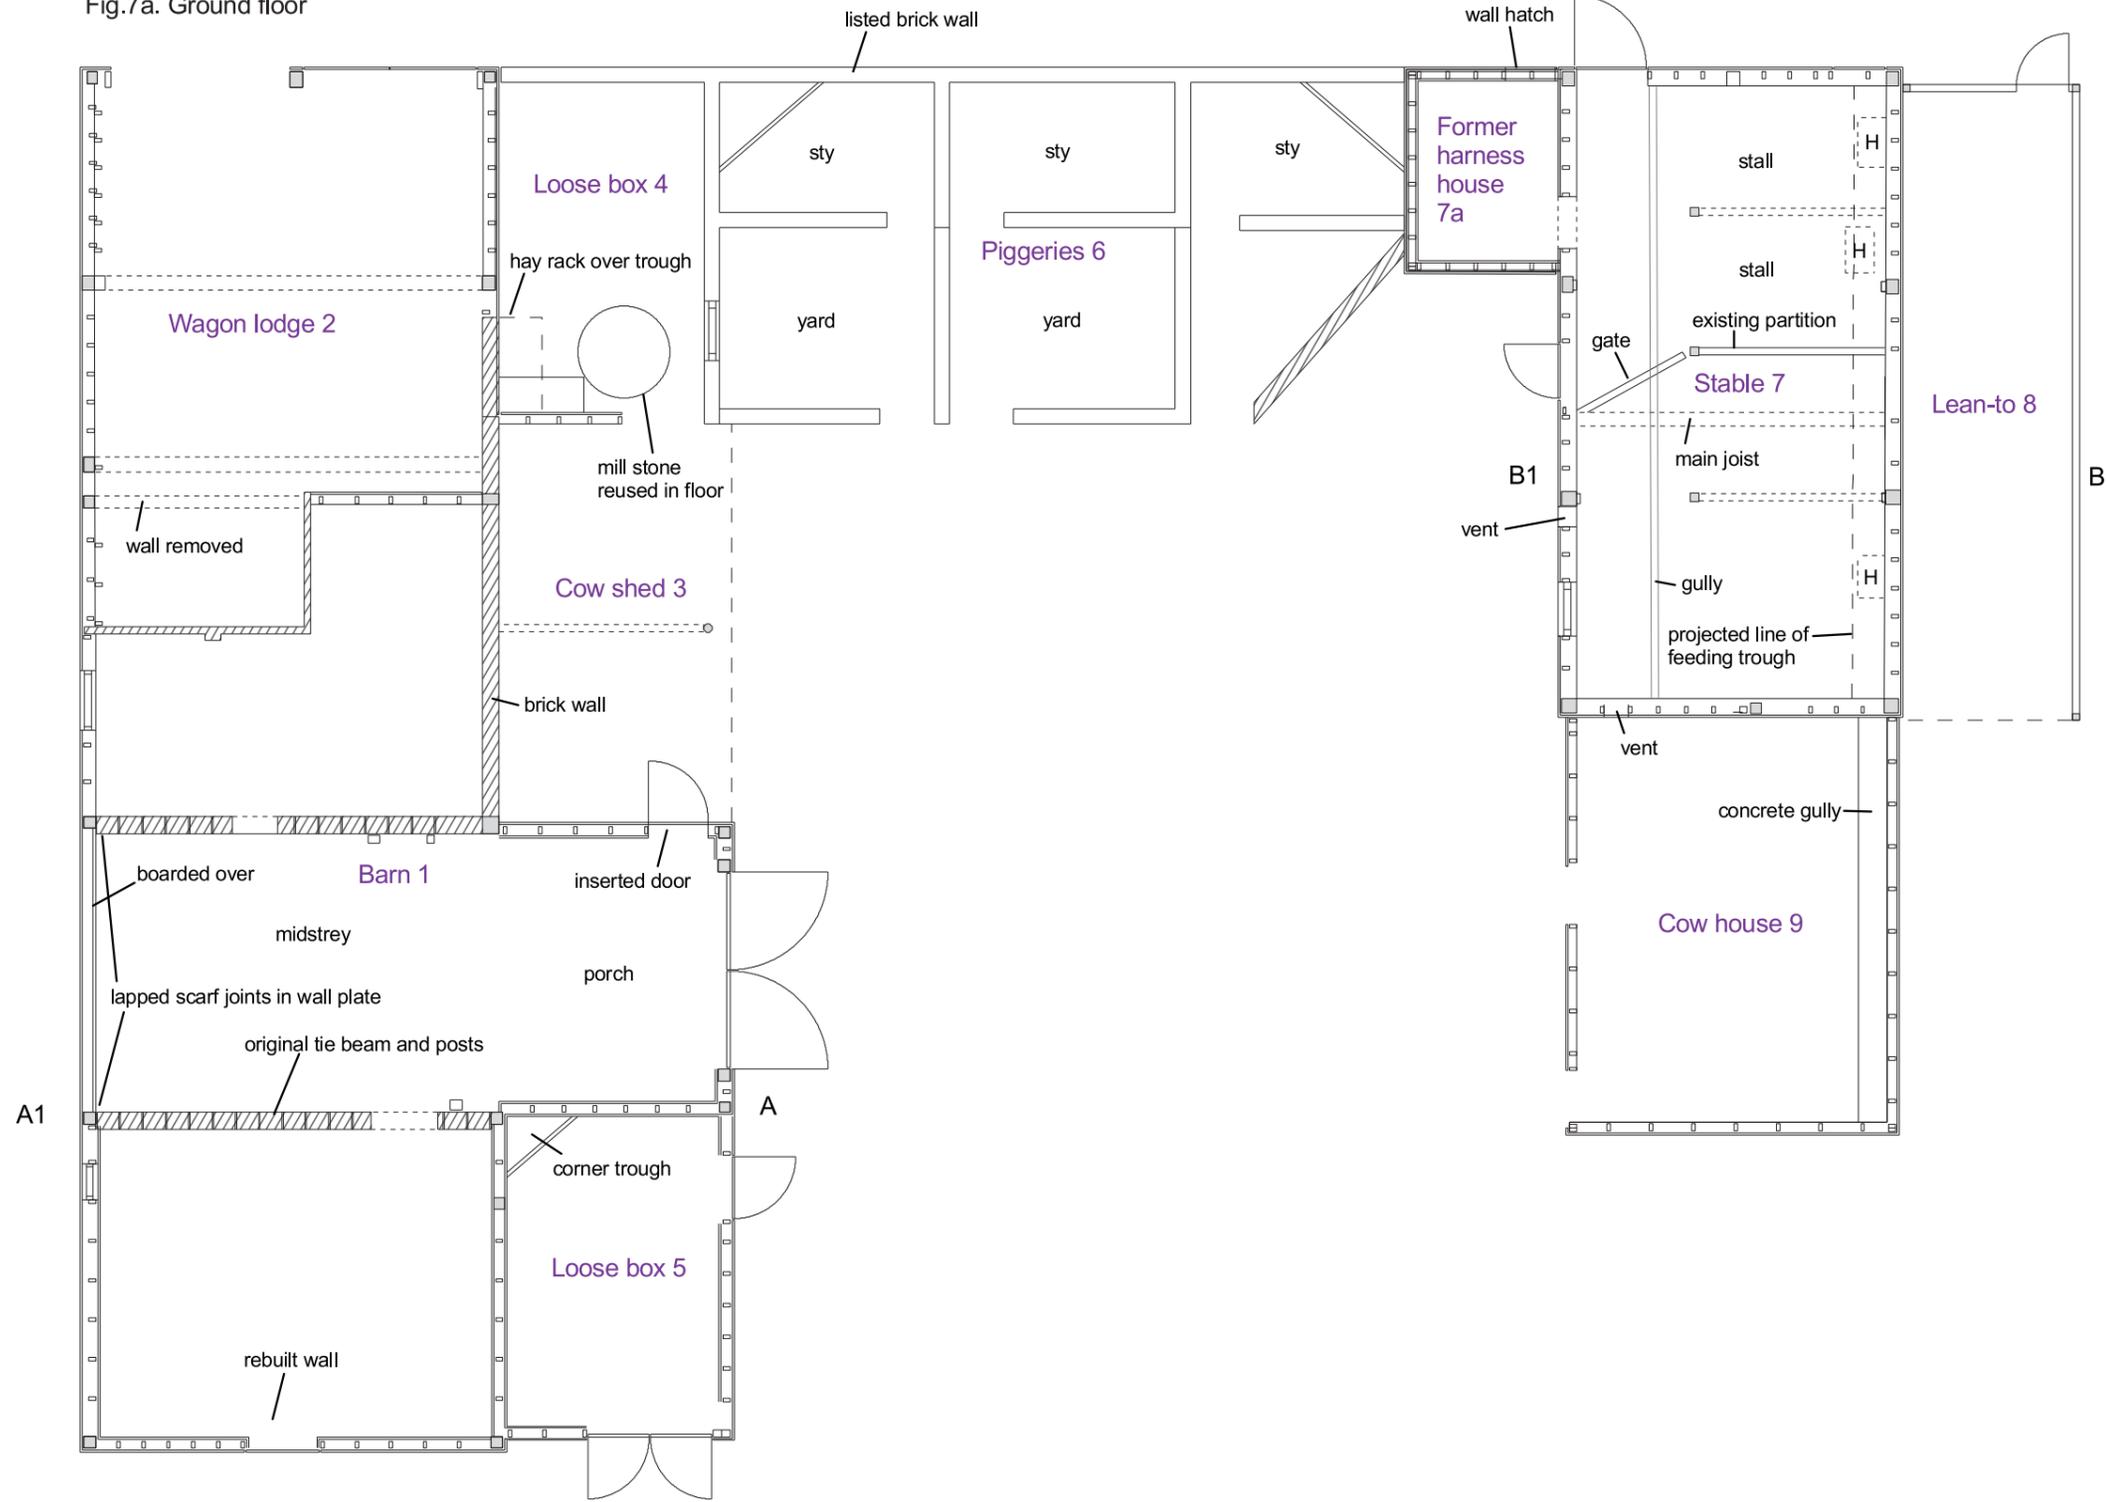
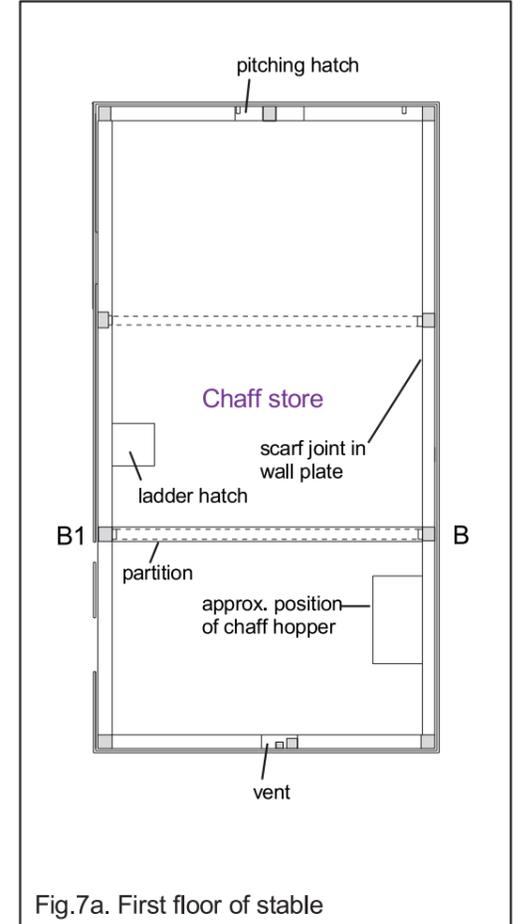
Fig.7. Existing plans of historic farmstead

Three brick pigsties stand along the northern wall, facing the warm southern side of the yard (plate 18). Each is typical in design, comprising a small brick floored yard and box (Peters 2003). One of the brick walls has been rebuilt in concrete block (fig. 7). The roofs are single-pitched and pantile-clad with slate eaves and overgrown with ivy, making entry difficult. There are wooden-slatted litter areas inside (plate 19).

The west elevation faces onto the yard (plate 4). Entry to the yard is by a central half-heck door, while a second door is located on the north side, both held on with wrought iron strap hinges. A stable vent is located to the south of the yard door, operated internally (fig. 7), and there is an eight-pane fixed window also, perhaps a later insertion. Following on from the stable is the modern cow house, which is described in section 5.10.

Inside, the stable is laid out over three bays. Flooring is more complete than any of the other structures, laid in 7 inch brick setts, quite worn and sloping towards a gully on the yard side (fig. 7). Originally the floor was occupied by four timber stalls, only one of the partitions survives, dividing the second and third stalls (fig. 7, plates 21 & 22). The partition is typical in form, built of vertical boards nailed to a curving frame with the high end attached to the wall (east), and passing the full length of the horse to stop them biting or kicking each other (Peters 2003). Troughs and hayracks have been removed, which the stalls were formerly built onto. Above, on three of the four stalls, are hatches over the troughs for dropping chaff down as feed (fig. 7) and there was likely a fourth that no longer remains. Beside the west door is a stout wooden gate for guiding the horses out into the yard (fig. 7, plate 22). The vent on the west wall (plate 23) is designed to lift up and sit at an angle to encourage air circulation but prevent draught.

Wall-framing is in thin unpegged primary-braced timbers, consistent with the other buildings. Bay posts are slightly larger at c.20 x 18cm and mostly-reused. Unusually large knee braces, almost 2m in depth, span the ground and first floors, bolted between posts and tie beams (fig. 9). High wall braces run between post and up to the wall plate, some of which are cut into the studwork, suggesting secondary strengthening of the frame, which is carrying a heavy load. Wall plates are connected by face-halved and bladed scarf joints, one of which was seen on the eastern wall high up on the first floor chaff store (fig. 7).

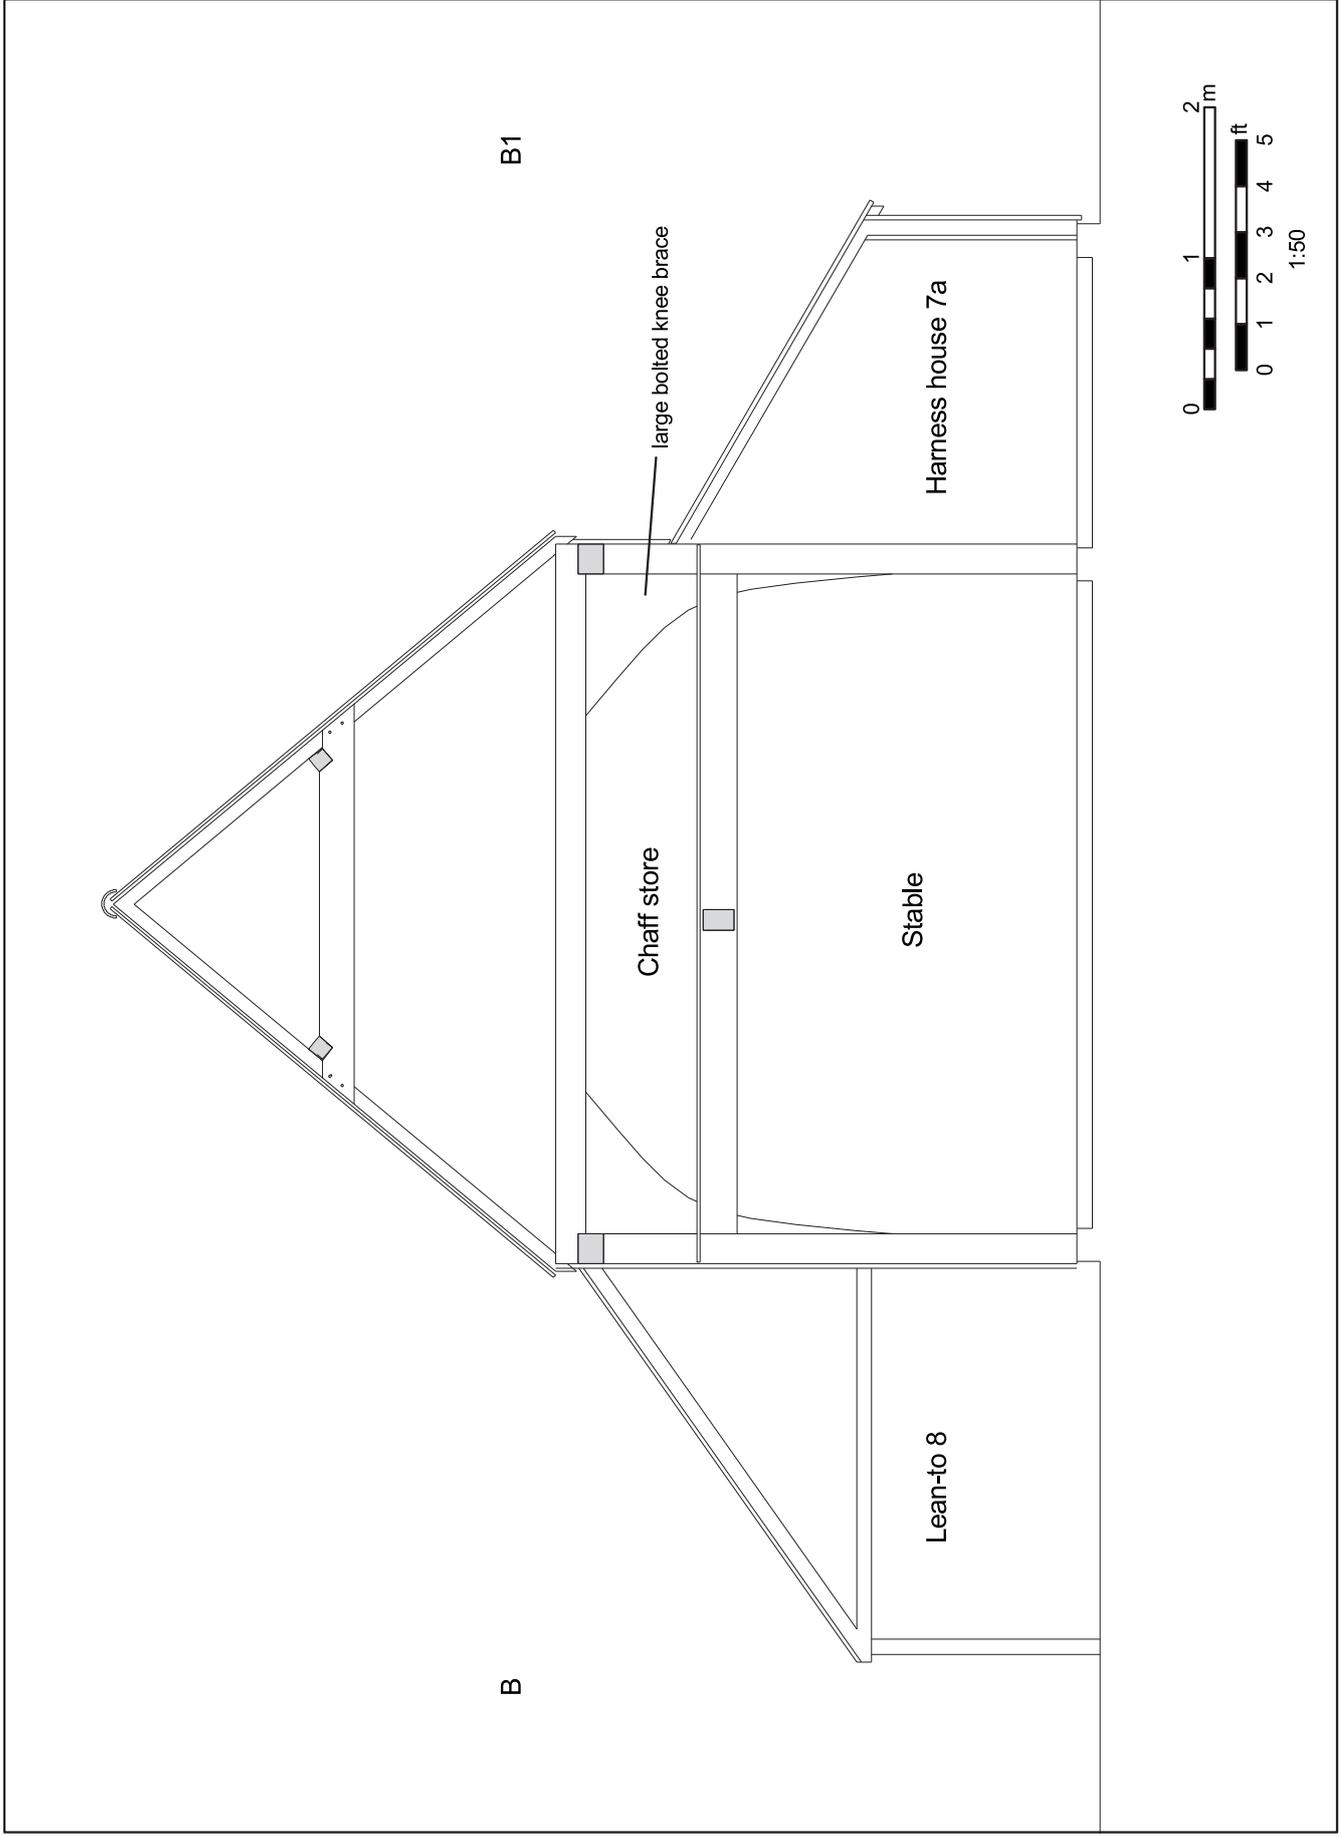
Fig.9. Section B - B1 through stable

Roof-framing is of double-pegged collar clasped purlin type, the same form as the barn, but with all original members (fig. 9).

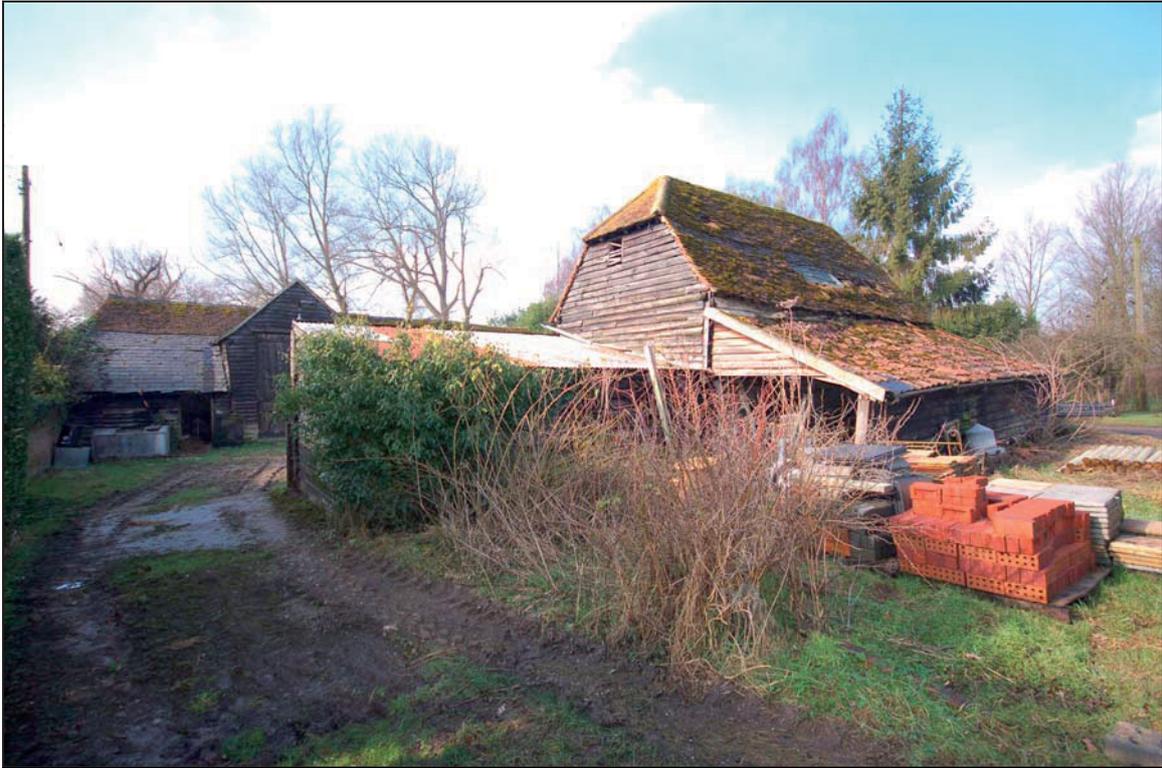
Plate 1 Historic farmstead viewed to west

The door on the north gable has had the bottom part replaced. Beside it is a narrow glazed light above which is a pitching hatch for throwing chaff up into the loft after threshing (plate 20). Elevations to east and south are largely occupied with other structures (fig. 7), but the south gable does contain a small slatted vent up in the chaff store, below the roof hip (plate 1).

The lean-to is linear in form and attached to the rear of the stable, open-sided to the traditional trackway (fig. 7, plate 1). A doorway on the north elevation has later T-hinges and is therefore likely to be an original insertion (plate 20). The boarded primary-braced frame is a slightly more robust version of the framing observed around the Victorian farmstead, but some of the roof timbers have snapped or are on the verge of snapping through damp and the weight of the pantile roof above (plate 26).

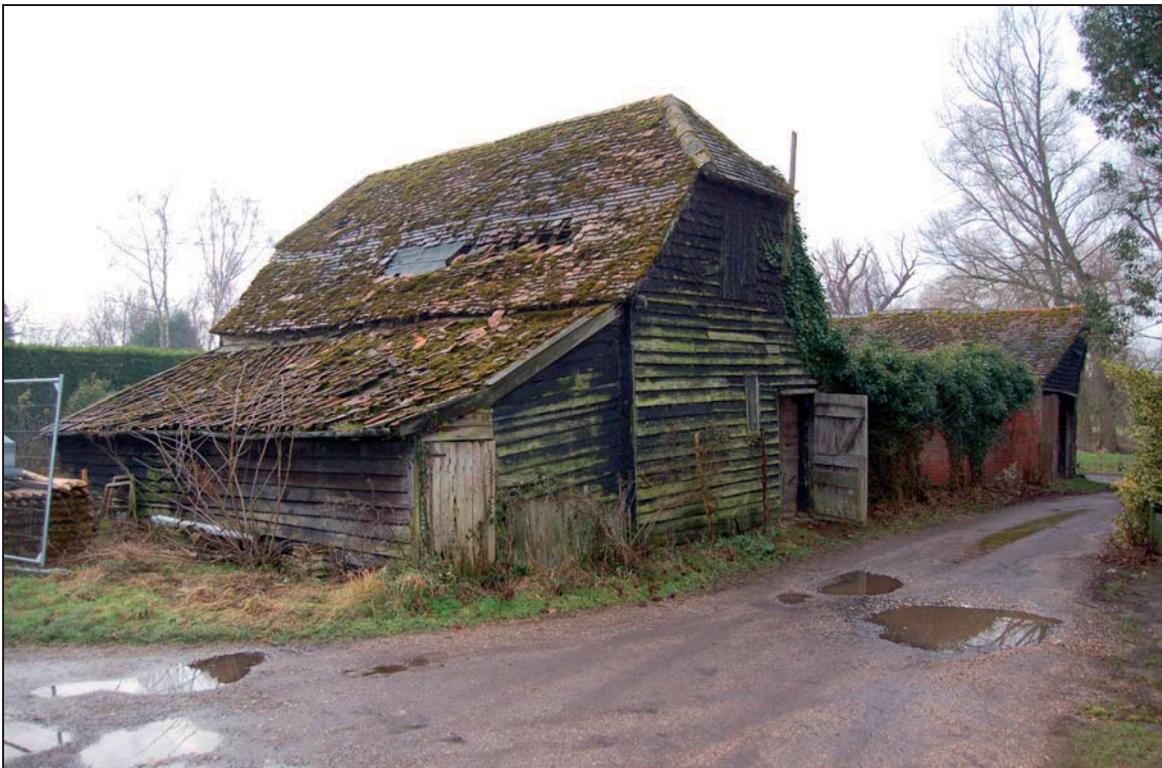
Plate 20 Stable and lean-to 8 viewed to south-west

The piggeries are built along the Listed yard wall that joins the barn and stable at the north end which is also overgrown with ivy (plate 20). The wall comprises good quality 9 inch soft red bricks neatly laid and pointed-up in Flemish bond, with dimensions varying from around 225-230 x 110 x 65mm, suggesting a 19th century date (Ryan 1996).

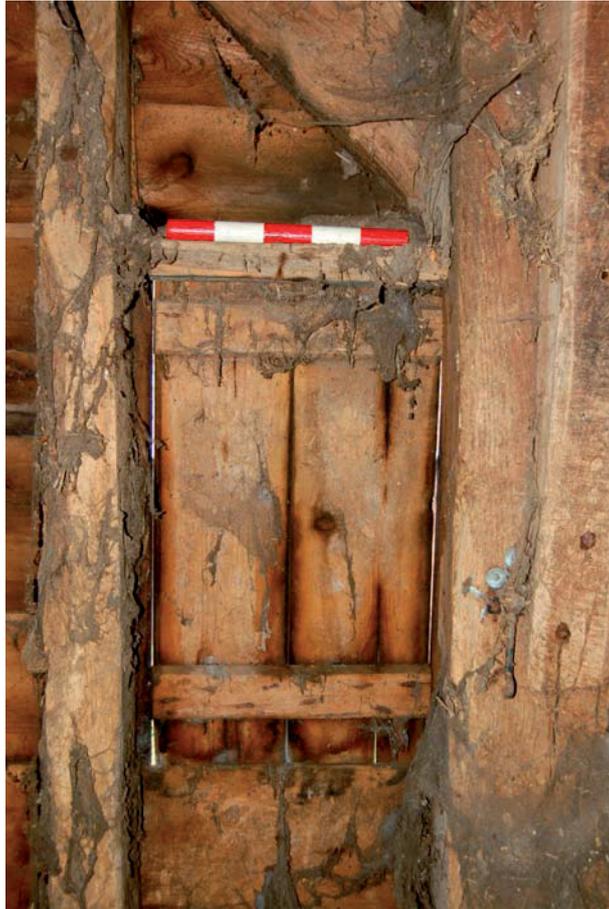
Plate 23 Stable vent on west wall (25cm scale)

The first floor chaff store is carried on a 23 x 20cm-thick central lateral joist, jointed to thinner bridging joists continuing to each end (plate 21). This is quite a span to carry, and since the floor has started to rot, the central joist is now acro-propped (plate 23), with additional modern posts added to support the joists in the northern bays. 9 inch floorboards are attached to minor joists lapped between the bridging joists and wooden clamps nailed to the studwork.

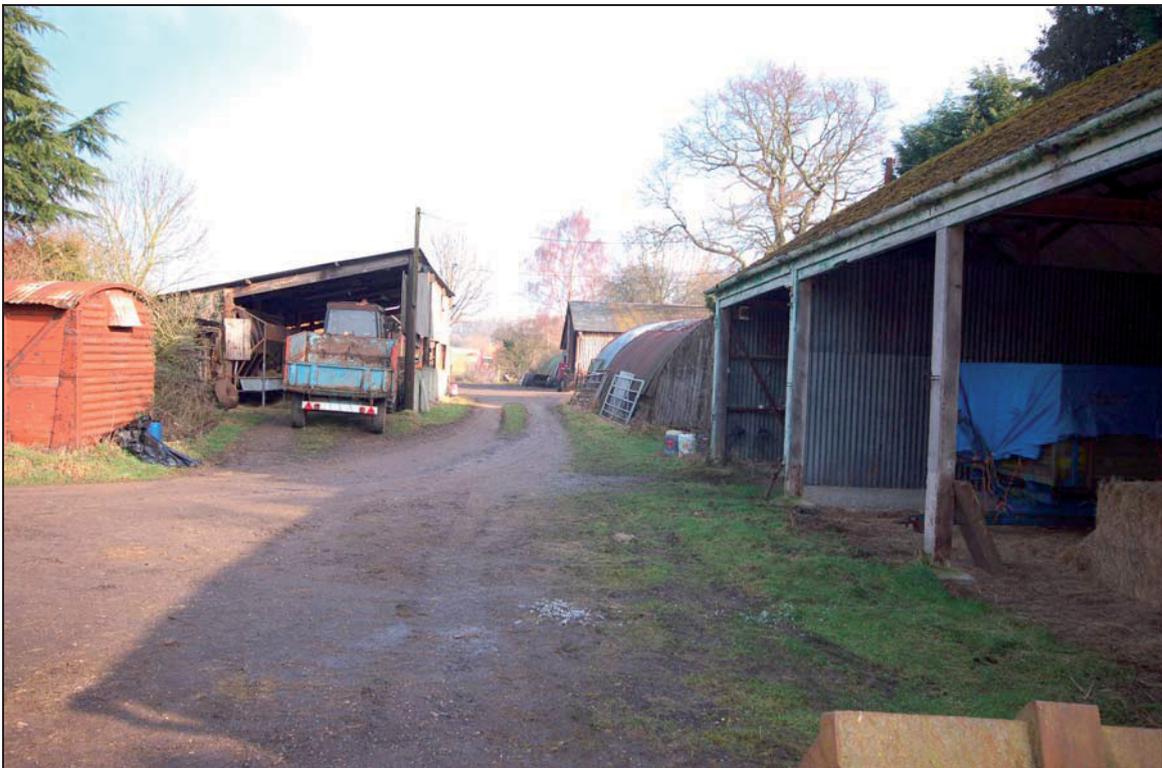
Plate 28 Pre-fabricated shed 10 (right) on approach to modern farm

A three-bay open-sided pre-fabricated building stands to the east of the farmstead on the south side of the old farm track. Clearly of 20th century date, plate 28 shows the structure along with other elements of the modern farm.
