**GAYNES PARK MANSION AND STABLE BLOCK
THEYDON GARNON
EPPING
ESSEX**

DESK-BASED ASSESSMENT AND HISTORIC BUILDING RECORD

October 2010

FAU Project No.: 2166

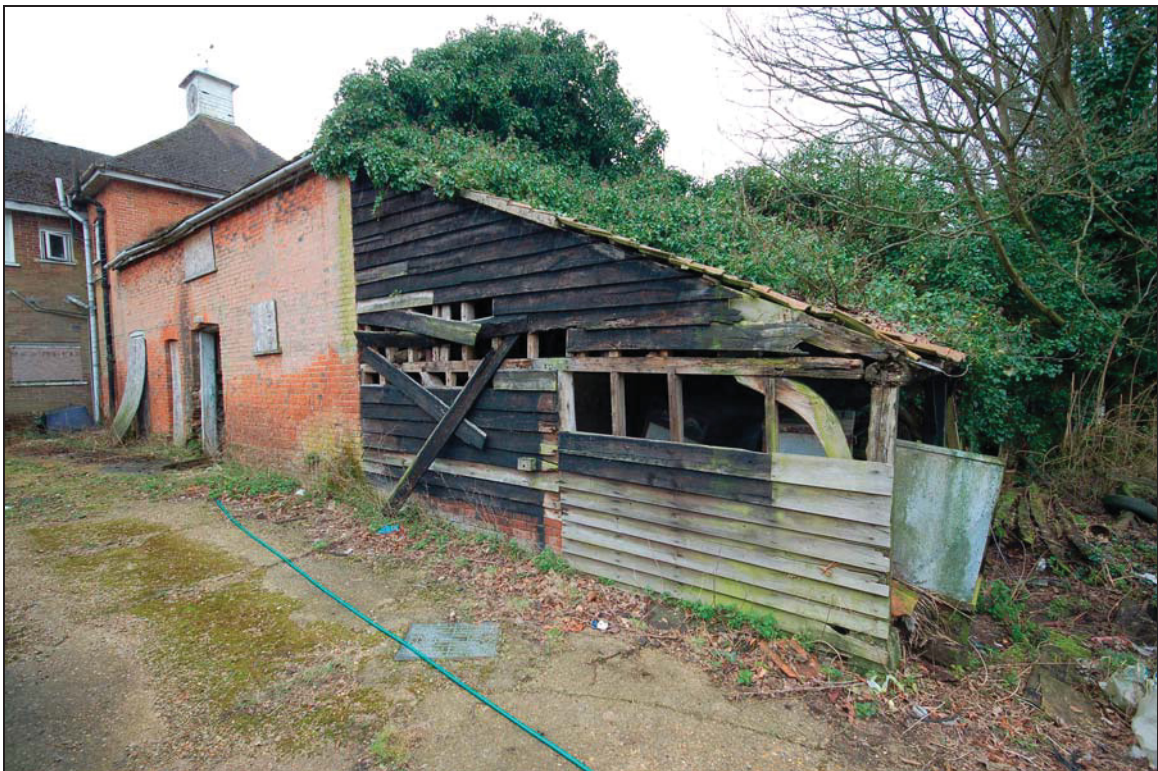
Plate 31 Stable block and house viewed from rear (north-west)

The rear part of the range (east) is built off the hip of the original stable. The main features are the two six-pane tilting windows on codestone sills and corrugated iron roof, the slates having been stripped-off (plate 31). The south elevation is built onto the existing boundary wall (plate 44) and originally provided an entry into the stable at the eastern end (fig. 13a), which was recently blocked.

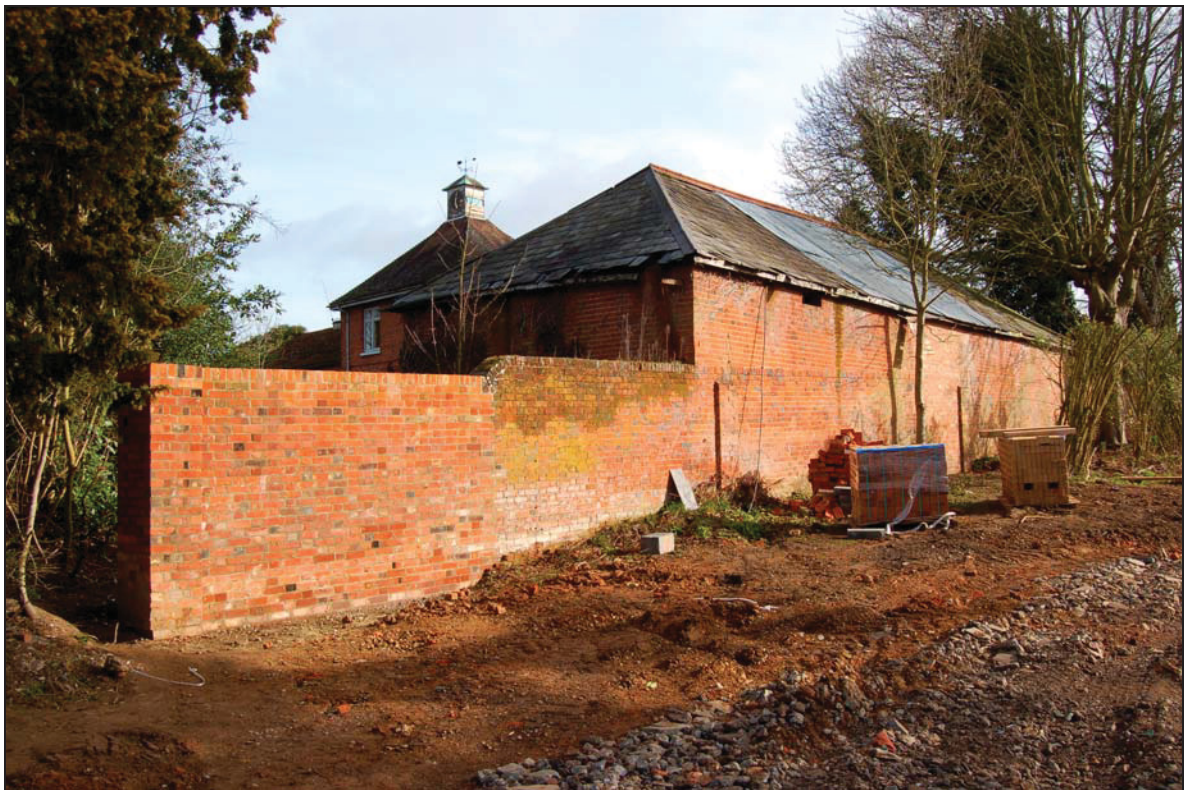
Plate 43 South wing of stable block (6): north elevation

The main elevation facing the yard is in a poor state. Half the coach doors are modern replacements that lack the relative elegance of the original ledged and battened doors (plate 43). Two carriage doors are located on the garage in the corner, while the garage at the west end has a separate singular access and a tripartite carriage doorway that is mainly modern (fig. 13a).

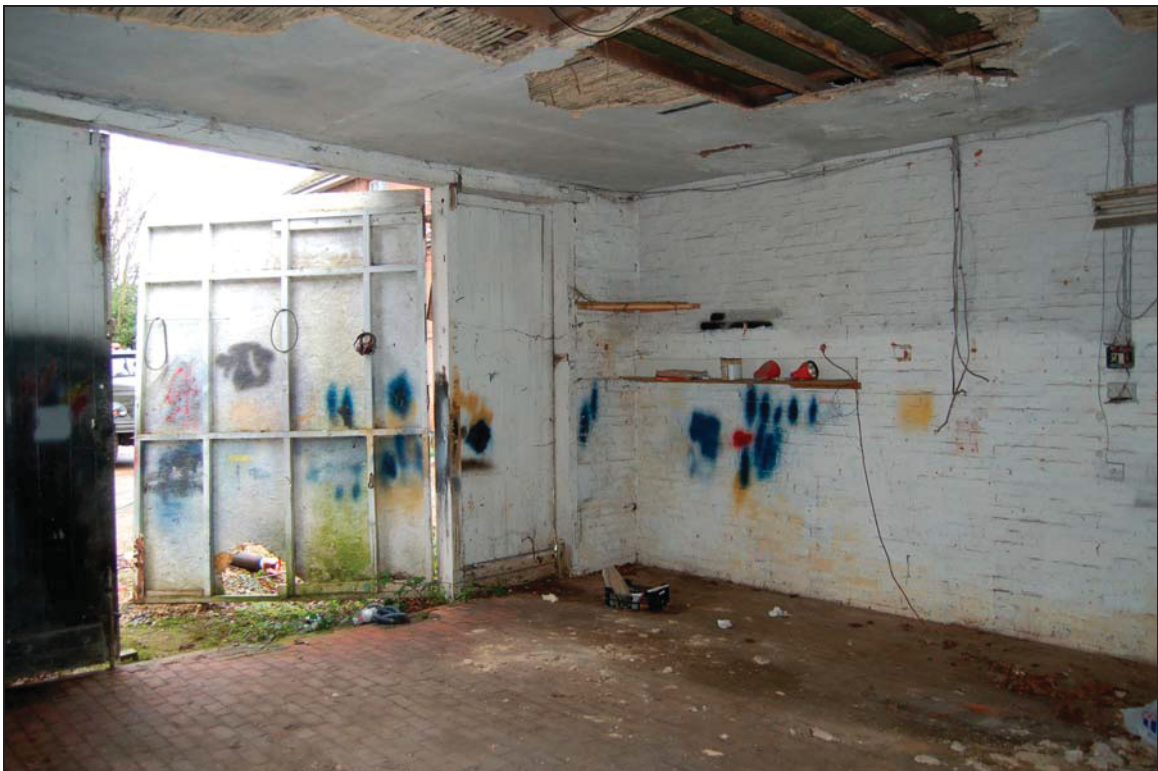
Plate 45 Interior of late 19th century stable extension

Inside the stable extension (6), much of the cream-coloured wall panelling remains and until recently wooden partitions survived along the south side, terminating in cast iron posts that divided the stalls (fig. 13a). Scars for former stall dividers on the east wall and accompanying tethering rings (one per stall) suggest facilities for six horses and on the north wall are scars for troughs (plate 45). Channels and cast iron gullies in the floor meant that liquid waste was
