# OAKHILL FARM, COPPICE ROW THEYDON BOIS ESSEX

# LEVEL II HISTORIC BUILDING RECORD

Essex County Council Field Archaeology Unit

December 2010

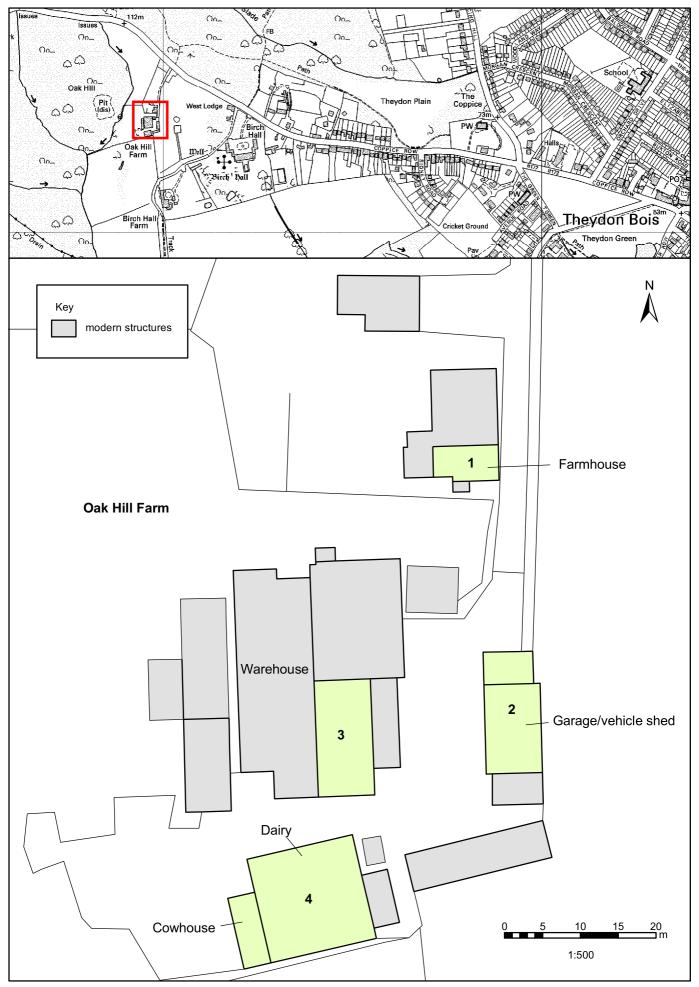
Fig.1. Location and block plan

during the survey to assist the identification of any historic structures, the results of which were added to a block plan of the site (fig. 1). As all but the farmhouse pre-dated WW II, basic external and internal architectural descriptions were made of the structures, which were categorised as follows in order of importance. Building numbers 1-4 are referenced to the block plan (fig. 1)

This appears to be the only historic building (pre-WW II) as defined in the brief (HEM 2010). Only a small element of historic fabric remains, the southern range, which is feasibly 19th century in date. A much larger extension, probably added in the inter-war period adjoins the north wall, more than doubling the size of the structure (fig. 1).

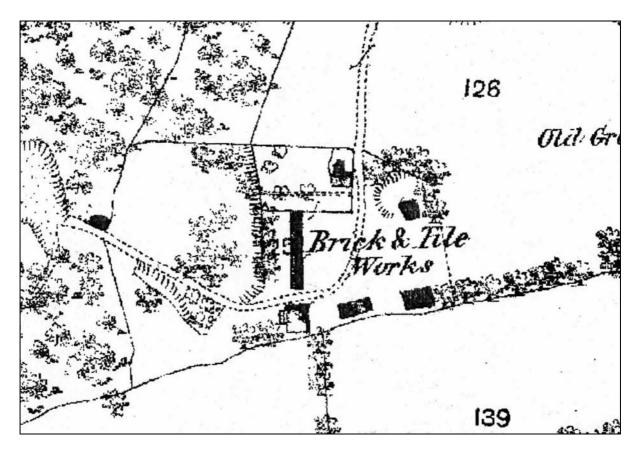
Fig. 2 Brick and tile works (first edition Ordnance Survey map c.1874)

A brick ground is shown on a Birch Hall estate map from 1799 (Ryan 2010), which by 1870 had become a brick and tile works (fig. 2). According to Trades Directories, David Todd advertised as a brickmaker in Theydon Bois from 1878 to 1886 (Ryan 1999). A map from 1870 shows an L-shaped house, possibly built for the brickmaker, a long drying shed and four other structures occupying the site (fig. 2). The building beside the clay pit south-east of the farmhouse was probably an old kiln and some of the other buildings may represent more recent kilns, plus workshops, mould stores, etc. Part of the house may have survived as the former farmhouse, building 1

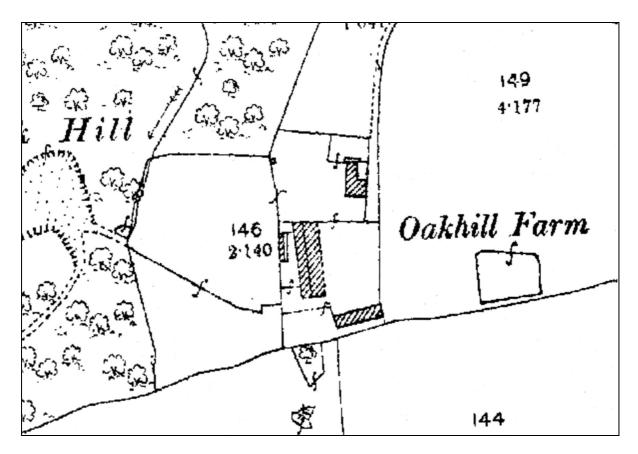
Fig. 3 Early map of Oakhill Farm (second edition Ordnance Survey map c.1896)

Oakhill Farm was established after 1886, an event resulting in the clearance of all the brick works buildings from the site and building afresh using bricks made on the site. The new complex, built as a dairy farm, comprised the farmhouse (possibly retained from the brickworks) and a yard to the south containing cattle ranges (shelter sheds, etc) and outbuildings on two sides, forming an an L-shaped plan form (fig. 3).

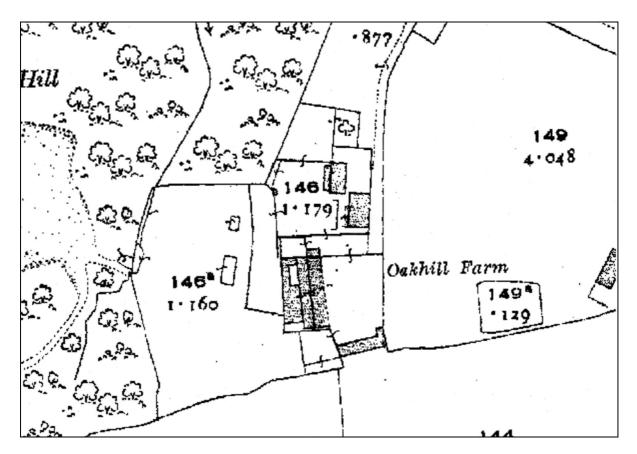
Fig. 4 Oakhill Farm in the early 20th century (New edition OS map, 1914-24)

Additions were made to the western ranges in the early 20th century and the farmhouse was extended on a rectangular plan form, with another building constructed to the north-west (since demolished) (fig. 4). The same layout continued into the post-war period (fig. 5).

The north extension is built of red brick beneath a long half-hipped roof. Its proportions and plain wooden windows (possibly replaced) suggest a modern date, though the tiled roof and dormer windows are typical of the inter-war chalet bungalow (plate 5), which, if it is the same building depicted on the early 20th-century map, suggests it was built in the 1920s (fig. 4)

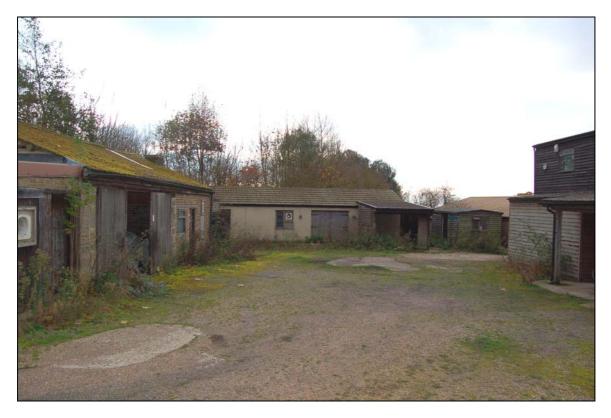
Plate 2 Farmyard viewed to south

This structure stands on the eastern side of the former farmyard (plates 1 & 2) as part of the post-WW II phase of the dairy farm. Most recently it was used, amongst other things, for locust breeding but may have previously functioned as a vehicle shed/workshop during the latter life of the farm. The main structure is four bays long and built of yellow stock bricks, some of which are discoloured, perhaps being reused kiln wasters from the old brickworks. They are coursed in a crude Flemish bond and laid in cement, incorporating concrete blockwork at the bases of the rear (east) wall and some of the partition walls inside.

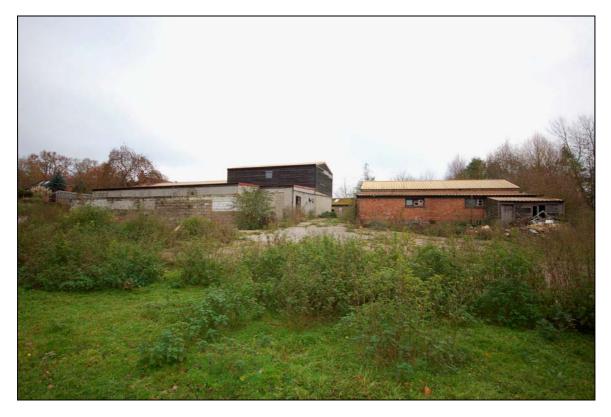
Plate 12 Dairy and modern structures viewed to east

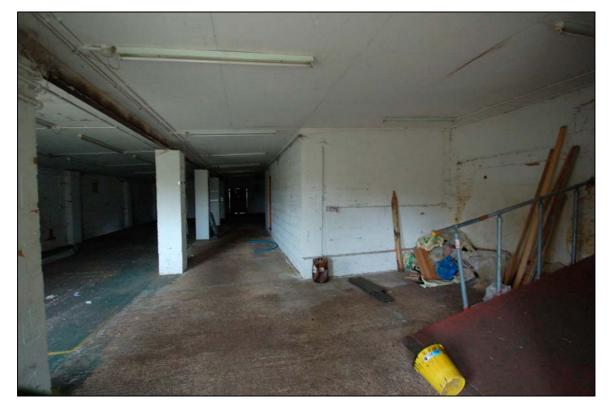
Plate 15 Interior of modern warehouse viewed to north

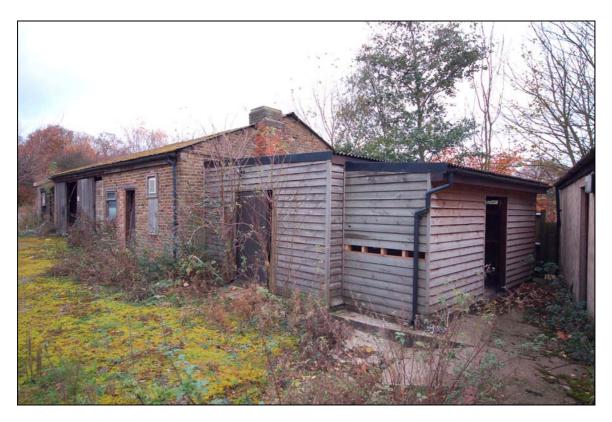
Plate 16 Typical modern shed, attached to building 2
