**ST ALBRIGHTS HOSPITAL  
(THE FORMER LEXDEN AND WINSTREE UNION WORKHOUSE)  
1 LONDON ROAD  
STANWAY  
COLCHESTER**

**HISTORIC BUILDING SURVEY**

**Essex County Council  
Field Archaeology Unit**

**April 2011**

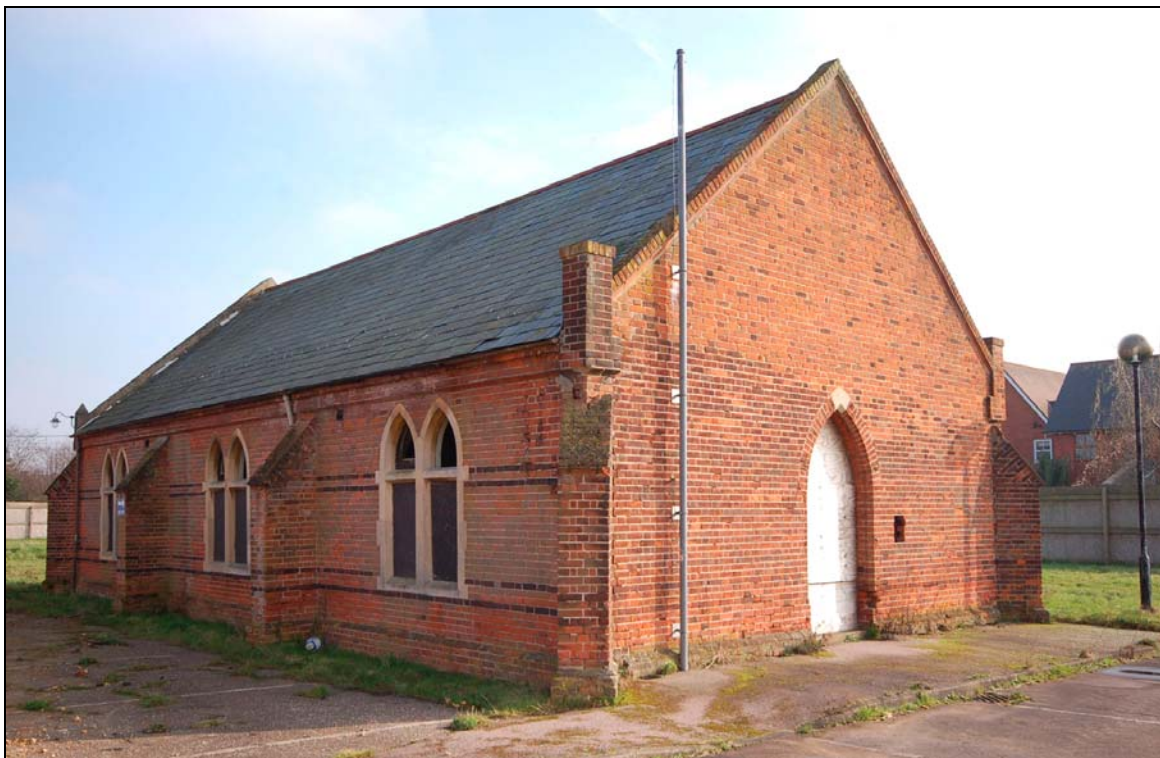
The chapel lies to the south of the infirmary and was constructed in the late 19th century (1876-96). It is single-storey, built of red brick with stained black bands and stone dressings (plates 55 & 56). The building is gabled to the east and west with a slate roof with a three-bay rectangular nave and small chancel at the east end, set slightly lower (plate 55). Diagonal and pilaster-type buttresses divide double lancet windows with a transom at springer level containing lead glazing. Tripartite windows stand at the chancel end and retain some stained glass detail from behind protective glass screens (plate 57).

Plate 55 Chapel viewed to north-west

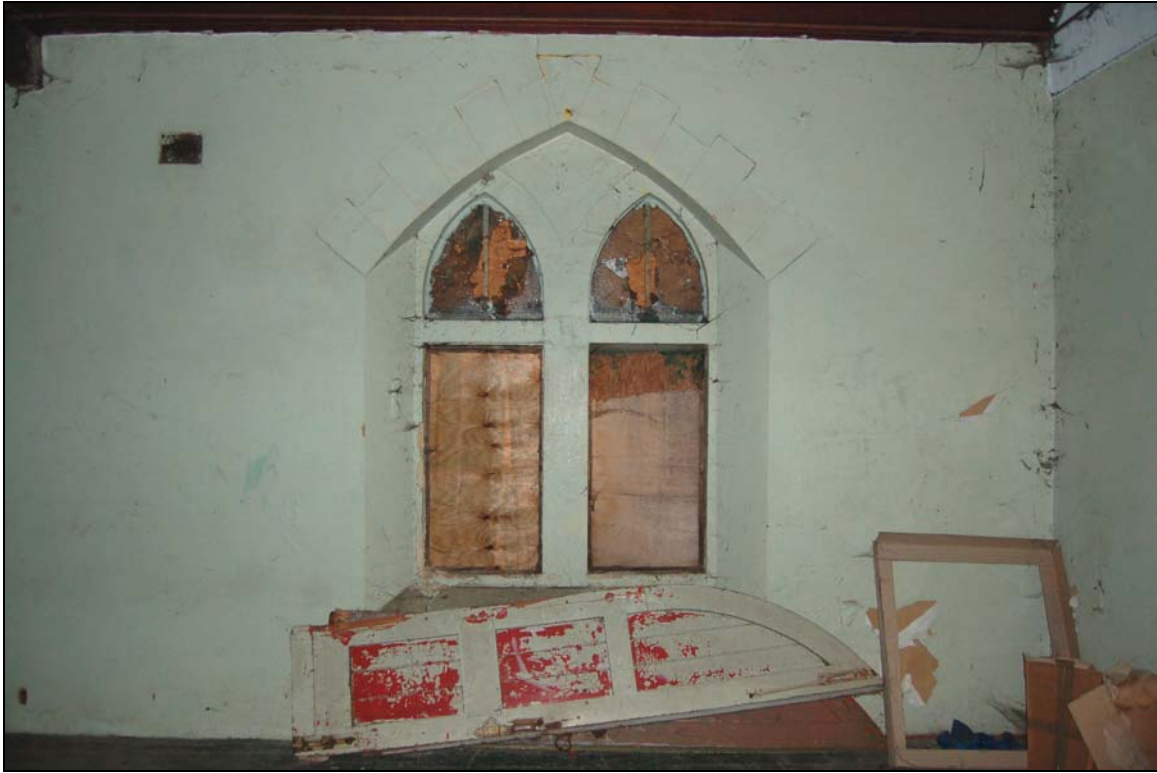
Entry is by a doorway set under a pointed arch at the west end. The floor is boarded and raised at the chancel end, where there is a chamfered pointed arch and also some square panelling (plate 58), partly fire-damaged. Vertical panelling survives in the north-west corner along with a coat rail. There is no other evidence of panelling and the rest of the interior is simply plastered. The windows have splayed reveals and sills and incised stonework around the heads (plate 59). The canted ceiling is built of stained pine boards and remains intact, divided by wooden tie beams.

Plate 58 Interior of chapel viewed to east

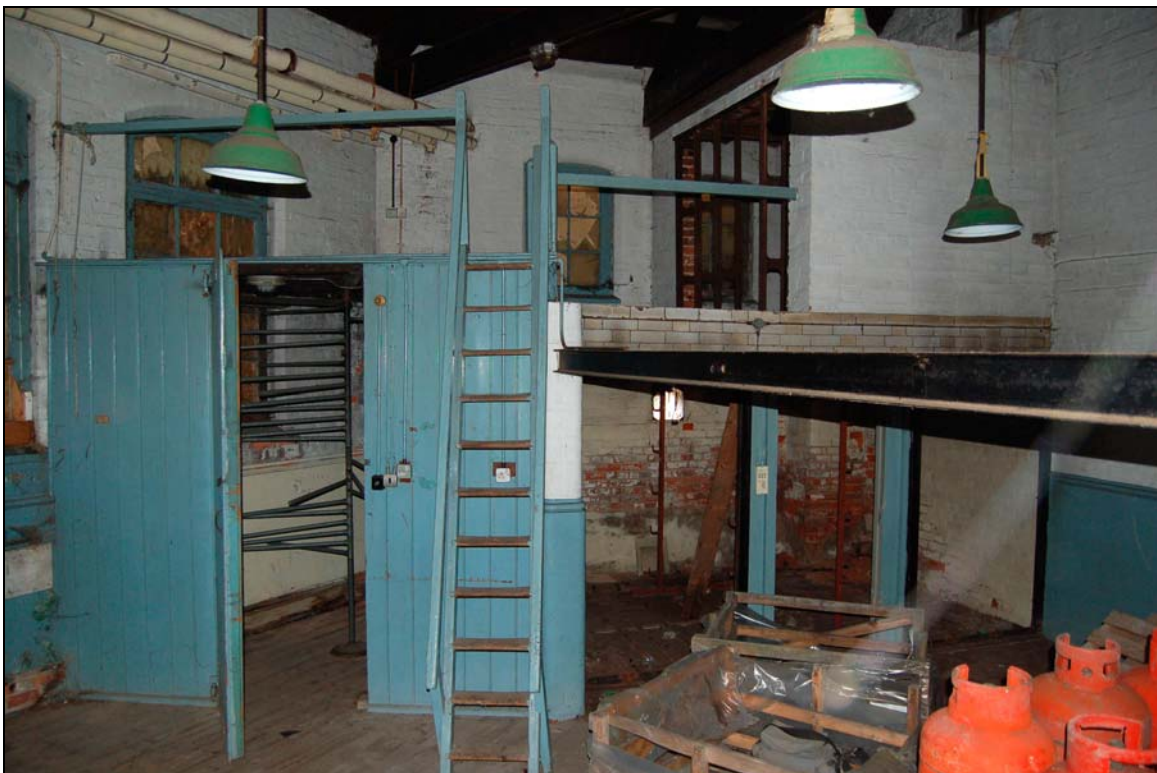
Inside are two large rooms. The washroom (fig. 12, plate 61) has been cleared out but retains a sink and concrete base for later laundry machines. The laundry contains a lobby area by the door, now used to store old pallets, and a large working area with drying rooms on the western side, with huge king post trusses above. One of these rooms has a circular steel-bar dryer, heated by wall-mounted elements (plate 62) and the other has iron racks. Above are wooden steps leading to a first floor area where other racks are located (plate 61). One of the main items of interest is a 'Tullis' Linen press, manufactured in Clydebank, Scotland (plate 63). Décor consists of a beaded dado under sill level in the laundry area but there is no such decoration in the washroom.

Plate 61 Interior of washroom viewed to north-west
