**'FANCY HALL'**  
**7 Church Street, Buntingford, Herts.**

HN1366

***HISTORIC  
BUILDING RECORD  
& ARCHAEOLOGICAL  
MONITORING***

Report no. 1175

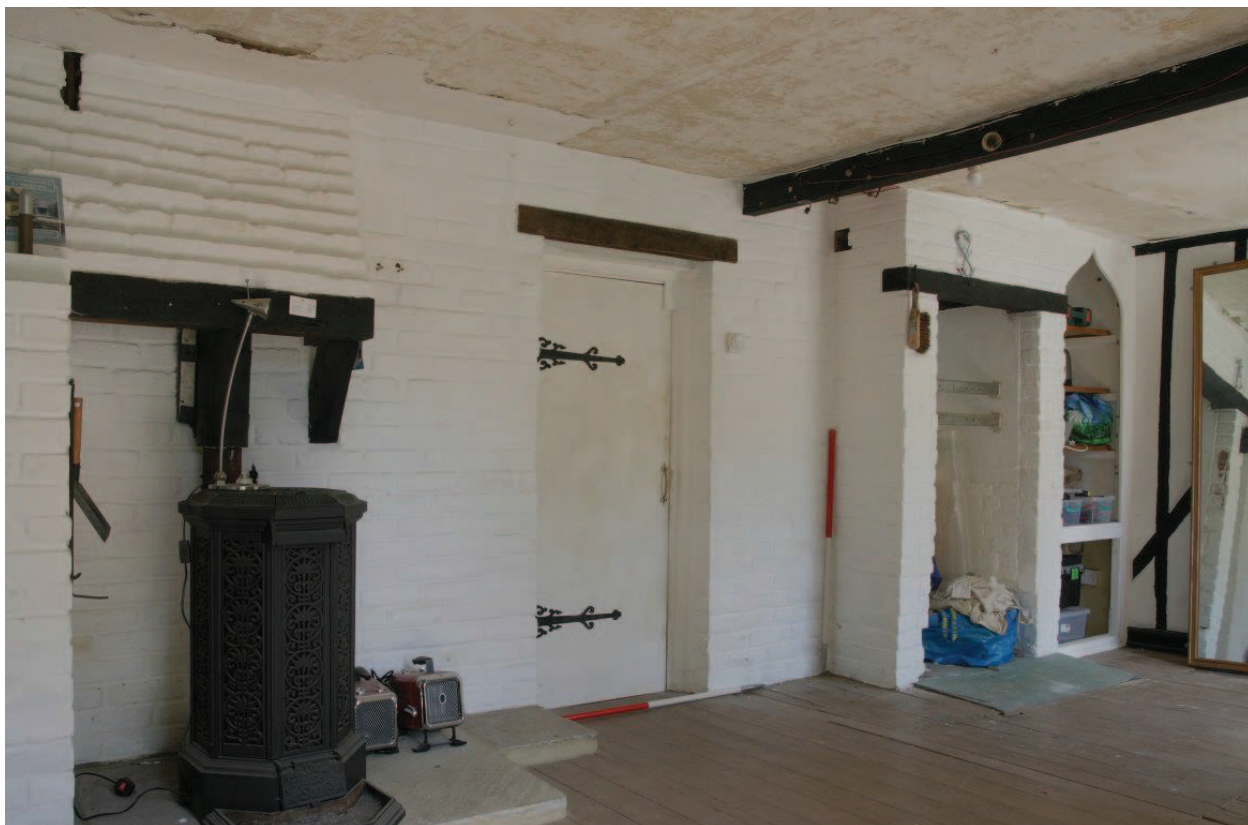
Plate 10 - Living room, north elevation, looking NE

**3.25.3** To the east of the doorway an original chimney has been encased in modern brick with a modern timber bressumer crossing the opening and a modern stone hearth, possibly in an original location (Plate 10). The hearthstone appears to be framed in part in original timber.

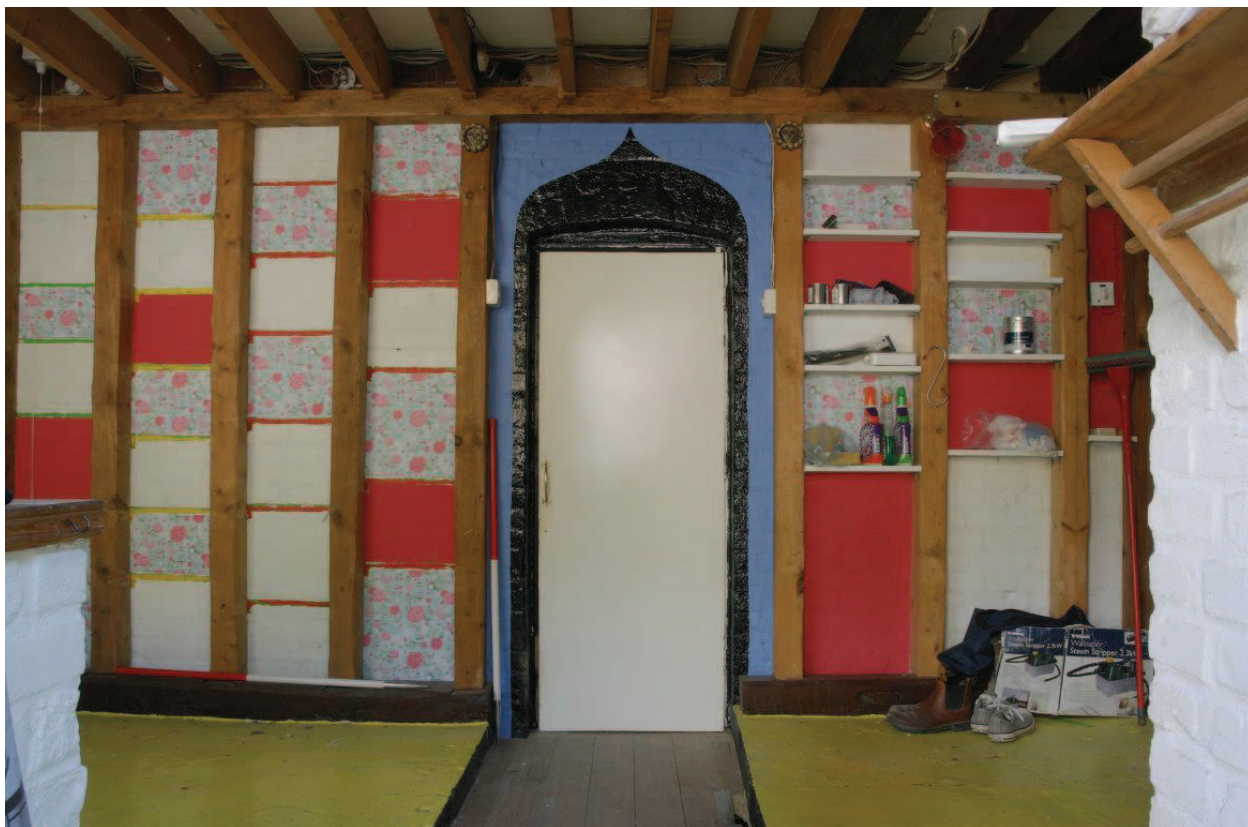
Plate 12 - Kitchen, S elevation, looking S

**3.28** The kitchen is located in the modern northern extension. Its south elevation forms the original north exterior to the house, visible behind the timber framing of the modern structure, and which consists of brickwork laid in Flemish bond (Plate 12). A central shallow arch-headed doorway leads south into the living room. The narrow wooden planking of the living room extends through the doorway to a distance of 1.7m, terminating in an apse and flanked by crudely-laid concrete (Plate 13). The function of this arrangement is unclear but it is possible that it accommodated a stair turret, giving access to the upper floor. A staircase could also have been accommodated on the east side of the east chimney though no evidence for this survives apart from a change in the floorboards to the east of the hearth.

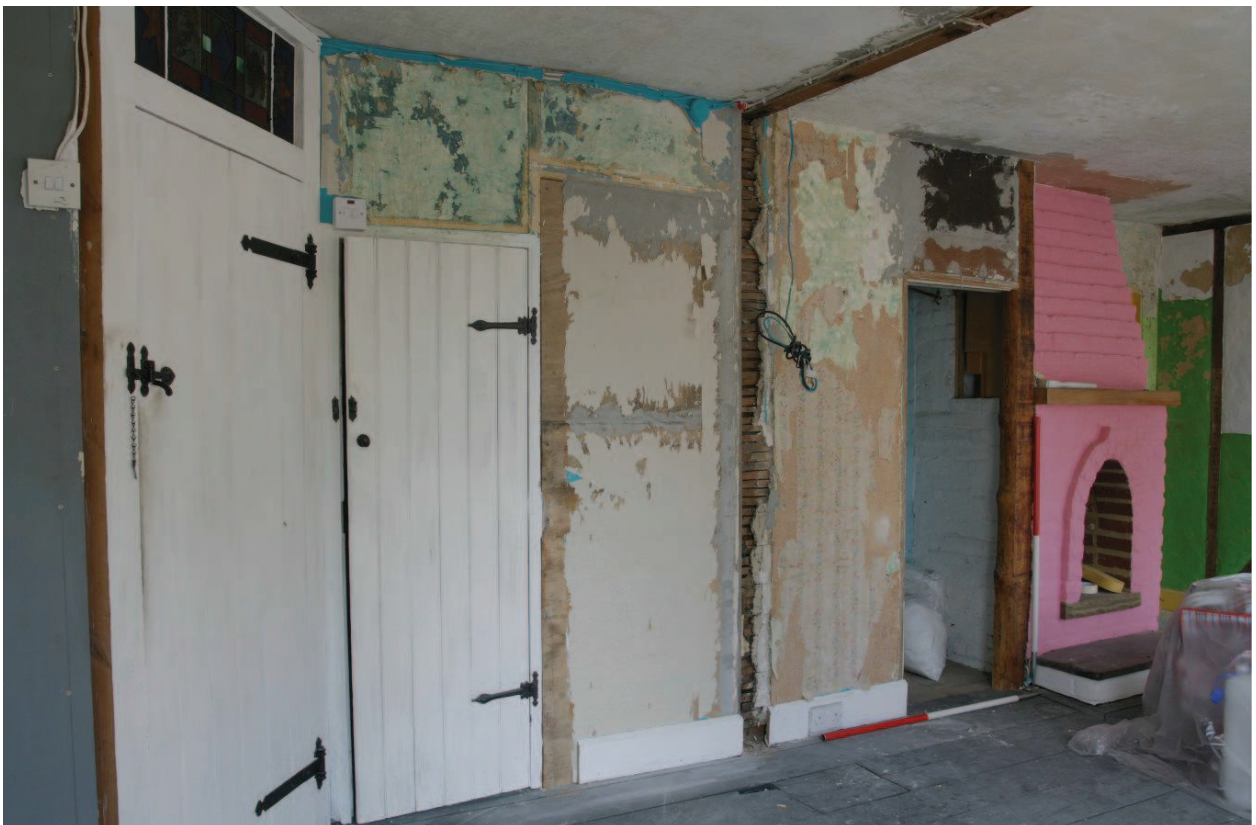
Plate 17 - Bedroom 1, north elevation, looking ENE

**3.32** The north-western corner of the room has been partitioned to create a lobby at the top of the stairs. A doorway, with a modern boarded door below a transom light, sits at an angle in the partition, giving access to the lobby. To the east of the door is a cupboard, with a modern boarded and braced door (Plate 17). This hides the chimney, which is square and shows no evidence for a fireplace.

**3.32.3** The chimney and fireplace that lie immediately to the east also appear to have been remodelled, with a raised hearthstone and a new frame to the fireplace in modern brick, with an ogee-arched opening to reflect those of the windows (see Plate 17).

separated by the passageway, while the first floor rooms were of unequal width, with the eastern room being the larger. The partition, which appears to coincide with the western edge of the passageway on the ground floor, is marked by a surviving beam, with regular mortice holes on the underside. This runs across the ceiling to meet a point on the north elevation where an upright has been removed (Plate 17).

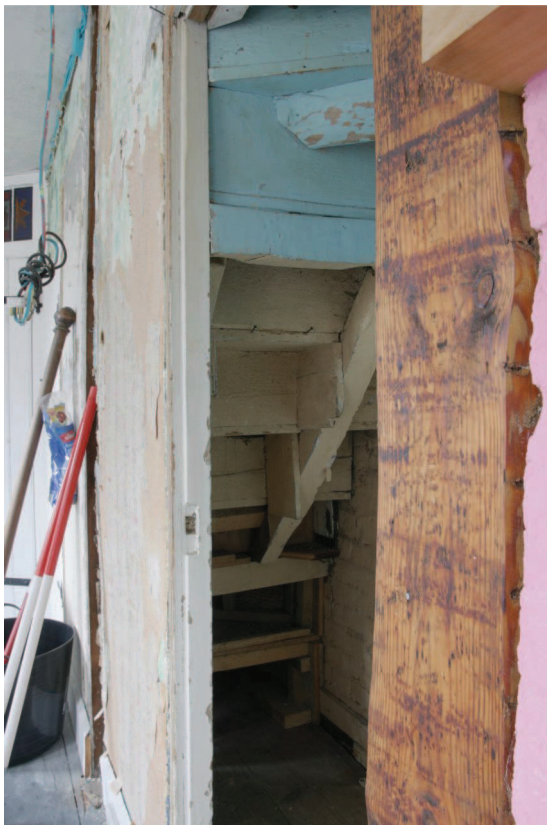
Plate 18 - Bedroom 1, N elevation, cupboard under the stairs, looking W

**3.32.2** A cupboard, which has apparently been remodelled, sits below the stairs to the east of the former doorway (Plate 18).

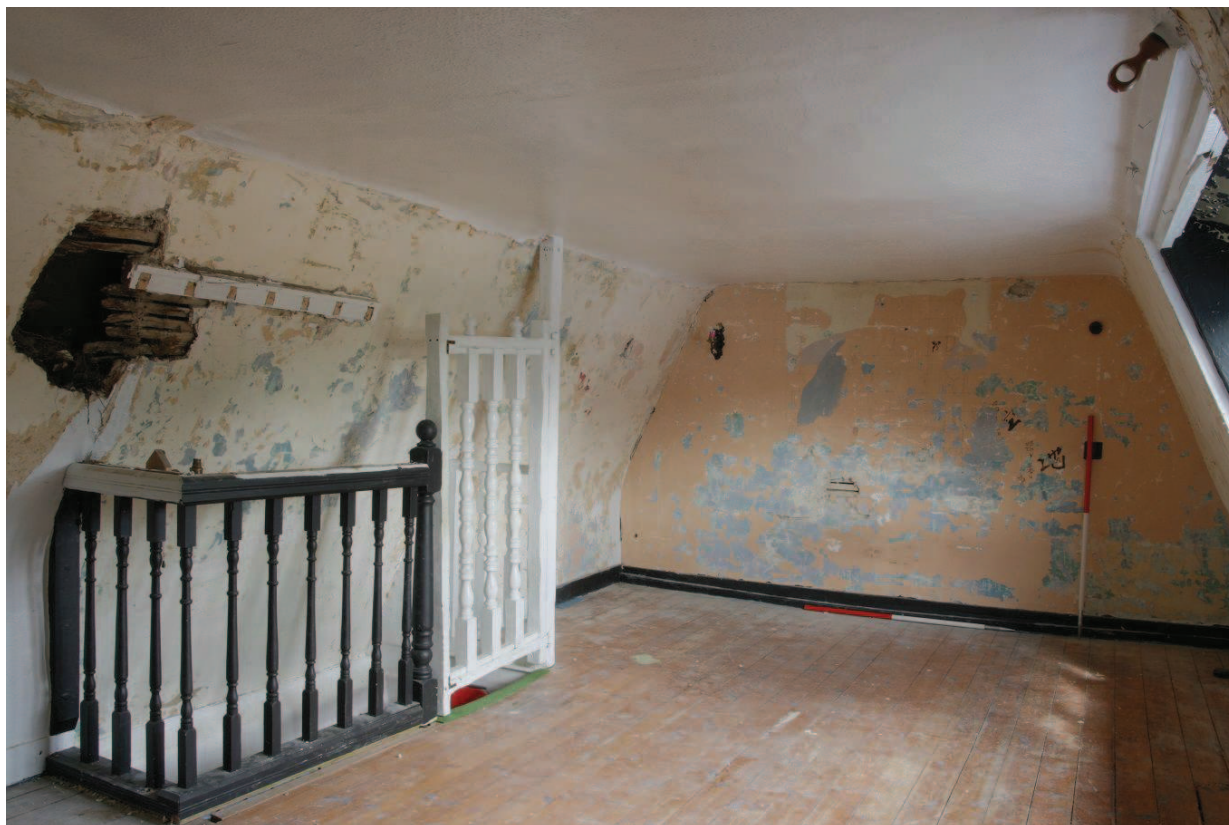
Plate 20 - Bedroom 2, N & E elevations & staircase, looking NE

**3.35** Bedroom 2 is located on the second floor, in the former attic, and is accessed via a staircase rising up against the north elevation (Plate 20). Usable space has been created through the construction of a Mansard roof, which has had a ceiling inserted at the level of the change of slope.

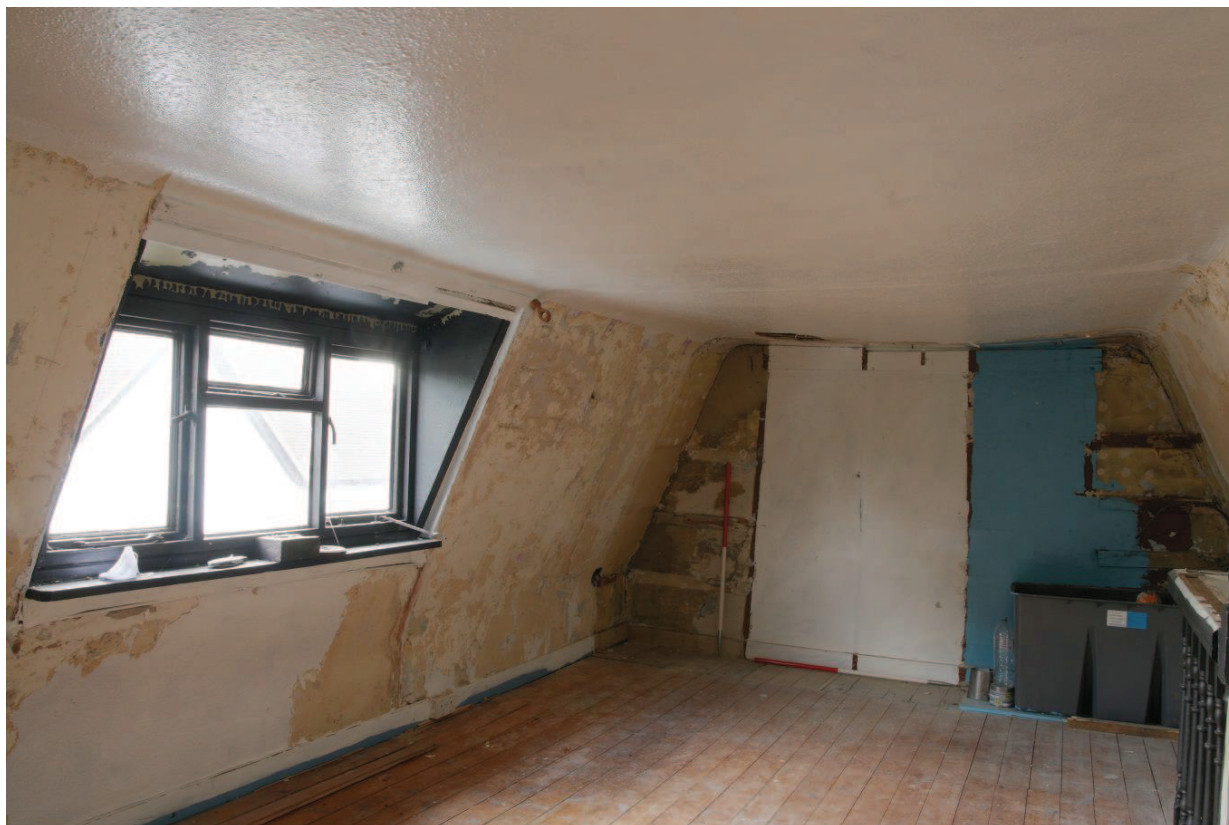
Plate 22 - Bedroom 2, S & W elevations, looking WSW

**3.42** The floor is, for the most part, formed of modern 4½" planking. Earlier planks, between 7" - 10" in width, survive on the site of a former cupboard in the south-west corner of the room (see Plate 22).

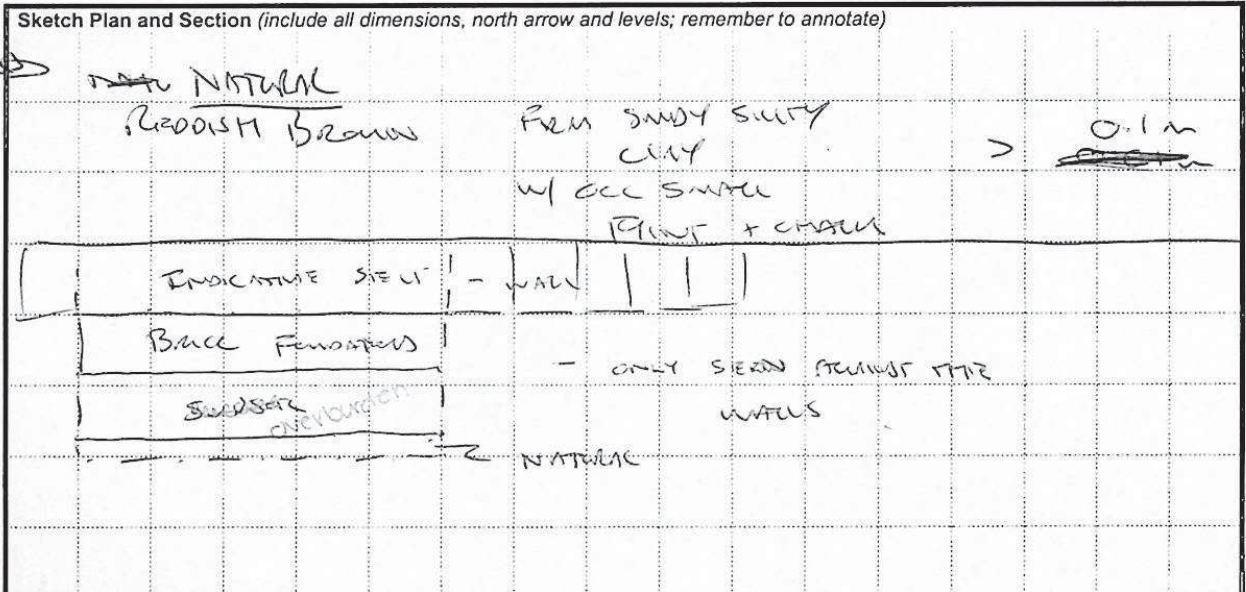
INTERNAL CROSS PRODUCTION WITHIN A MODERN RICHMOND EXTENSION TO A LISTED BUILDING. ALL FOUNDATION CONCRETE FLOOR OVER HEAVY MIXED RUBBLE OVER NATURAL. THIS WALL LIES RED THE EXTENSION AND SUBSOIL. THE INTERNAL SPACE HAS BEEN PRODUCED TO NATURAL.
