## **35-41 SILVER STREET Enfield, Middx.**

(HN470 / SVS04)

*Historic Building Record &  
Archaeological Evaluation Report*

Report No.248

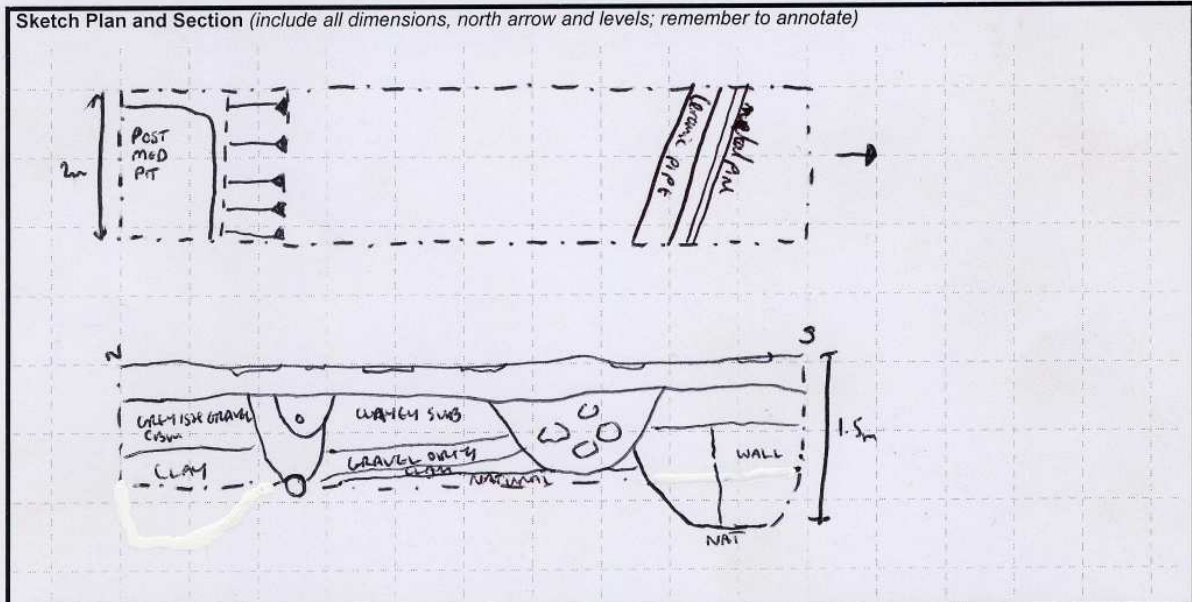
Discussion and interpretation **mostly blank trench, contains two services pipes & a post medieval pit which was augered to a depth of 0.27m below base of trench sondage.**
