THE GREAT BARN, Rectory Farm, Pirton, Herts.

HN976

HISTORIC BUILDING RECORD

February 2011

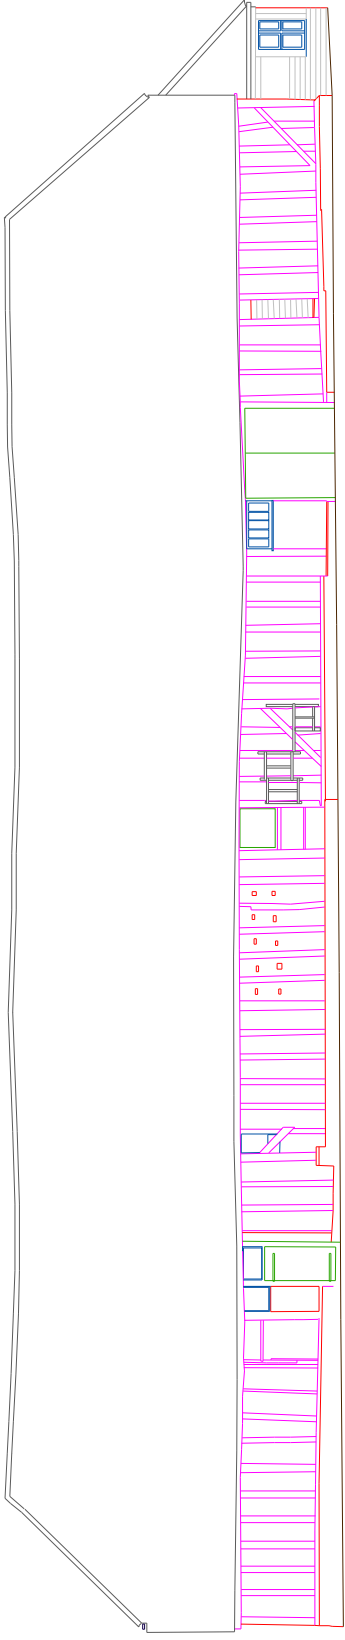
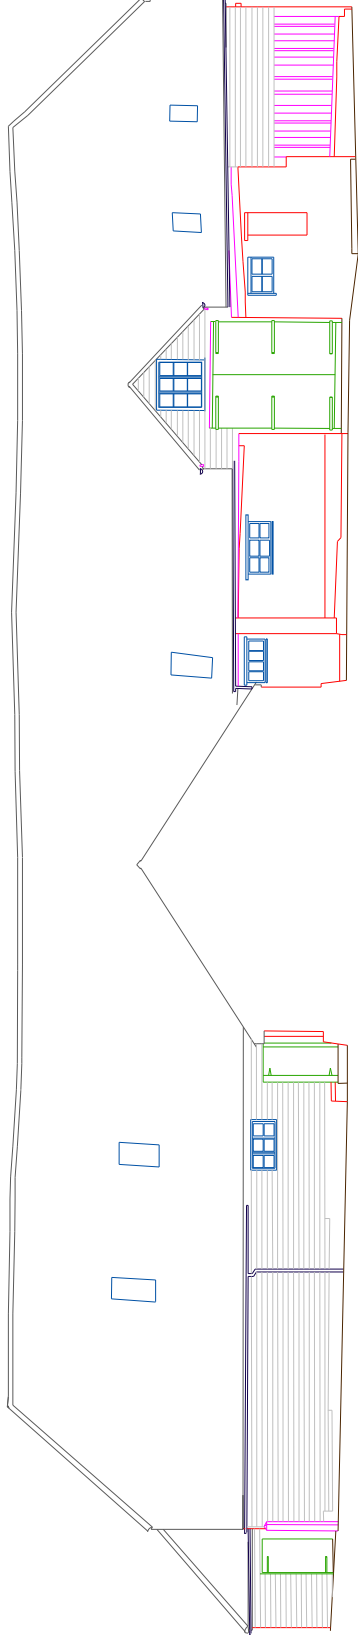
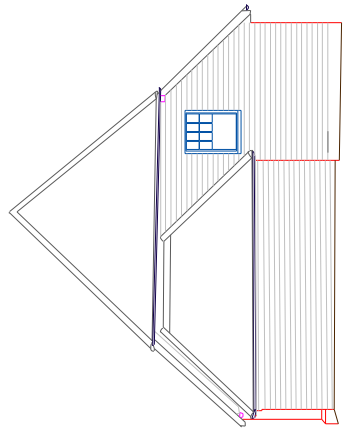
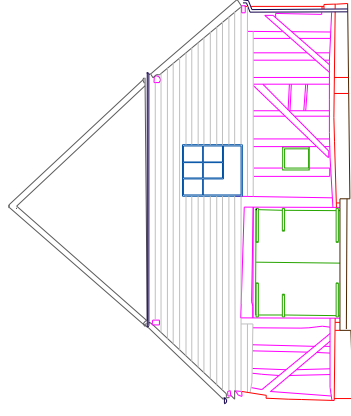
HN976	Scale 1:150	Figure 6
-------	-------------	----------

3.3 The southern exterior elevation is dominated by a lean-to extension, offset to the west, faced with weatherboard and roofed with slate (Figure 6; Plate 1). The main barn is also weatherboarded in modern softwood, above a plinth formed of Arlese white bricks laid in English bond with a lime mortar. Just to the east of the end of the lean-to roof, a modern 8-over-8 sliding sash window has been inserted. The horns of the arcade plate project below the hip, and those of the aisle plate project at the eaves. Within the lean-to, the elevation of the Tithe Barn preserves some earlier weatherboarding, above a plinth consisting of six courses of modern Arlese white brick (Plate 2).

3.6 The northern exterior elevation has exposed studwork below the line of the eaves, with diagonal primary bracing to the aisles, and to the western half of the nave, infilled with nogging of narrow red brick (Figure 6; Plate 11). The framing sits on a modern buttressed brick plinth of five courses laid in Flemish bond with a header course to the top. The eastern half of the nave is occupied by modern double doors and a concrete ramp. Above the level of the eaves, there is modern softwood weatherboarding, and a modern single light window of 9 panes, offset to the west. The horns of the arcade plate project below the hip, and those of the aisle plate project at the eaves.

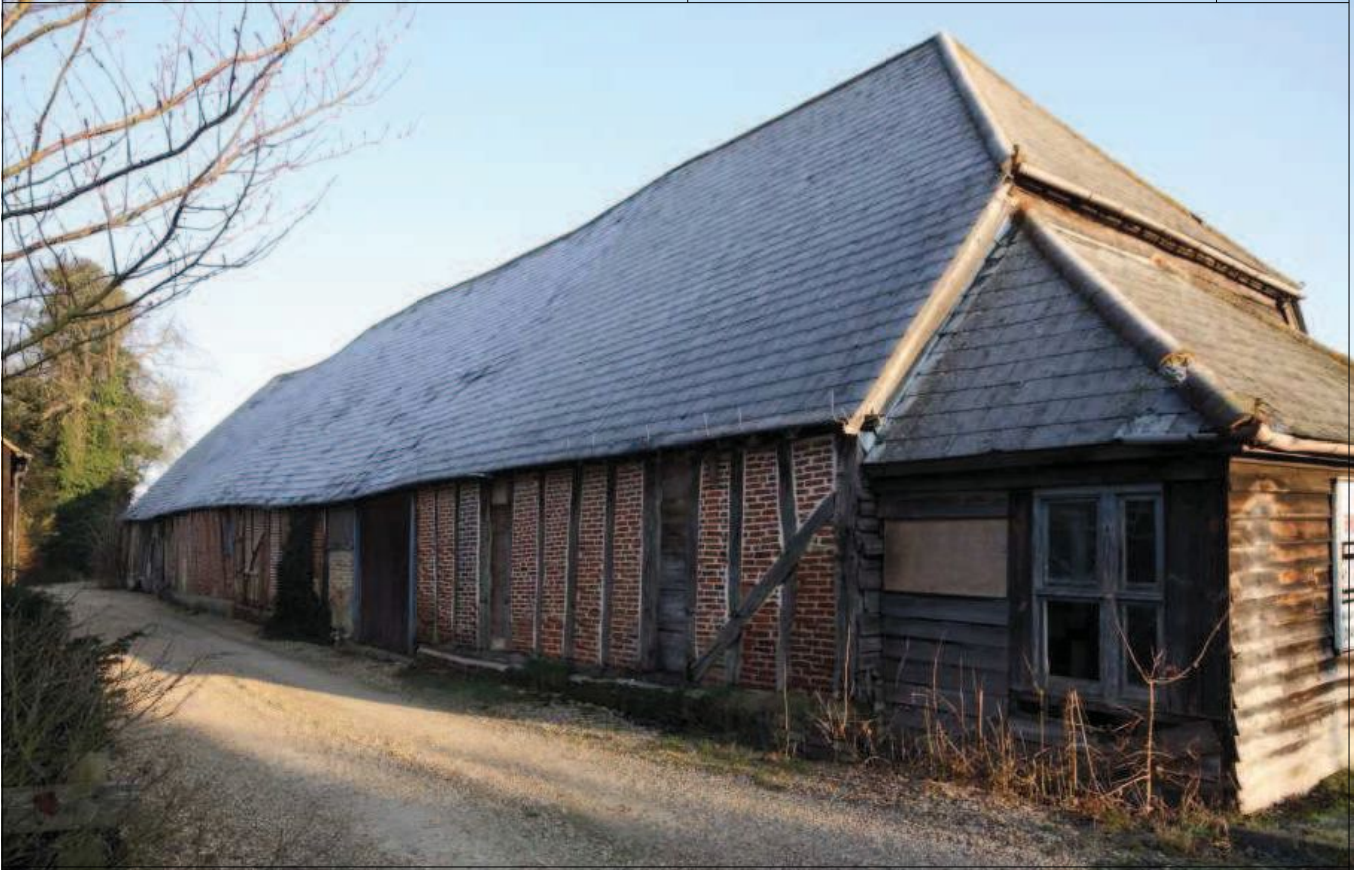
Plate 3: West exterior elevation, looking NE

3.5 The western exterior elevation of the lean-to is weatherboarded with a modern window offset to the south (see Plate 3).

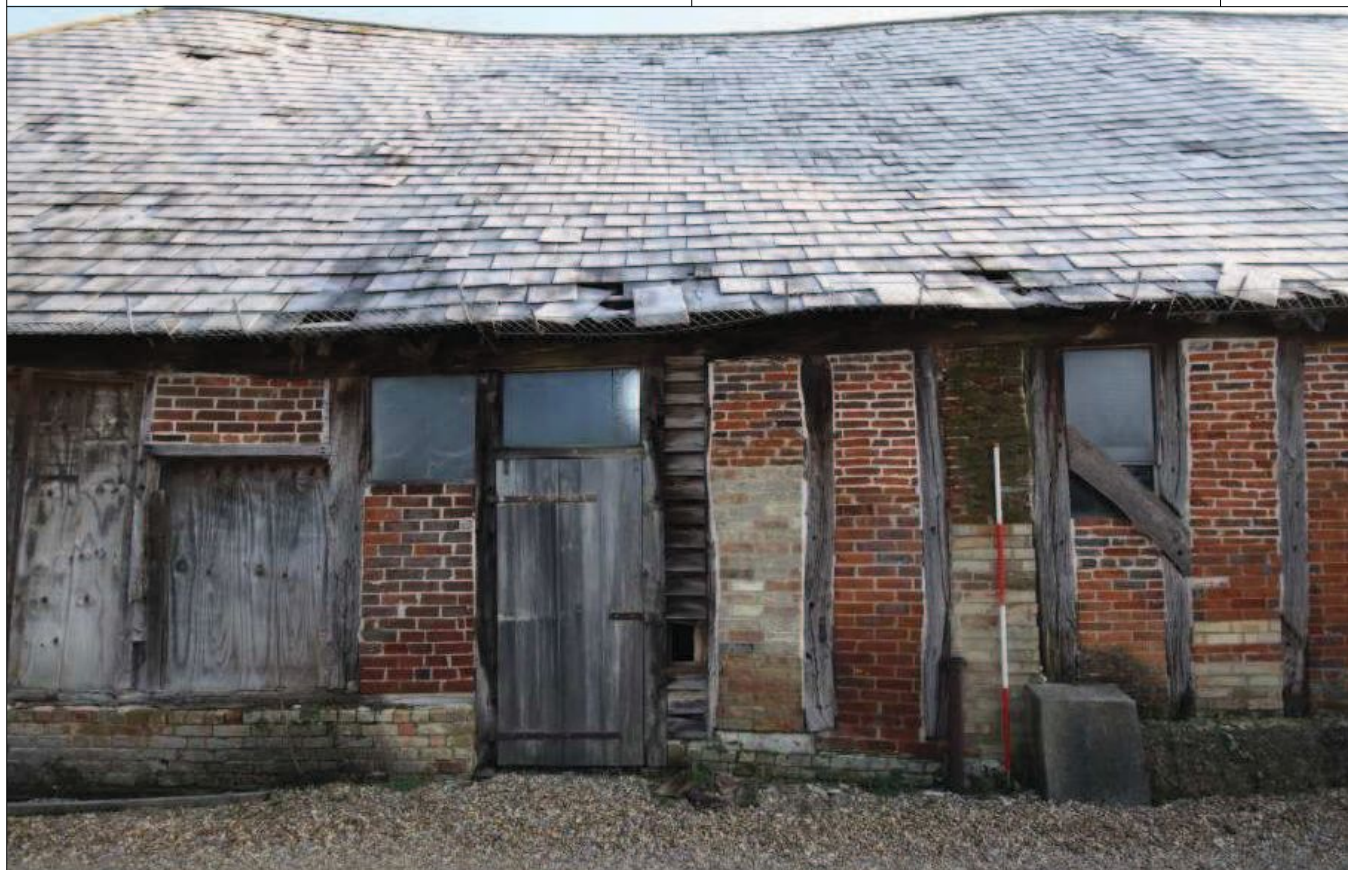
Plate 5: Detail shot of Bays 3 - 4 west exterior elevation

much decayed but survives in Bays 1, 2, 6, 7, 9 & 10. This rests on a brick plinth, formed of Arlesey white bricks measuring 8½” x 2¾” x 4¼” (216mm x 70mm x 108mm) in Bays 1, 2 & 3 and the southern end of Bay 10 (Plates 4, 5 & 9), and narrow red bricks measuring 8½” x 2” x 3½” (216mm x 51mm x 89mm) in Bays 6, 7, 9 and the northern end of Bay 10 (Plates 7 & 9). Bays 4 and 5 are supported on modern shuttered concrete (Plate 6). Bay 5 has two rows of holes punched through the upper half of the brick nogging, possibly intended for ventilation (Plate 6). The underside of the aisle-plate in Bay 2 shows drilled dowel holes to house wattle-and-daub infill that would have pre-dated the brick nogging (Plate 10). A modern personnel door with glazed light above the transom has been inserted at the north end of Bay 3; a modern sliding hatch has been inserted at the north end of Bay 6; and modern double doors have been inserted in Bay 8.
