MANOR HOUSE **21 High Street, Baldock, Herts.**

HN503

Historic Building Record

Report No.278

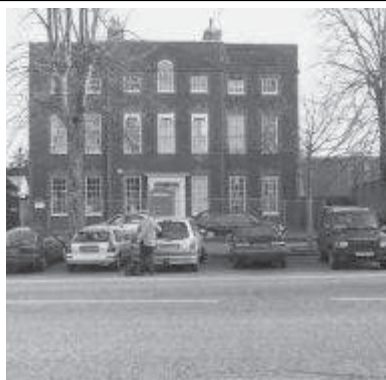
THE HERITAGE NETWORK LTD		Manor House, 21 High Street, Baldock	HN503		
1/1

3.5 The front elevation consists of seven bays, on three floors, with the central three bays breaking forward and topped with a pediment (Figure 3, Photos 1/1-3, 7/12). There is a plinth at the base of the wall, with four courses of bricks visible. The brickwork has been ruddled and traces of tuck pointing can still be seen, for example, beneath the ground floor windows (Photo 1/9). Occasional burnt bricks can also be seen.

Front Elevation		Front Elevation		Front Elevation	
1/4

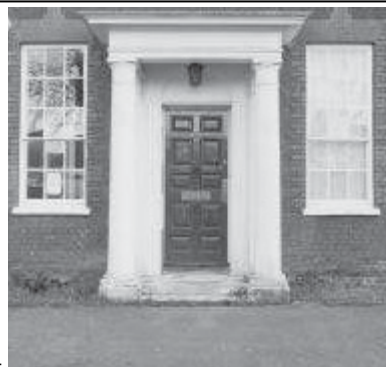
3.7 The principal entrance, in the centre of the ground floor, is sheltered by a projecting Tuscan porch with simple cornice hood, and two freestanding columns with pilasters to rear (Photo 1/4). This is likely to be an early 19th century modification. Two steps in Portland stone rise to the door, with an ornamental footscraper attached on either side (Photos 1/7-8).

Front door : detail		First floor, central window: detail		First & second floors, central windows	
1/7

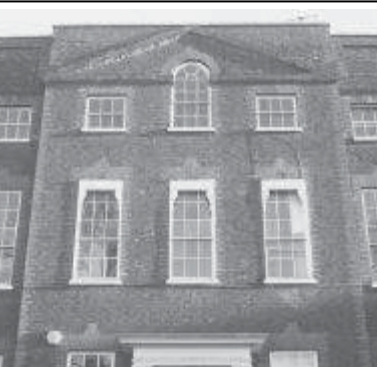
1/6

3.10 The first floor windows are similar to those on the ground floor, but the centre three have shaped wooded casings for blinds fitted to their upper section (Photo 1/5).

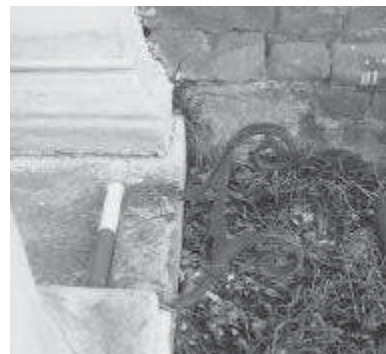
Foot scraper : detail		Foot scraper : detail		Tuck pointing : detail	
1/10

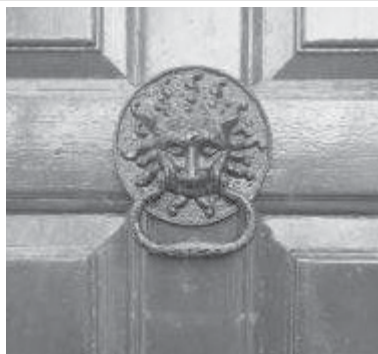
1/11

3.8 The doorway is arch headed, although it is now blank infilled and covered with plywood. The door case is essentially plain, but the lintel has reeded decoration which is typical of the Regency period. The door has ten raised and fielded panels, and has a lion's head door knocker (which is attached with modern screws and may, therefore, be secondary) (Photo 1/11).

Tuscan porch, column base: detail		Door knocker : detail		Entrance Hall, east archway: detail	
Roll 1

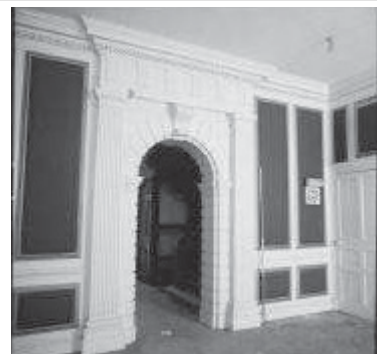
1/12

3.31 To the east of this a doorway leads into the northern front room. Opposite, a later inserted doorway leads into the southern front room, the surrounding paneling having been remodeled to accommodate it (Photo 2/7). The original doorway is located at the western end of this wall. A decorative archway leads off to the east to the principal stairway (Photos 1/12, 2/6).

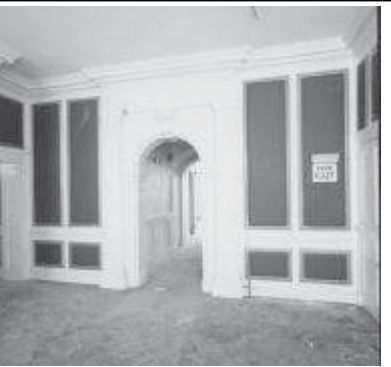
2/6

Entrance Hall, East elevation

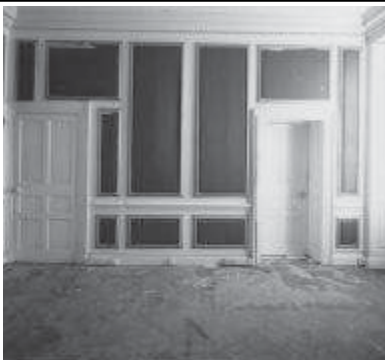
2/7

Entrance Hall, South elevation

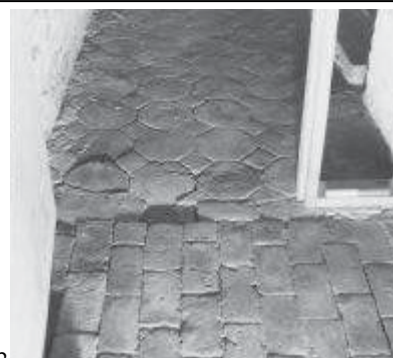
3/12

Cellar flooring: detail

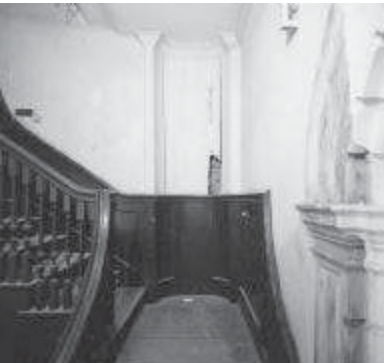
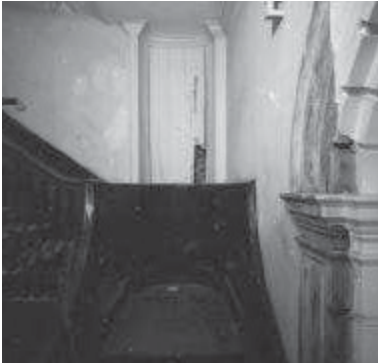
4/4		4/5		4/6	
Staircase niche		Staircase niche		First Floor, Centre Front North elevation

3.50 A tall niche stands at the first turn of the stair (Photos 4/4-5), possibly intended to accommodate the clock mentioned in Mary Grave's will, and the wall paneling mirrors the ramped rail noted previously. As the stairway approaches the first floor, the banister has been destroyed where the stairwell had been boxed in as part of the most recent remodelling.

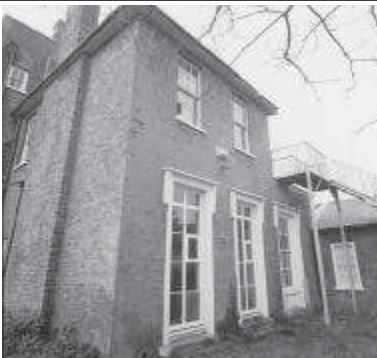
7/8

3.27 At ground level, the eastern elevation includes a single storey link with the servants' wing noted above (Figure 3; Photos 7/8-9). Three full height windows give on to the garden, each having architraves in severe Greek form with console brackets comprising upper *paterae* and lower *guttae*. The mannerist style is of probable Regency date and matches the Tuscan porch on front. All three windows are likely to have originally been French, the northern one now being infilled with double hung sash window of 12 panes.

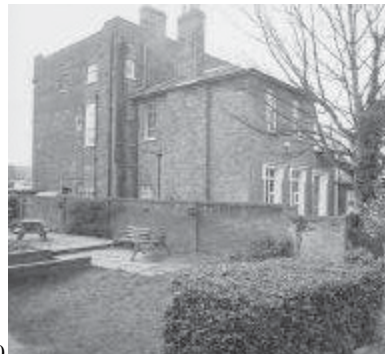
Southern and eastern elevations		Extension, Eastern elevation		Rear elevation	
7/10

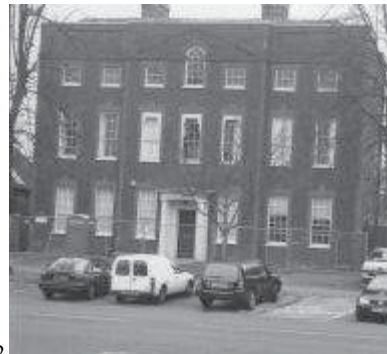
7/12

Southern exterior elevation		Southern & Western elevations		Front elevation	
Roll 7
