TANKARDS BARN **Tea Green, Offley, Herts.**

HN446

*Historic Building Record
& Archaeological Monitoring Report*

Prepared on behalf of the Kings Walden Estate

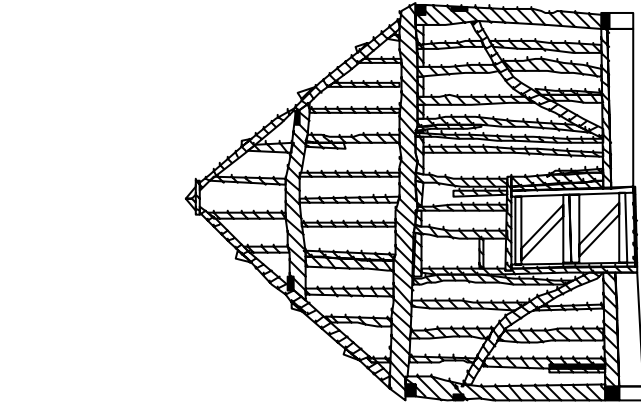
East elevation

2.13 The east elevation has internal tension bracing and a stable door offset towards the north. The door may be a later addition, as is suggested by the fact that the door frame posts do not reach the tie beam and that the sill beam to the south of it has been replaced. The bracing is of interest as the studs are not continuous behind the brace, but are tenoned into it, as would be the case in primary bracing. This technique, as well as the curved braces, suggests that this was constructed around 1600 AD.

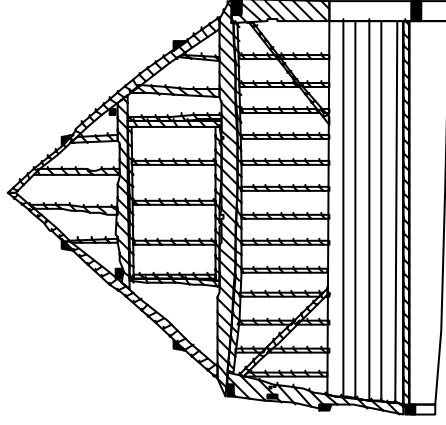
West elevation

2.10 All of the timber work below the tie beam in the west elevation has been replaced with primary bracing in a timber subframe. An additional sub frame has also been added between the tie and collar beams. The studs are thin sections of sawn timber, primarily of Scots Pine, and may be dated to shortly before World War I.
