MUNDENBURY **Great Munden, Herts.**

HN1067

ARCHAEOLOGICAL MONITORING REPORT

Archaeological Monitoring Report

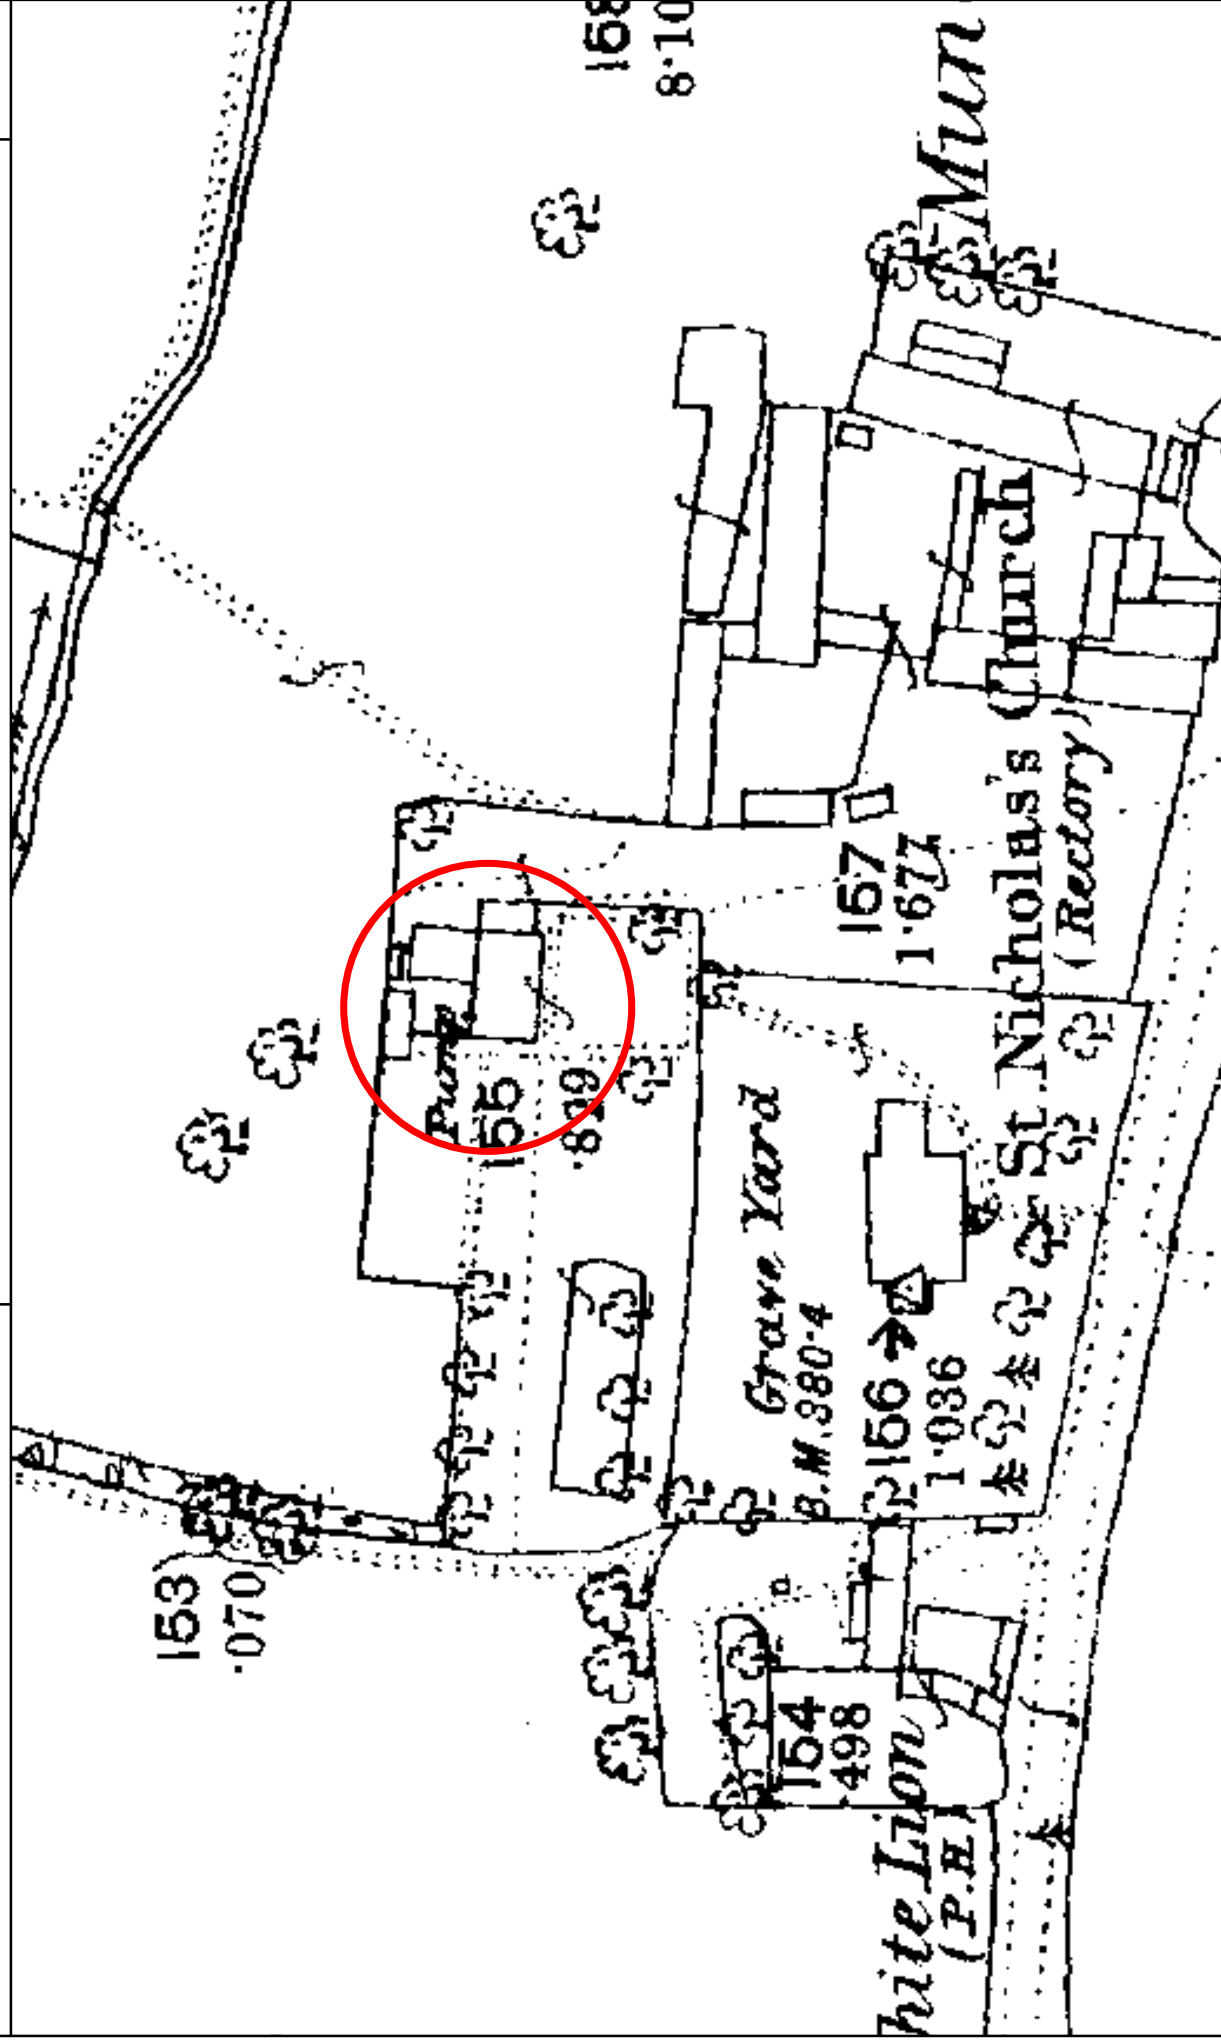
Recorded sections: north footings and soakaway

2.14 Beneath the turf [38] and topsoil [3], the made ground was formed of four layers consisting of multiple dumps, all of which contained mixed material characteristic of demolition (Figures 4 & 5, Plates 3 & 4, 7 & 8):

2.16 The stratigraphy in the soakaway was broadly consistent with the rest of the site, except that there were only three layers of disturbed ground over the natural [35] (Figure 5, Plate 10).
