**BURGESS BUILDING,
Wratten Road East,
Hitchin, Herts.**

HN1113

***HISTORIC BUILDING
RECORD &
ARCHAEOLOGICAL
MONITORING REPORT***

Historic Building Record and Archaeological Monitoring

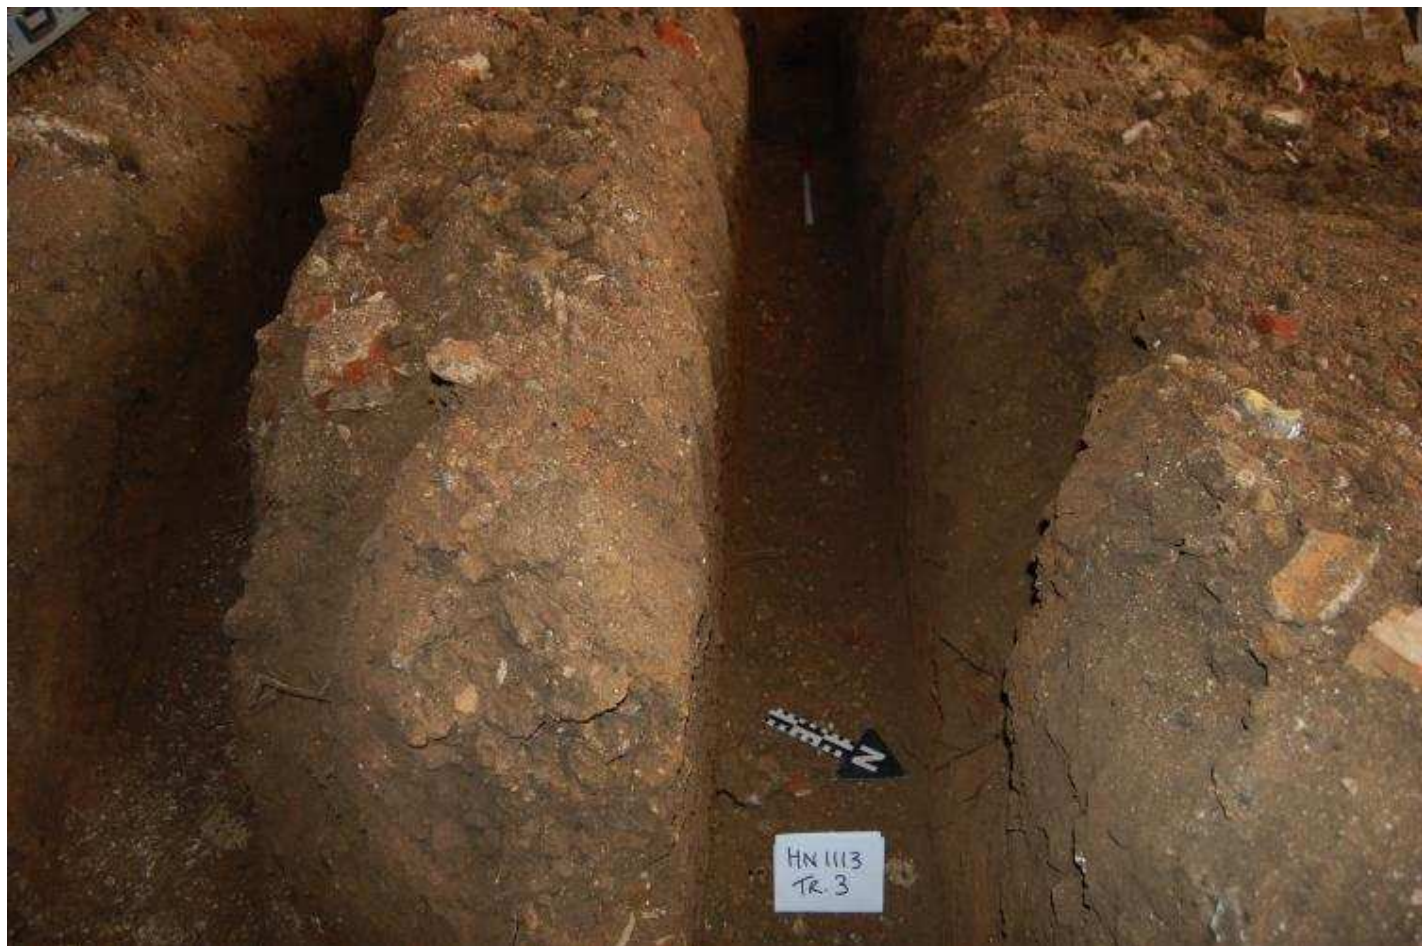
Plate 43 - Trench 3, looking SW

4.24 The sections revealed that deposits (1020) and (1021) reached a depth of approximately 0.40m below the impact level. Subsoil layer (1021) was encountered at the north-eastern end of both trenches, beyond wall [1014] (Plate 43). This overlay the redeposited yellowish brown sandy silty clay natural.

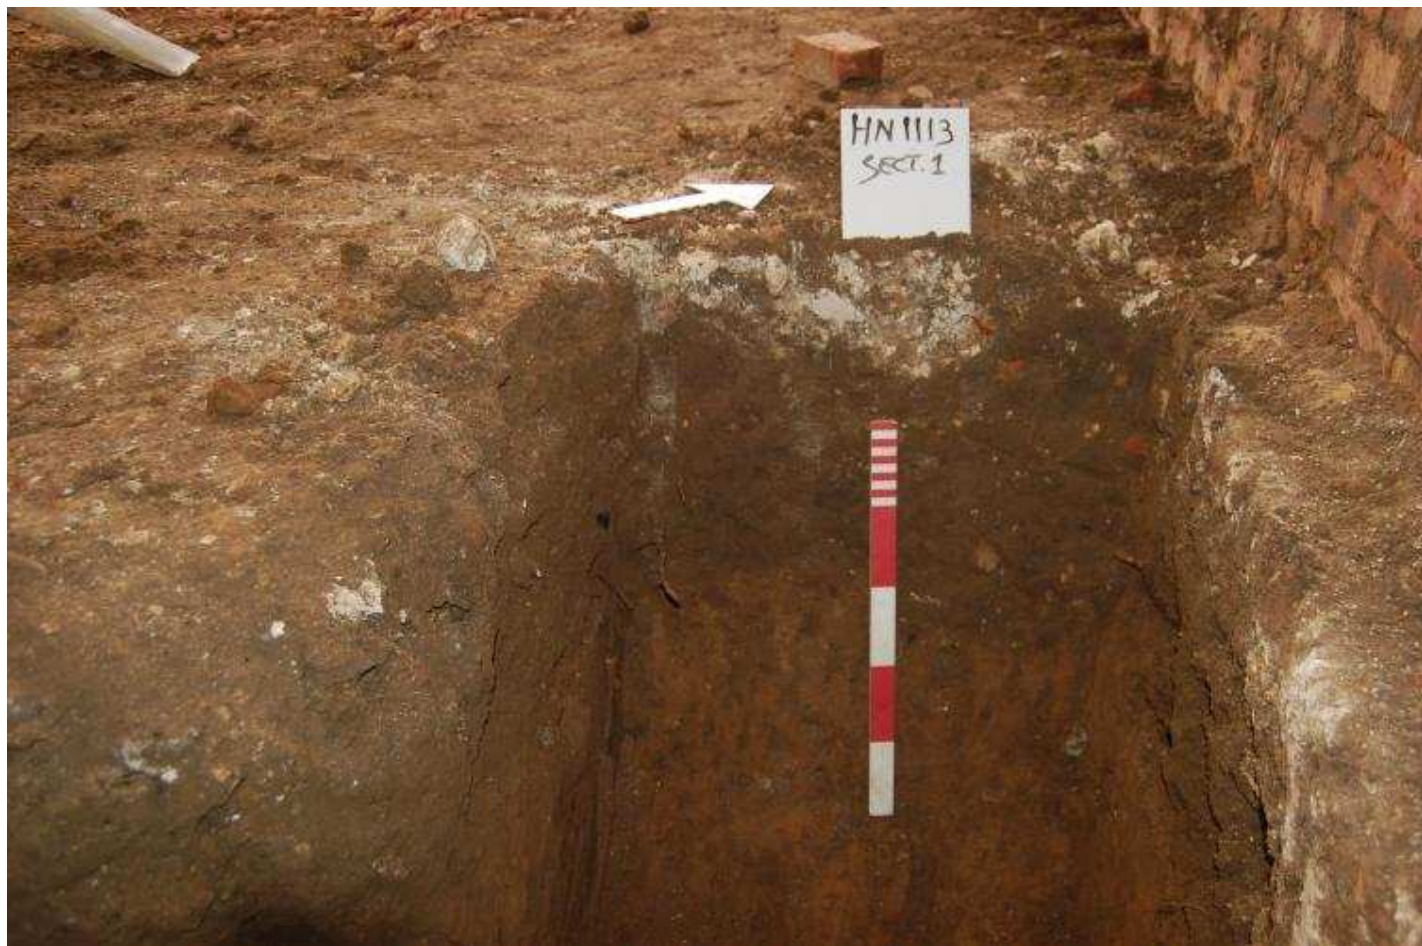
Plate 44 - Section 1, showing surface (3002), looking NW
(c) The Heritage Network Ltd.

4.25 The western edge of a possible chalk surface, (3002), was revealed in section at the north-eastern end of Trench 3 (Figure 6, Plate 44). This consisted of compacted chalk fragments, up to 0.08m in size and measured 0.50m in width and 0.10m in depth. The surface did not appear to continue eastwards.
