**Church of St Mary the Virgin, Harlington, Bedfordshire.**

Report No.849

As part of the faculty requirements for the repair of two existing buttresses supporting the north-western corner of the north aisle at the Church of St Mary the Virgin, Harlington, Bedfordshire, the Heritage Network was commissioned to undertake a watching brief on the groundworks.

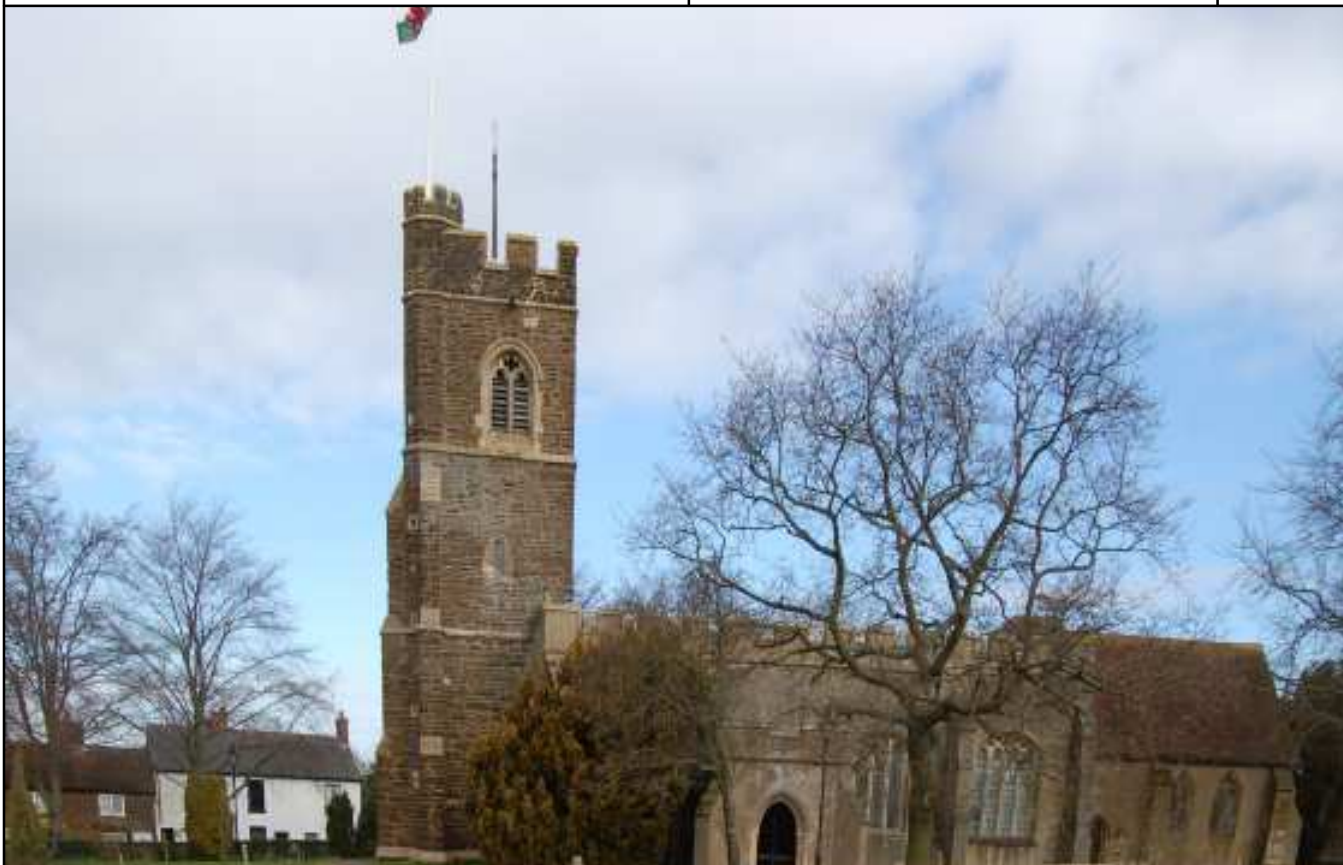
The Church of St Mary the Virgin is located on the southern edge of the village, on the southern side of Church Road, centred at NGR TL 03653 30451 (Figure 1, Plate 1).

Plate 1: The Church of St Mary the Virgin, looking north
