## **NORMANS FARM** **Willian, Herts.**

HN630

***Historic Building Record &  
Archaeological Monitoring Report***

Report no.403

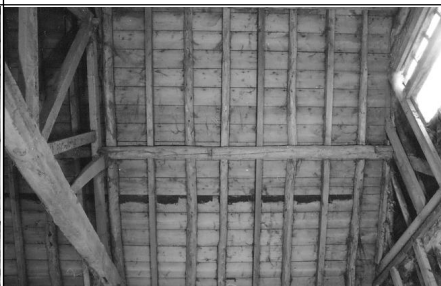
Frame 14: Barn 2, Bay 1, W roof

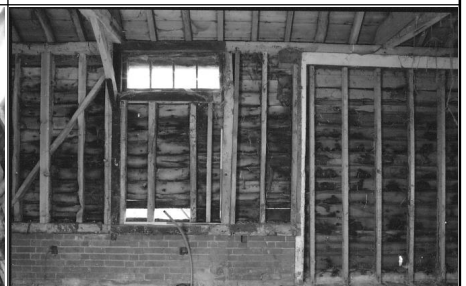
Frame 15: Barn 2, Bay 2, W elevation
