**ASHDON HALL,
Ashdon, Essex**

HN679

*Historic Building Record
& Archaeological Monitoring Report*

Report no.457

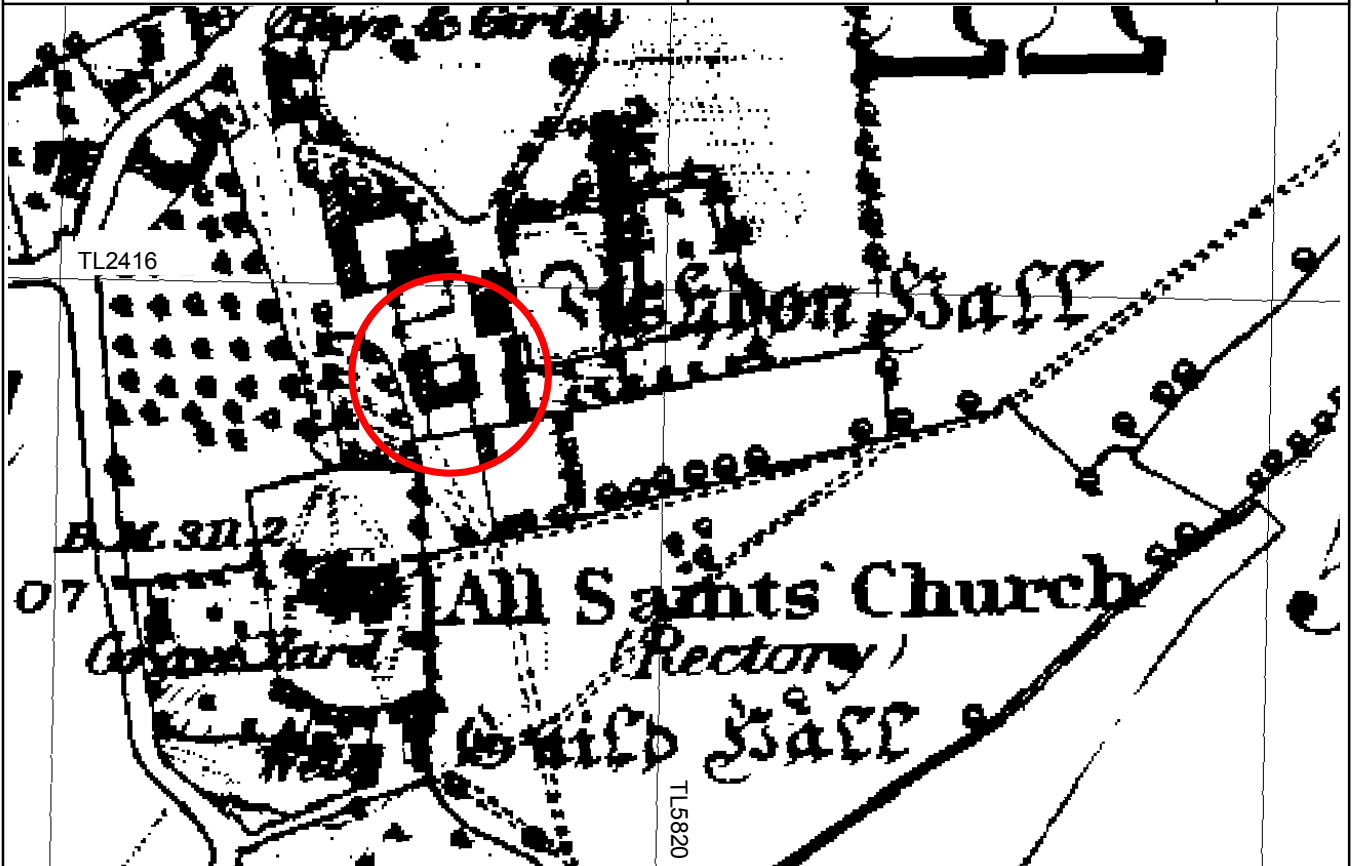
Figure 2

2.20 Cartographic evidence demonstrates that these structures were in existence in the late 19th century. They are shown on the 1st edition OS map of 1880 (Figure 2). At that period the northern side of the yard was enclosed by a wall extending west from the northern end of Barn 3. A second enclosed yard lay to the north, butting the northern end of Barn 2. A small enclosed yard was located on the southern side of Barn 1.

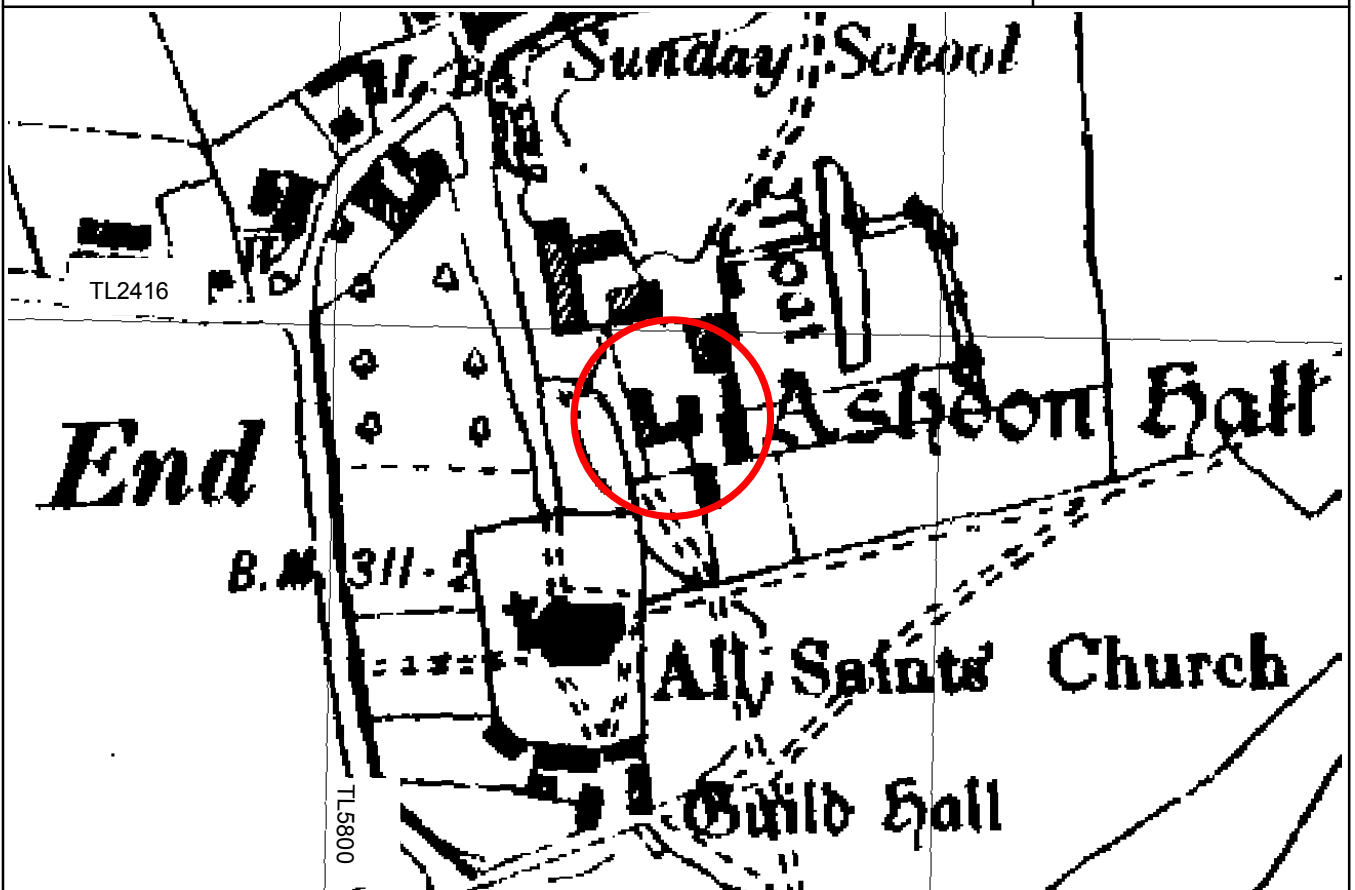
Figure 3

2.21 Little change to this layout occurred between 1880 and 1980 (Figures 2 - 5). The northern yard and the boundary across the farmyard had disappeared by 1903 (Figure 3).

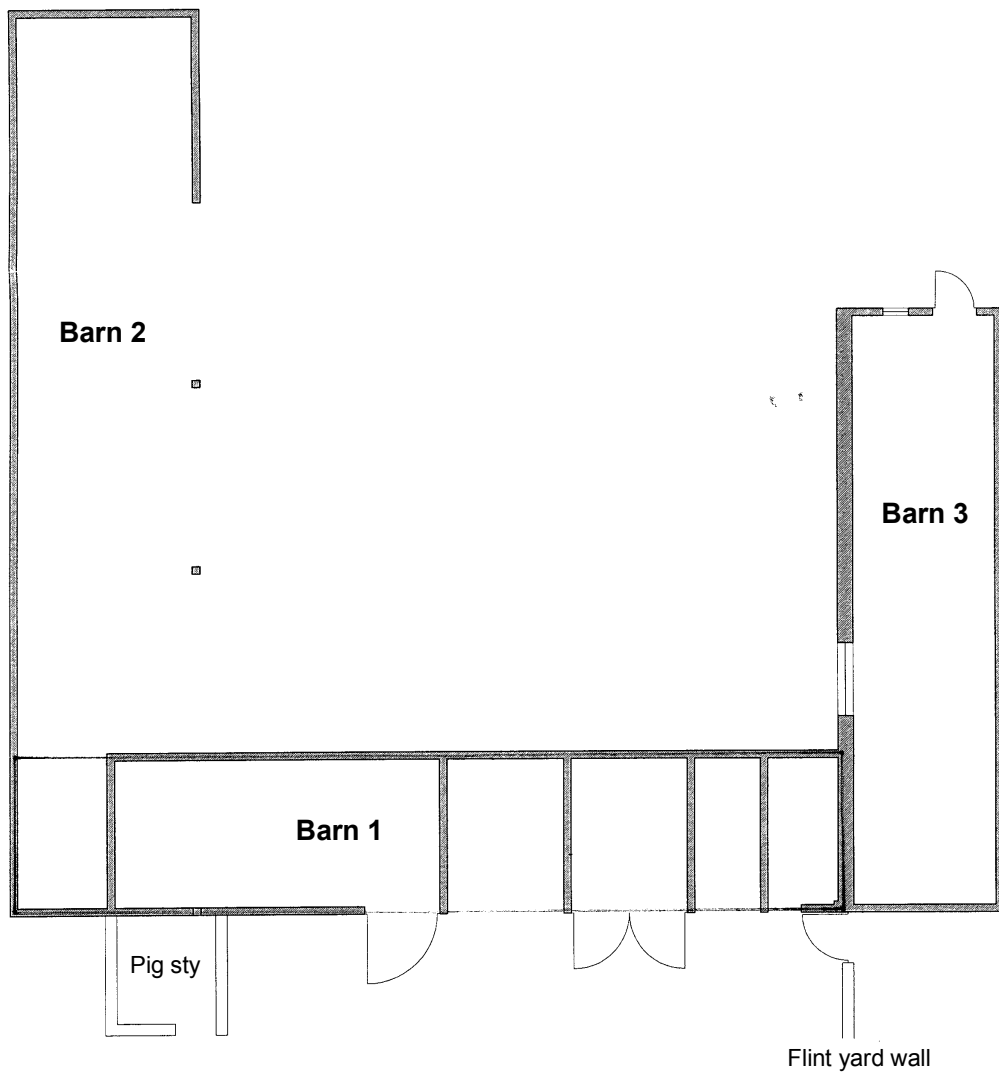
Figure 6

2.22 Barn 1 forms the southern range to the farmyard and is a timber framed building of five bays, linking the southern ends of Barns 2 and 3 (Figure 6). It is partially open to the south (Plate 1) and closed with vertical elm boarding to the north (Plate 2). The northern elevation rests on a brick plinth, formed of Cambridge white bricks rising eight courses above the existing ground level (Figure 7). The boarding is nailed to horizontal battens which are tenoned into the softwood principal posts. These are formed of poorly finished branches and support a wall plate, also possibly in elm.

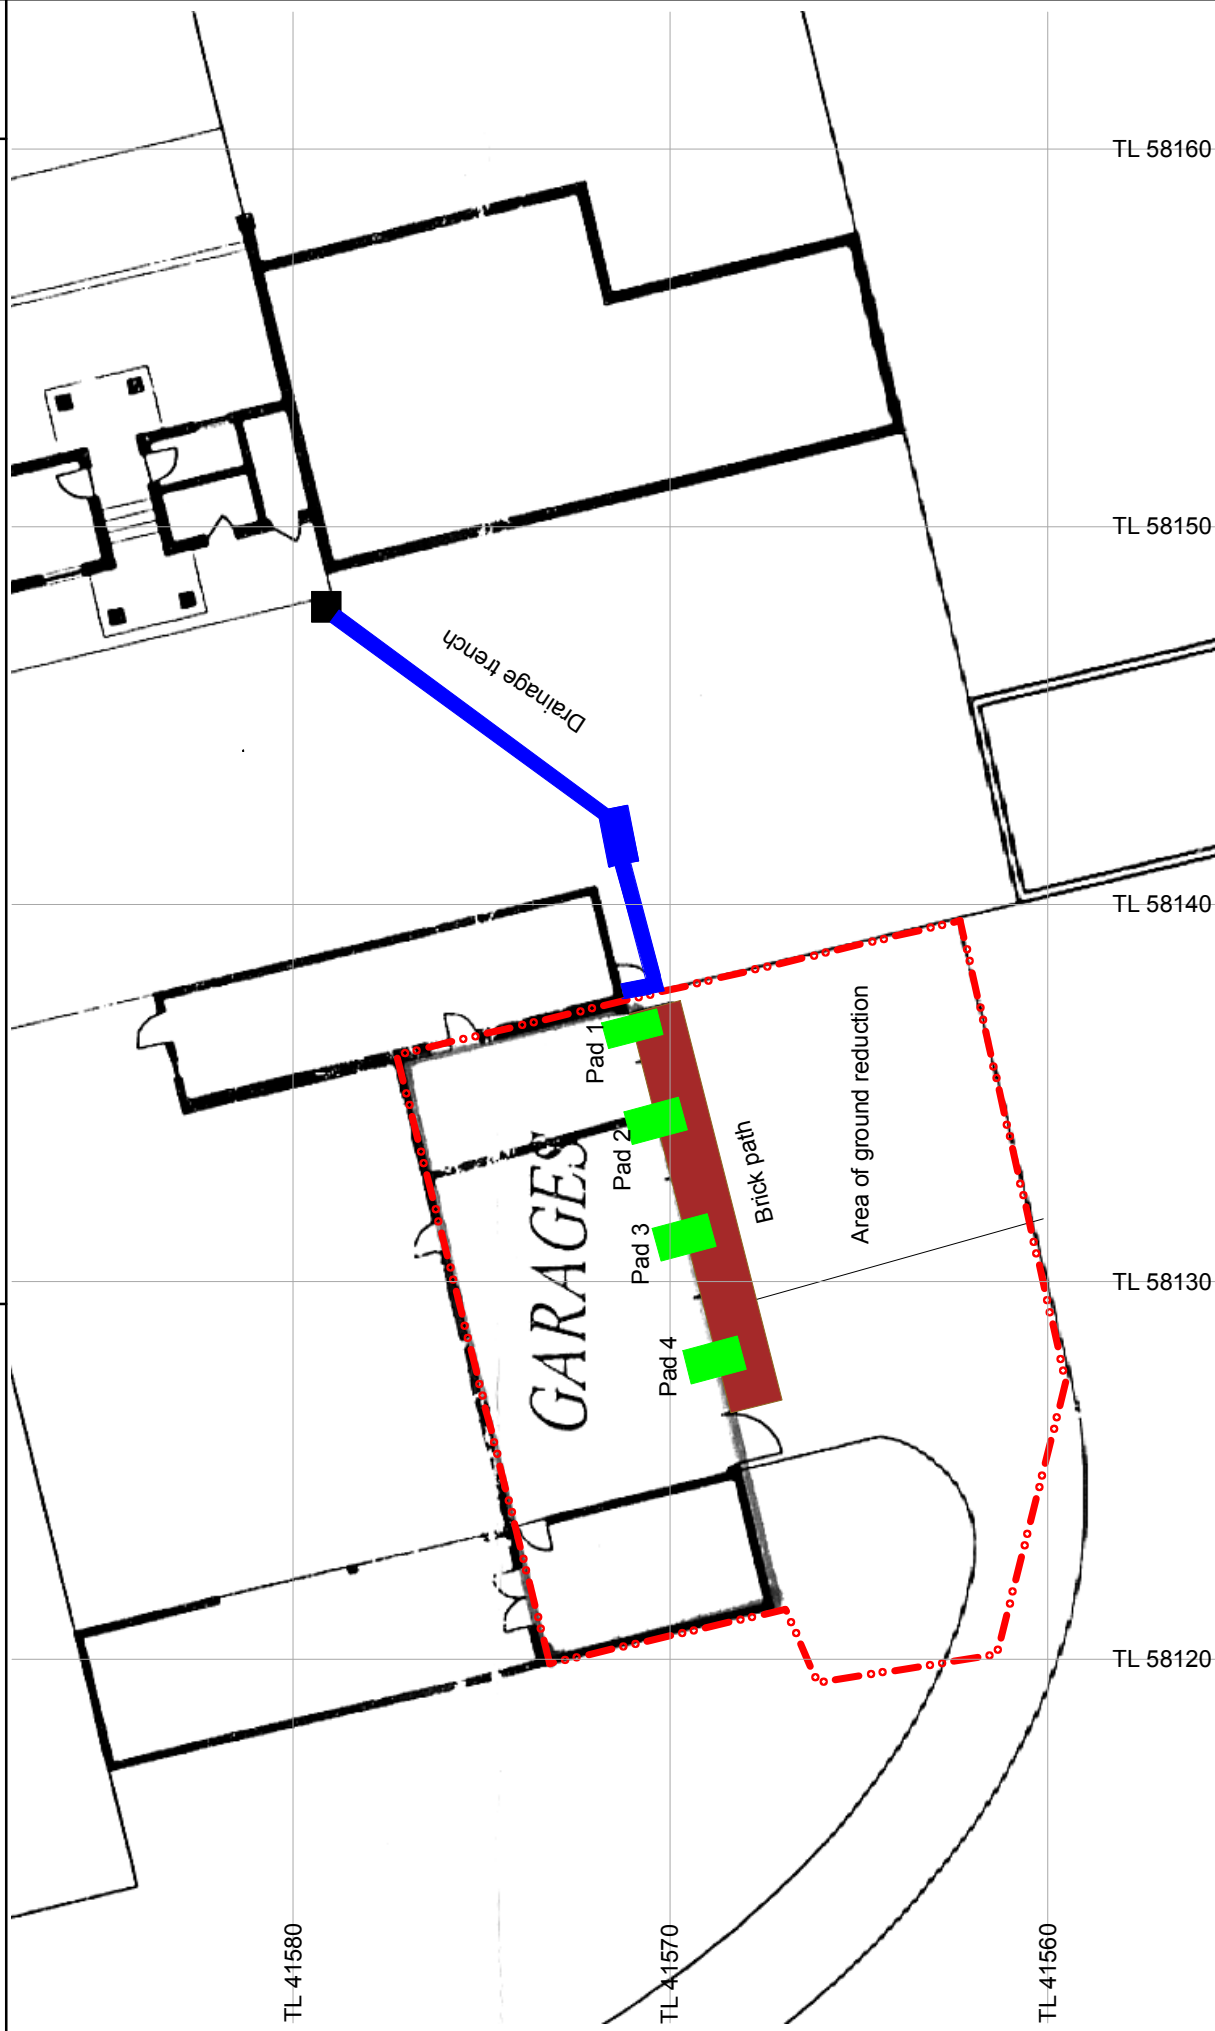
Scale 1:200
Figure 8

2.4 The development involves the demolition of the southern wing of the existing range of farm buildings and the construction of two larger garages in the same location (Figure 8).

2.33 An area to the south of the site of Barn 1, measuring 8.5m x 19m, was reduced by approximately 0.30m (Figure 8). The topsoil in this area consisted of a dark brown silty clay, 0.30m in depth.

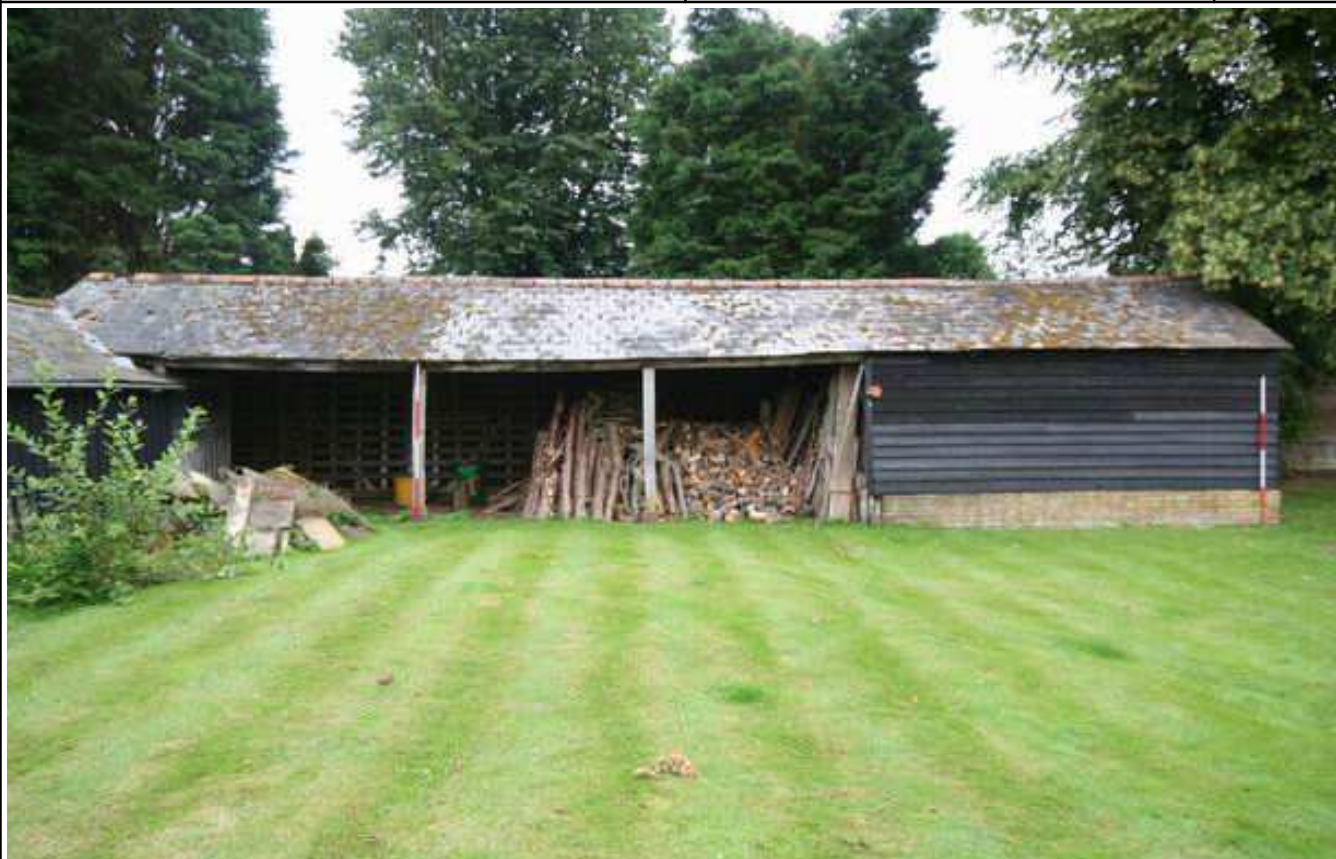
Plate 7: Barn 2, east elevation, looking W

2.28 Barn 2 is a timber framed building of six bays, with an earth floor and a slate roof, which forms the western range of the U-shaped group. It has been built around Barn 1 at the southern end, and Barn 1 occupies much of the first bay (Plate 6). Bays 2 to 4 are open to the east, with the oak wall plate being supported on modern oak posts resting on modern brick piers (Plate 7). Bays 5 and 6 are enclosed with diagonally braced studwork, the sill beam resting on a dwarf all of Cambridge white bricks. An original principal post in the eastern elevation between Bays 4 and 5 has a protective 'bumper' at the base suggesting that this was originally an open cart shed.

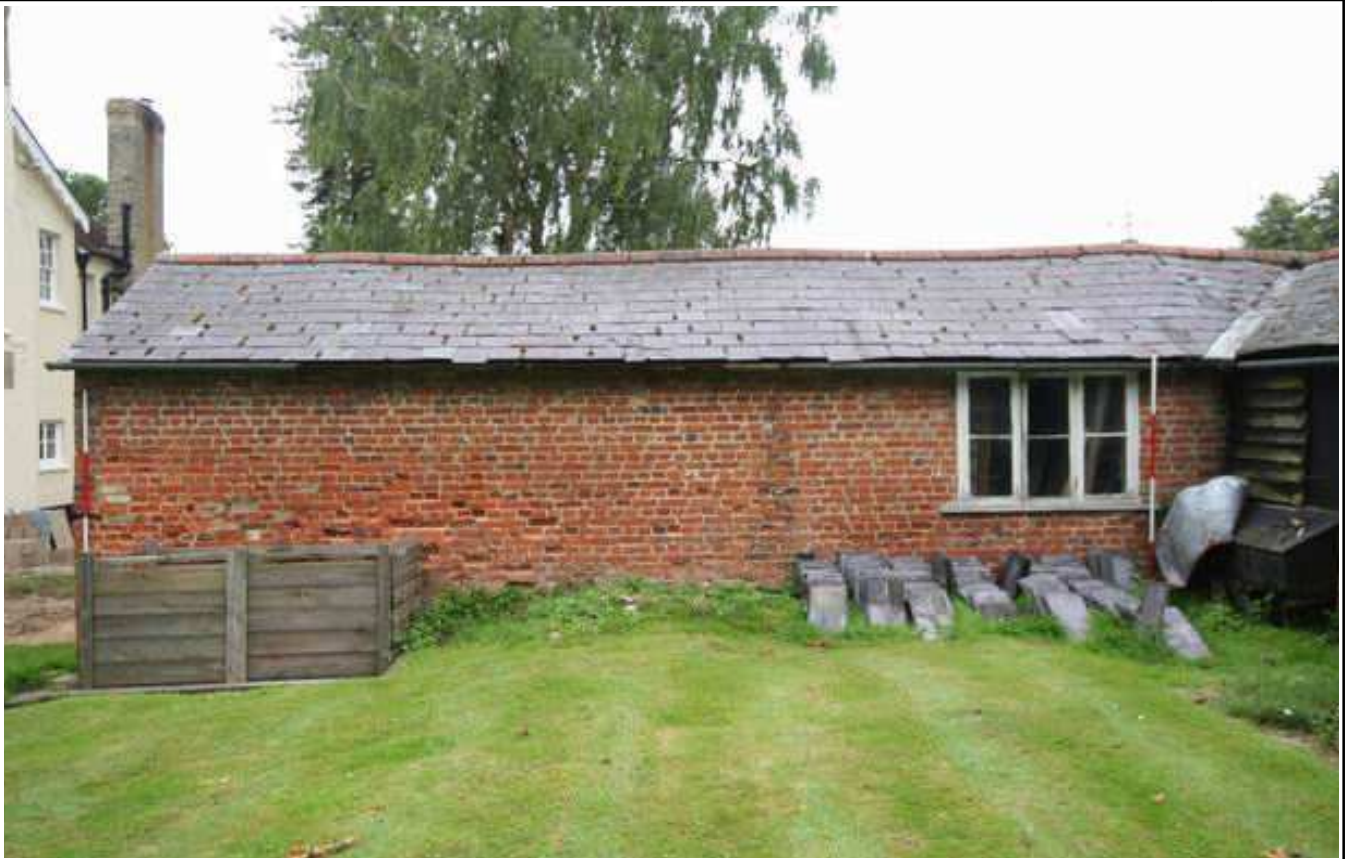
Plate 9: Barn 3, west elevation, looking E

2.31 Barn 3 is a timber framed barn of 5 bays which forms the eastern range of the U-shaped group. It is likely to predate Barn 1 and its western elevation is formed of red bricks, laid in a rough English bond (Plate 9). Its eastern elevation is weatherboarded, with a line of stable doors (Plate 10).
