CROWN COTTAGE. Kelshall, Herts.

HN818

*Historic Building Record
& Archaeological Monitoring Report*

Report no.612

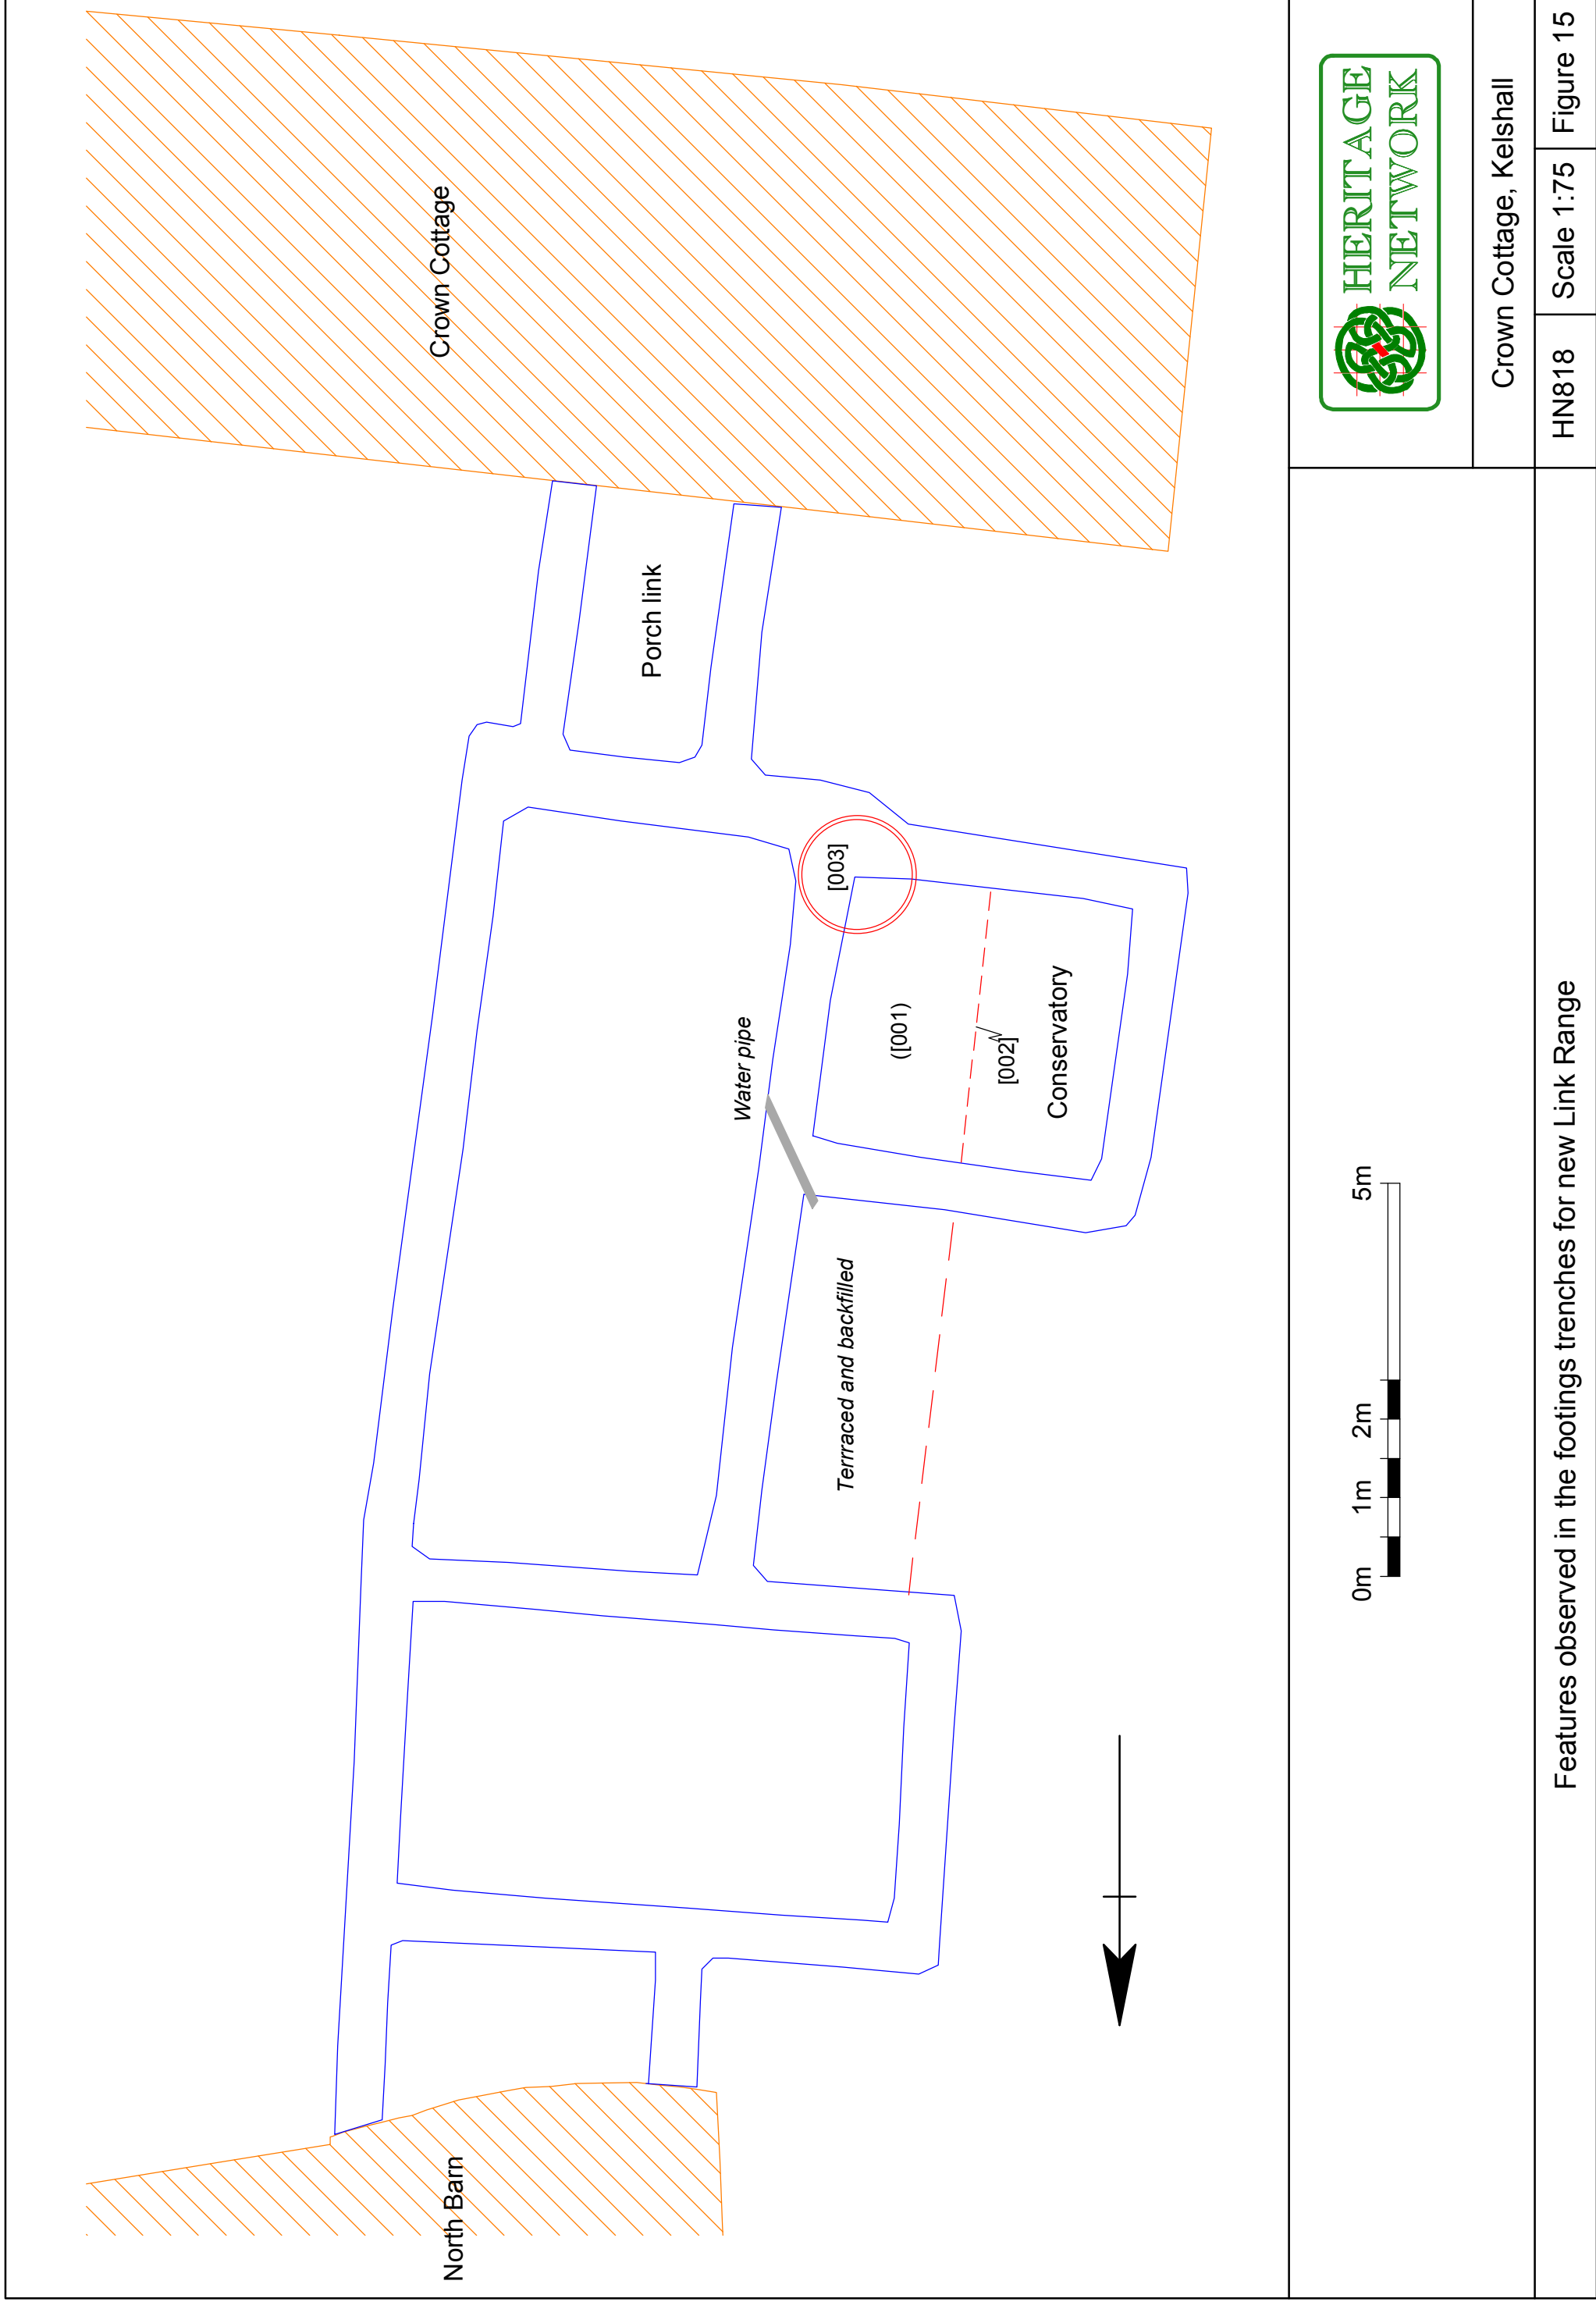
HN818 Scale 1:75 Figure 15

4.8 The footings trenches for the replacement Link Range measured 0.60m in width and were excavated to a depth of 1m (Figure 15).

4.9 A cut line, [002], was noted 2m to the west of the footings (Figure 15). This defined the limit of a mixed deposit, (001), comprising dirty clay with brick and tile fragments and general debris, approximately 0.75m in depth, which was also observed in the western trenches (Plate 49). It represents the backfilled terracing of the natural slope to accommodate the link building. Sherds of brown glazed pottery of 18th-19th century date were recovered from this deposit, along with a modern handmade ash tray, in thick white clay with a skull in the centre. This is likely to have been made by a child at school and is marked on the base with an indistinct stamp, which may read 'L. Smith'.

Features observed in the footings trenches for new Link Range

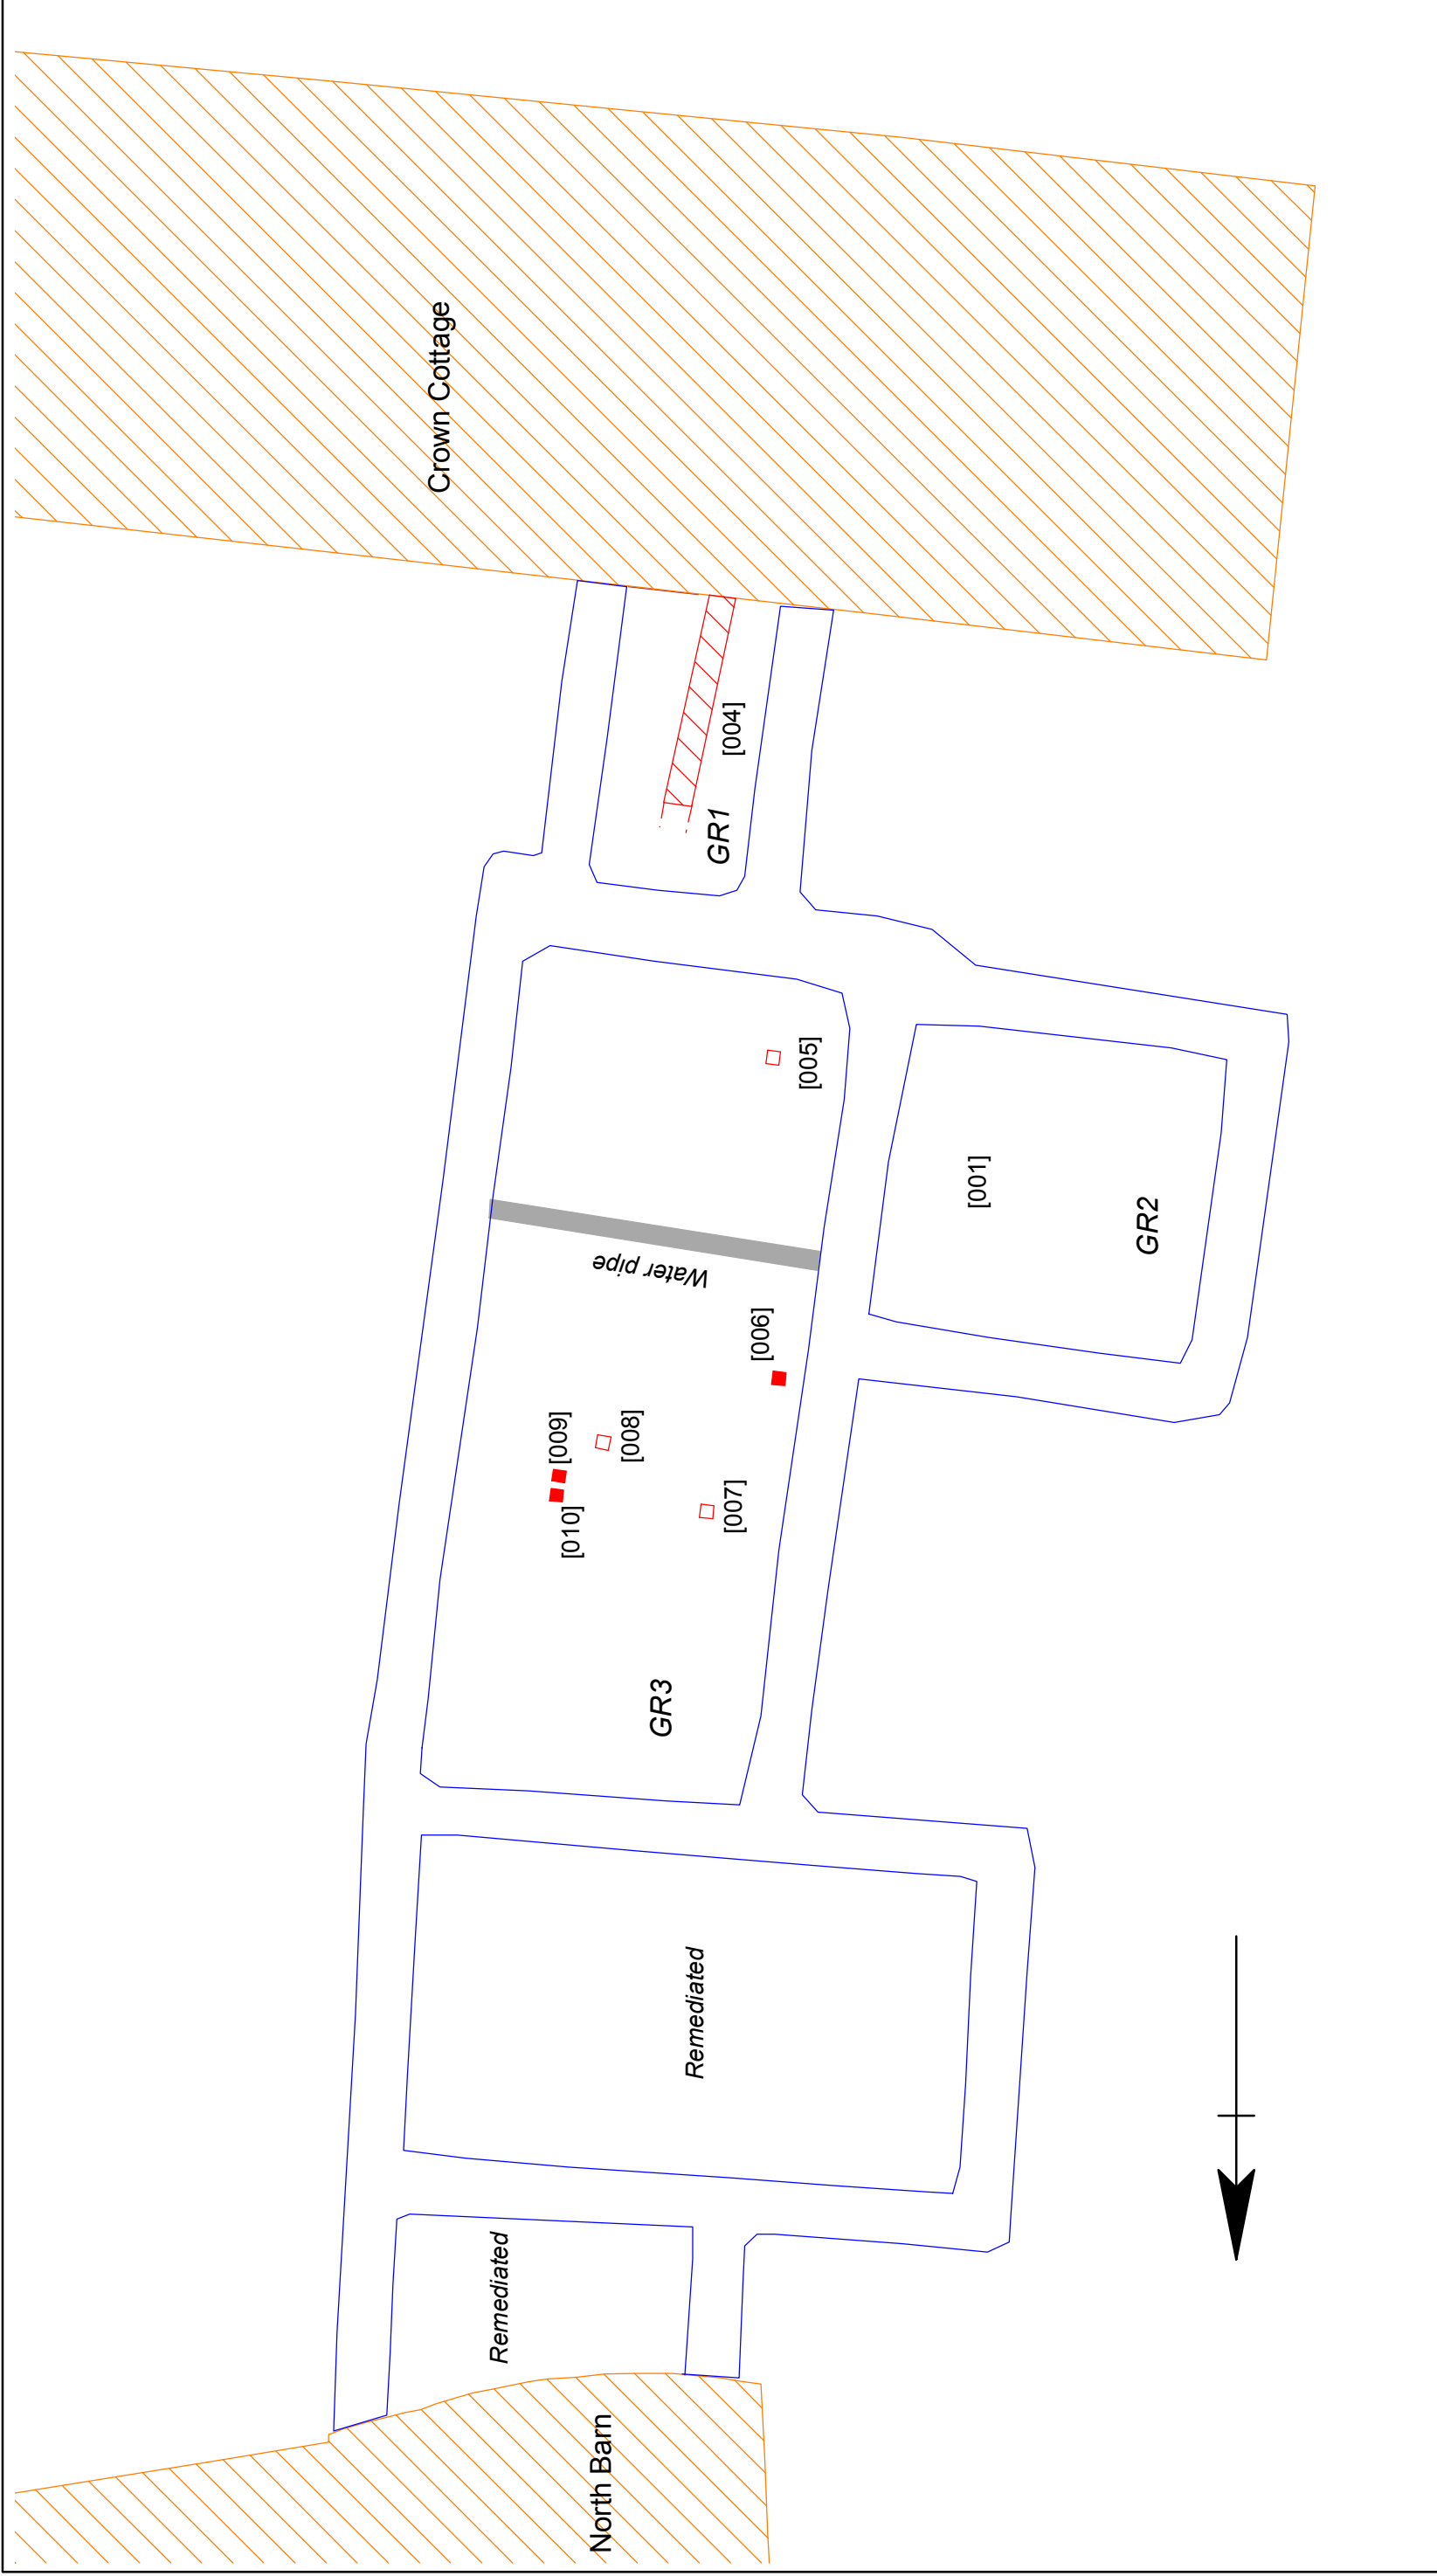
HN818 Scale 1:75 Figure 16

4.13 Three areas of ground reduction (numbered GR1 – GR3) were monitored at the southern end of the new Link Range, representing 'islands' within the footings trenches (Figure 16; Plate 51). GR1 represented the area of the linking porch; GR2 the area of the new conservatory and GR3 the southern part of the main block. The two 'islands' to the north had already been subject to remediation and were excluded from the monitoring programme.

4.17 A number of features were observed at the natural horizon (Figure 16). These comprised three square post holes, each aligned north to south and measuring 0.15m square (contexts [005], [007] and [008]) (Plates 52 – 54). Cuts [005] and [007] contained a similar fill, comprising a dark greyish brown damp clay, with frequent charcoal flecks and were relatively shallow, extending to 0.07 below the natural horizon; cut [008] was filled with redeposited chalk and was over 0.15m in depth.

Archaeological Features exposed in the ground reduction

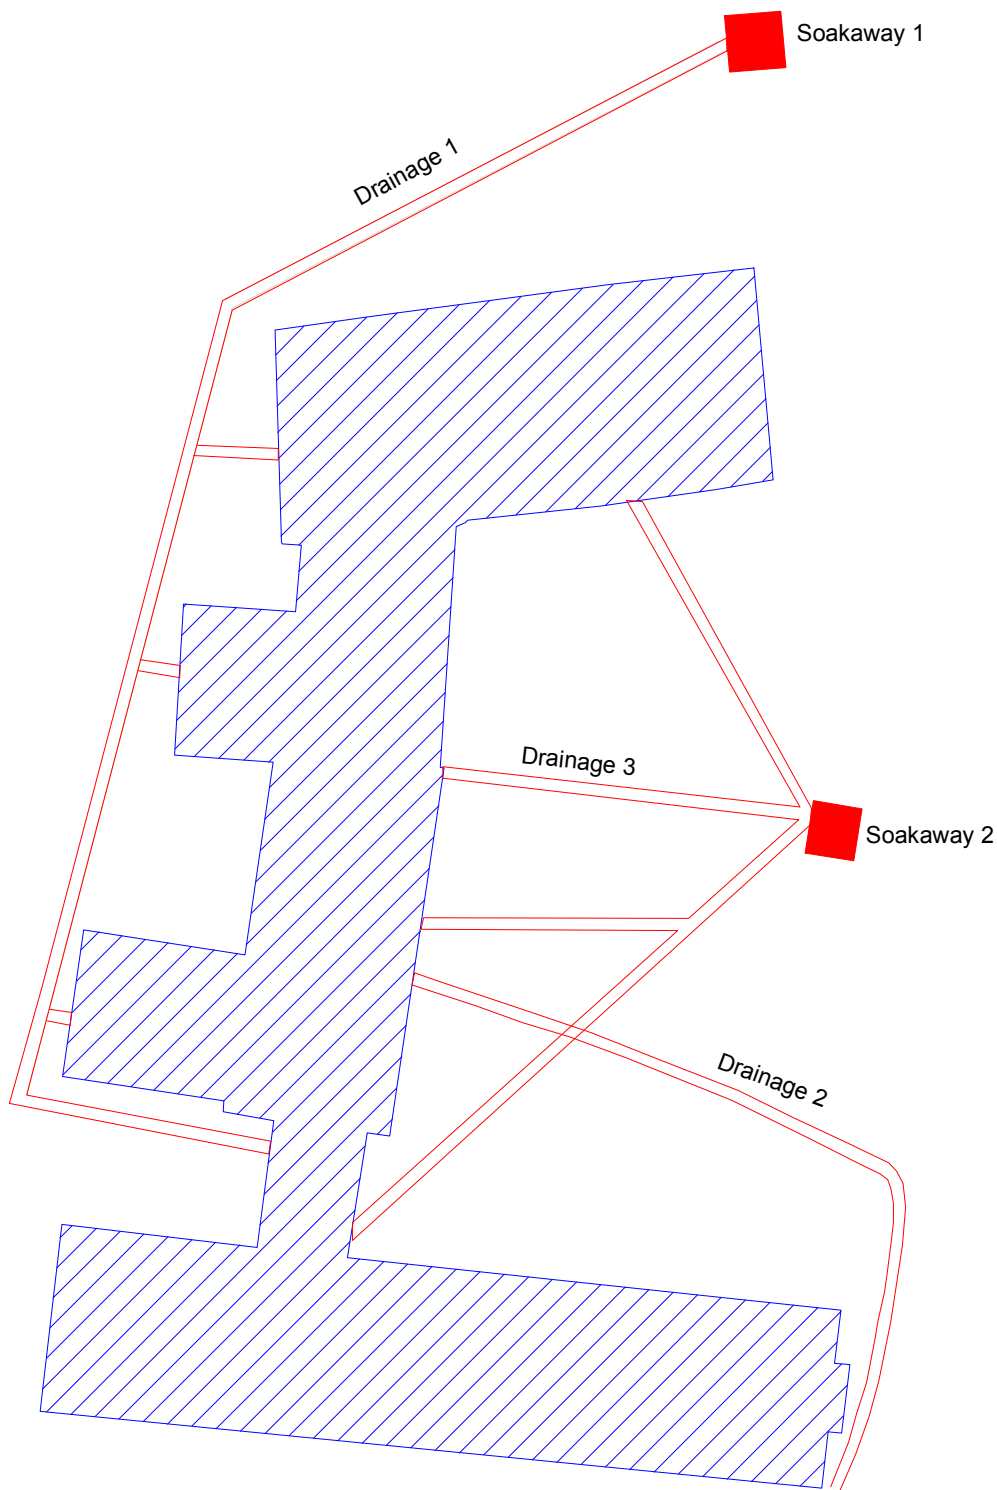
Figure 17

4.20 A series of drainage trenches and two soakaways were excavated to the north, west and east of the North Barn and the Link Range (Figure 17).

Plan showing drainage trenches

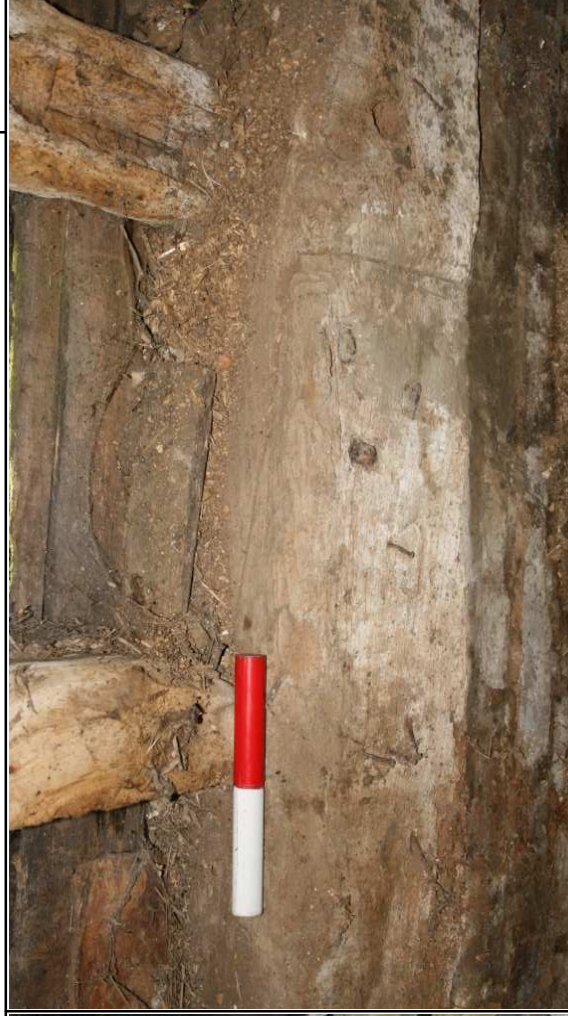
Plate 10: North Barn, N elevation Bay 2, face halved & bladed joint in sill beam

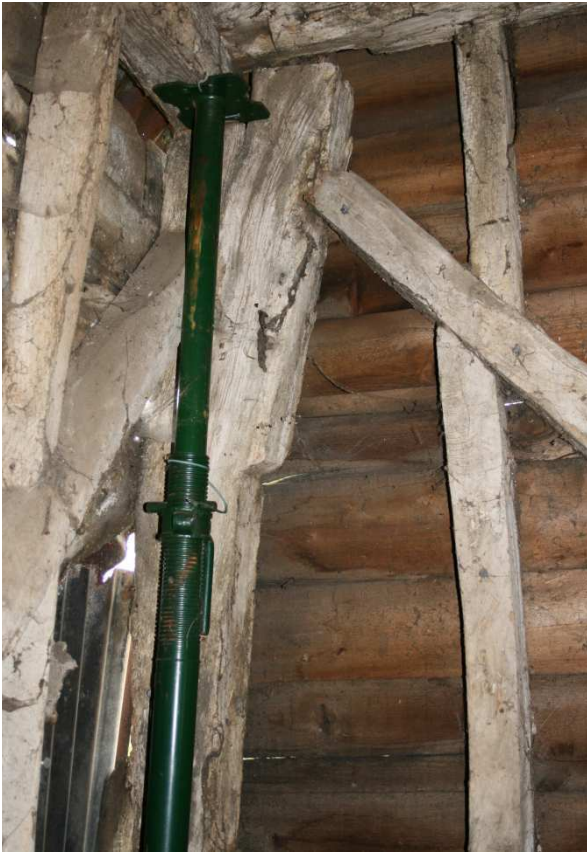
Plate 13: North Barn, detail of SW corner post

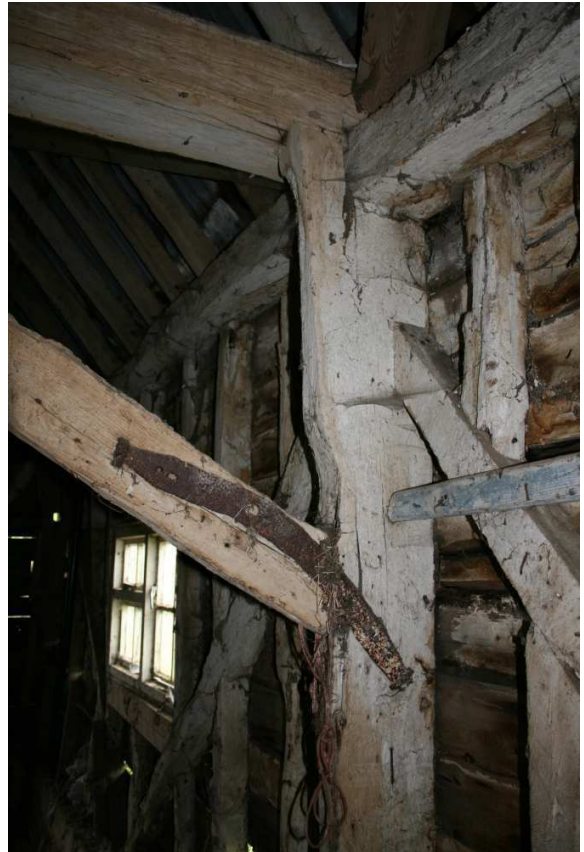
Plate 14: North Barn, detail of N principal post, Bays 1-2

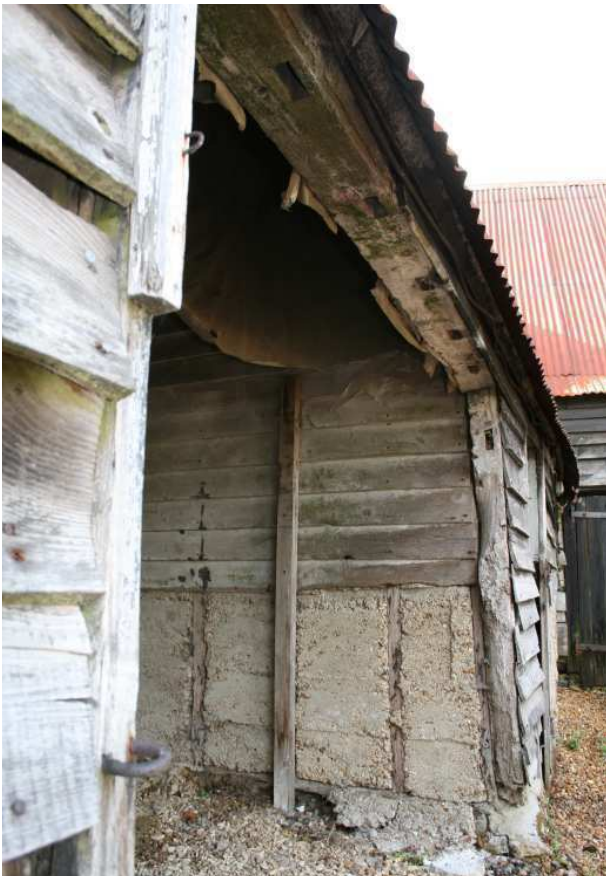
3.37 Block 2 is open fronted to the east (Plate 30), although the wall plate has mortices, suggesting that it was originally closed (Plate 15). The northern elevation consists of lime washed weatherboard, whilst the western elevation is studded and diagonally braced below the wall plate, with half-height concrete lining. The south elevation is a softwood partition to wall plate height, with half height concrete lining below weatherboard.

Plate 15: Block 2, detail of mortice holes in underside of E wall plate

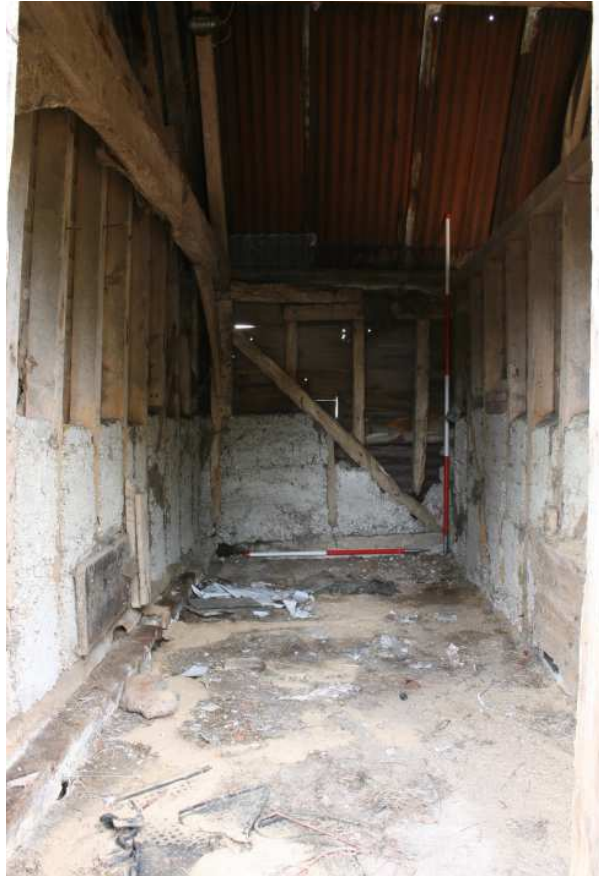
3.40 There is a boarded, ledged and braced personnel door offset to the south in the east elevation of Block 3. The west elevation has studwork and diagonal bracing, with half-height concrete lining (Plate 16). The southern elevation has a double gable, open to Block 3 and closed to Block 4. The open element takes the form of an intermediate truss to the post and frame structure, with curving braces to the principal posts (Plates 31-32). There is no evidence to indicate that this was closed and it appears to form part of a taller structure. This unit appears to have been created from a larger structure, reused here.

Plate 16: Block 3, looking west

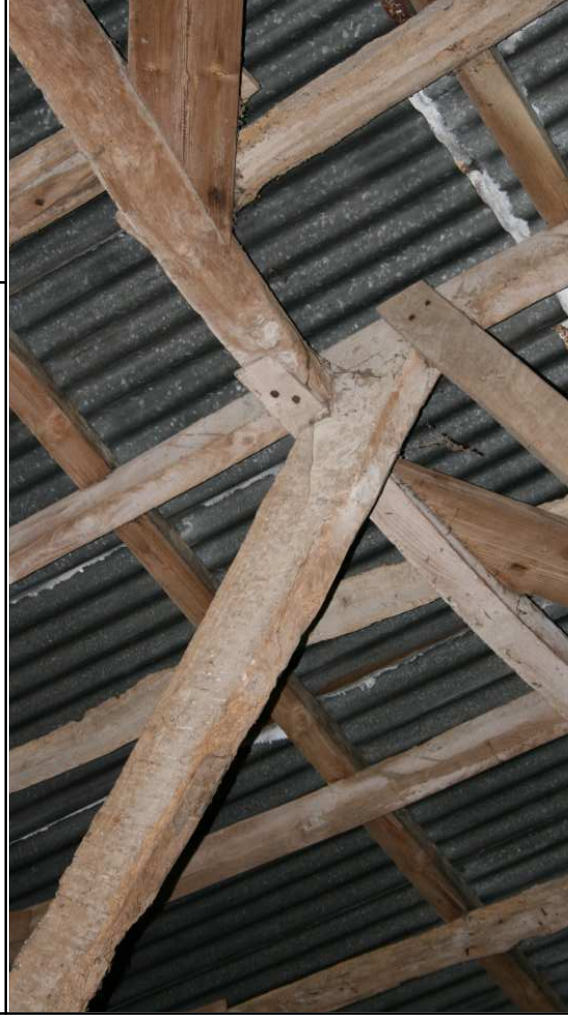
Plate 17: North Barn, S elevation roof structure, detail of junction between purlin & collar
