**STAMFORD YARD,
Kneesworth Street,
Royston, Herts.**

***Historic Building Record &
Archaeological Monitoring Report***

Report No. 194

June 2003

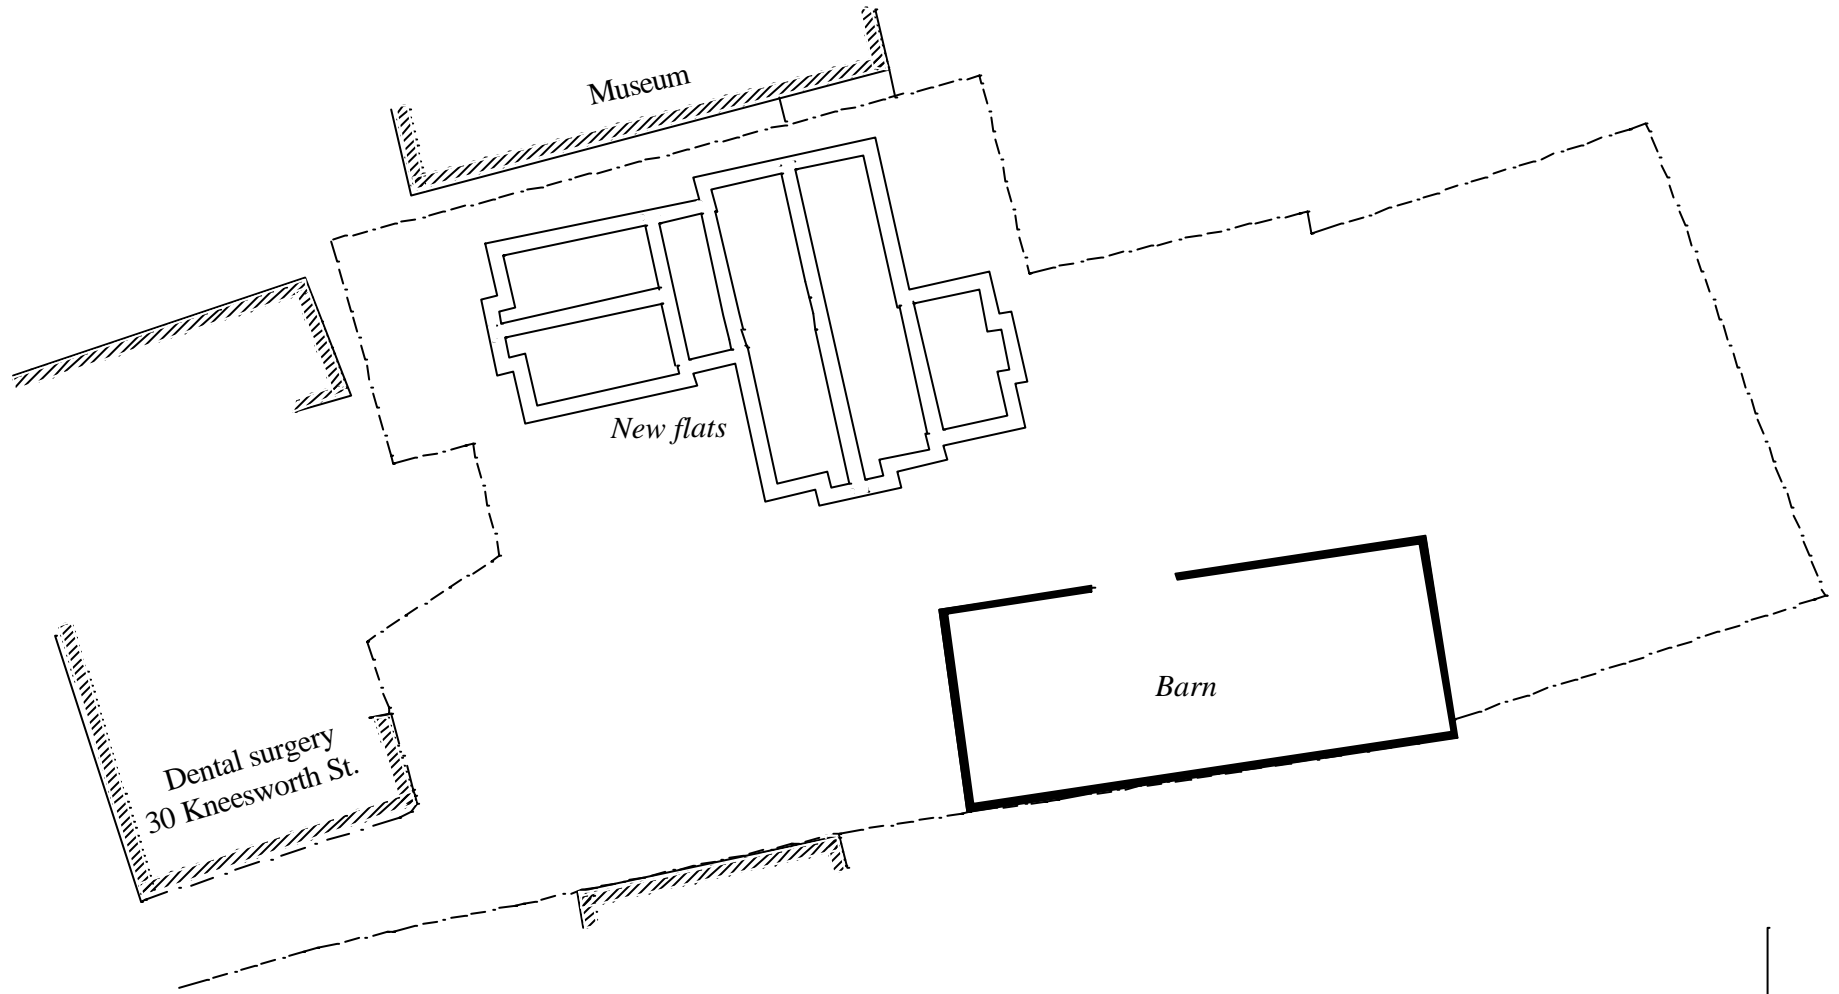
Figure 5

2.2 Further analysis of the barn reveals that it is of typical post-medieval construction, whereby oak has been used for the sill beams, whilst the cross frames are constructed from elm and the studs of pine. The elevations are also indicative of a post-medieval date, in that they consist of primary bracing, which suggests an early 17th century date (Fig.5).

2.4 On the whole, the studs above the middle rail are original. However, wholesale replacement can be seen below the middle rail, where the studs are machine cut and of uniform scantling. The west elevation appears to have undergone major rebuilding in recent years. The modern appearance of the timber work is further substantiated by the use of Fletton brick in the supporting dwarf wall. Some replacement has also taken place of the sill beam, as is evident in the north elevation of Bays 3 and 4.

2.6 The principal posts have gunstock jowls, which are typically medieval and continued in use until the early 17th century. All but one of the posts have undergone major repairs, in that the section below the middle rail has been replaced. The exception is the principal post in the north east corner. Saw marks are visible on a number of these posts, such as that in the south east corner. Chisel cut carpenters' assembly marks were also noted on the fourth truss from the west.

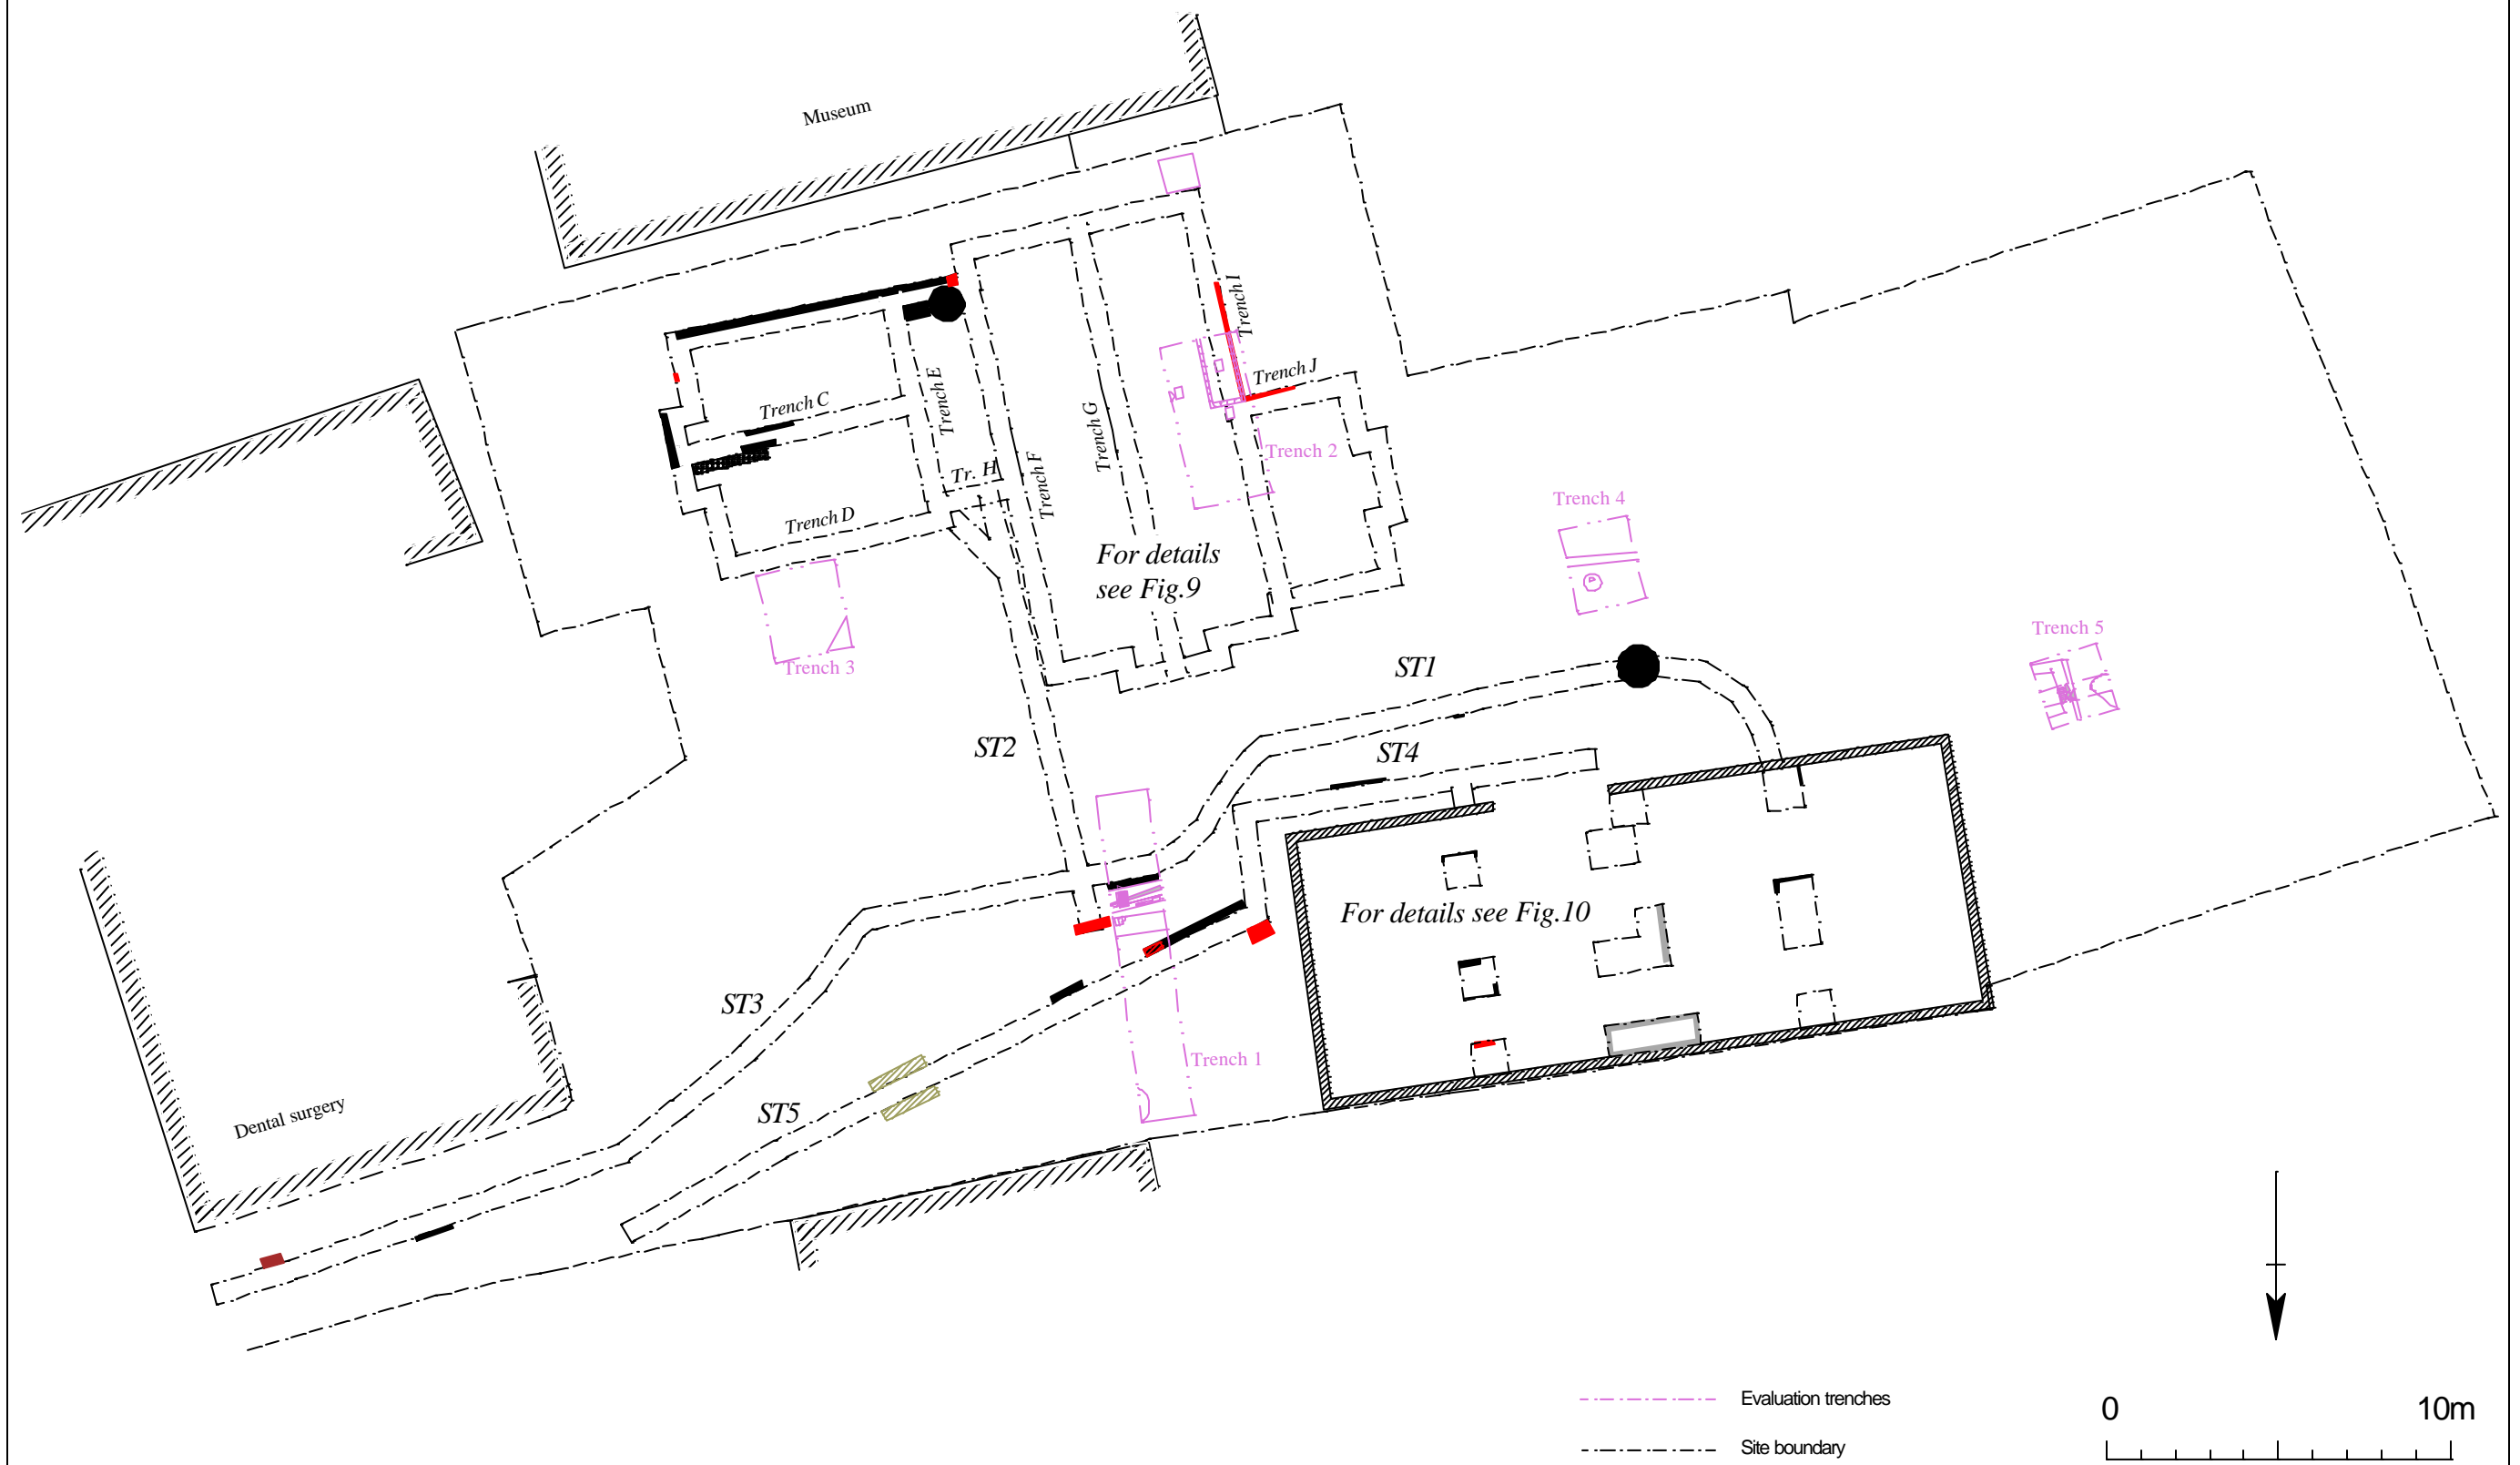
Archaeological features-overview

3.17 Ten foundation pads were excavated within the barn, two of which (Pads 3 and 8) were dug as one (Figs.7&9). They varied in size from 1.0 x 1.0 x 0.85 to 0.90 x 2.70 x 1.10m.
