ARCHAEOLOGICAL
SERVICES
DURHAM UNIVERSITY

Bedford Lodge
Bishop Auckland
County Durham

archaeological assessment and
building recording

report 4400
March 2017

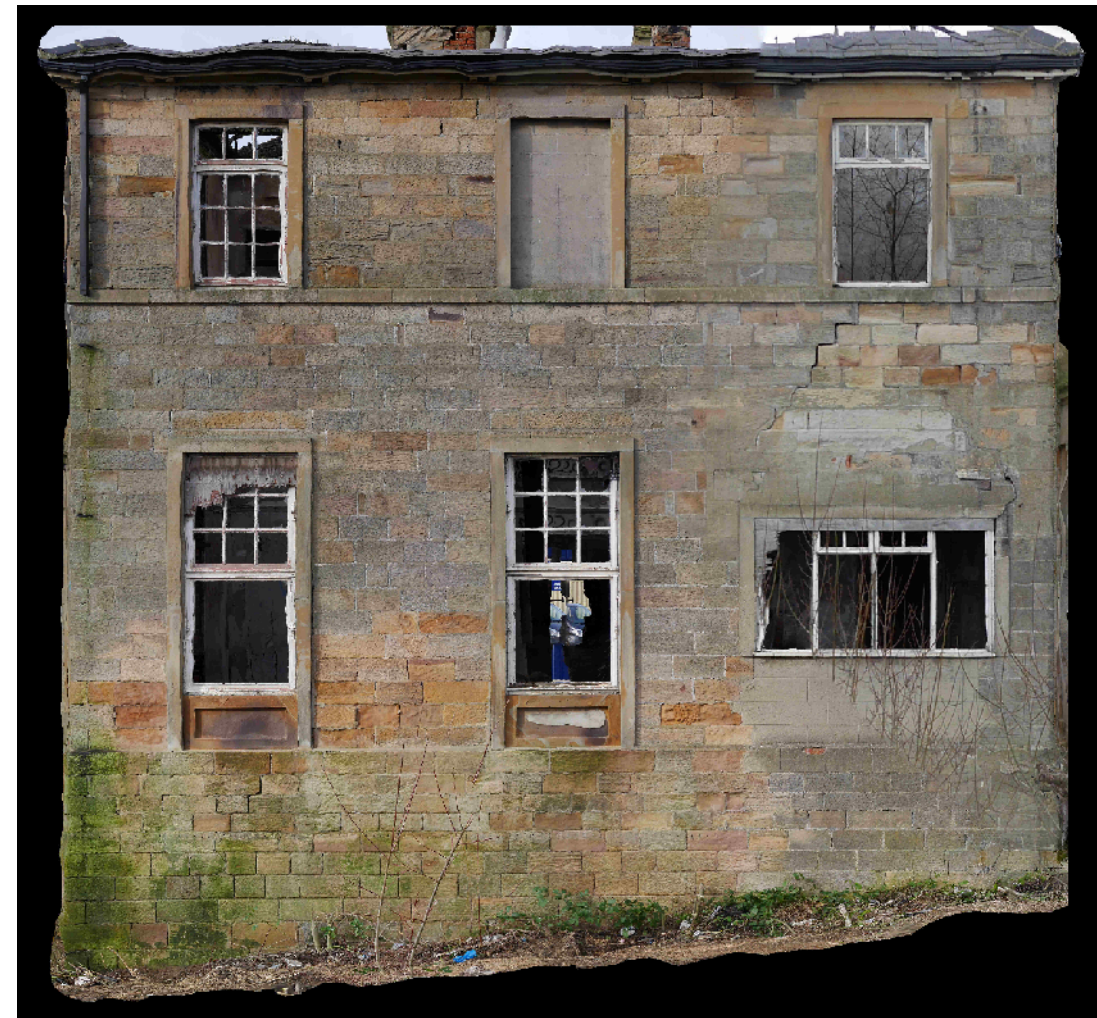
East elevation

- 5.4 This east face contains the largest single alteration in the building. The right-hand window on the ground floor has been replaced with a lower and wider opening under a timber lintel. The infill above and below is finished with cement mortar, crudely marked to reflect the original ashlar. The stonework in the plinth below this ugly insertion is a different colour from that in the rest of the face. A row of holes for

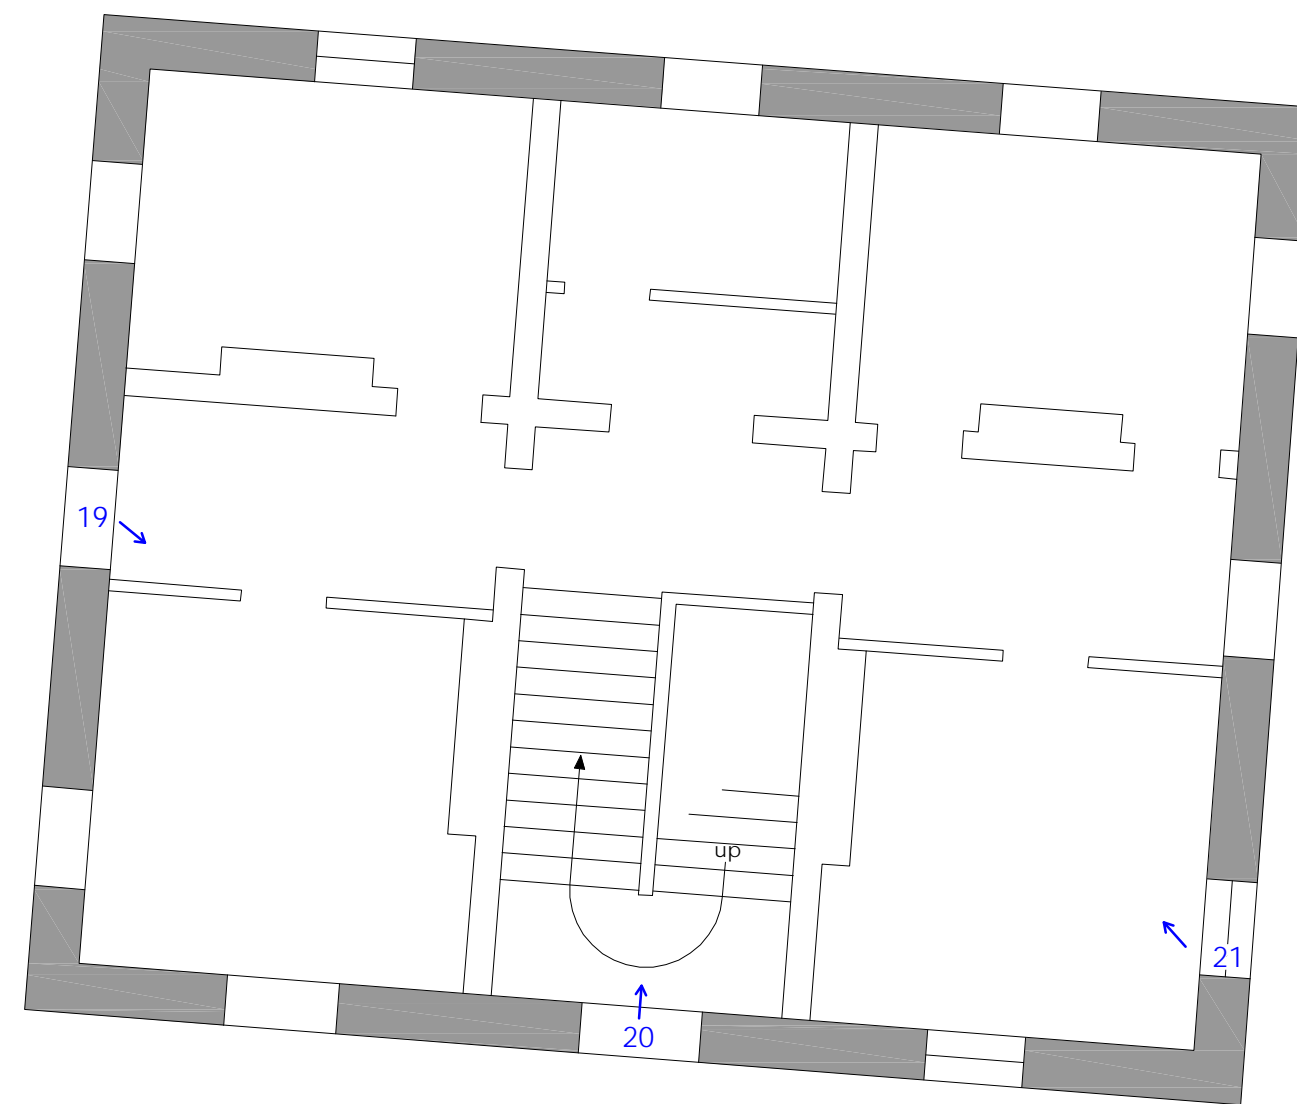
Ground floor

- 5.7 The recent blockings have been smashed and access to the interior is possible, but the house is far from being in a safe condition. The photographs in this report were taken from outside the building. The basement is entirely bare and largely filled by piles of debris from the floors above. Sketch plans, reconstructing some lost elements, have been made on the basis of observations from various windows and doors (Figure 4).
