17 South Bailey Durham Co Durham

archaeological building recording

report 4643 December 2017

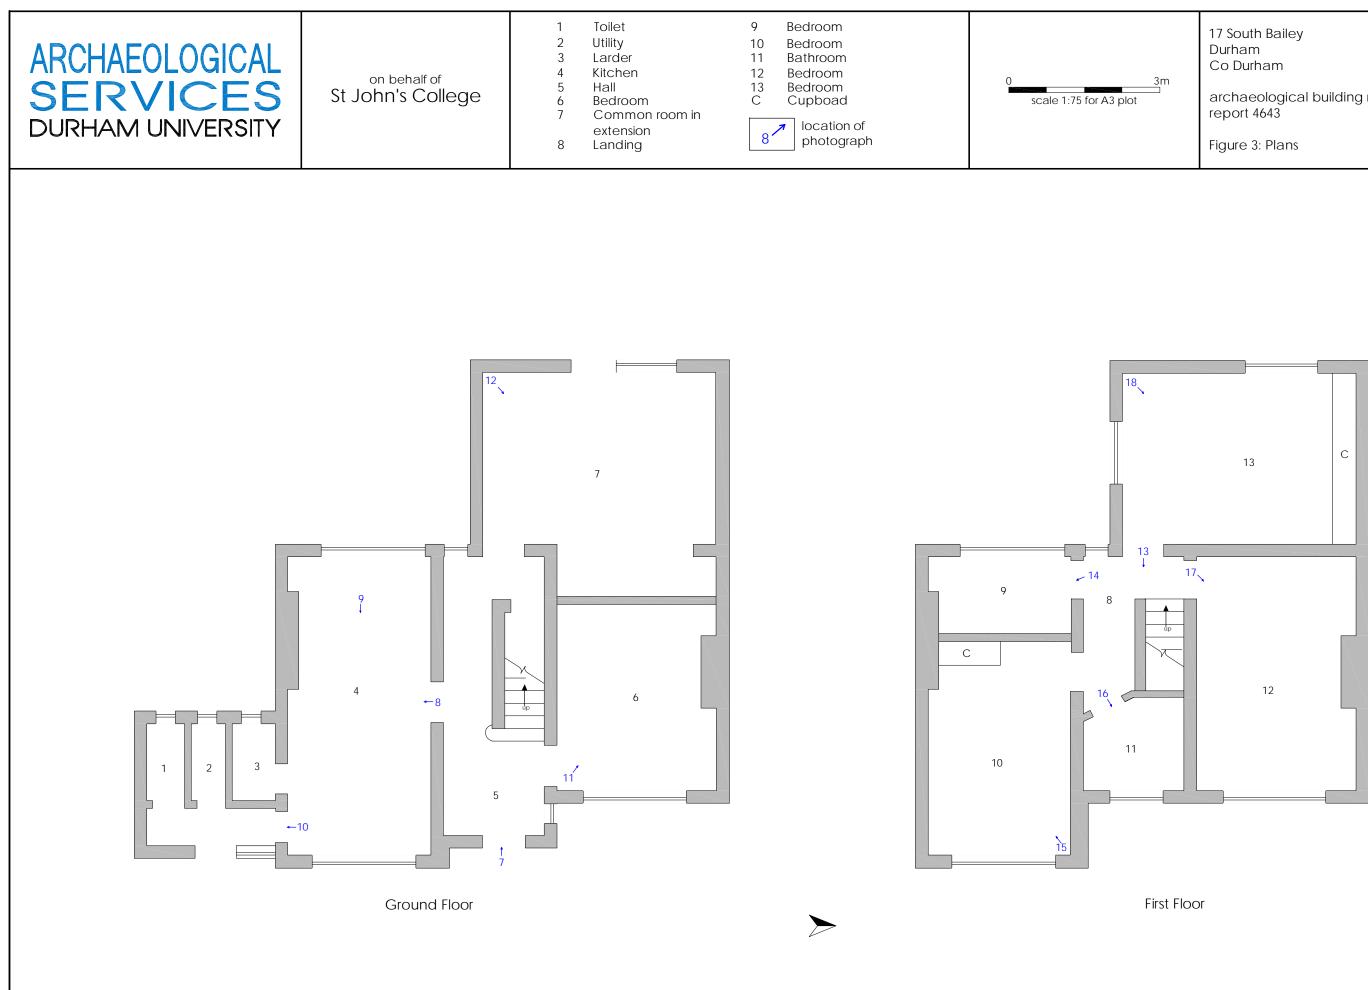
3m 	17 South Bailey Durham Co Durham archaeological building recording report 4643 Figure 3: Plans

- 5.3 The plan of the house is shown in Figure 3. At the front, the slightly later porch opens into a central hall [5] with the staircase on the right-hand side (Photograph 7). To the left, the kitchen [4] extends across the full depth of the building. It contains modern fixtures and the old fireplaces have been closed up (Photographs 8 & 9). The small shed at the south (Photograph 10) contains three small rooms; a toilet [1] at the south, a utility room [2] in the centre and a store [3], formerly a larder, at the east end. Rooms 1 and 2 probably once opened into the yard outside; the present corridor consists of a brick stub wall and a light construction made of two modern glazed front doors. The northern of the three rooms, the old larder, has a separate door from the kitchen.
