ARCHAEOLOGICAL
SERVICES
DURHAM UNIVERSITY

Church of St John the Evangelist
Rookhope
County Durham

archaeological building recording

report 4898
November 2018

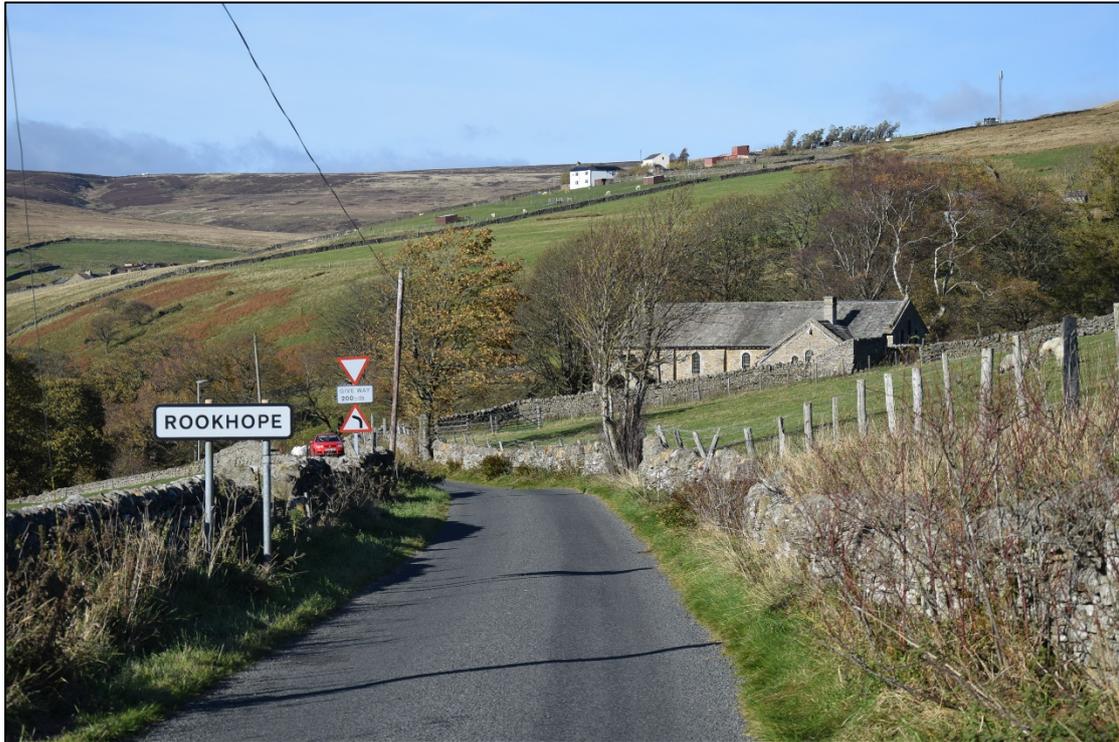
Photograph 1: A view of St John's church and its setting, as seen from the south. The lane descends to the main road at the bottom of the valley

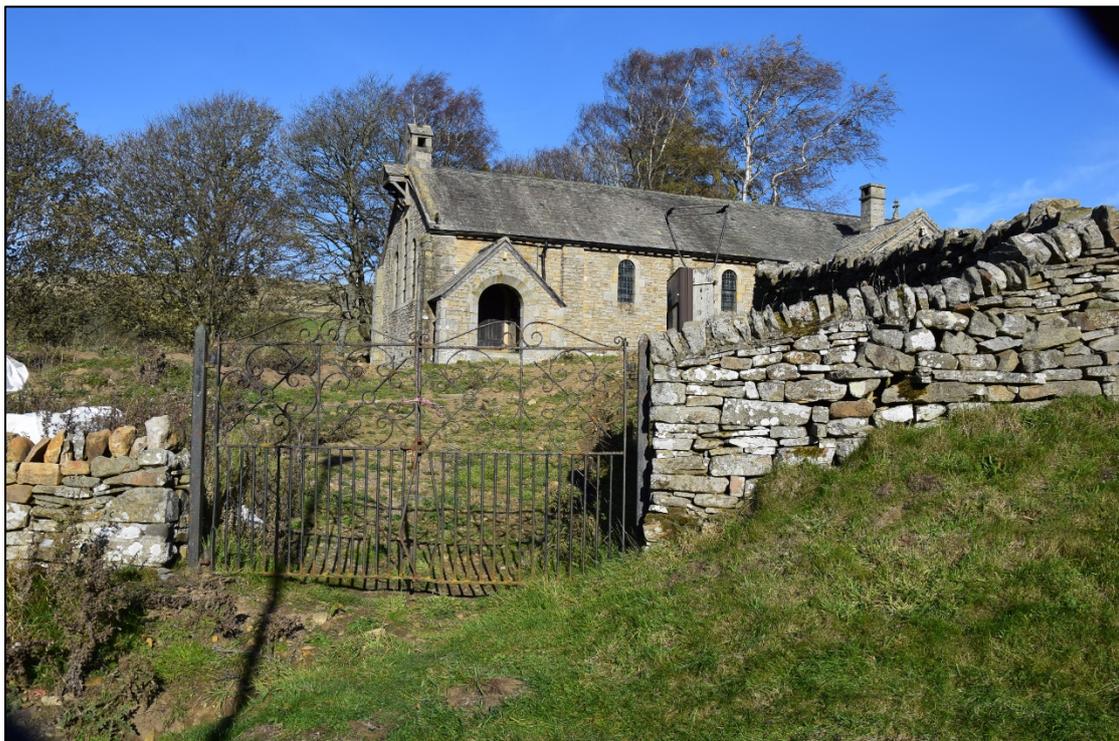
Photograph 2: The church gate, the porch and the rough grass of the churchyard, seen from the lane to the south-west

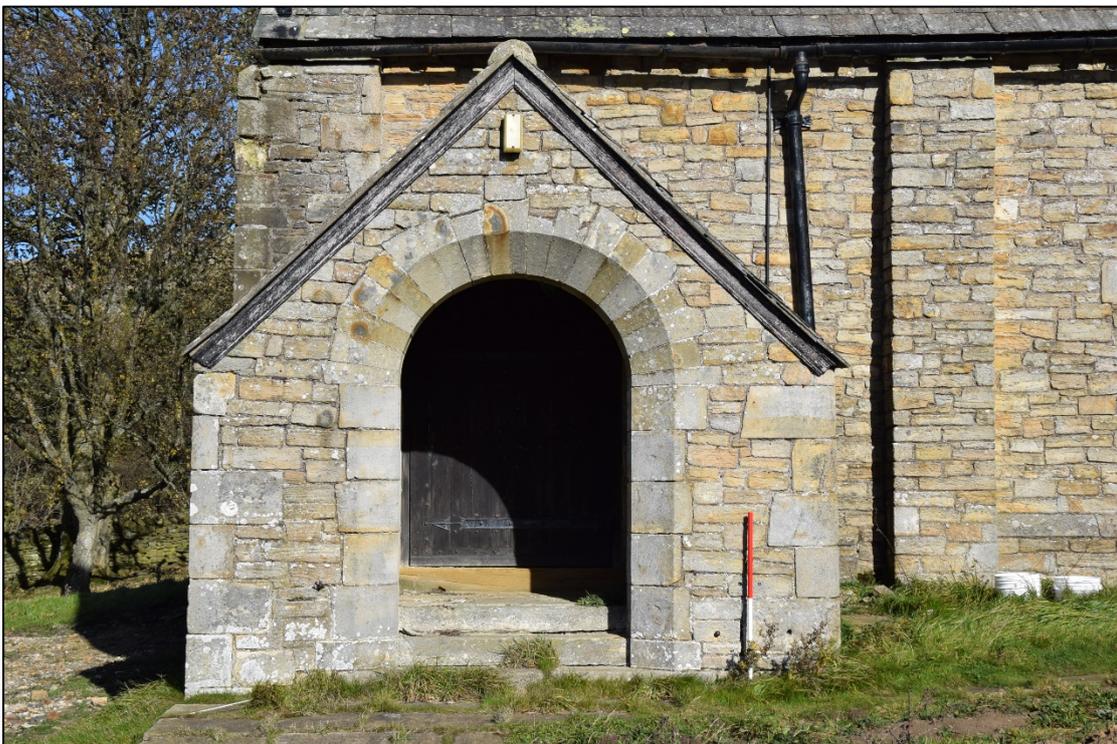
Photograph 4: The porch, with some sloping stone paving outside it. The scale is 1m long

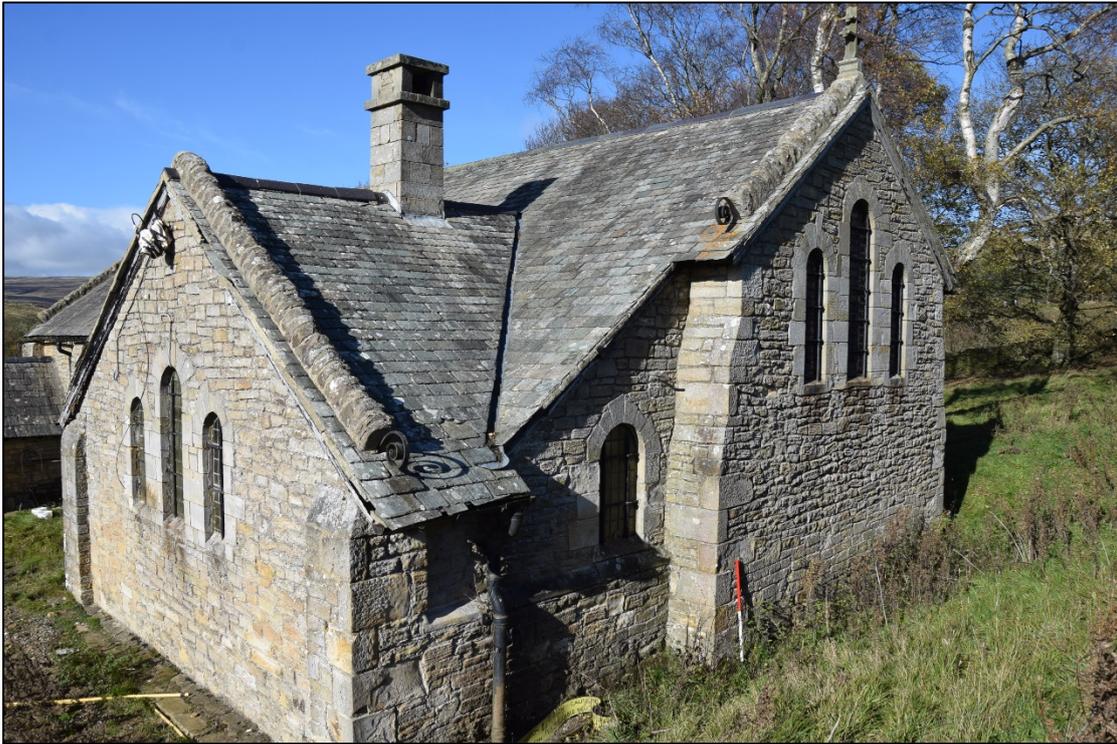
- 5.4 The east end of the church is cut into the slope and has a triple window set high in the gable (Photograph 9). There are chamfered offsets at the south side, where the vestry wall is slightly set back, and on the opposite corner. The stone coping of the gable is formed of a row of rounded roughly-dressed stones, set directly on the slates. The conscious rusticity of this feature is slightly undermined by the use of spiral iron brackets in the place of kneelers (Photograph 10).

Photograph 9: The east end of the church is cut into the slope. The chimney served a stove in the vestry

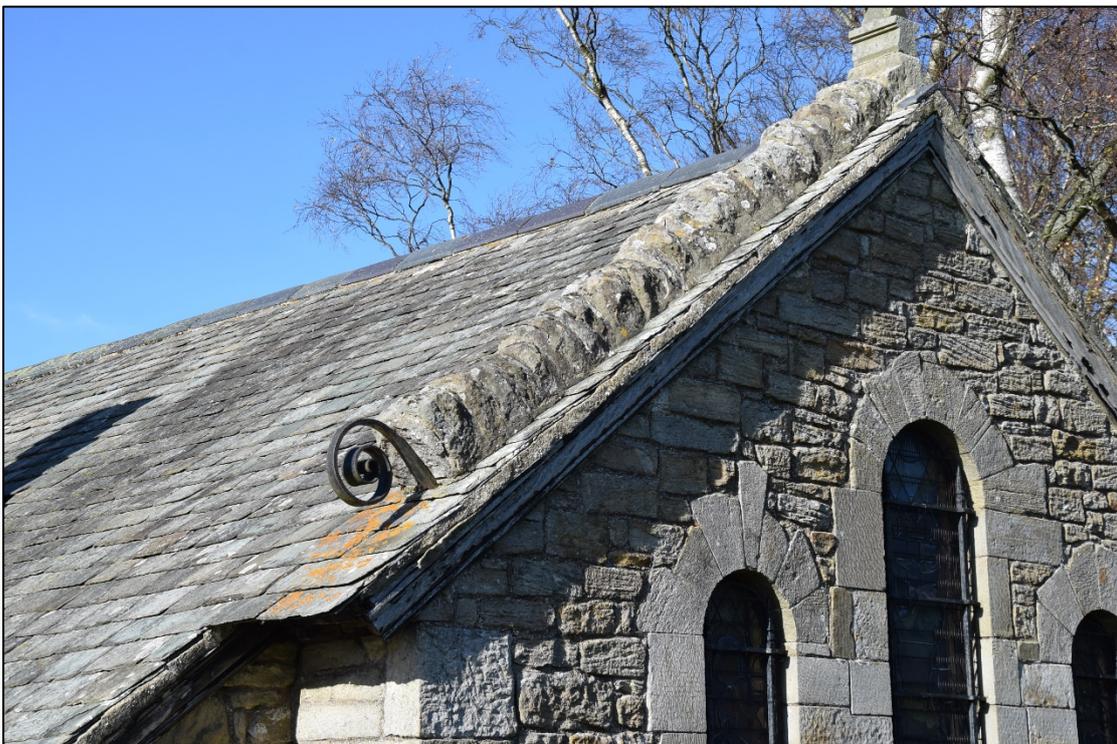
Photograph 10: Detail of the rustic coping on the east gable. Note the random lengths of the dressed quoins in the three-light east window

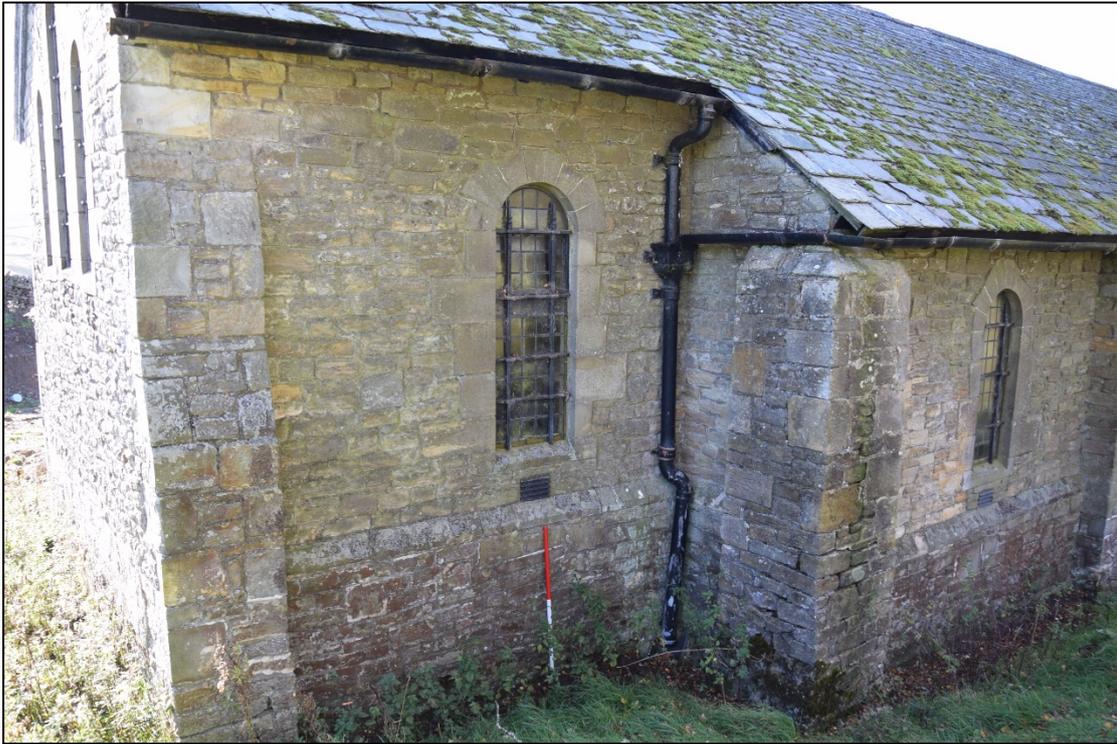
- 5.5 The north face is fairly plain. The chancel window is higher than those of the nave (Photograph 11); below it, as below the others, there is an iron louvre embossed 'COWELL'S VENTILATOR, BLACKBURN' (Photograph 12). As on the south face, the plinth steps down to follow the natural slope (Photograph 13), and the windows have plain dressed masonry and iron bars supporting clear leaded lights (Photograph 14). At the west end is a sunken heating chamber with a concrete slab roof. This is secured by a steel door and was not accessible for this survey (Photograph 15). It is assumed that a boiler here was vented by means of a flue in the west wall of the church, but this could not be confirmed.

Photograph 11: The north window of the chancel, seen from the natural ground level north-east of the church

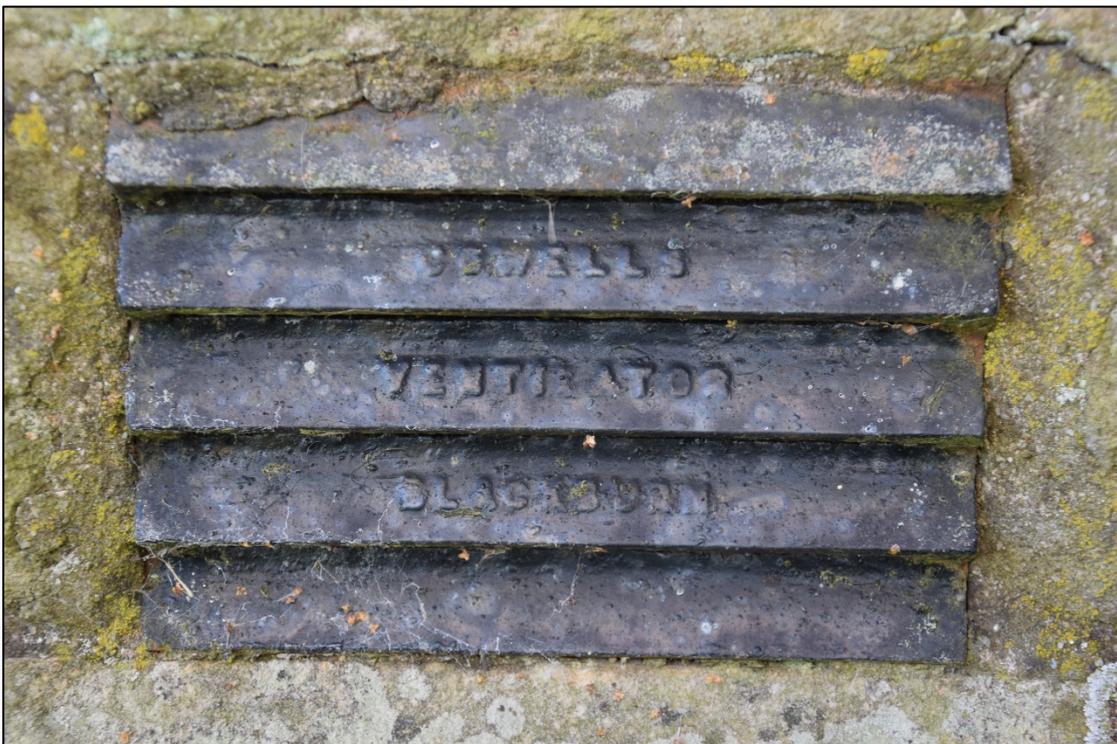
Photograph 12: One of the iron ventilators fitted below the windows

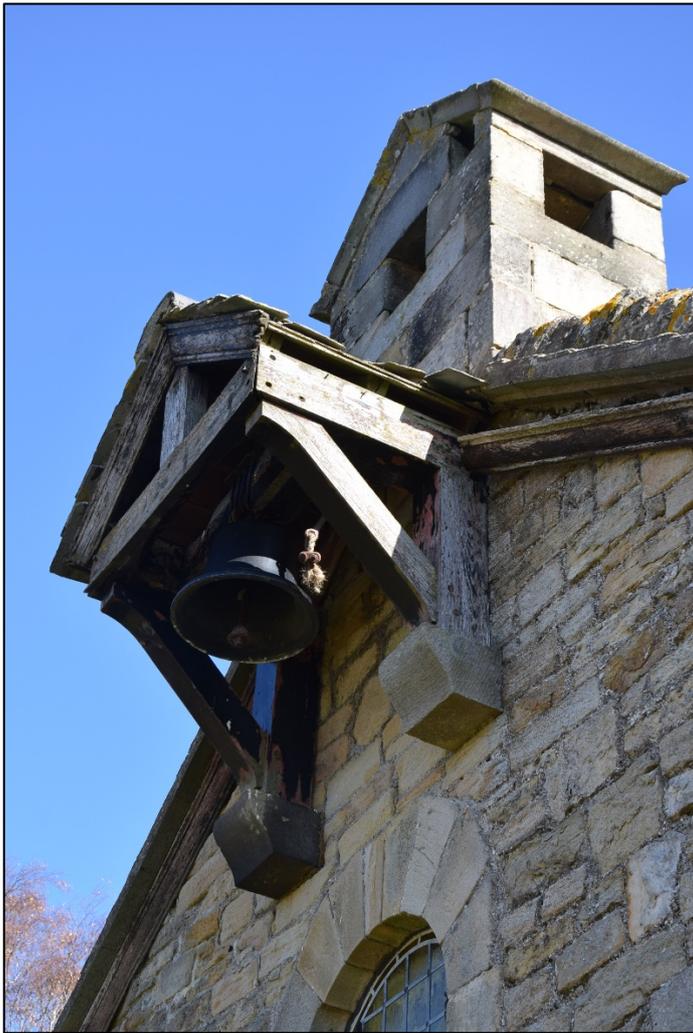
Photograph 17 (left): The ventilator on the west gable, with the bell cote below it

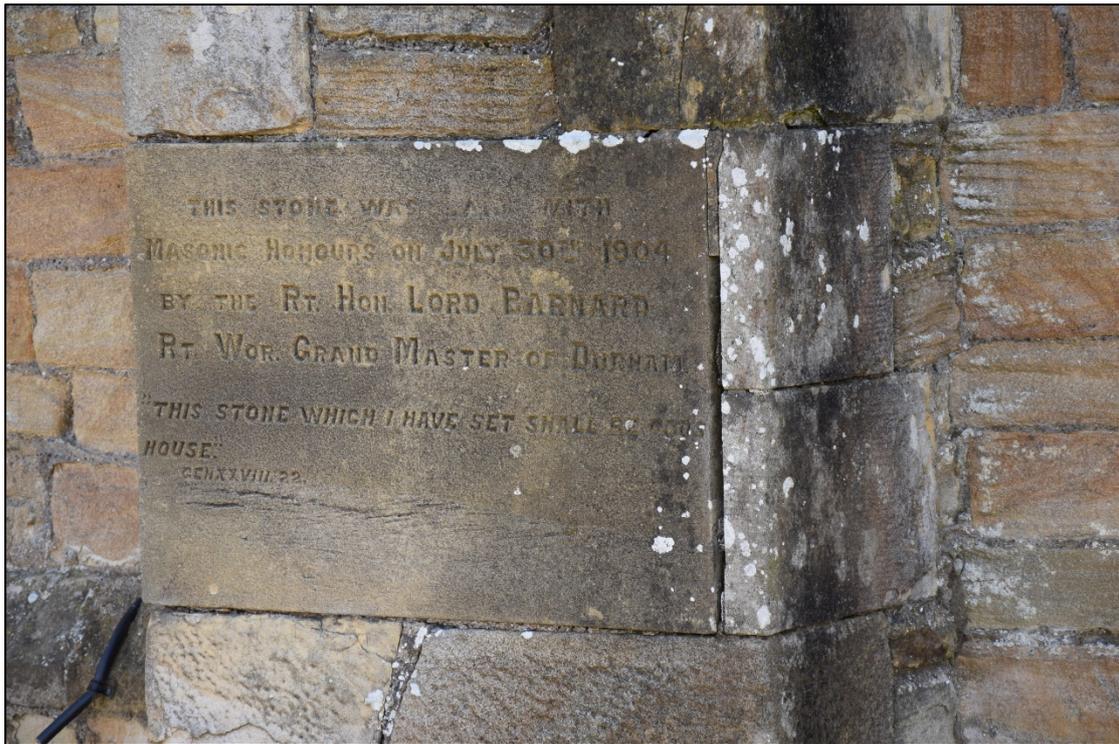
Photograph 19: The foundation stone and the fillets of masonry that make it fit the width of the clasping buttress

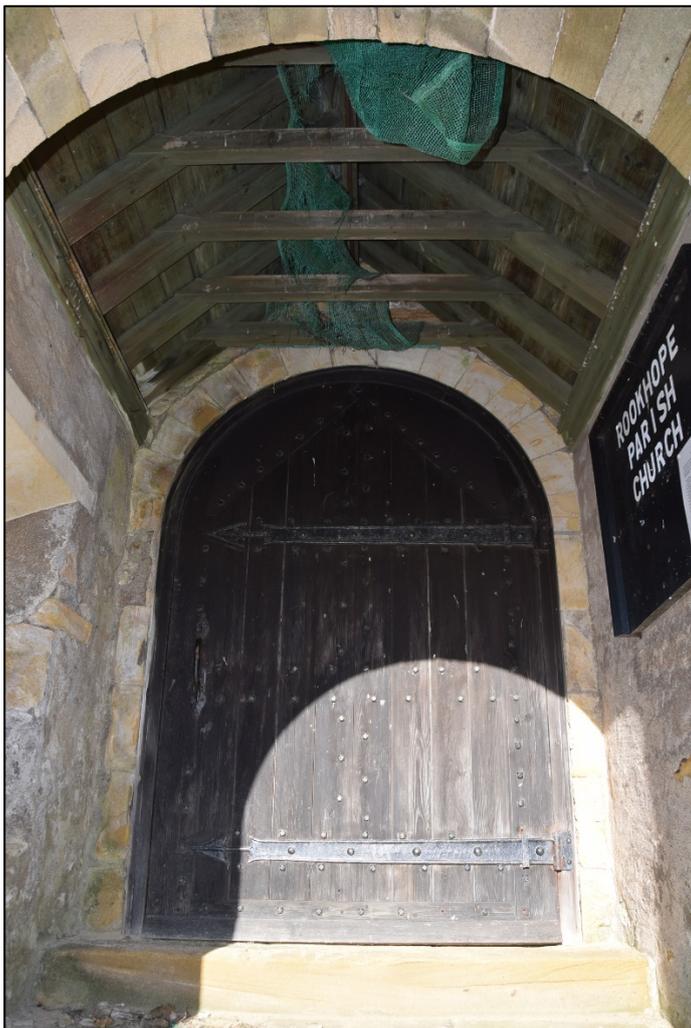
- 5.7 The porch roof has open trusses and the west window and the chamfered door jambs are quite plain (Photograph 20). The heavy plank door has decorative furniture in a rustic style that matches that of the fabric; there are long strap hinges with arrow terminals (Photograph 21).

Photograph 20: A view looking up into the porch

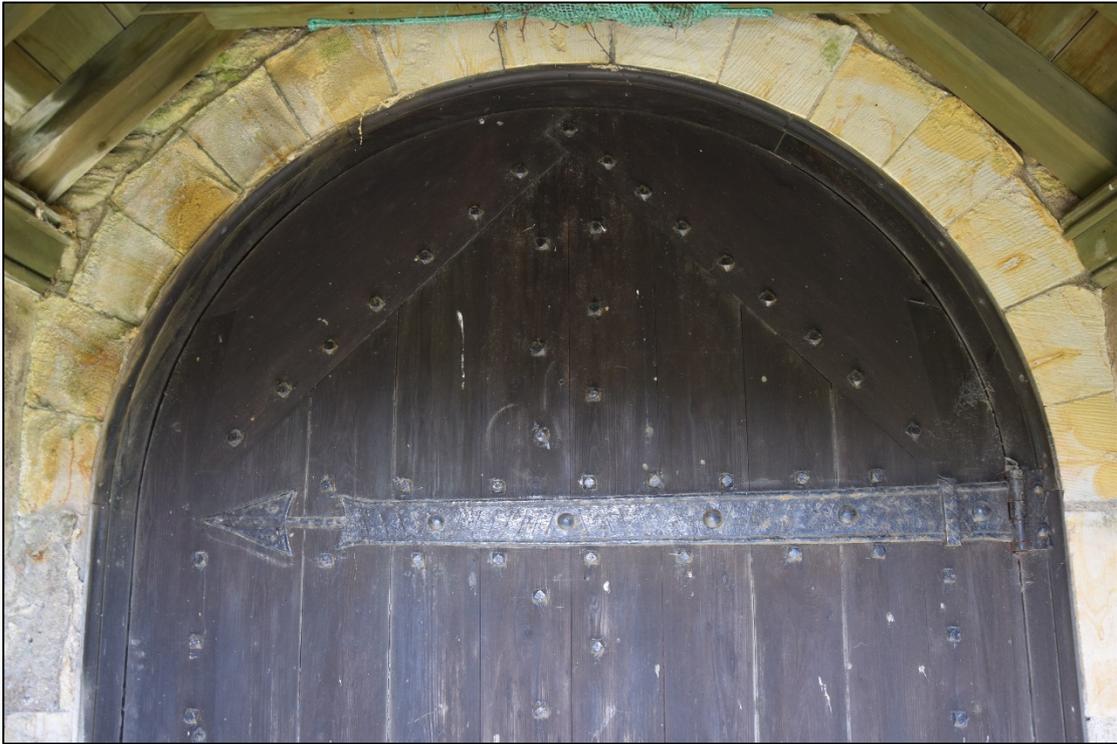
Photograph 21: Detail of the decorative hinge and nailing on the church door

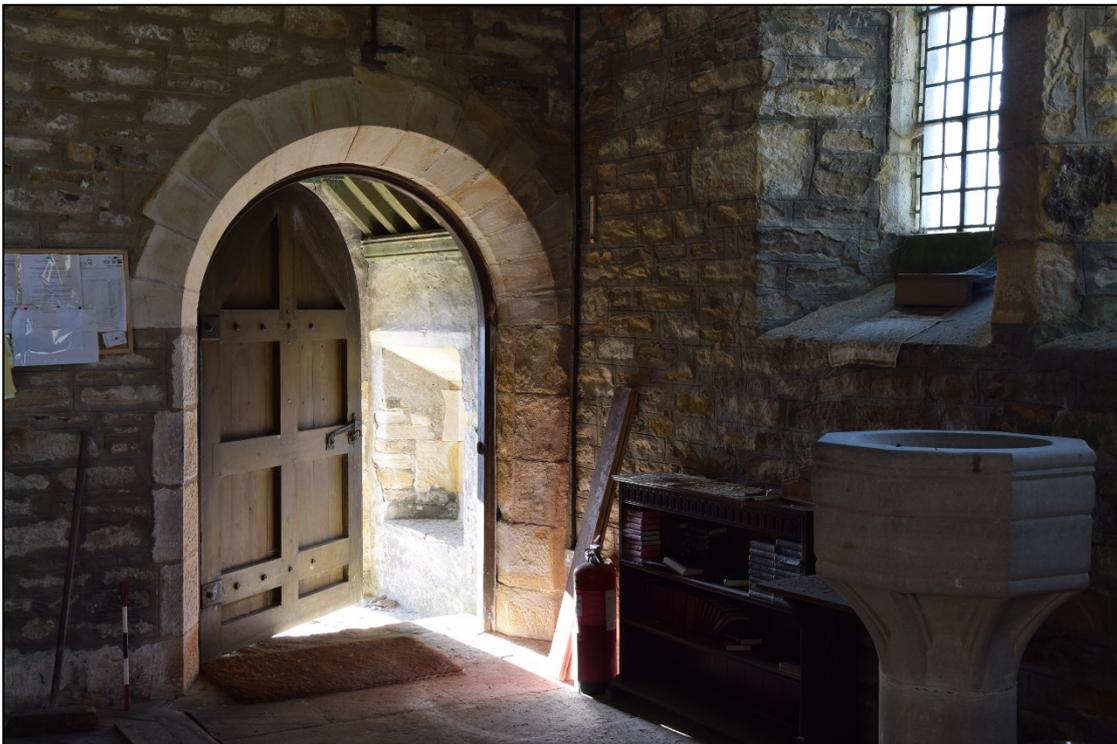
- 5.8 The simplicity of the porch is matched inside, where the church door has a deeply-chamfered round arch (Photograph 22). The internal walls have exposed rubble masonry and the dressed stone of the chancel arch, organ chamber and window heads stands out (Photograph 23). There is no sign of heating pipes on the nave walls, but modern gas-fired heaters are present. Each wall has three splayed windows with ventilation grilles in their sills (Photographs 24, 25). Below the three-light west window is the font (Photographs 26, 27). The masonry has suffered from damp which has caused spalling of parts of the face. The 'harsh repointing' mentioned by Carøe's biographer (paragraph 4.8, above) seems to have contributed to this damage; it is a dark grey mortar, scored with trowel lines that crudely define individual stones (Photograph 28).

Photograph 22: The simply chamfered entrance and heavy door, seen from the nave. The scale is 0.5m long

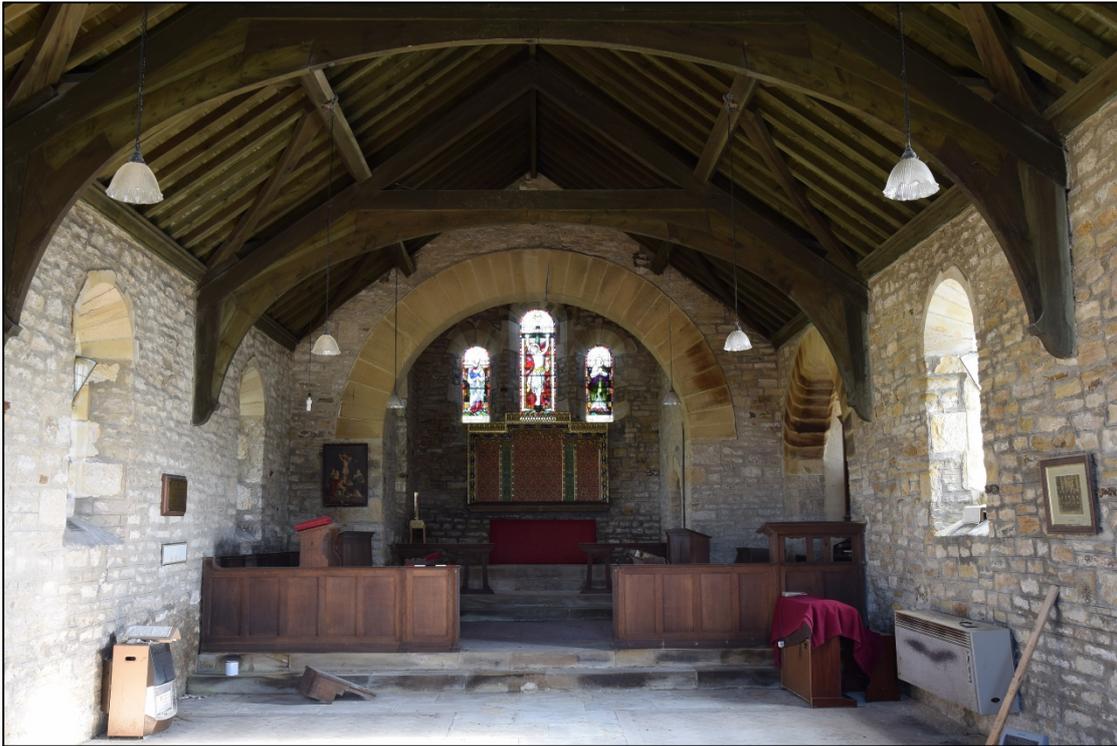
Photograph 23: A view looking east from the west end of the church. The wide chancel arch has no chamfers

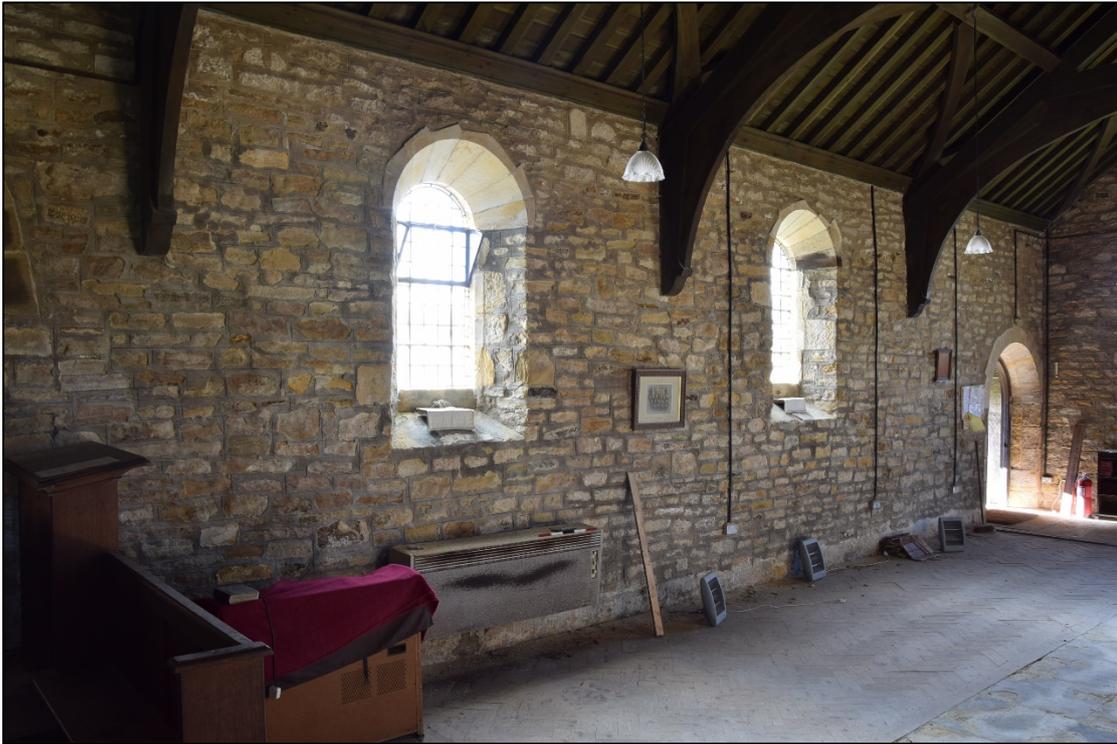
Photograph 25: The south wall of the nave, with one of the modern gas heaters

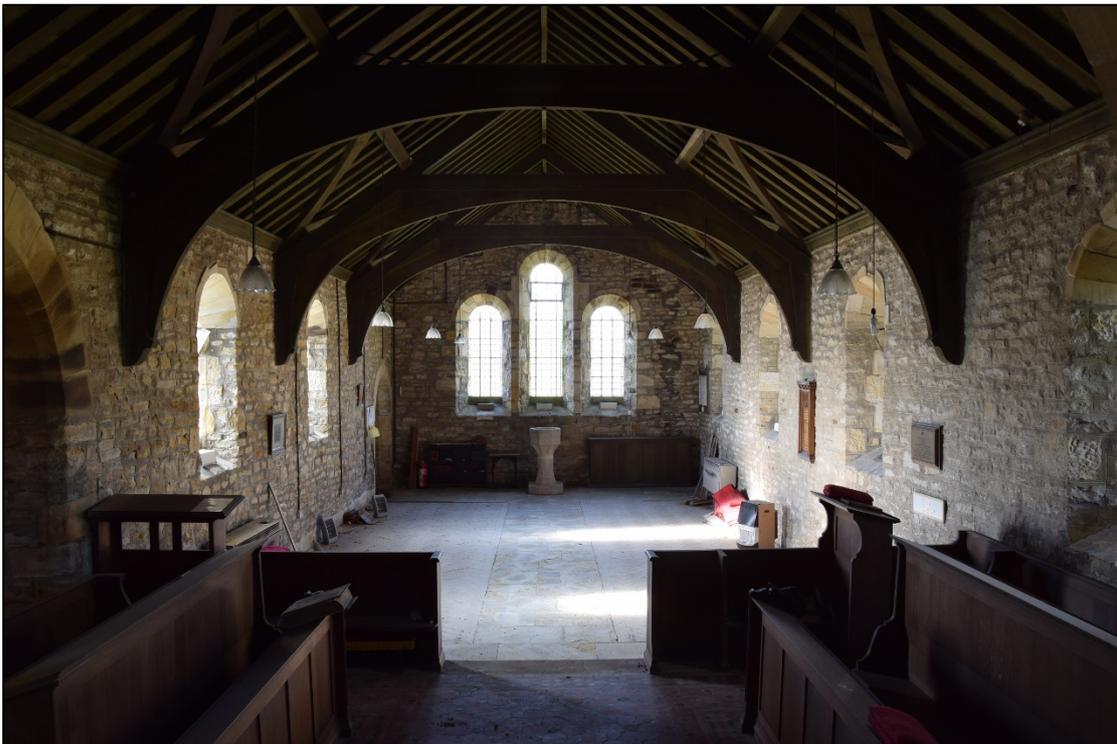
Photograph 26: The church seen from the east end. The stone flags at the centre of the nave are flanked by parquet where the pews stood

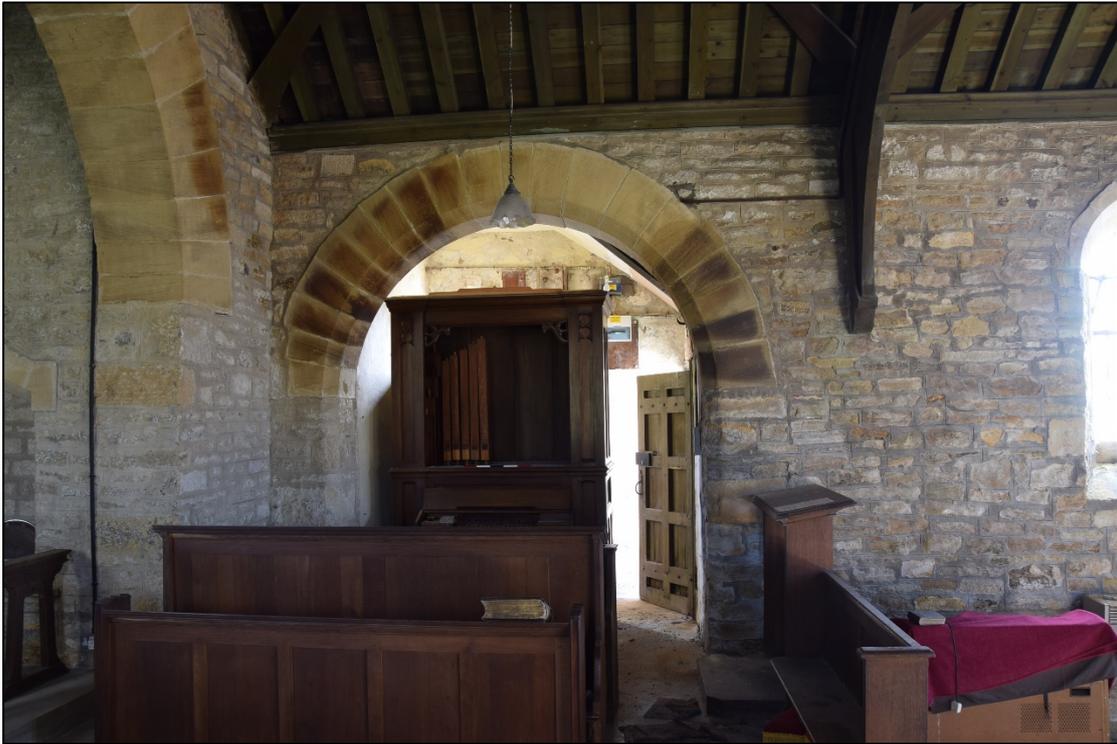
- 5.9 The choir is a step above the floor of the nave. It retains its fixed seats and screen; on the south side is the round arch of the organ chamber (Photograph 29). This has a splay that is continued in the rubble wall below the dressed voussoirs. Another step leads to the chancel, with an oak communion rail and two steps to the altar plinth (Photograph 30). The three-light east window is slightly obscured by a reredos. There is a single light in the north wall and a low stepped sedilia niche in the south. The fixed oak stalls of the choir (Photograph 31) are part of the original Carøe design but the Vestry Meeting minutes show that the tiled floors in the east end are later additions (Photograph 32, 33). The Arts and Crafts-style oak altar rails - the Laudian screen mentioned by Surtees - are also Carøe's work (Photograph 34). There is no obvious evidence that they were moved from their original positions, as was proposed in 1909.

Photograph 29: The south side of the choir, with the arch to the organ chamber and vestry

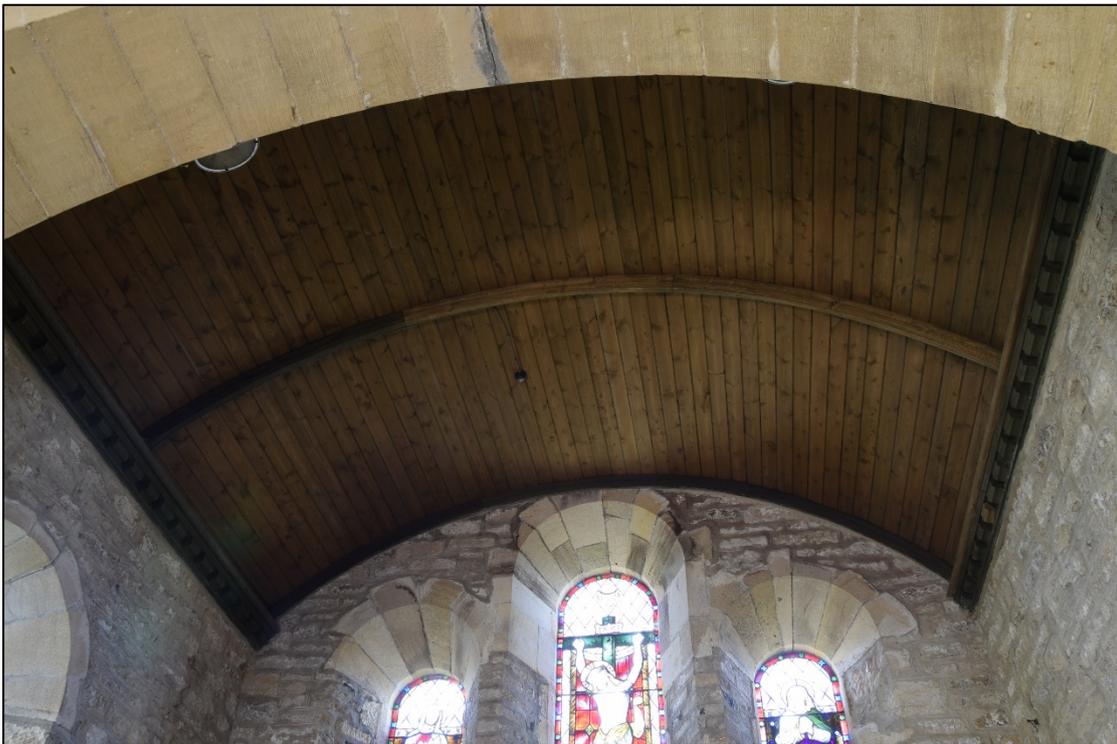
- 5.10 The close-boarded roof over nave and choir has three open trusses with arch-braced collar beams and wind braces below a single purlin on each side (Photograph 35). The principal rafters are set into the heads of the walls and the braces run down to moulded ends without corbels. By contrast, the chancel has a boarded wagon roof

with a single moulded transverse rib (Photograph 36). The roof springs from decorative longitudinal timbers with moulded billets.

Photograph 36: The wagon roof over the chancel

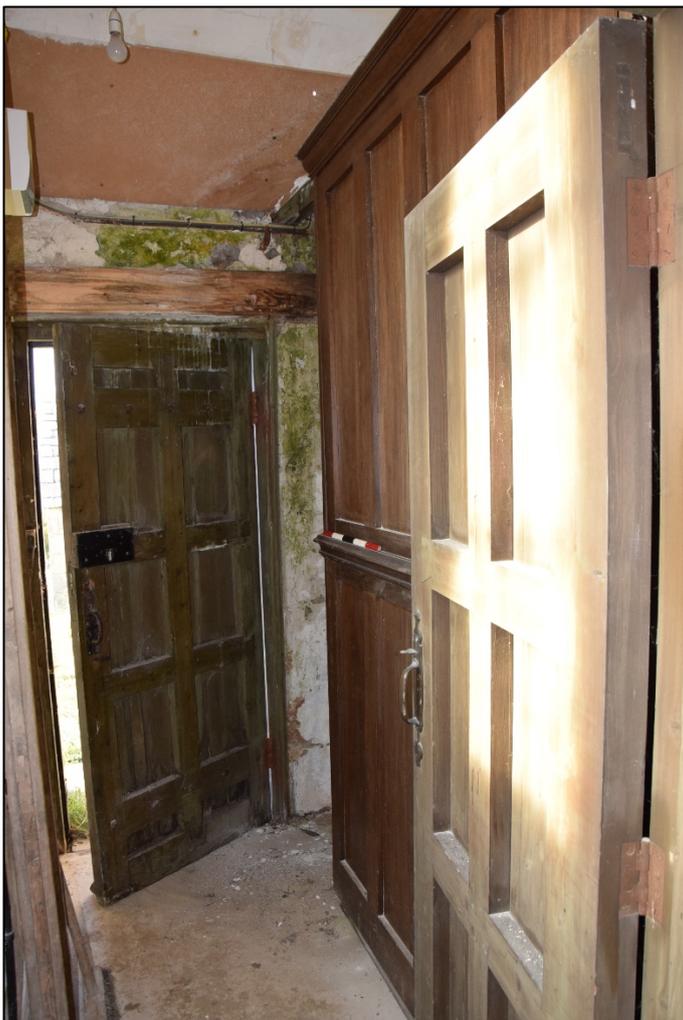
- 5.11 On the south side of the choir, the organ and its bench are still in place, but most of the pipes have been removed (Photograph 37). Behind the instrument is the passage to the vestry. The external and internal doors show the same style of simple heavy joinery seen in the main church door, very typical of the Arts and Crafts movement (Photograph 38).

Photograph 38 (left): A view looking west from the vestry. Note the simple heavy joinery of the two doors

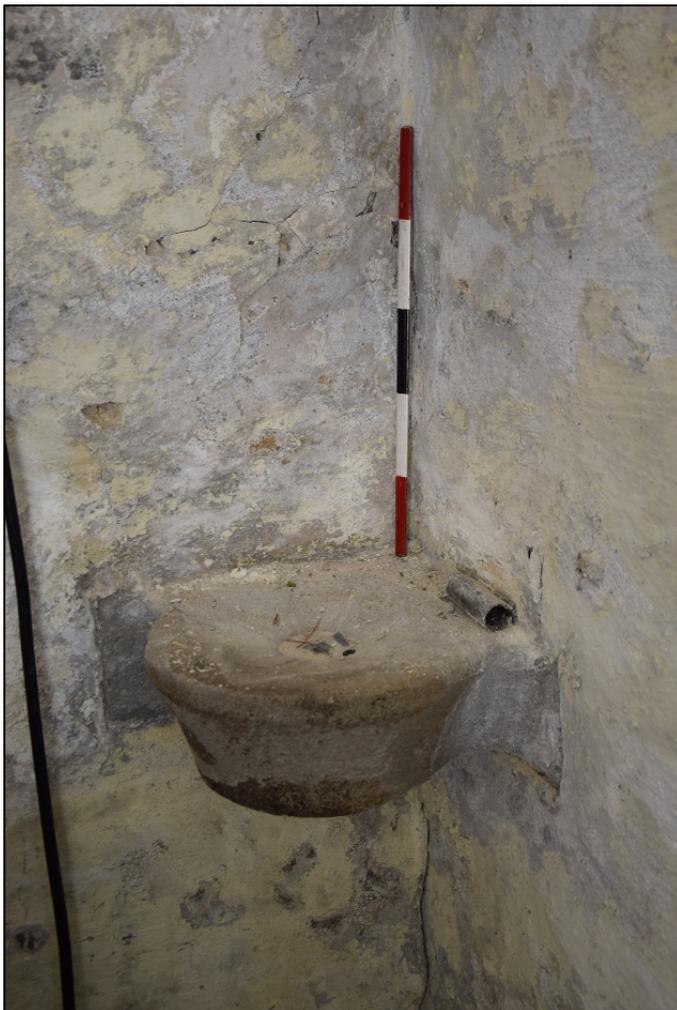
- 5.12 The vestry is plastered and whitewashed and its walls are badly affected by damp (Photograph 39). A modern excavation for services has been cut against the east wall. In the south-east corner there is a small round piscina with a drain (Photograph 40). Traditionally, the water from the piscina would be led into the ground rather than being led to a sewer. No obvious outlet for the small drain here was seen. There is a fitted cabinet with numbered hooks for choir surplices in a niche on the north wall (Photograph 41); an angled wall beside the door has the traces of the coke stove that formerly stood here (Photograph 42).

Photograph 39 (above): The east wall of the vestry, showing a recent hole for cable ducts and the damp-affected plasterwork

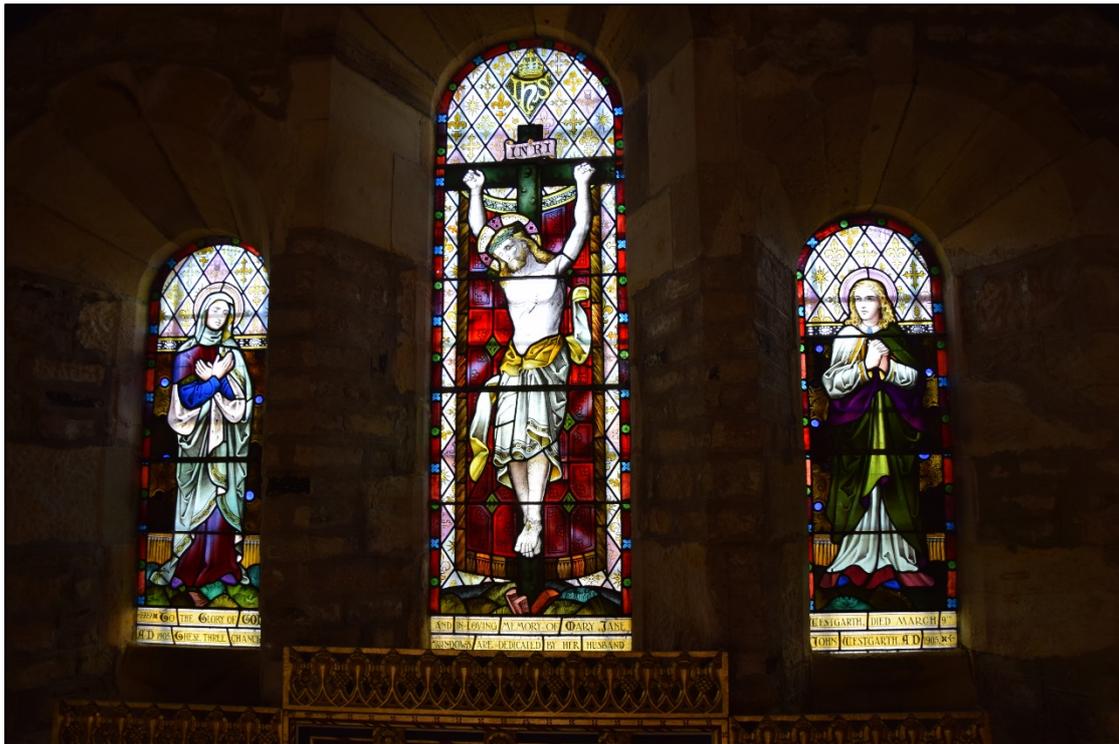
- 5.13 The east window is the only one in the church with stained glass. It shows the Crucifixion flanked on the left by the Virgin and on the right by St John (Photograph 43). An inscription at the base reads 'TO THE GLORY OF GOD AND IN LOVING MEMORY OF JANE WESTGARTH, DIED MARCH 9TH 1905, THESE THREE CHANCEL WINDOWS ARE DEDICATED BY HER HUSBAND JOHN WESTGARTH. AD 1905' (Photographs 44-46). The carved and painted oak reredos below the window has a small plaque reading 'ERECTED BY THE WOMENS HELP SOCIETY / IN MEMORY OF / REV. H. W. FORBES, M.A. VICAR 1915-19' (Photograph 47). On the north wall of the nave, close to the choir step, is a brass plaque in memory of Ethel Whitehead (Photograph 48). Near the middle of the north wall is an oak panel commemorating twelve men of the parish who died in the First World War (Photographs 49, 50). At the west end, near the font, is a large monument of black and white marble that was transferred from the old church. This commemorates Ann Featherston (*sic*), who died at Gateshead in 1834 (Photograph 51). On the south wall, a small wooden plaque by the door lists the Vicars of Rookhope (Photograph 52). This reads 'Vicars of Rookhope. Augustus Davies, 1866-1872: Clement Francis Cobb, 1872-1873: Richard Waters, 1873-1877: John Wagstaff, 1877-1883: James Johnson, 1883-1885: James Philip Shepperd, 1885-1891: William Robert Hartley, 1892-1902: Joseph Baker, 1902-1912: George R Christie, 1912-1915: Henry Warren Forbes, 1915-1919: Arthur White Officer, 1919-1972. Priests-in-Charge. John Kenneth Young, 1972-1973: Andrew J Bealing, 1973-1985'.

Photograph 43: The east window
