ARCHAEOLOGICAL
SERVICES
DURHAM UNIVERSITY

Mount Pleasant Farm
Darlington
archaeological building recording

report 5030
April 2019

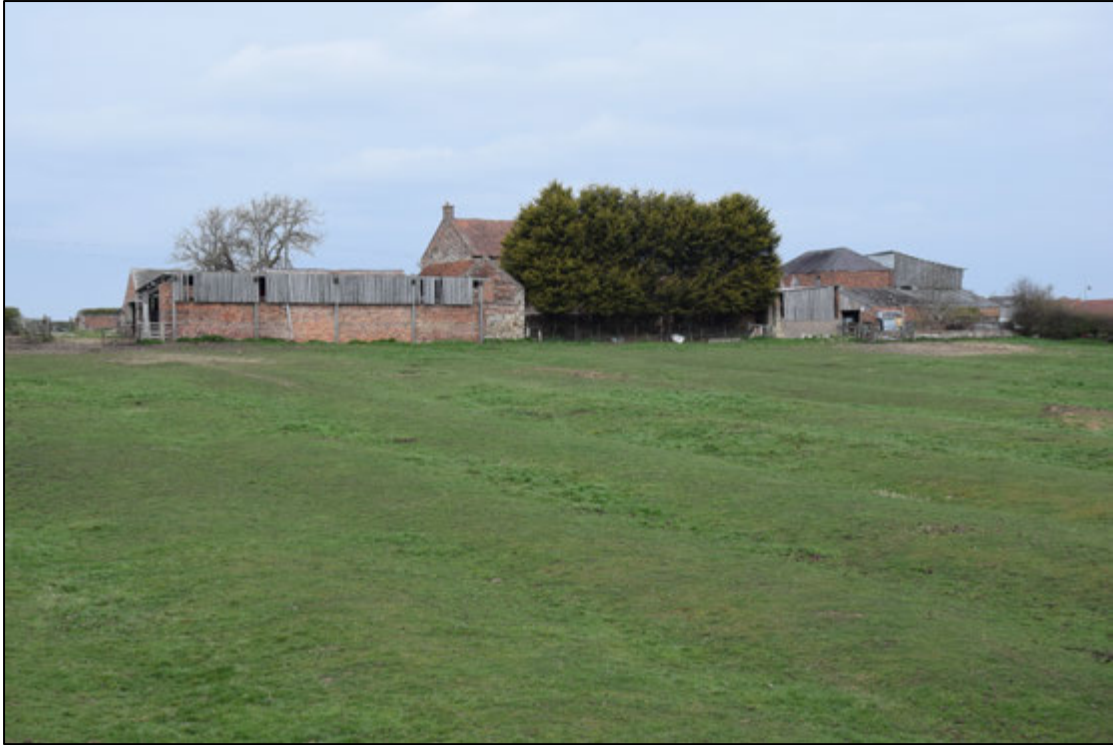
- 5.1 The steading stands at the top of a field of well-preserved ridge and furrow that slopes down to the south (Photograph 1). The compact group of old buildings is centred on the house, which is hidden by a row trees filling the gap between the former barn and stable buildings. From the north, the buildings are more clearly visible through what remains of the orchard that is shown on old maps (Photograph 2). When the site was examined, the old yard at the east end was still in use but the former stable building on its west had been substantially altered (Photograph 3). The same was true of the western group of buildings, which showed a mixture of traditional brick construction and pantiled roofs alongside reinforced concrete and corrugated sheets (Photograph 4).

Photograph 1: The Mount Pleasant steading seen from the south-west. The house is screened by conifers at the end of the garden. Note the well-marked ridge and furrow in the field

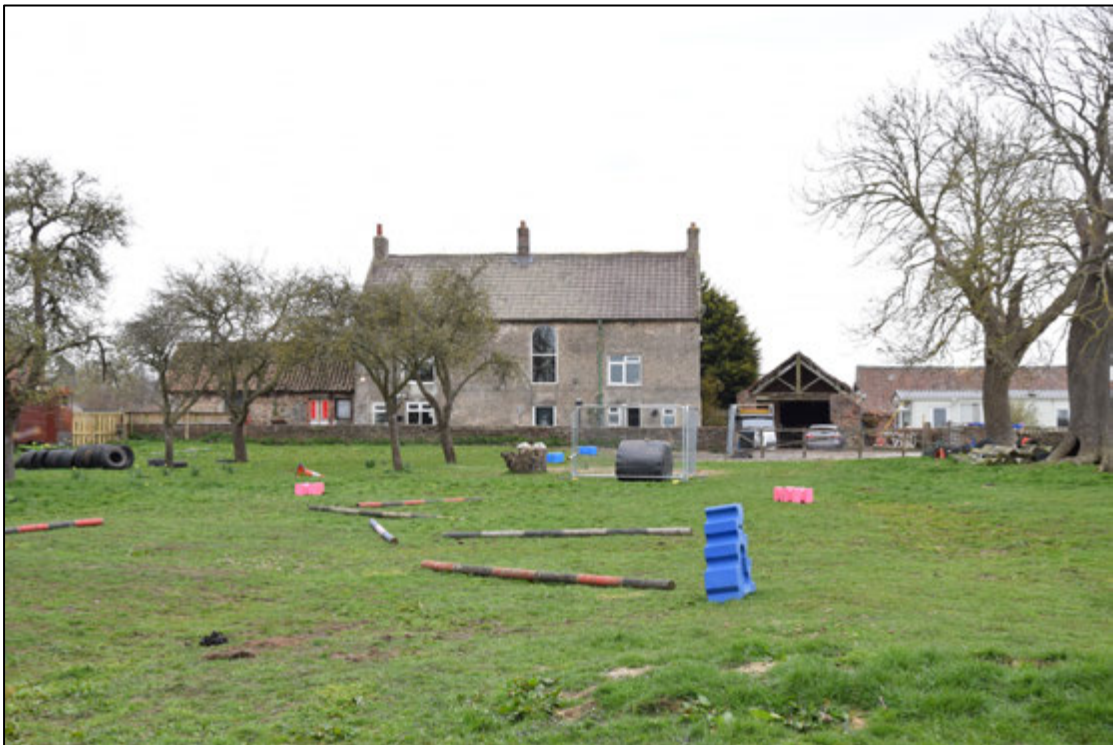
Photograph 2: The buildings seen from the former orchard at the north of the site. The house is flanked by the workshop [B] at the left and the barn [D] at the left

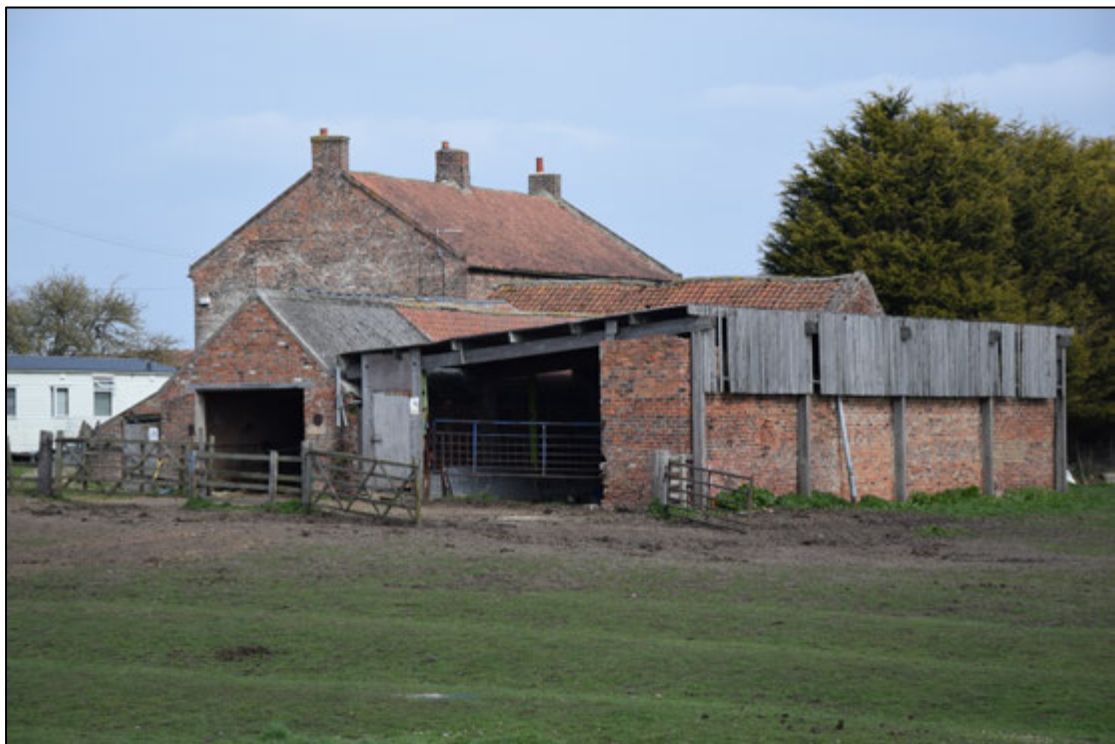
Photograph 4: A view looking north-east, showing the western group of buildings. The wavy ridge-line at the centre is the roof of the old barn [D]

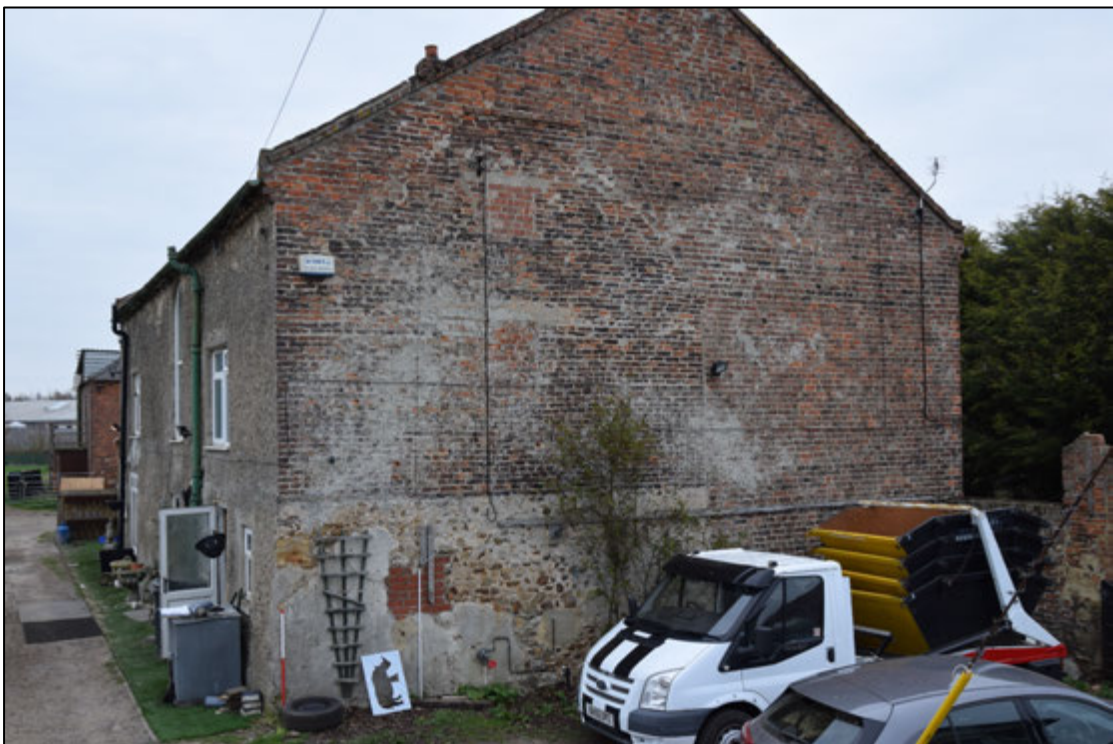
Photograph 8: The west gable. The outline of the older brick house can be seen in the left-hand half of the wall, with rough stone masonry in its lower section

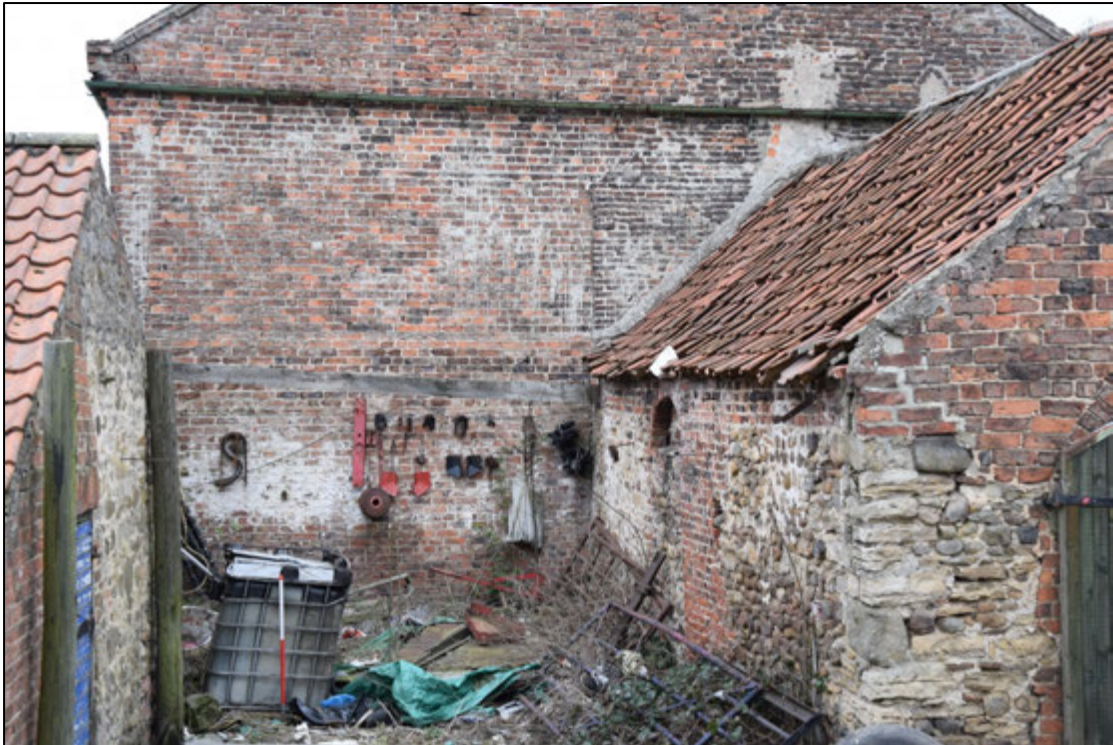
- 5.5 The outline of the old house is equally clear in the east end, though much of this wall is concealed by a single-storey workshop [B]. At the former south-east corner, the old brickwork projects slightly from the face of the later addition (Photograph 9). Unlike the old west end, this gable wall extends to the ridge. It is marked by the scar of a chimney from the lower building B, and, near the north side, a small triangular-headed attic window, now blocked up (Photograph 10). In the lower part of the east wall there is a roof scar from a vanished shed.

Photograph 9: The outline of the old building projects slightly from the east gable, above the roof of the adjoining workshop

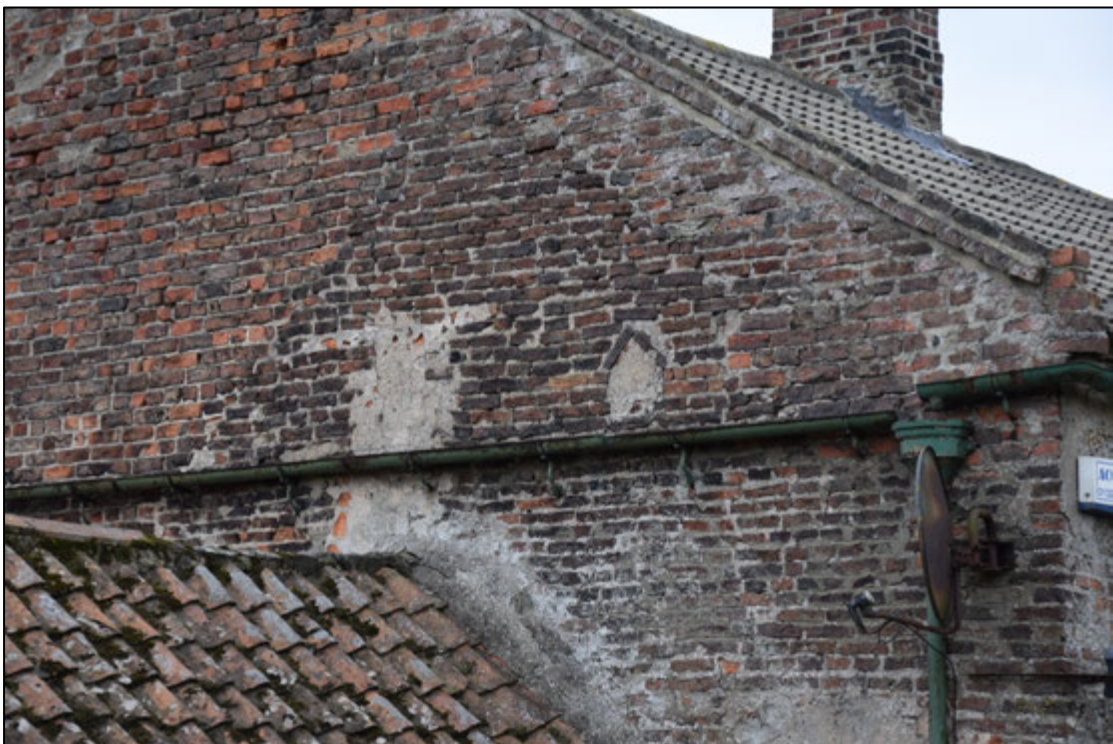
Photograph 10: The old gable visible above the roof of the workshop. Note the scar of a chimney rising from the lower roof, and the small blocked opening with a triangular head to its right

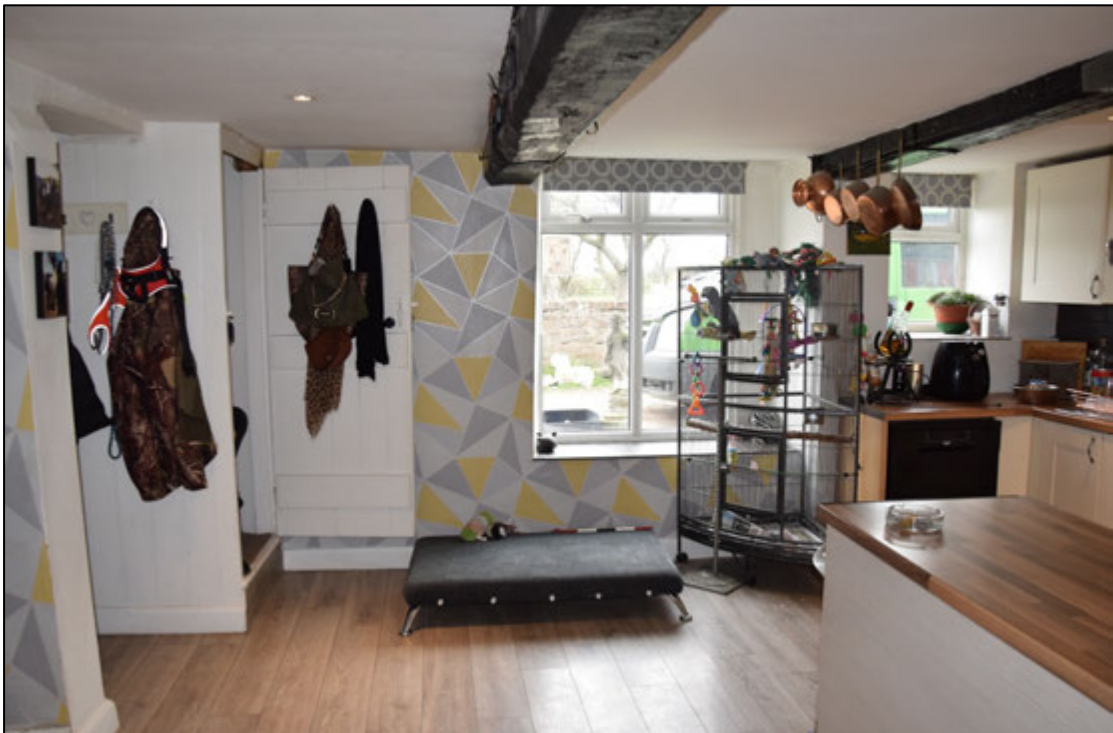
Photograph 12: A view looking north across the kitchen, showing heavy old ceiling beams with hooks, the box stair and the modern windows

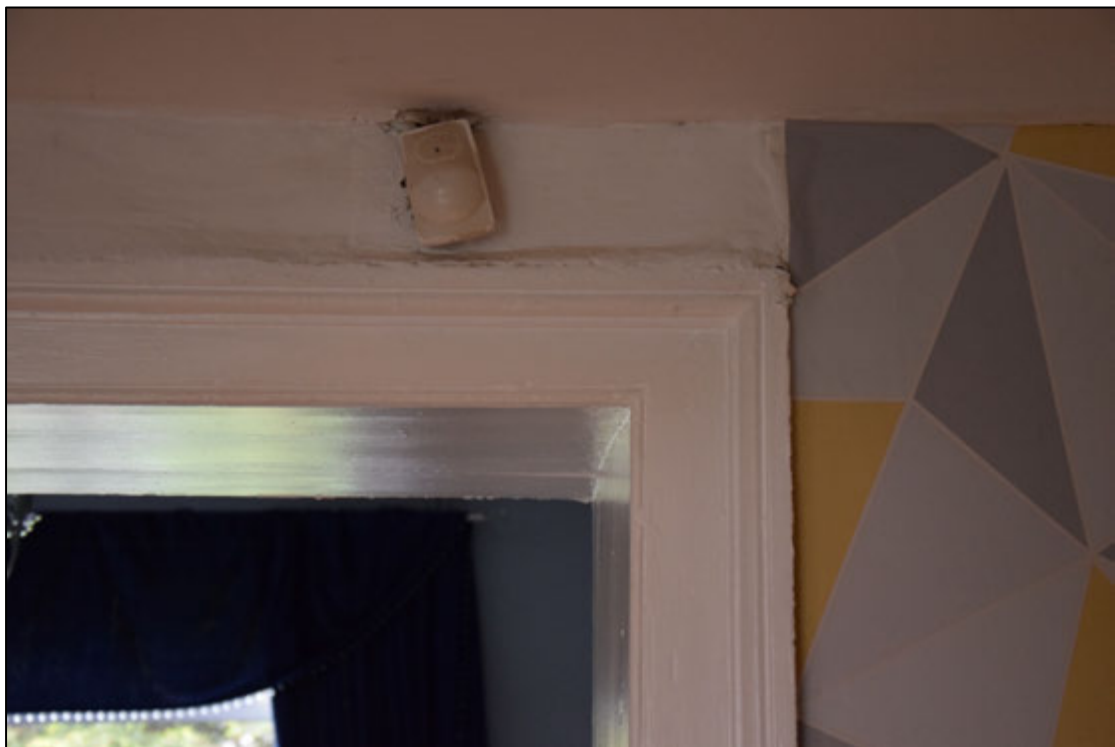
Photograph 14: The architrave on the kitchen side of the door seen in Photo 13

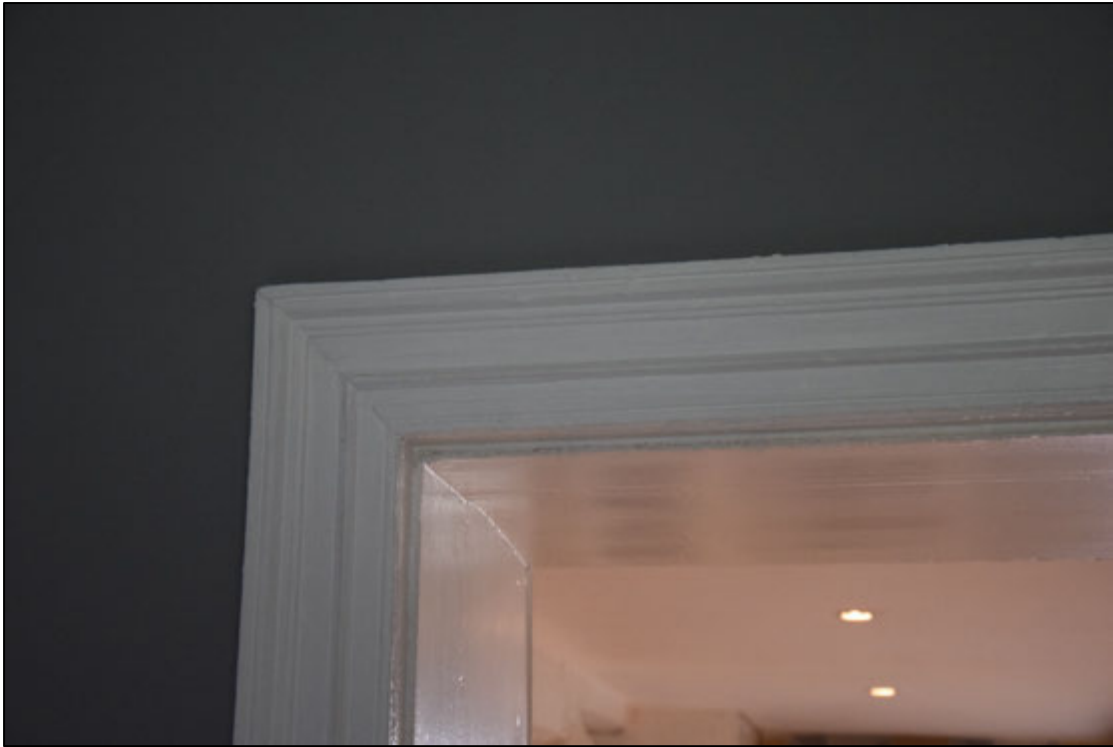
Photograph 15: The architrave on the south side of the same door has a more decorative moulding

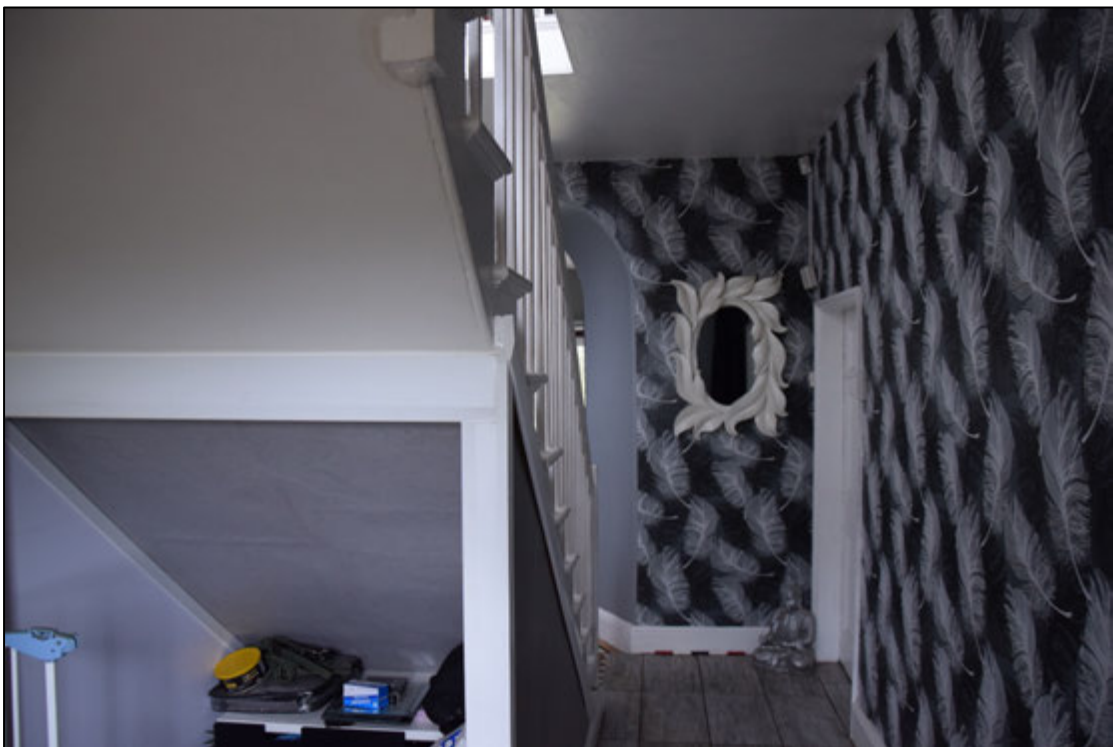
staircase [2] (Photograph 16). Two store rooms [3, 4] east of the hall have old ceiling beams and joists; in the smaller room there are wooden pegs of the kind used for horse gear (Photographs 17, 18). A thin modern partition separates these rooms from a tack room [5] which has its own modern entrance. As in [3], the ceiling beam here has hooks like those seen in the kitchen (Photograph 19).

Photograph 16: 19th-century stairs fill the north end of the former through-passage and the hall occupies part of the room on the low side. A view looking south

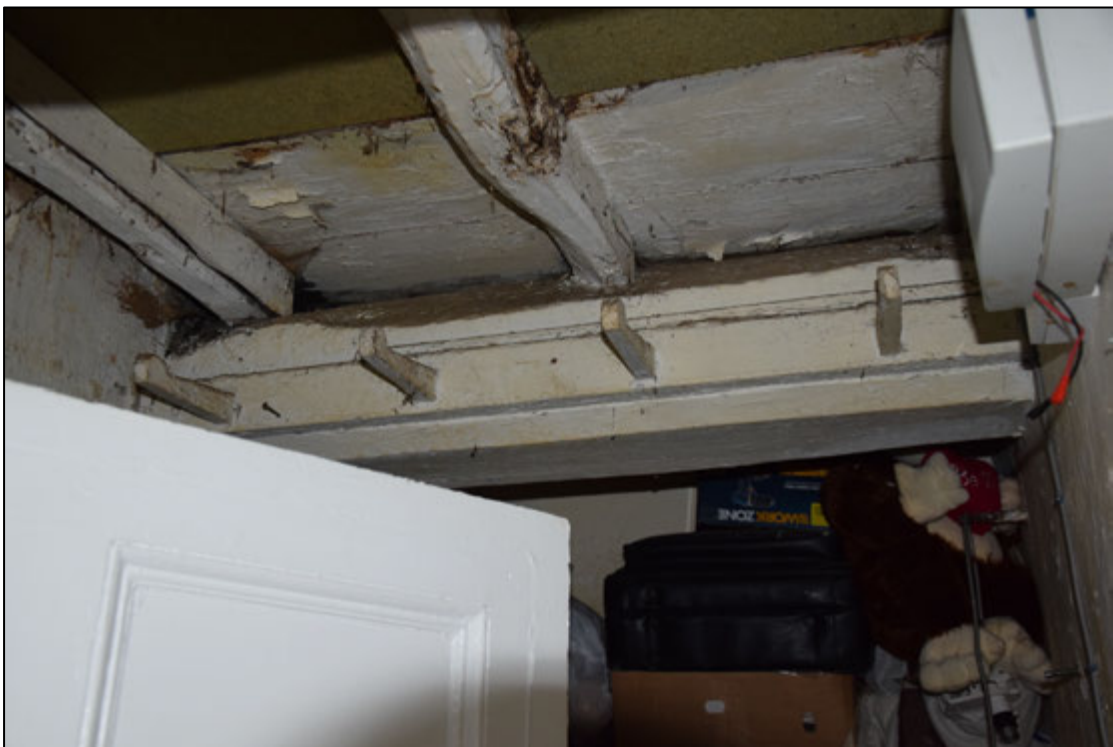
Photograph 18: The beam, joists and wooden hooks in the small store room 4

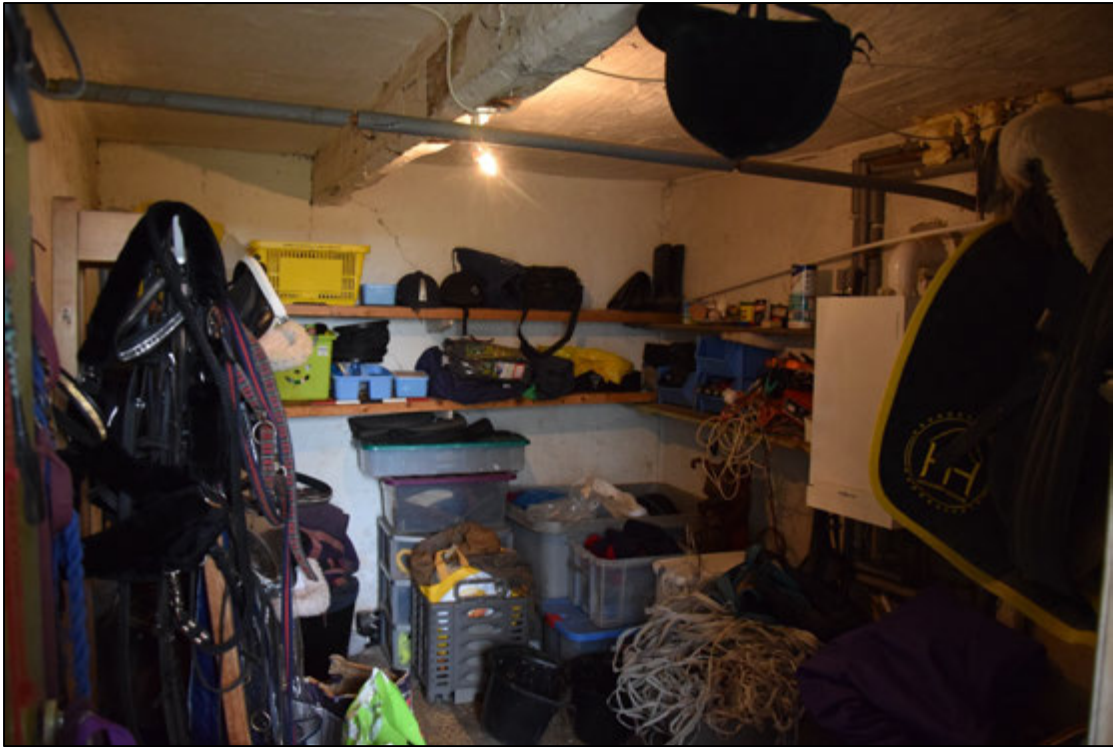
Photograph 19 (above): A similar beam in the tack room 5, at the north-west corner of the house. A view looking south-west

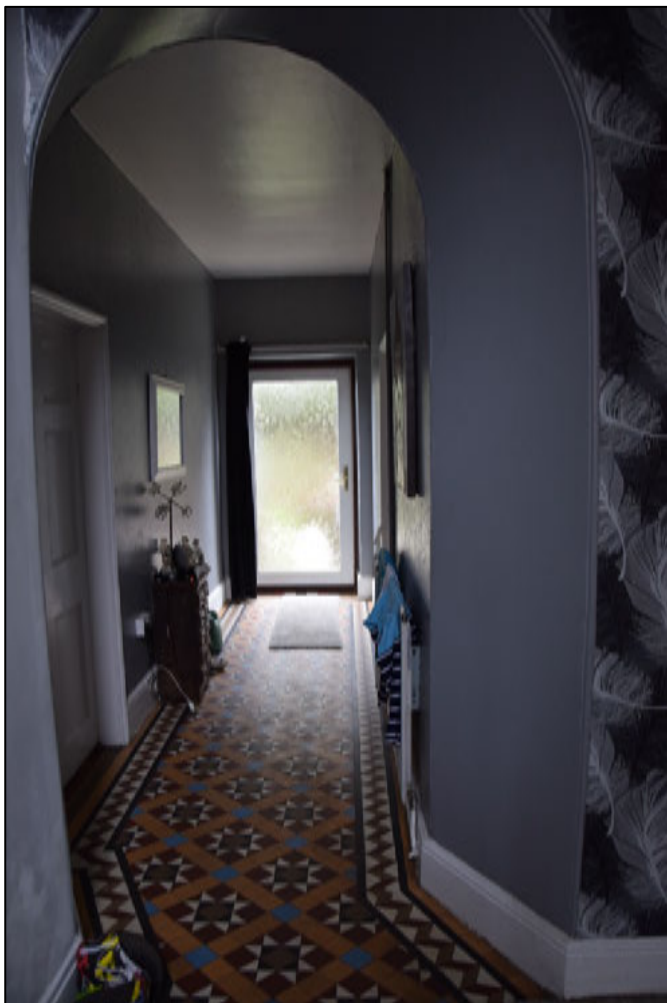
Photograph 20 (left): The modern hall 6, seen from near the original south door of the old house

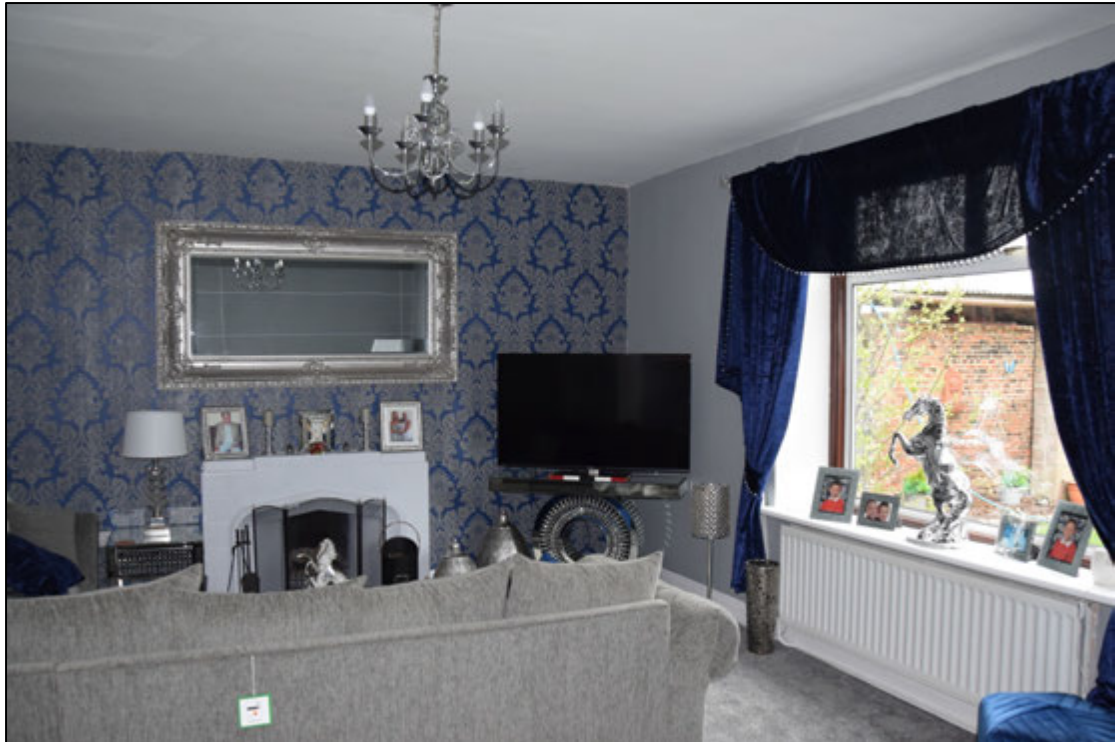
Photograph 21: Room 7 occupies the east end of the 19th-century extension. There is no chimney breast

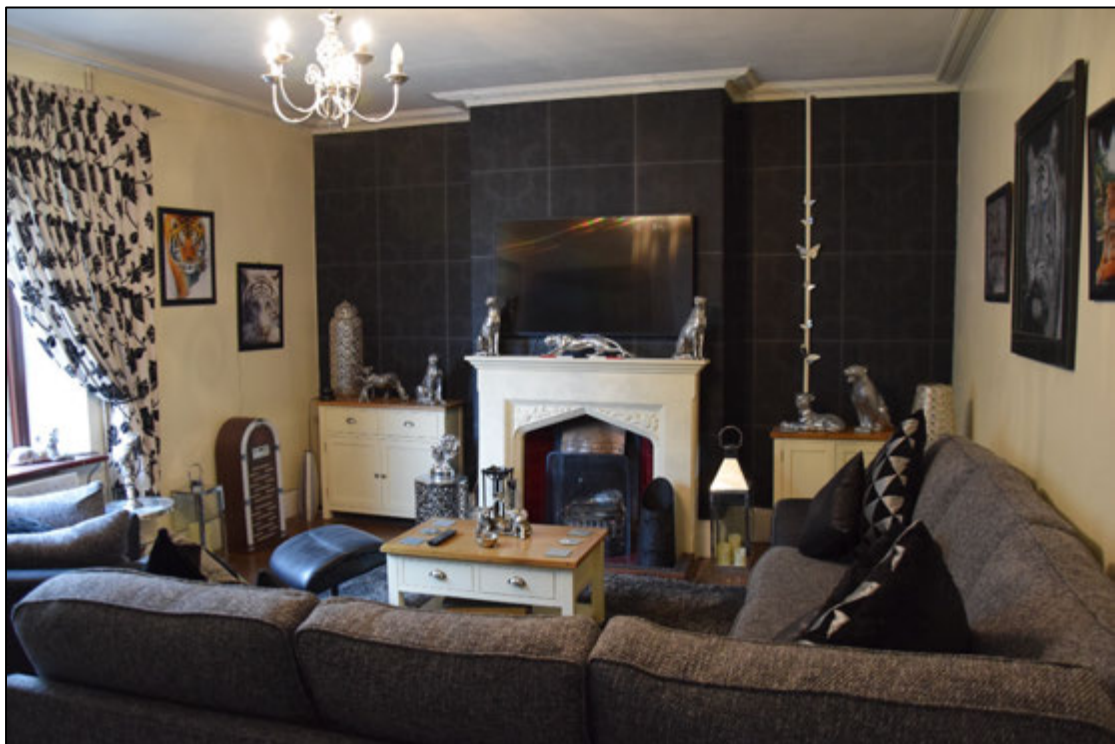
Photograph 22: Room 8, at the south-west corner, retains its chimney breast but the fireplace is modern

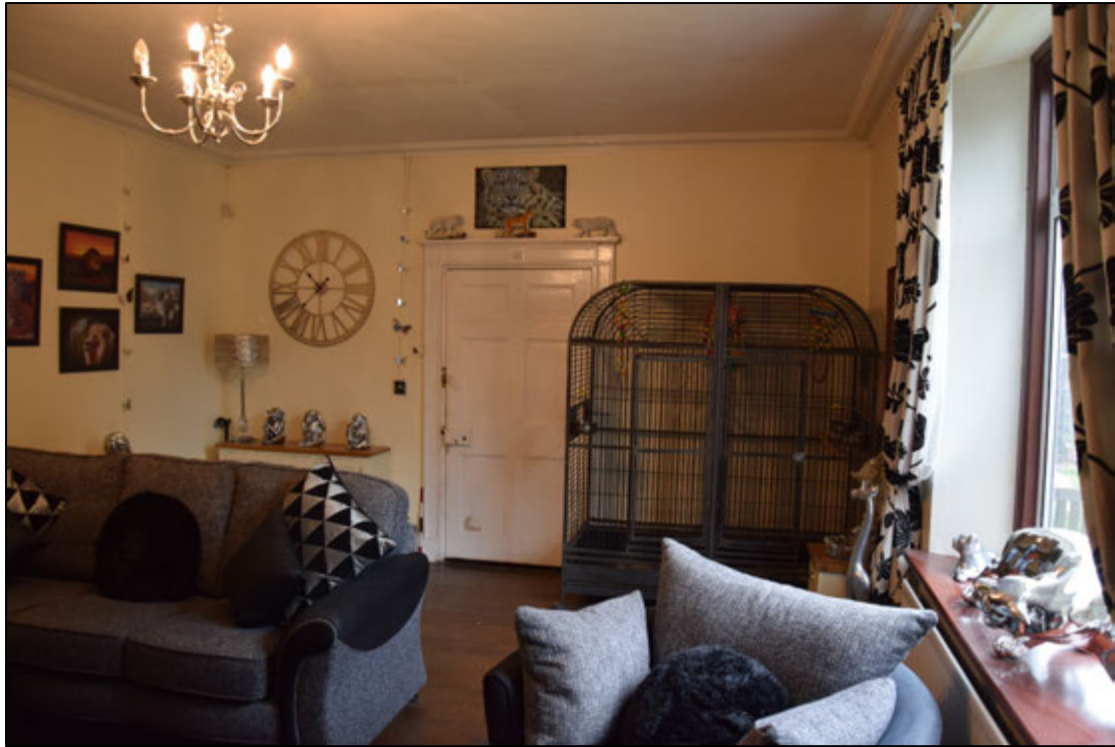
Photograph 23 (above): The east end of room 8, showing the widened modern window and a moulded door case

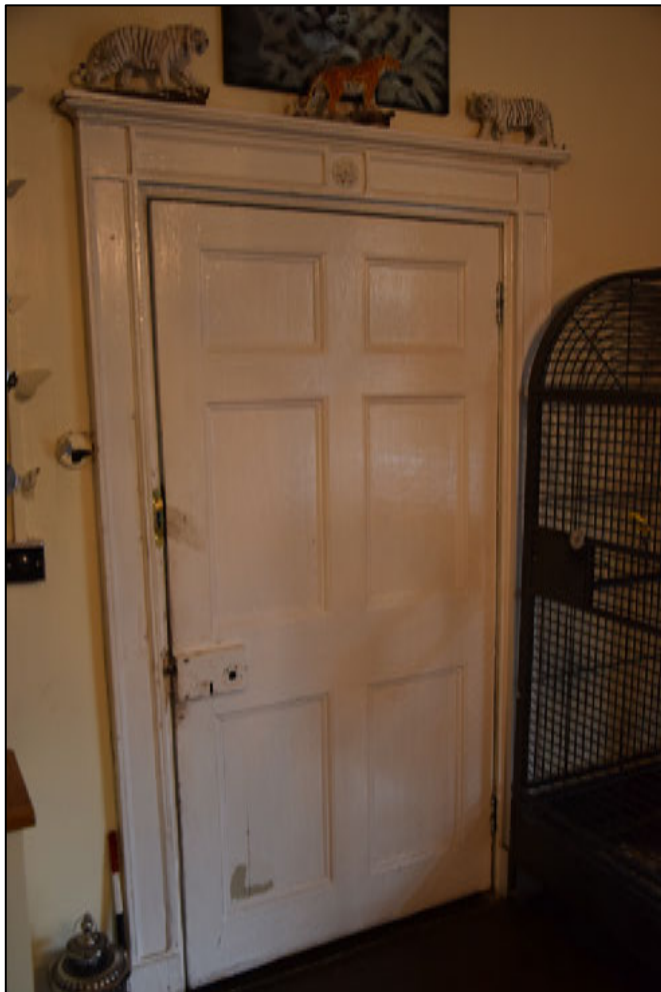
Photograph 24 (left): Detail of the six-panel door and door case in room 8

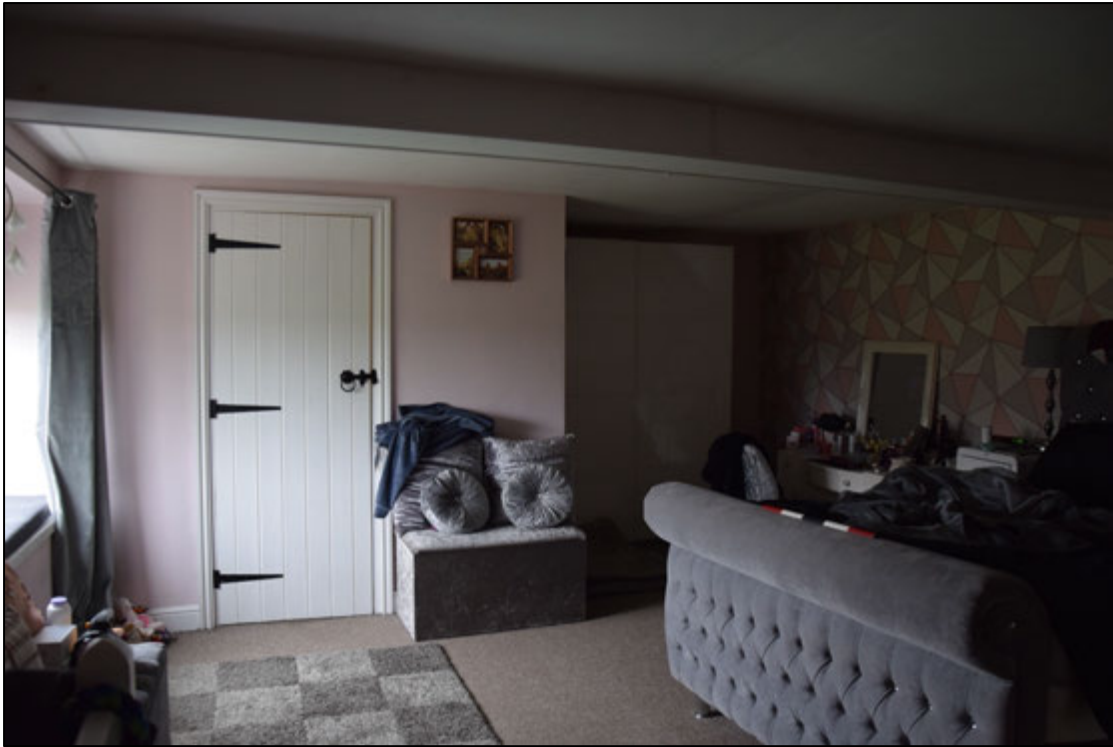
Photograph 25: A view looking south-east in room 9. The door leads to a recent bathroom

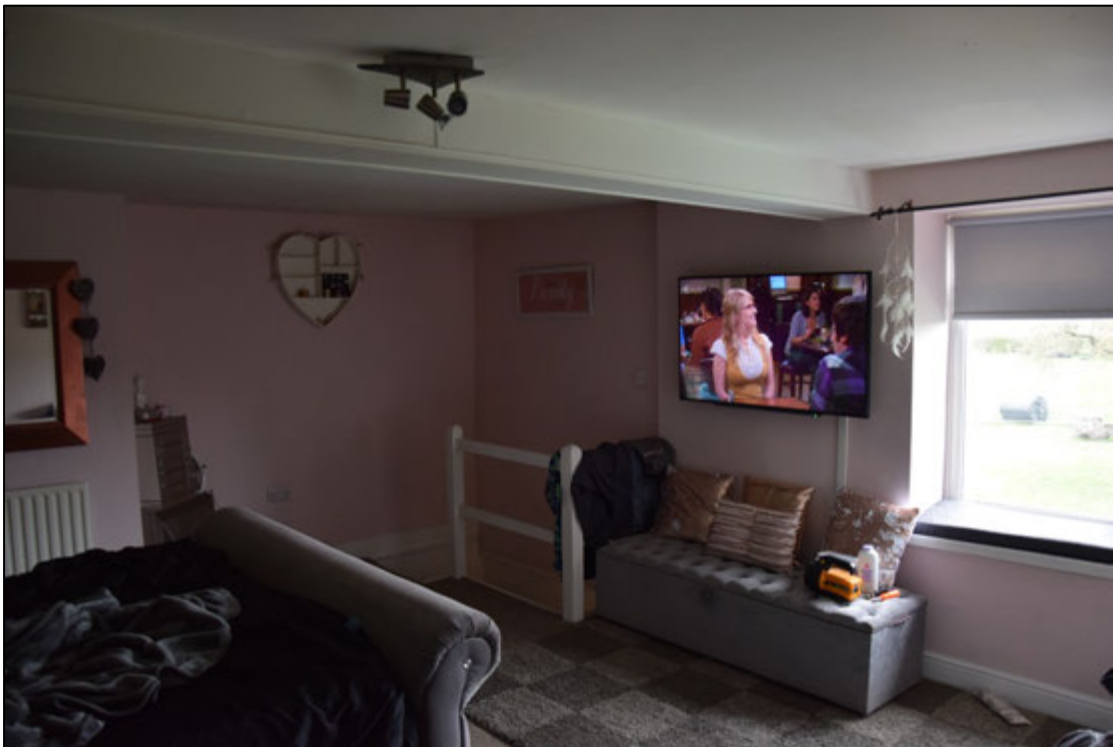
Photograph 26: Room 9 seen from the south-east corner. This view shows the top of the stair from the kitchen and the boxed-in ceiling beam

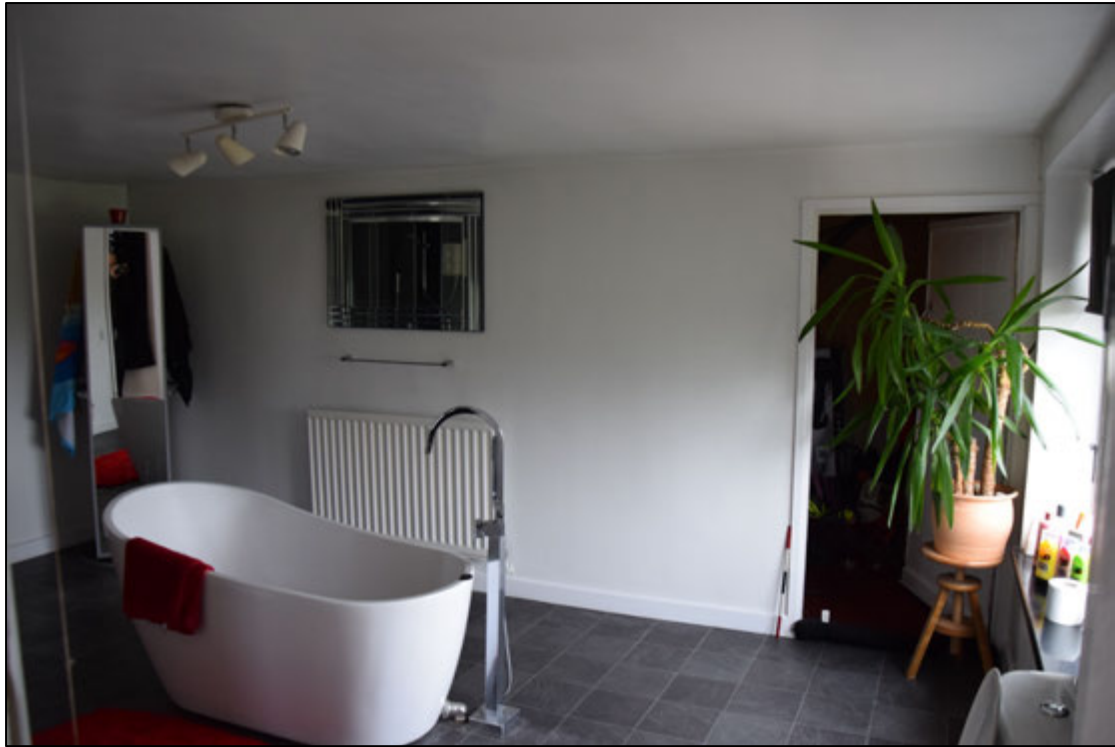
Photograph 27: The modern bathroom 10 has no historic features but the far wall is an old plank-built partition

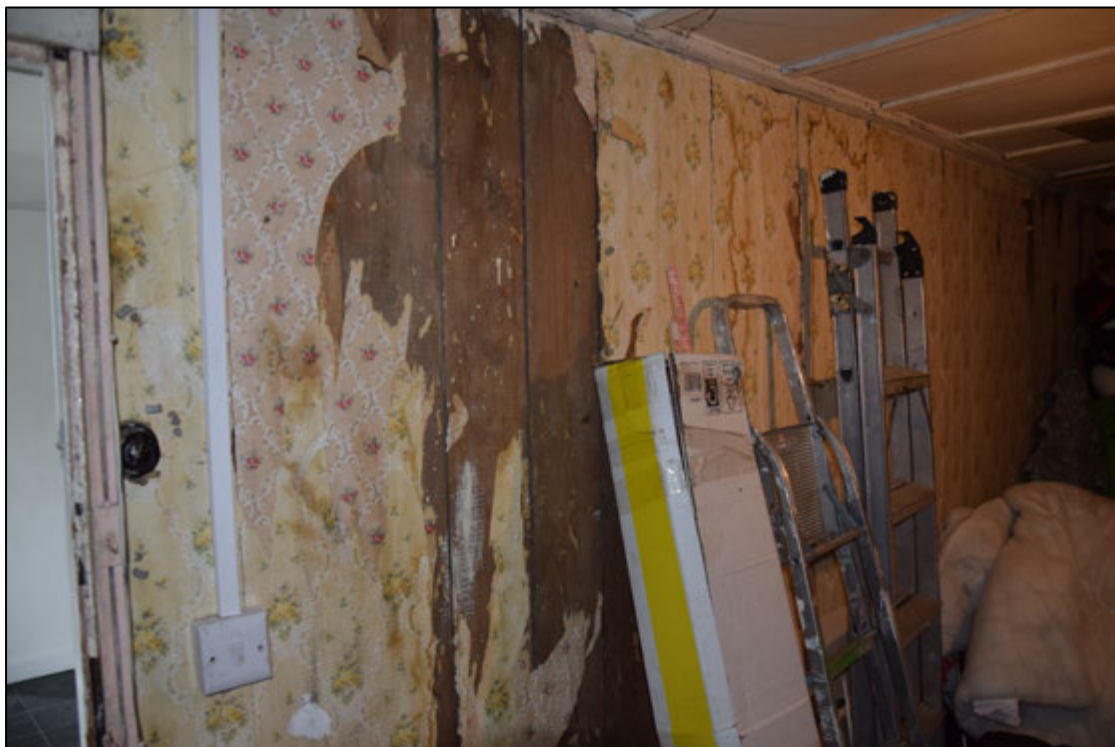
Photograph 28: The wooden wall of the bathroom store 11, with 20th-century wallpaper applied directly to the boards

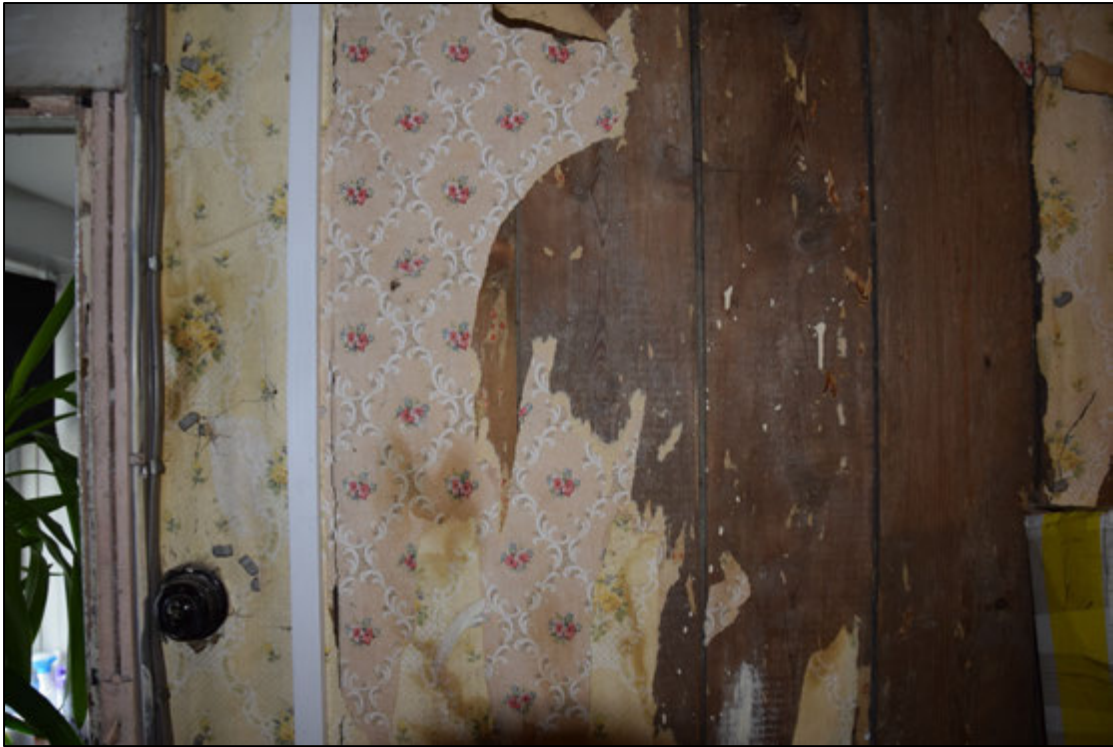
Photograph 29: Detail of the wallpaper and plank wall in room 11

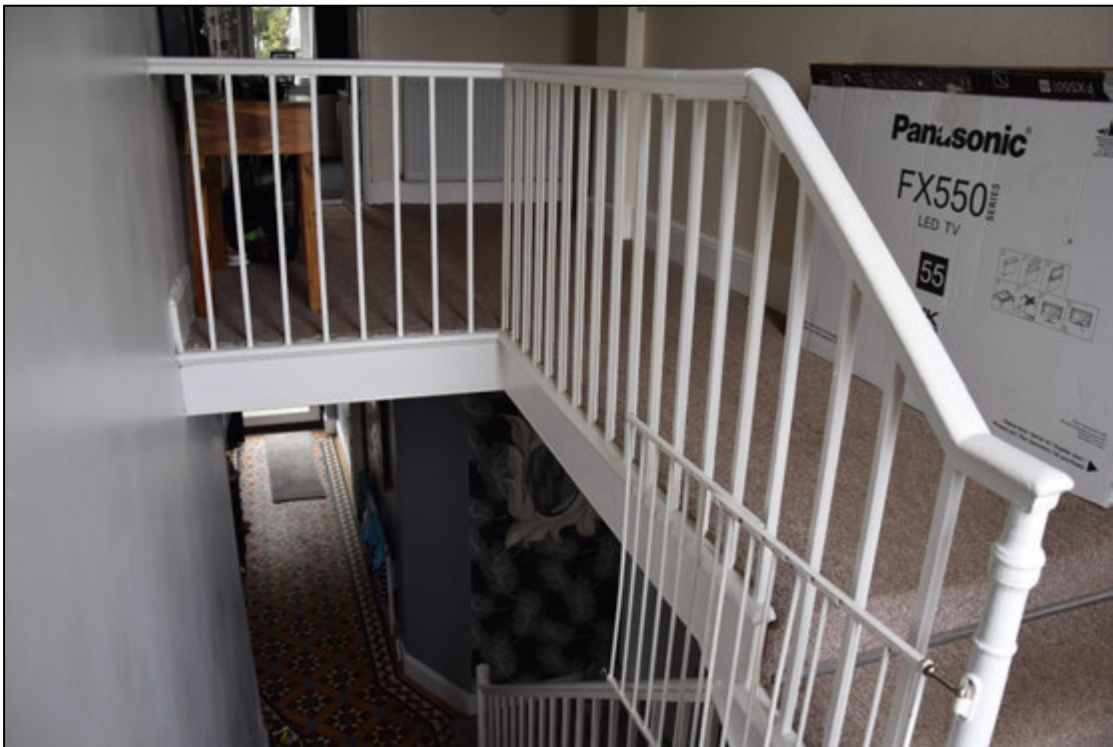
Photograph 30: The simple rail and staircase, part of the 19th-century extension of the farm house

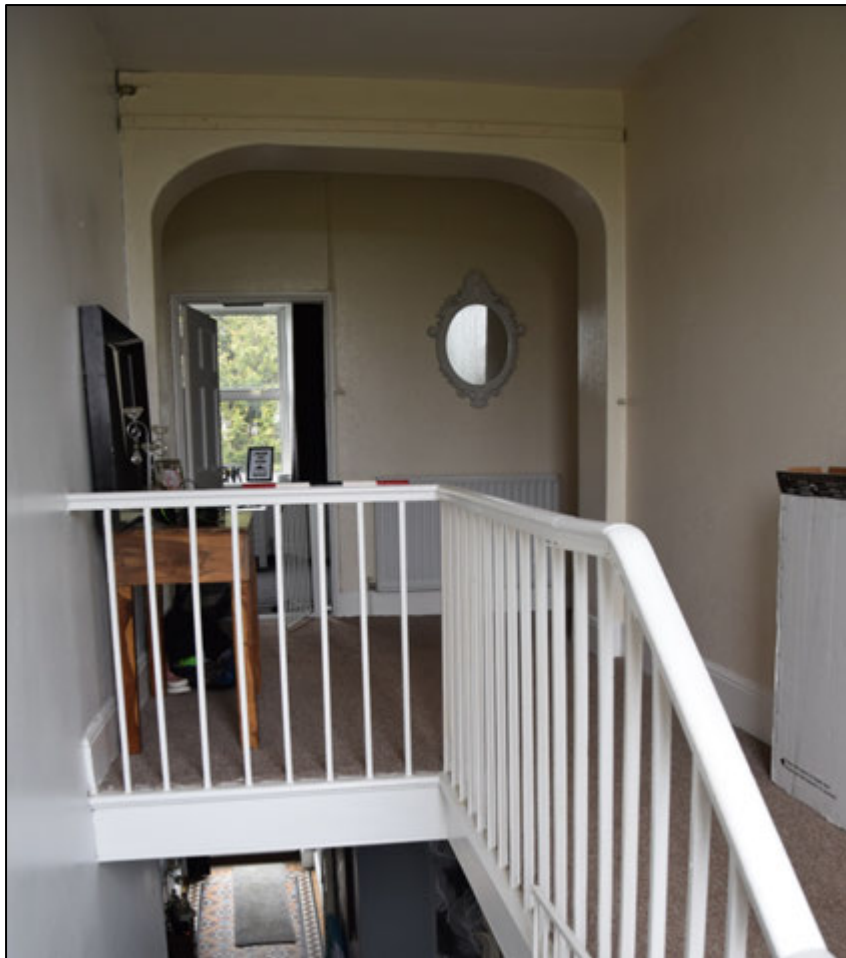
Photograph 31
(left): The plaster arch on the landing 12 marks the line of the old south face of the house.

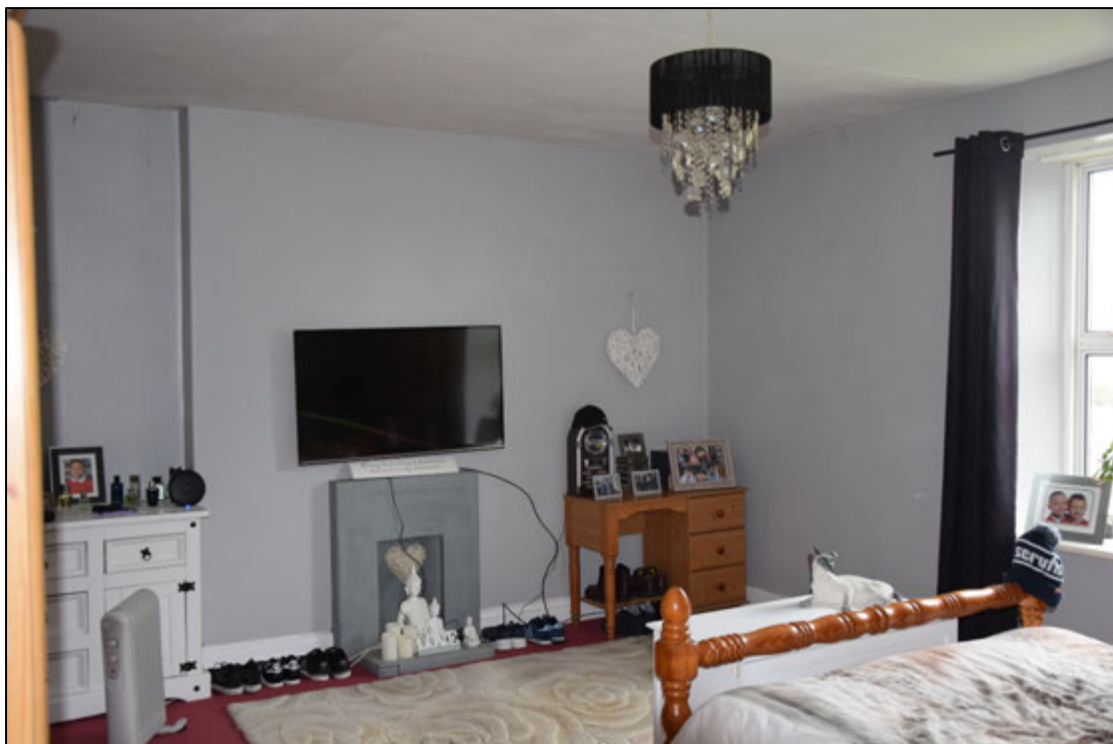
Photograph 32
(below): Bedroom 13, at the south-east corner, retains a small step in the wall that marks the position of a chimney breast

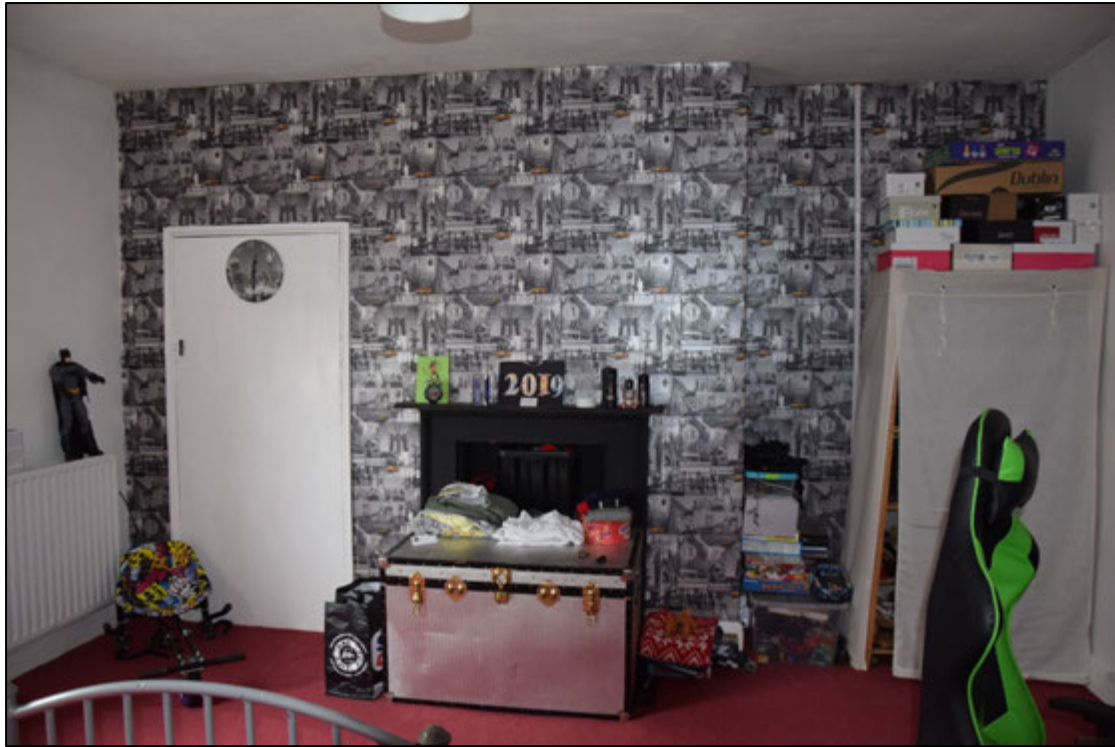
Photograph 33: A chimney breast and flanking cupboard in room 14, at the south-west corner of the house
