ARCHAEOLOGICAL
SERVICES
DURHAM UNIVERSITY

Mount Pleasant Farm
Darlington
archaeological building recording

report 5030
April 2019

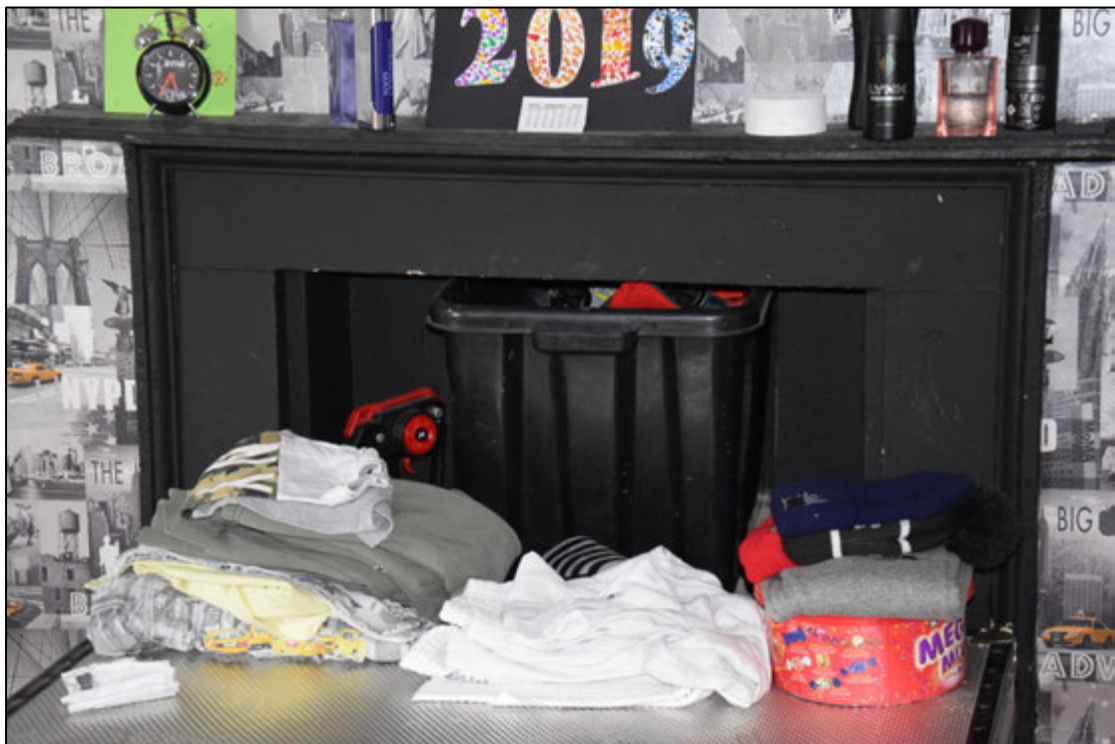
Photograph 34: Detail of the simple stone fireplace in room 14

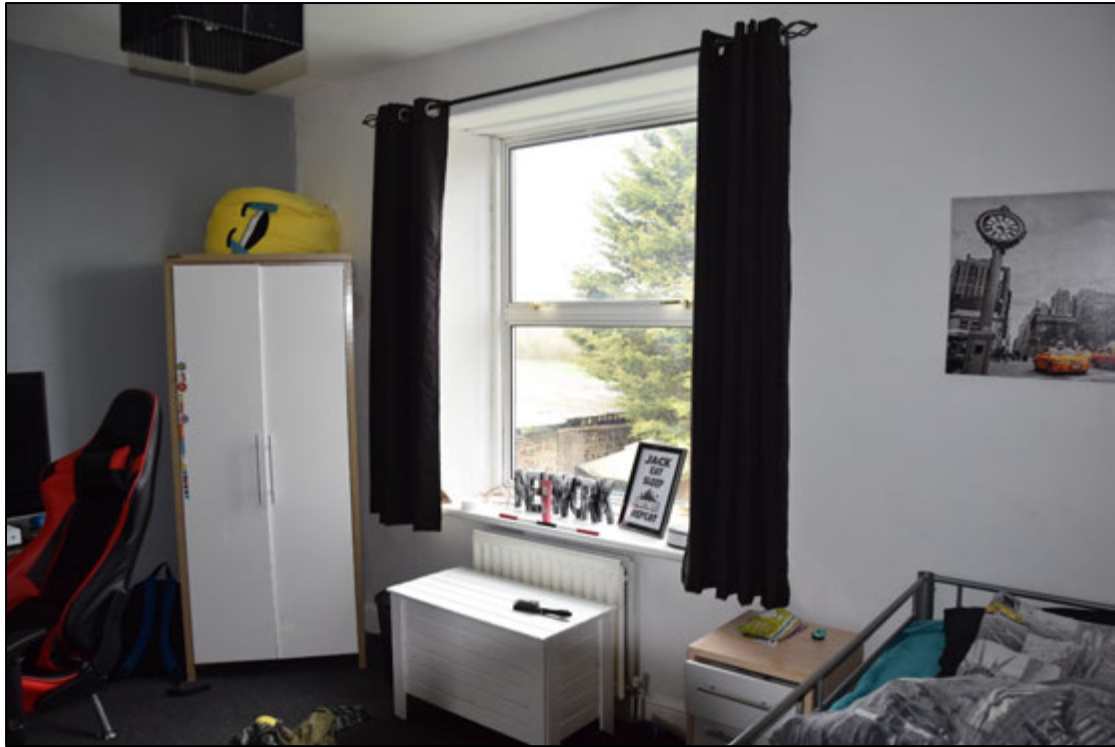
Photograph 35: Room 15, with its modern window

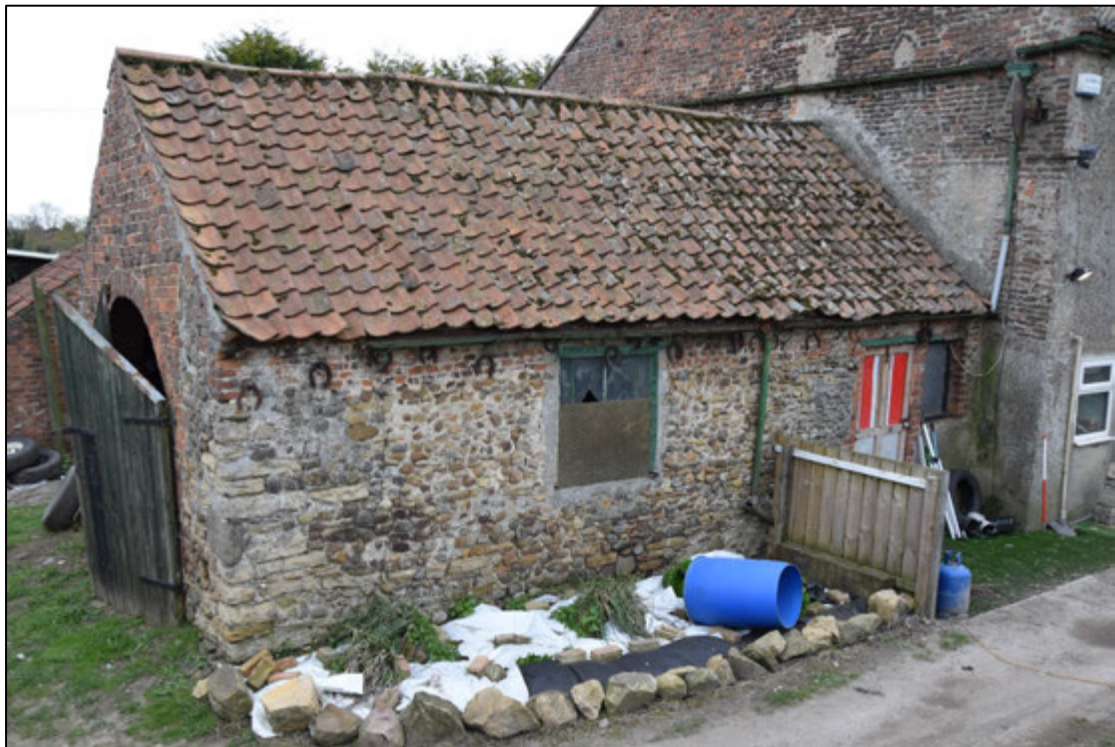
- 5.11 This is a narrow single-storey gabled building at the east end of the house. It is built of rubble masonry and brick and has a pantile roof. Its stone north wall, set slightly back from the north face of the house, has been raised by the addition of several courses of brick (Photograph 36). The small windows and the scar of a chimney in the wall above the west end of the ridge suggest that the building might once have been a smithy, but a location abutting the main room of the house would be unusual. Brickwork fills the centre of the east end and forms a large arched double door (Photograph 37). The same pattern is seen in the south face where a central panel of brick contains an arched door, now blocked up. The raising of the roof can be seen here (Photograph 38).

Photograph 36: The workshop, building B. Note the similarity between the stonework here and that in the west end of the house, seen in Photo 8. Brick courses used to raise the eaves can be seen here

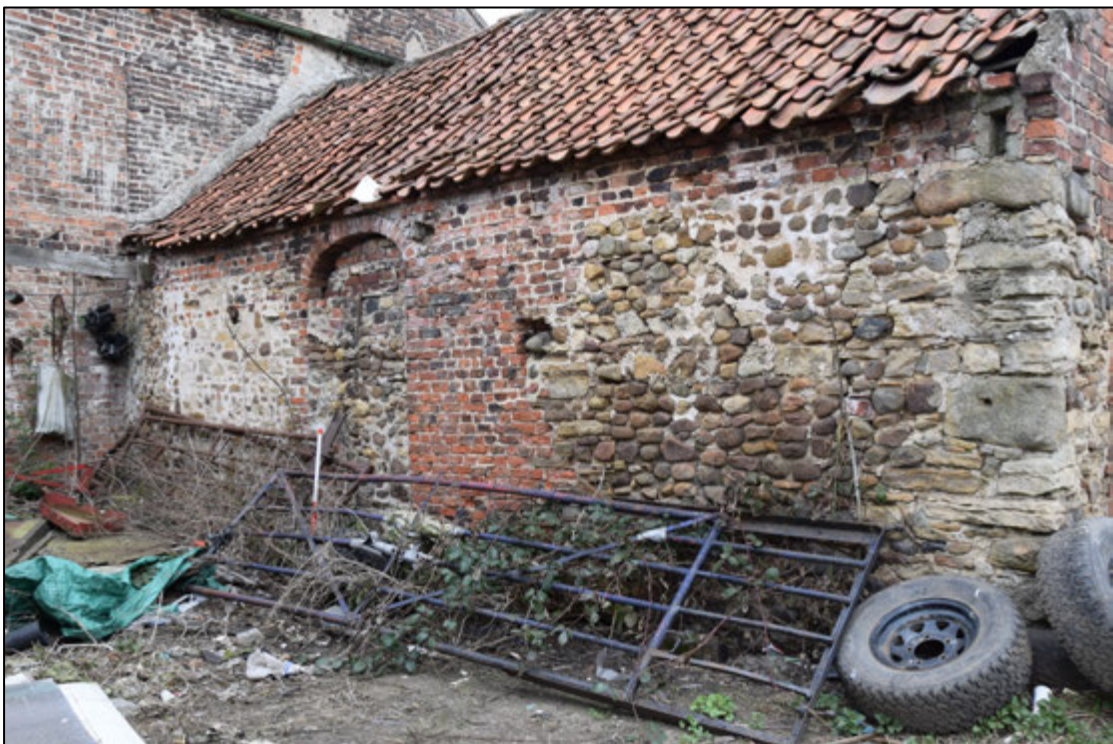
Photograph 38: The south face is a mixture of brick and stone

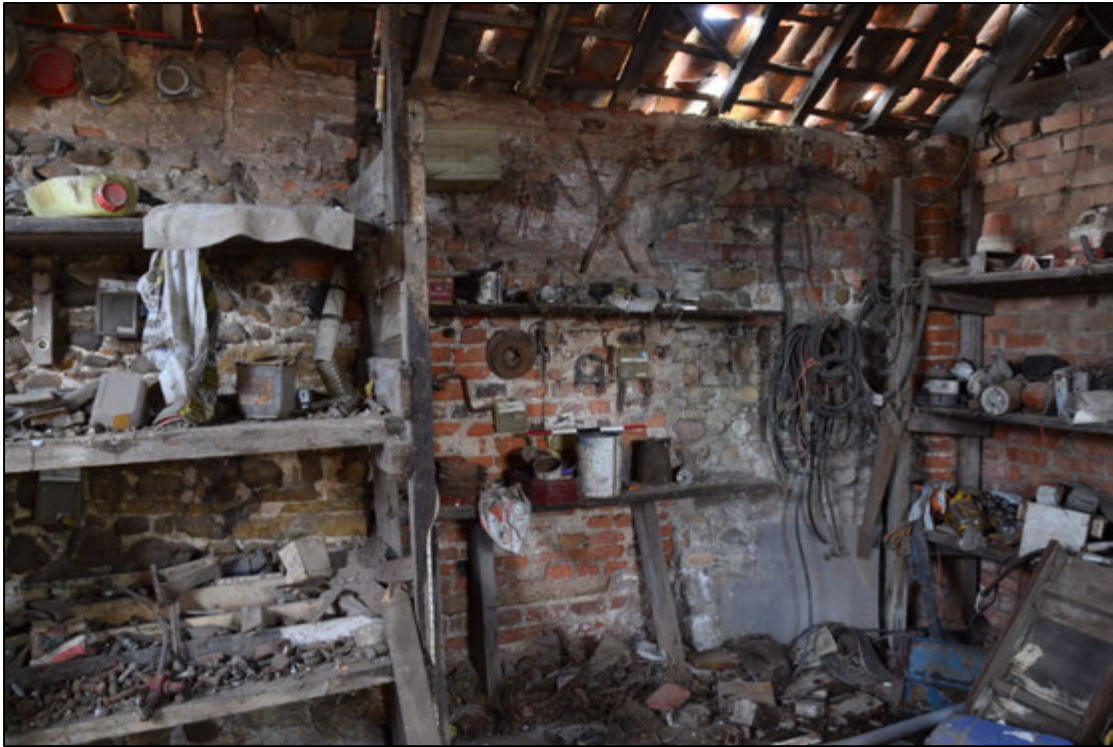
- 5.12 Inside the building, in the east end, the former farm workshop, the difference in thickness between the old stone walls and later brick sections can be seen (Photograph 39). Some areas of plaster remain on parts of the walls. The roof is open and the north window is relatively modern (Photograph 40). A modern brick wall that rises to the tie beam divides the building in two (Photograph 41). The area beyond this wall was inaccessible for survey.

Photograph 39: The brick rebuild in the south wall of the workshop, with the blocked door seen in the previous photograph at the right

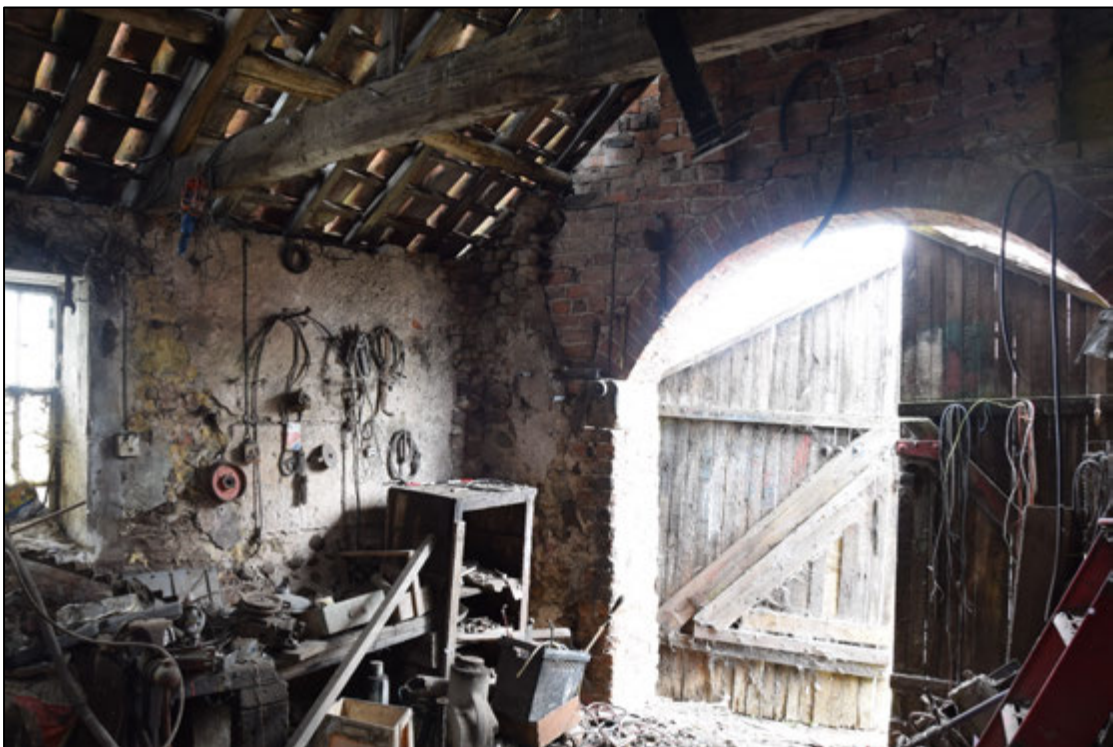
Photograph 40: Mixed brick and stone in the north-east corner of the workshop, with some plaster on the walls

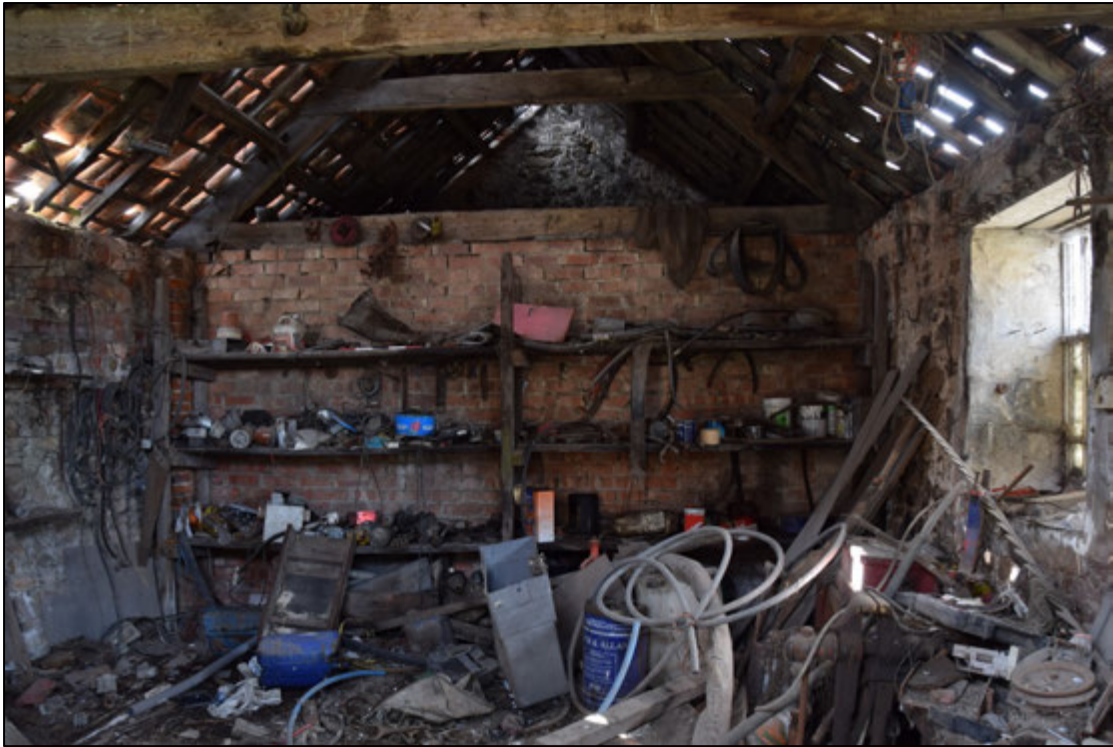
Photograph 41: The modern wall that divides the workshop only reaches the bottom of the simple roof truss

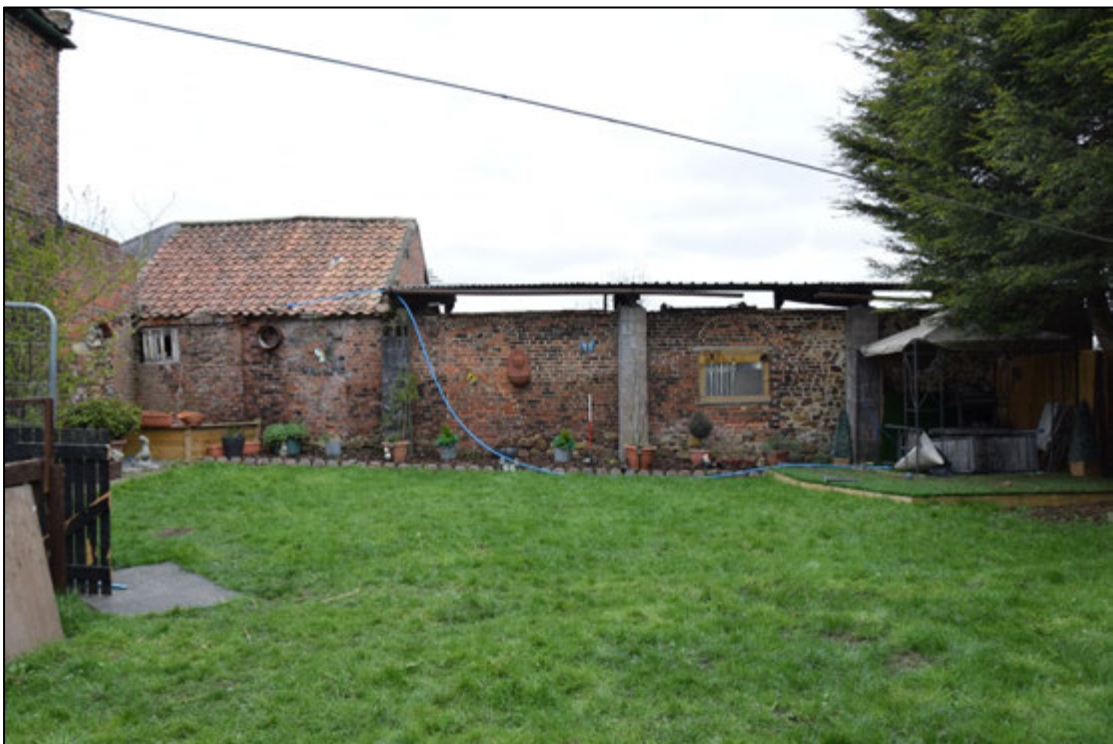
- 5.13 The south side of the garden at the front of the house is now closed by a row of conifers. On its east side is a long brick building, the former stable (Photograph 42). Though the footprint of the building is still visible, the southern three-quarters of the

Photograph 42: The west face of the former stable C, seen from the garden

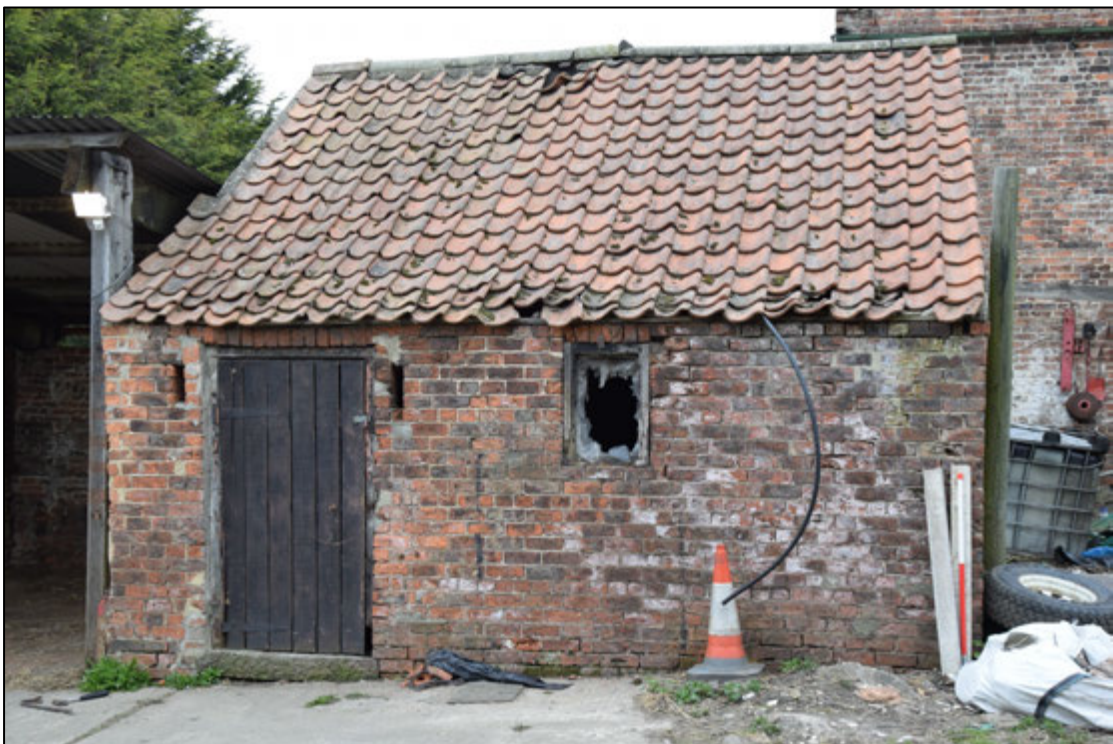
structure has been replaced with a pole barn, leaving only the west wall standing (Photograph 43). The north end remains complete (Photograph 44). The east face is entirely brick under a pantile roof. The north end shows older random rubble masonry like that seen in the north wall of the workshop and the west end of the house (Photograph 45). At the north-west corner, a screen wall with a blocked gate links the stable to the house (Photograph 46). At the south end, largely rebuilt in concrete blocks, the only old fabric that remains is the end of the west wall (Photograph 47). The lower courses are squared blocks of stone, with brickwork above. At the north end of the west face, a straight joint shows that the northernmost bay was once open on this side; the brick infill contains a small window. South of the straight joint, the first of three blocked doors can be seen in the irregularly-bonded wall (Photograph 48). All of these have simple brick arches; there is a blocked ventilator opening between the middle and southern doors (Photographs 49, 50). At the south end of the wall, stone rubble masonry survives almost to the level of the eaves.

Photograph 44: The surviving section of the stable's east face, entirely built of brick

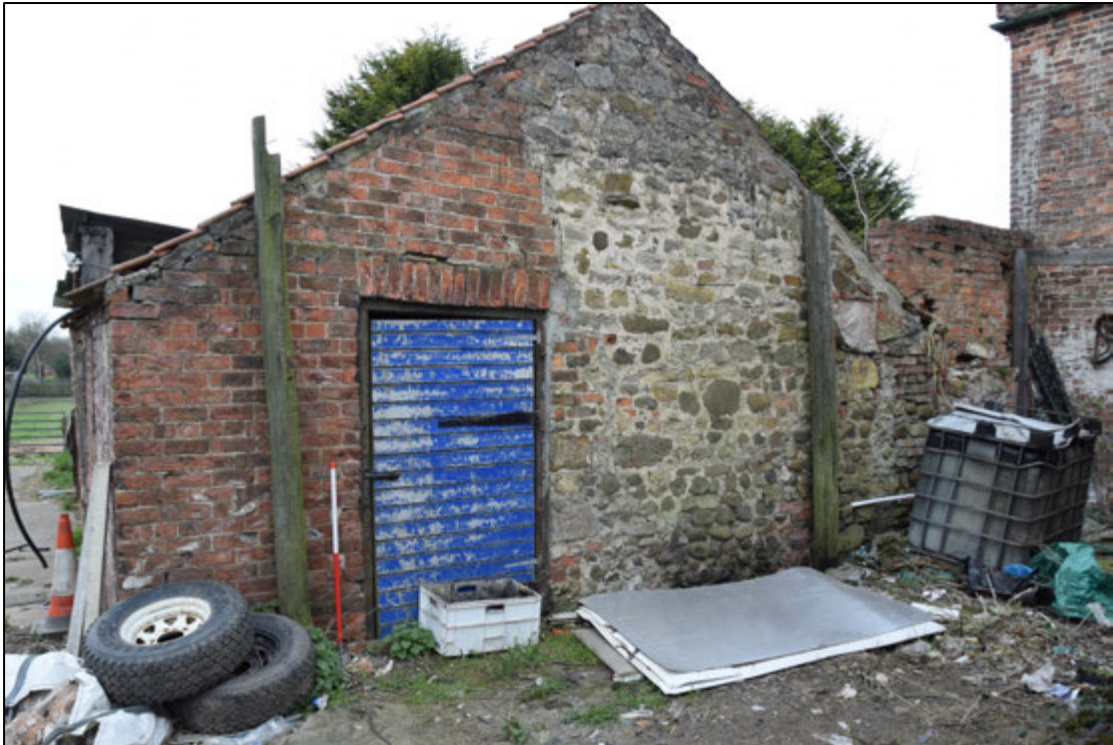
Photograph 45: By contrast, the north wall includes some older stone masonry of a character like that in the house and the workshop

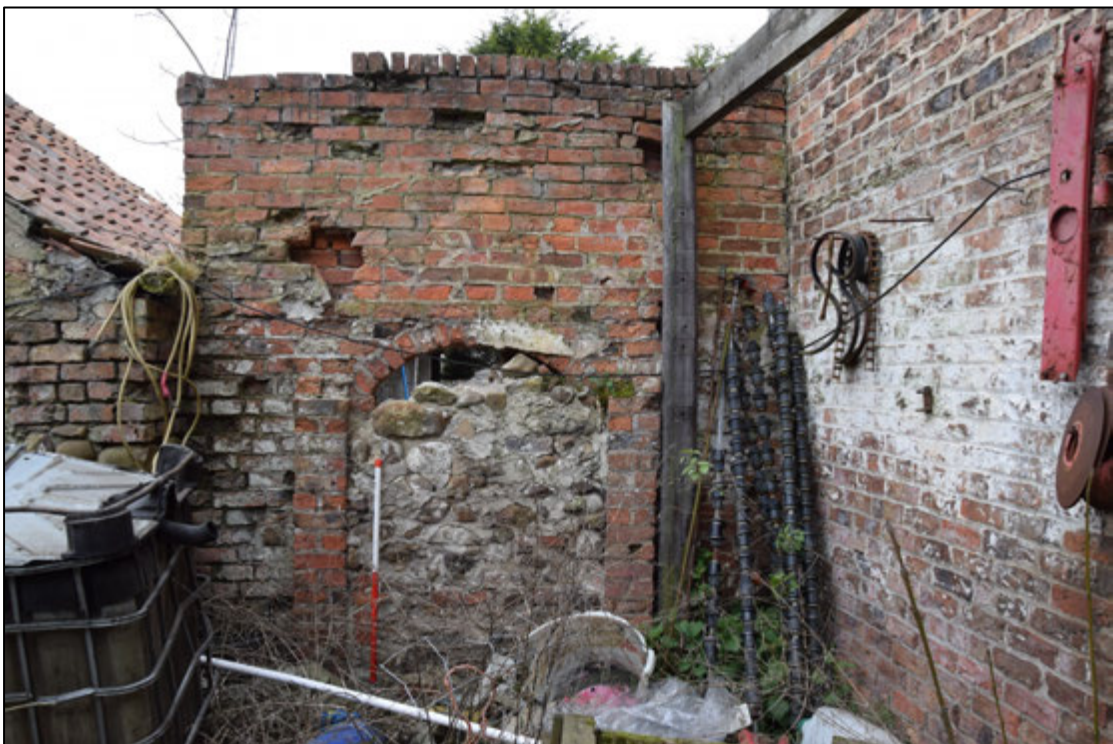
Photograph 46: The screen wall between the stable (left) and the house. A view looking south

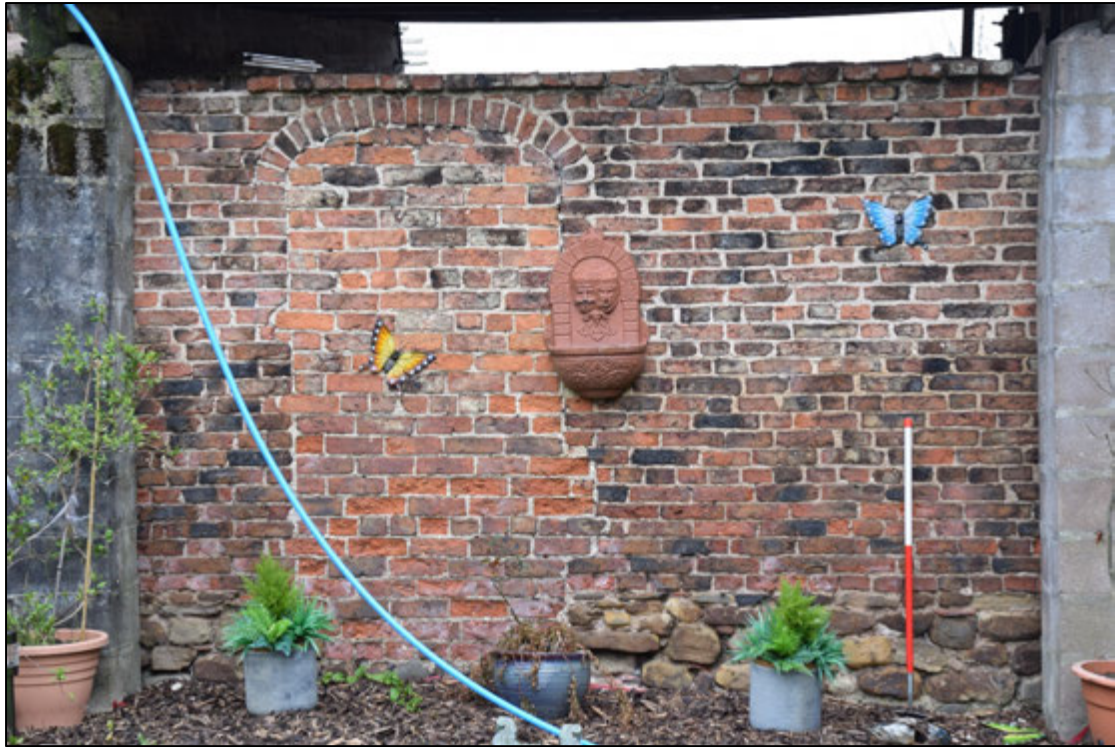
Photograph 49: Another blocked opening in the second bay from the north end of the stable

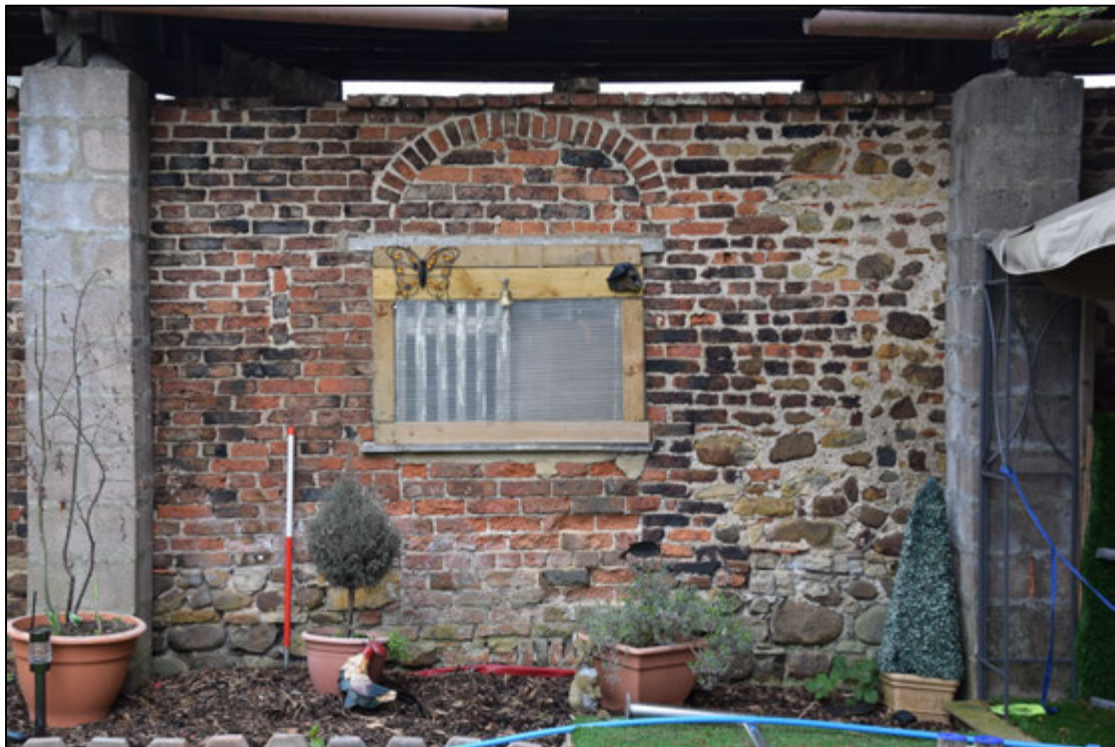
Photograph 50: A third blocked door in the west face of the stable. There is a small breather slit to its left, above the scale. Note the change to old rough stone masonry at the right

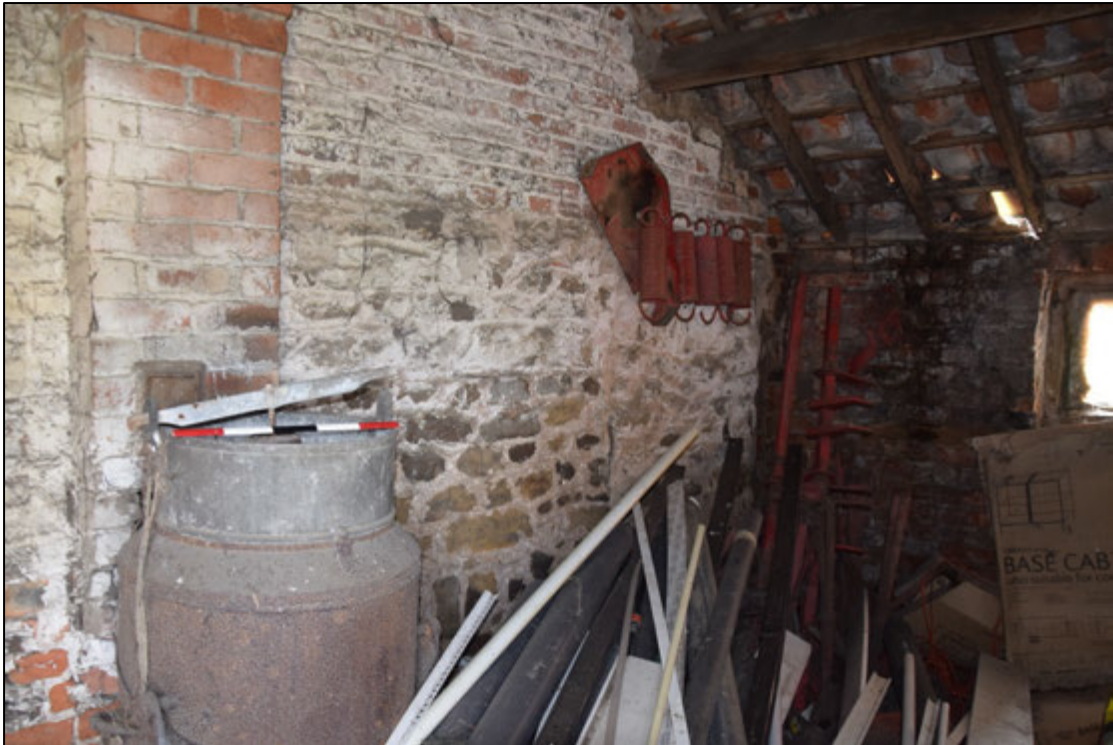
- 5.14 There are two small rooms in the surviving part of the building, divided by a wall in stone and brick. Against the north face there is a late flue for a stove pipe; west of this is a blocked door (Photograph 51). There is another blocked opening to the east in a brick section of the wall (Photograph 52). The narrow south section is used as a tack room. The blocked door to the garden can be seen, together with mixed stone and brick masonry near the door (Photographs 53, 54). Beyond the modern south wall, traces of the former stable plan can be seen. The floor, which is covered with six-block bricks stamped 'COMMONDALE', shows traces of stall partitions with rough concrete around the sockets of the heel posts. There is a small blocked niche or wall cupboard near the modern wall (Photographs 55, 56). As on the opposite face, stone can be seen in the wall at the south end (Photograph 57). Just north of this there is another blocked niche which has a triangular head (Photograph 58). Similar features are known from other 19th-century stable buildings in the region; they provided a place for brushes during grooming, or a space to stand a lantern.

Photograph 51: A view looking south-west inside the north room of the stable block. The brick at the left is the later flue for a stove

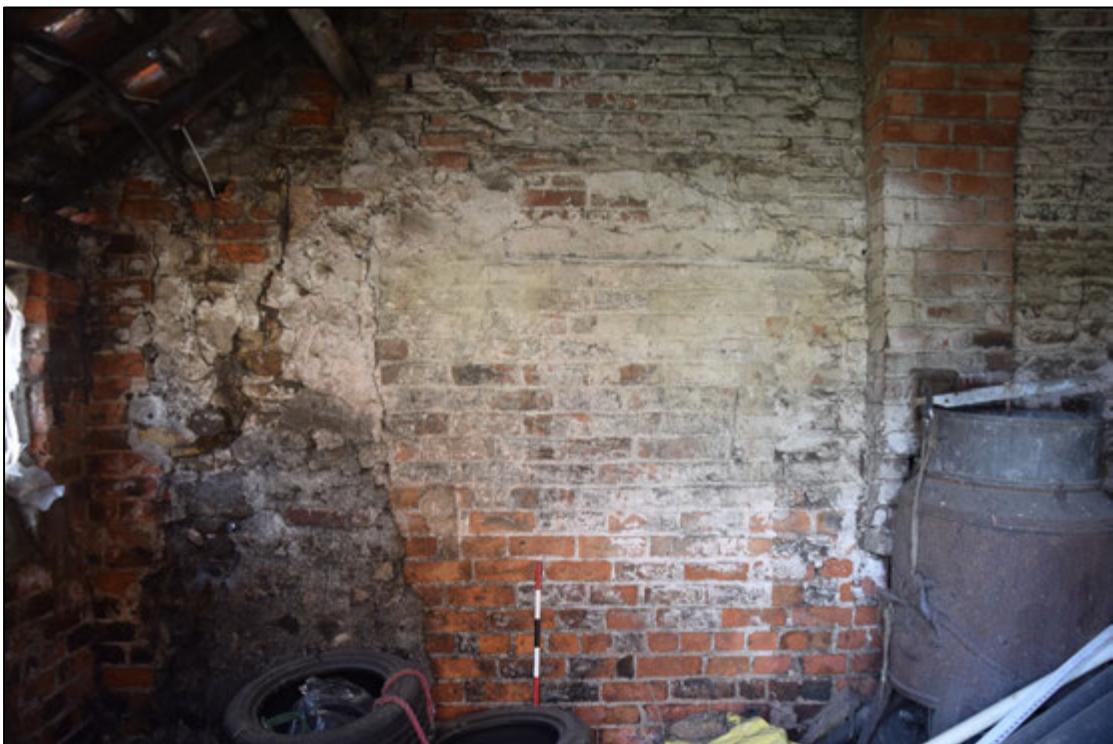
Photograph 52: A blocked opening in the south wall of the shed, with old stone masonry at its left side

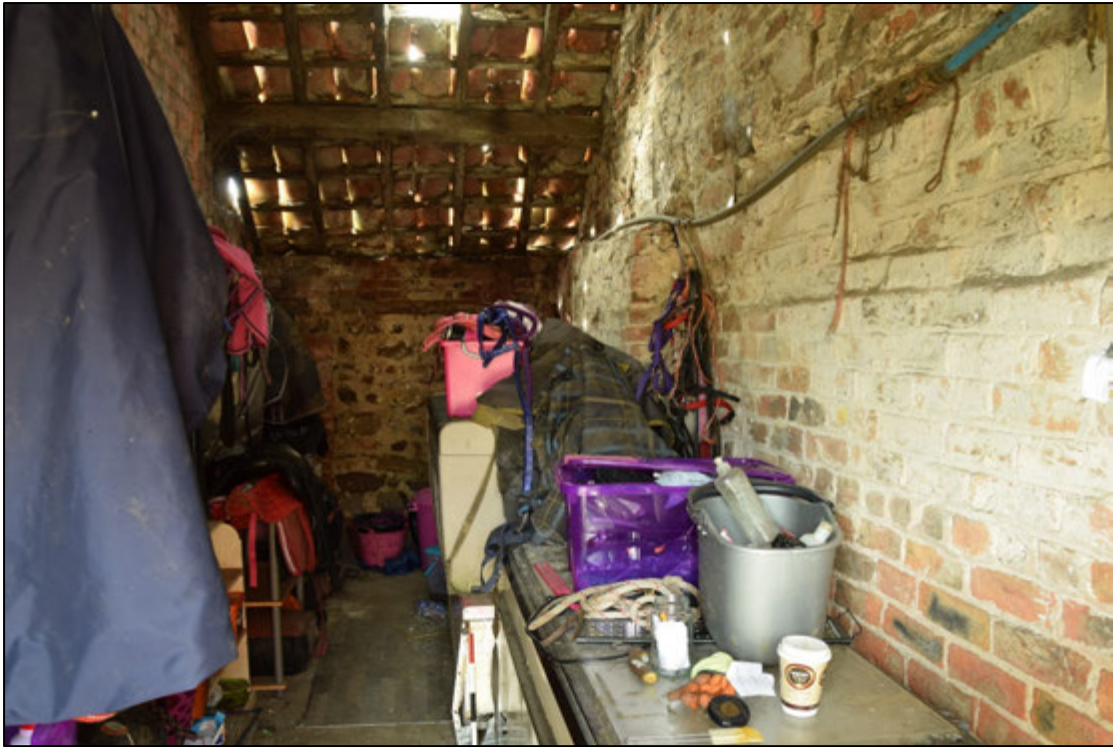
Photograph 53: Looking west into the tack room that occupies the south side of the surviving stable building. At the far end, the lintel of a blocked opening can be seen; this is the door shown in Photo 48

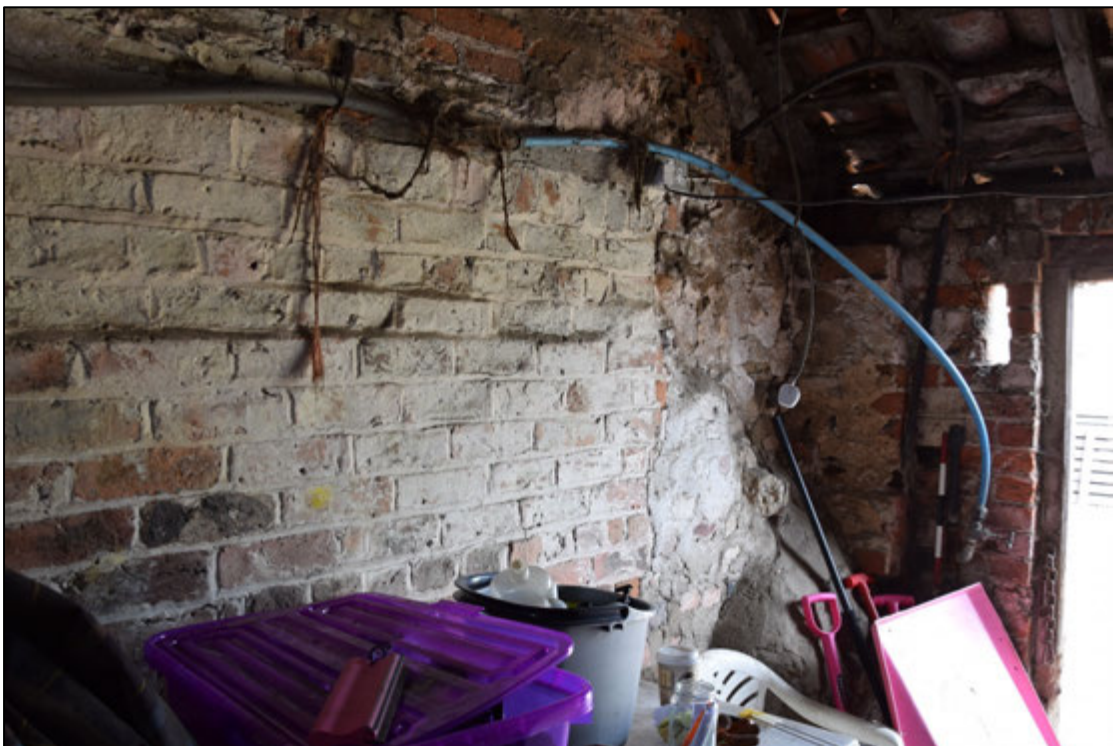
Photograph 54: Mixed brick and stone at the north-east corner of the tack room. The brickwork fills the old door seen in Photo 52

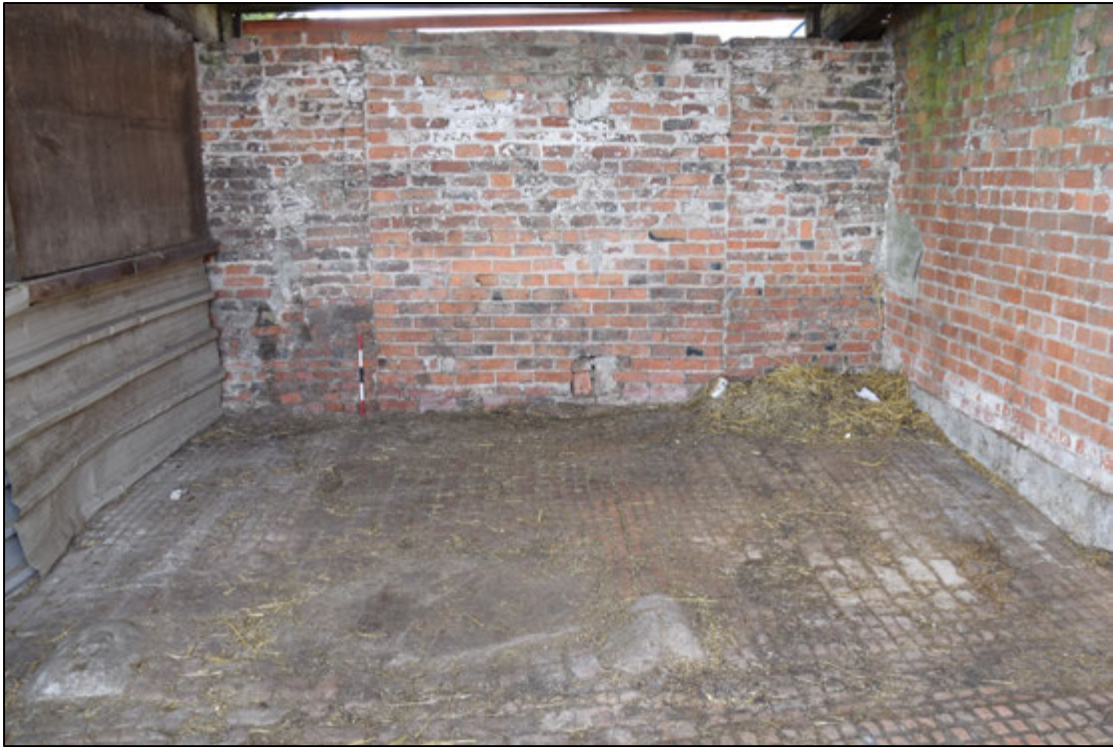
Photograph 55: The marks of stalls can still be seen in the stable floor. The wall at the right is the modern insertion. Note the small blocked rectangular niche near the right-hand end of the far wall. A view looking west

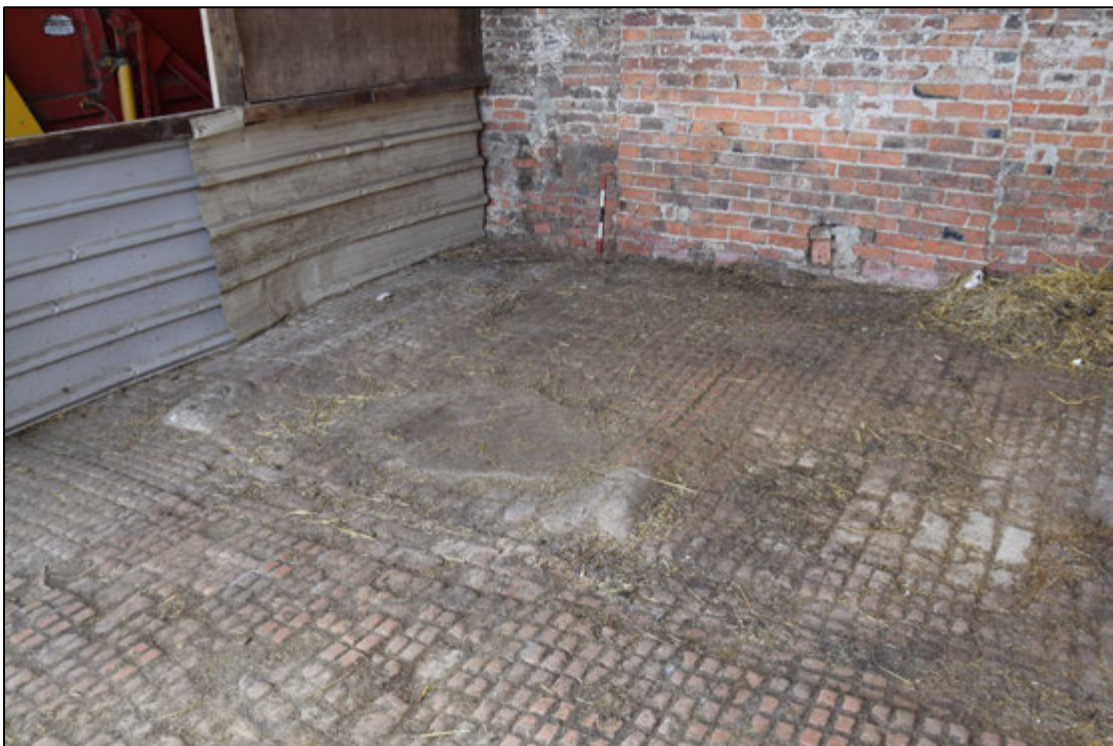
Photograph 56: Concrete surrounds the sockets for heel posts and the floor drain at the rear of the former stalls can still be seen

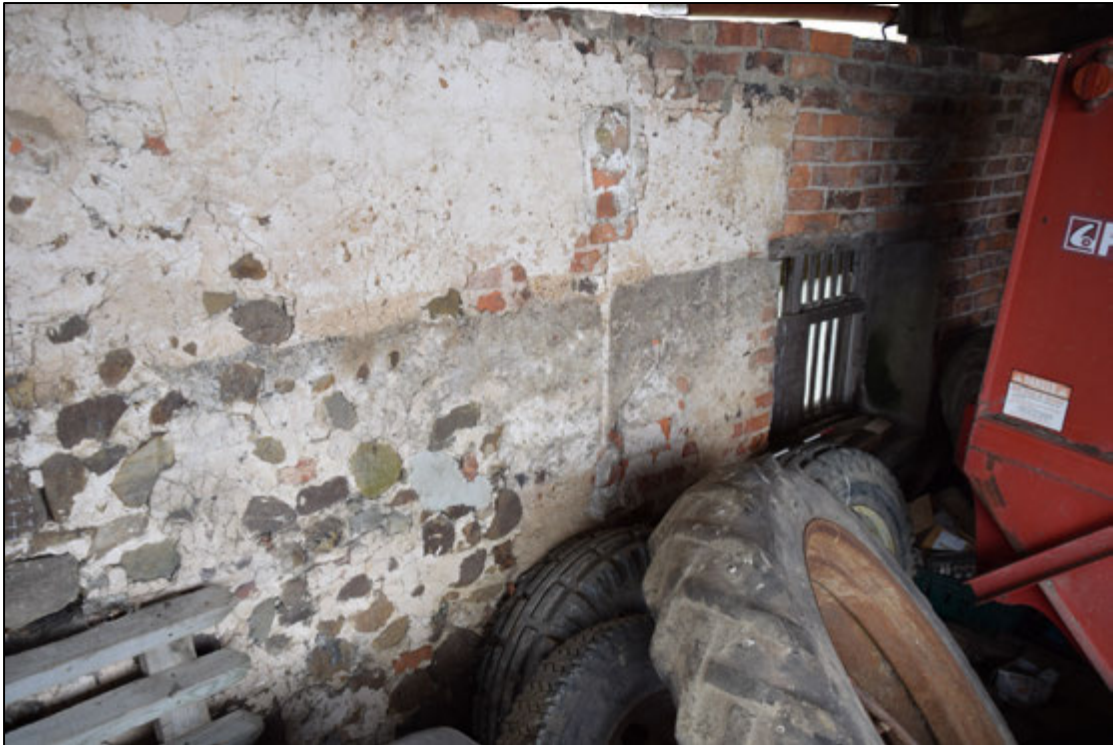
Photograph 57: The inside face of the west wall of the stable, inside the modern shelter. The window is set into a blocked door. There is a blocked triangular-headed niche above the tyres

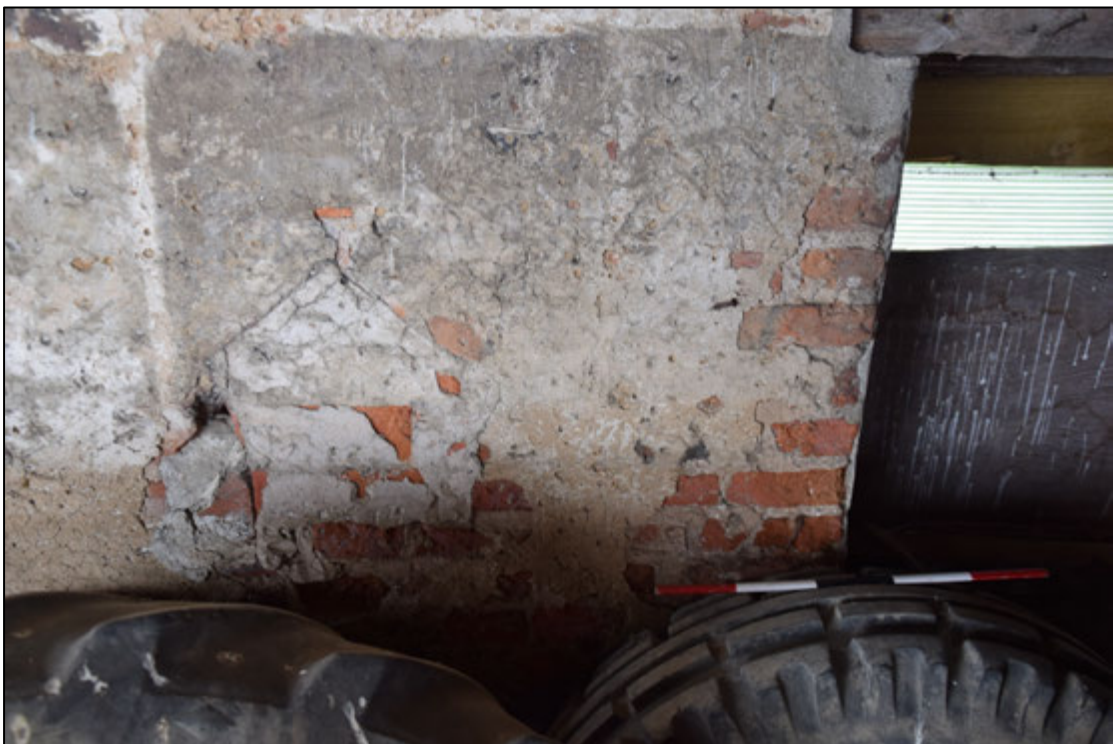
Photograph 58: Detail of the blocked niche, which would have been used for equipment or a lantern

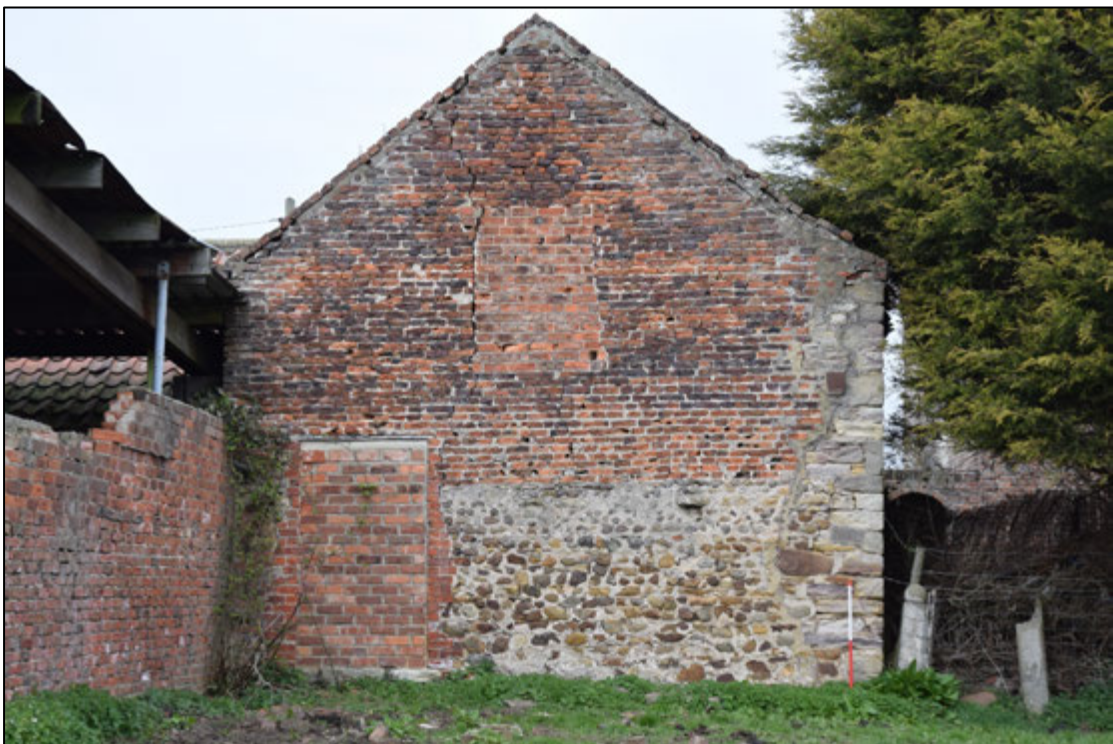
Photograph 60: Rougher stonework can be seen in the lower part of the barn's south end. The door at the left is clearly a later addition but the pitching door in the gable is contemporary with the surrounding brickwork

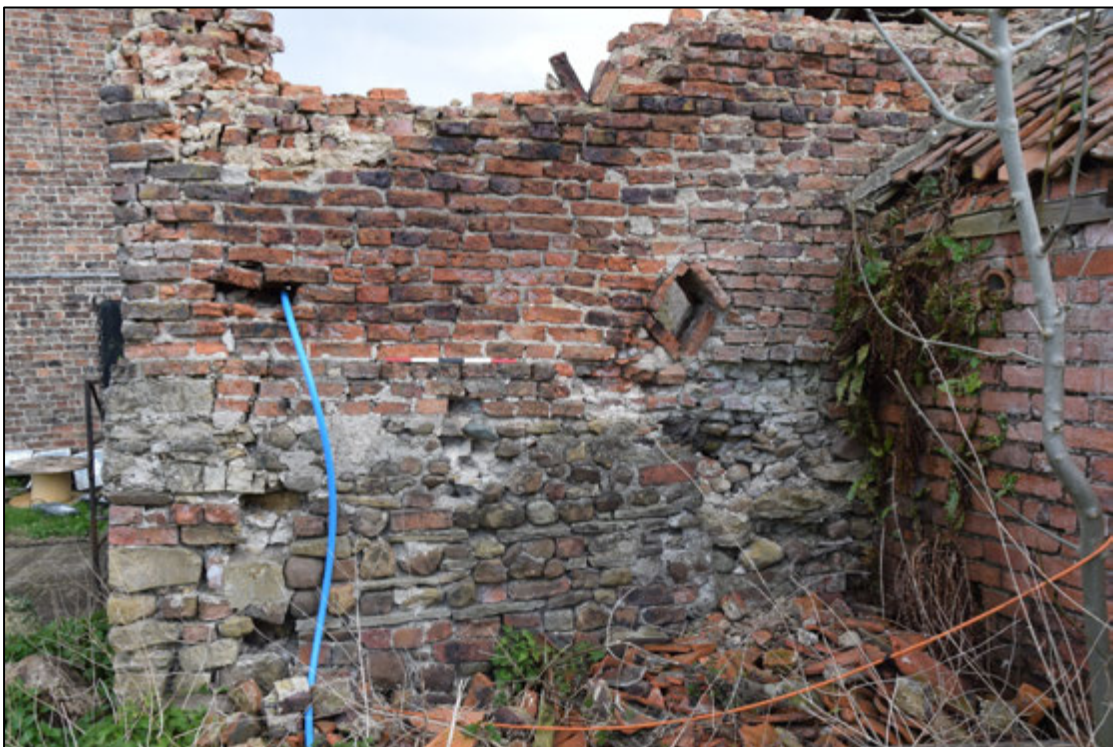
Photograph 62: Brickwork over older rough stone at the north-west corner of the barn. The wall at the right is the later stable, building H

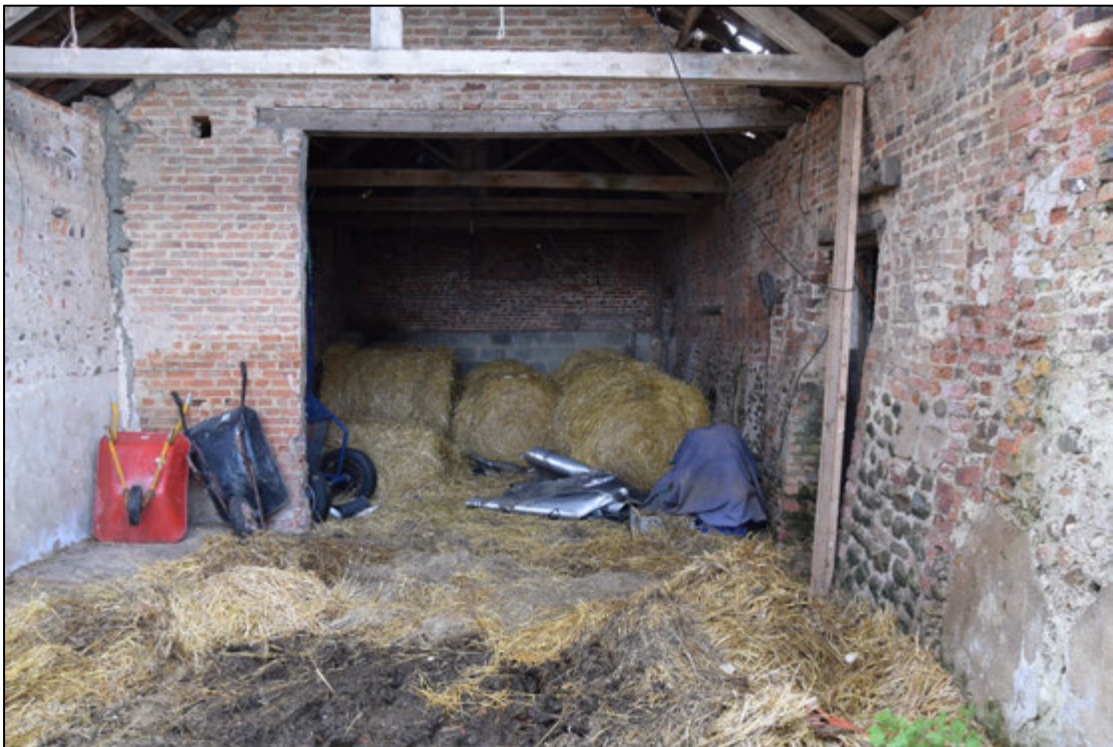
- 5.16 The interior is unequally divided by a brick wall with a large opening (Photograph 64). Evidence of alterations can be seen in all of the internal walls. The lower part of the south end has been reinforced with concrete blocks (Photograph 65) and the

Photograph 64: A later brick wall inside the barn; a view looking south

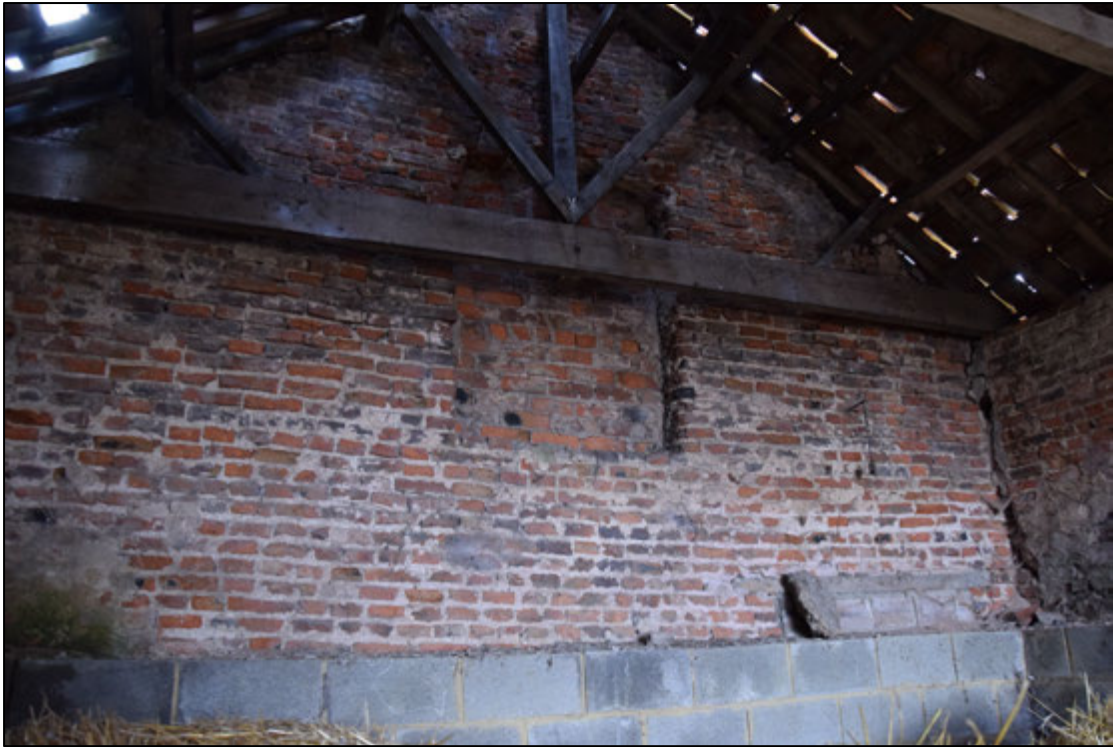
Photograph 65: The pitching door in the south gable. The head of the blocked door seen in Photo 60 is just visible above the later concrete block lining at this end of the building
