ARCHAEOLOGICAL
SERVICES
DURHAM UNIVERSITY

Mount Pleasant Farm
Darlington
archaeological building recording

report 5030
April 2019

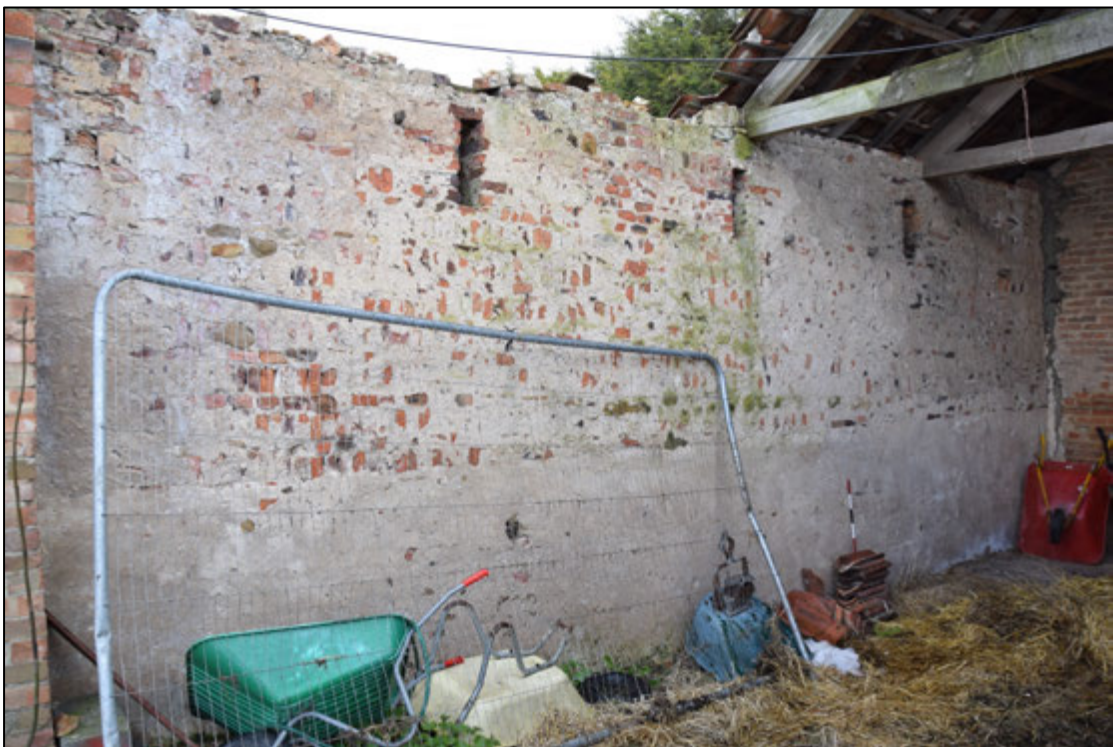
east wall is partly lined with cement render (Photograph 66). A few stubs of timber project from this face. These are too small and too widely-spaced to be joists for a loft; five run in a line just below the level of the breather slits, but there are two more at higher level near the north end. There are no signs of any kind of floor in either of the side walls of the building. As elsewhere, the west wall has rough stone below brick and there are several patches or repairs. A blocked and an open door at the south end now lead into the adjoining byre building E, but the presence of breather slits here shows that at one time they gave access to the open air (Photograph 67). At the south end, the upper part of the wall is built in fairly neat common bond, 5+1, but there is more irregular masonry elsewhere (Photograph 68). The door at the centre of the west wall leads to the stable, building H (Photograph 69). Its jambs are brick, showing that this is not an original feature. Since building H is on the site of the horse gin, it would be usual for there to be a hole for a drive shaft in the barn wall here. The only candidate is an irregular patch of brickwork south of the door, but this is not expressed on the other face of the wall. The north end of this wall is irregular brick and stone, with the unusual diamond ventilator (Photographs 70, 71). Parts of the outside face of the barn can be seen in buildings H and E. In the stable, H, the wall is painted. In both buildings, thick later brickwork forms the peak of the gables above the level of the barn wall (Photographs 72, 73).

Photograph 66: The inner face of the east wall, with brickwork, cement render and small timber stubs below the level of the breather slits

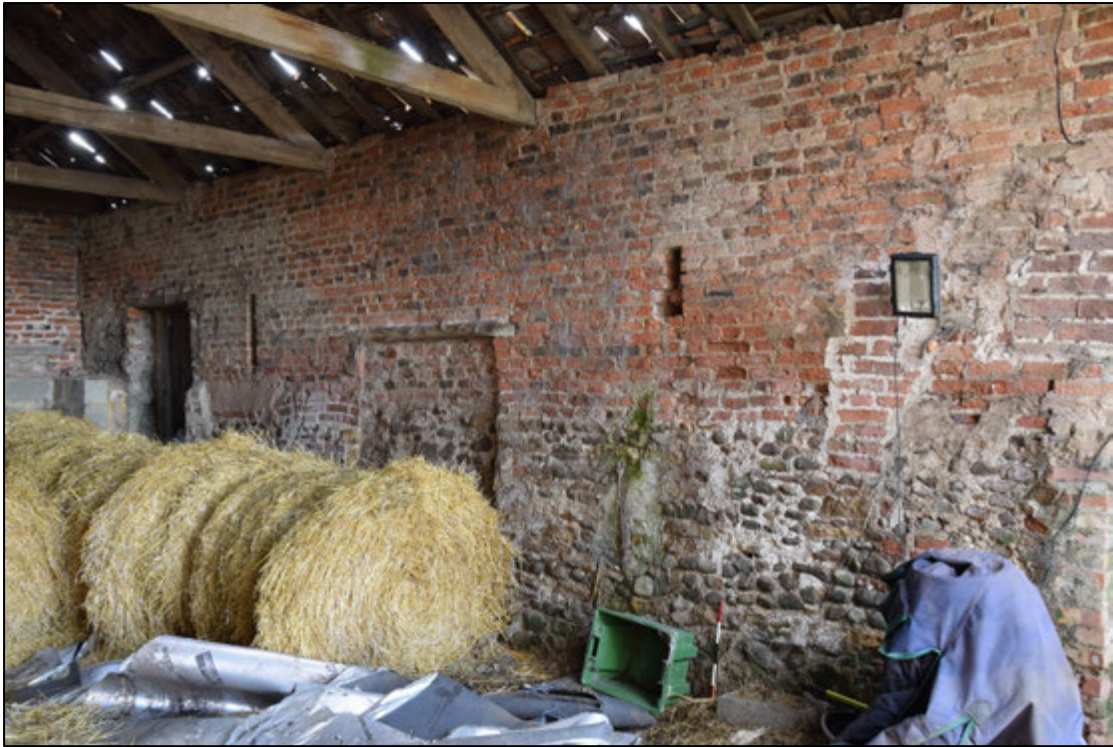
Photograph 67: The south end of the west wall in the barn. The mixture of brick and older stone can be seen here as elsewhere. The blocked door is now covered by the byre, building E

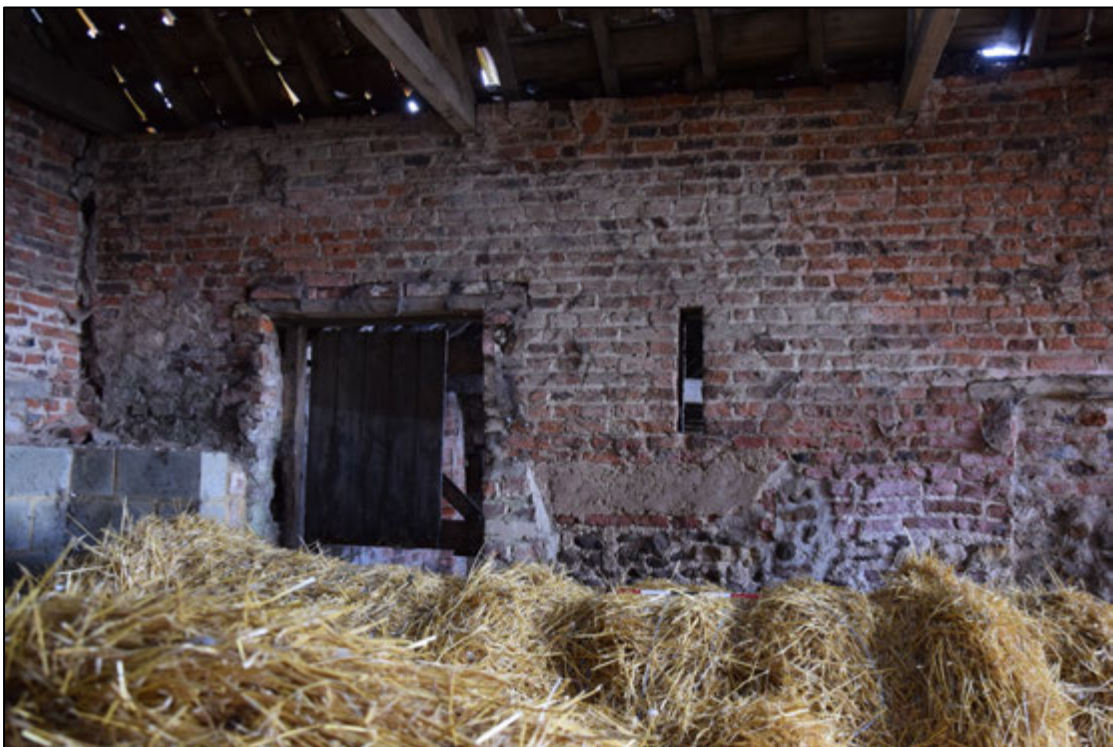
Photograph 68: Most of the brickwork at the south-west corner of the barn is more even than that in the lower part of this wall, or at the north end (Photo 62)

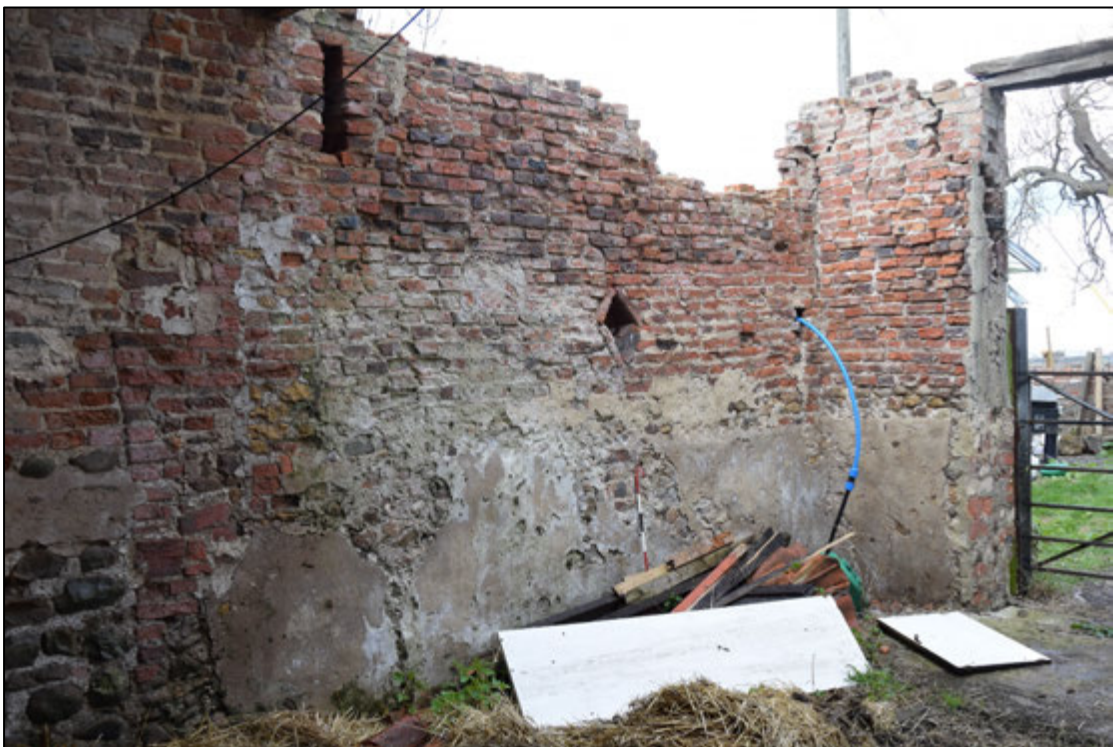
Photograph 70: Irregular brickwork and the diamond-shaped ventilator at the north-west corner of the barn

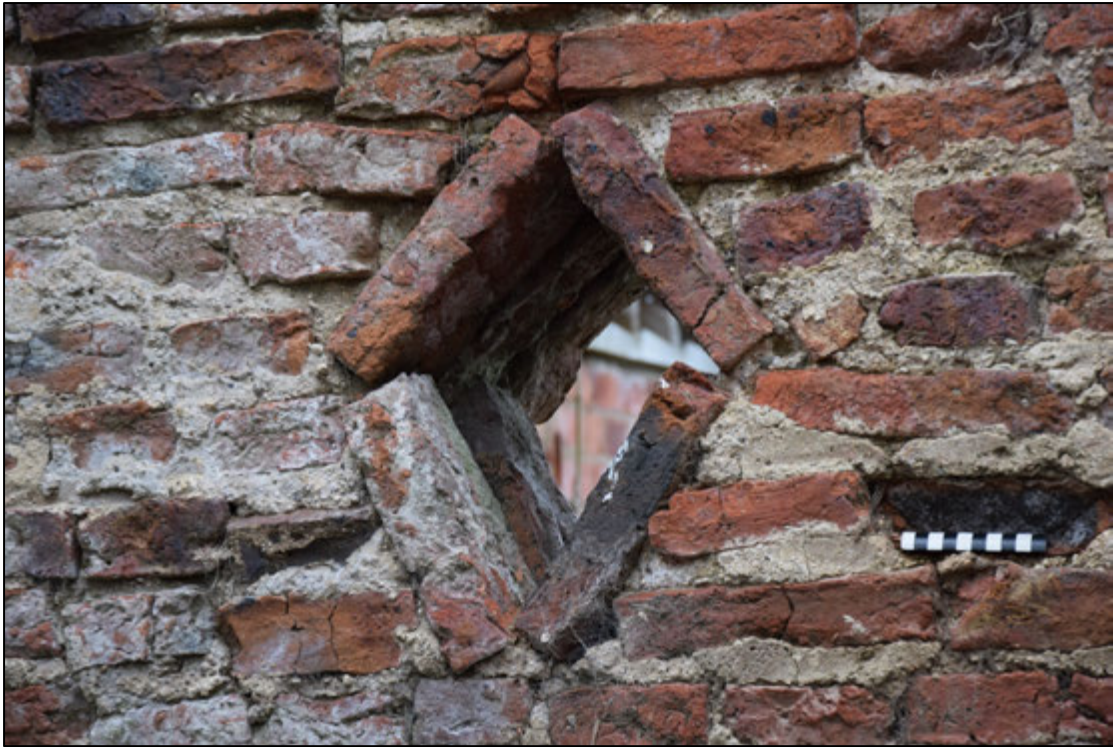
Photograph 71: Detail of the ventilator seen in the previous photograph. The scale is 10cm long

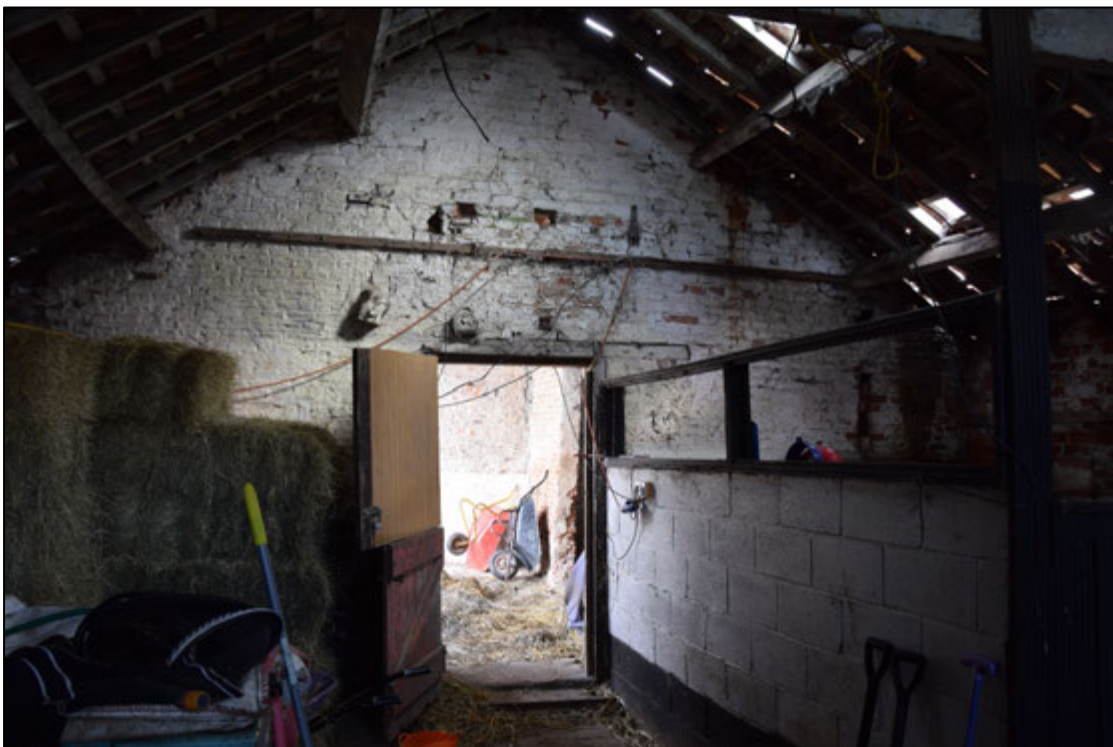
Photograph 72: The west face of the stable seen from the stable. No evidence of openings or fittings connected with a gin-gang can be seen here

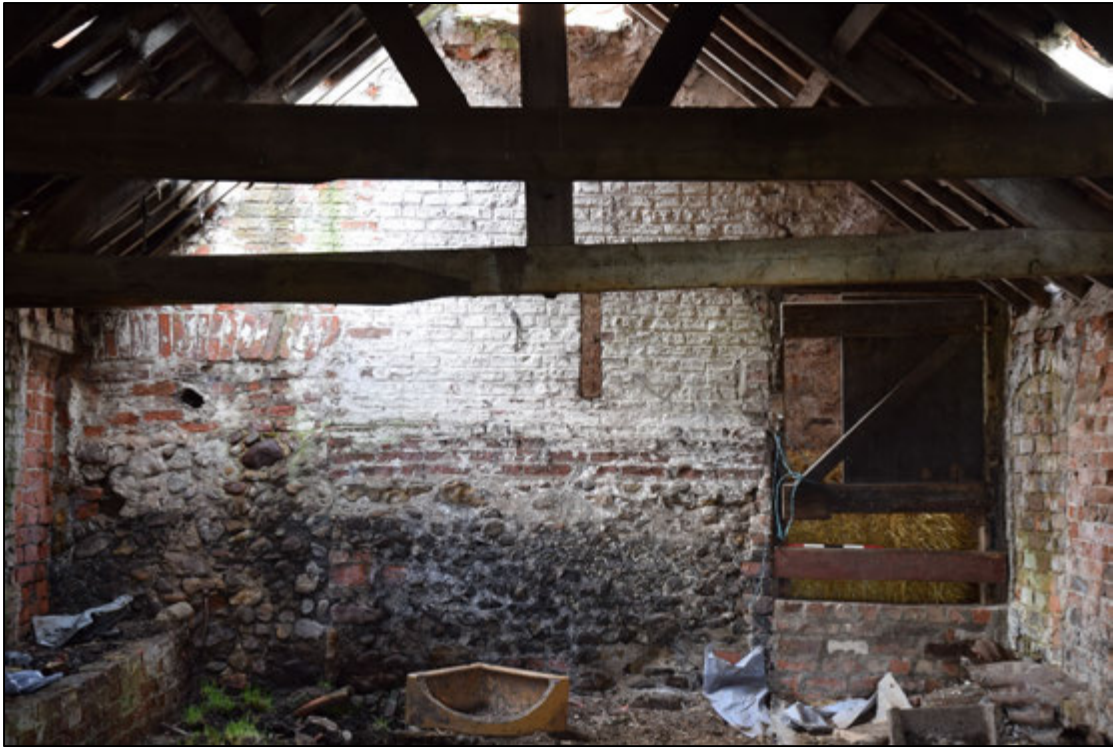
Photograph 73: The west face of the stable seen from the byre. The door at the left is blocked with a mixture of stone and brick, reflecting the old and later masonry of the wall

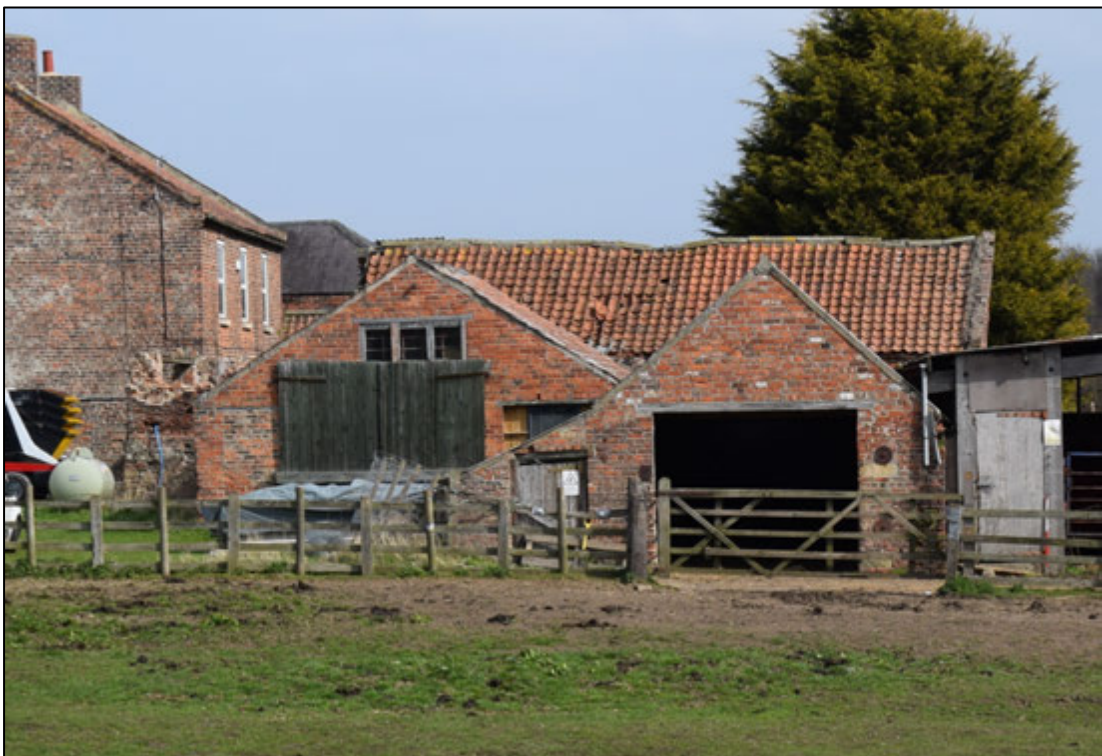
Photograph 74: The west end of the byre, building E, with the stable at the left and the later bull pen G at the right

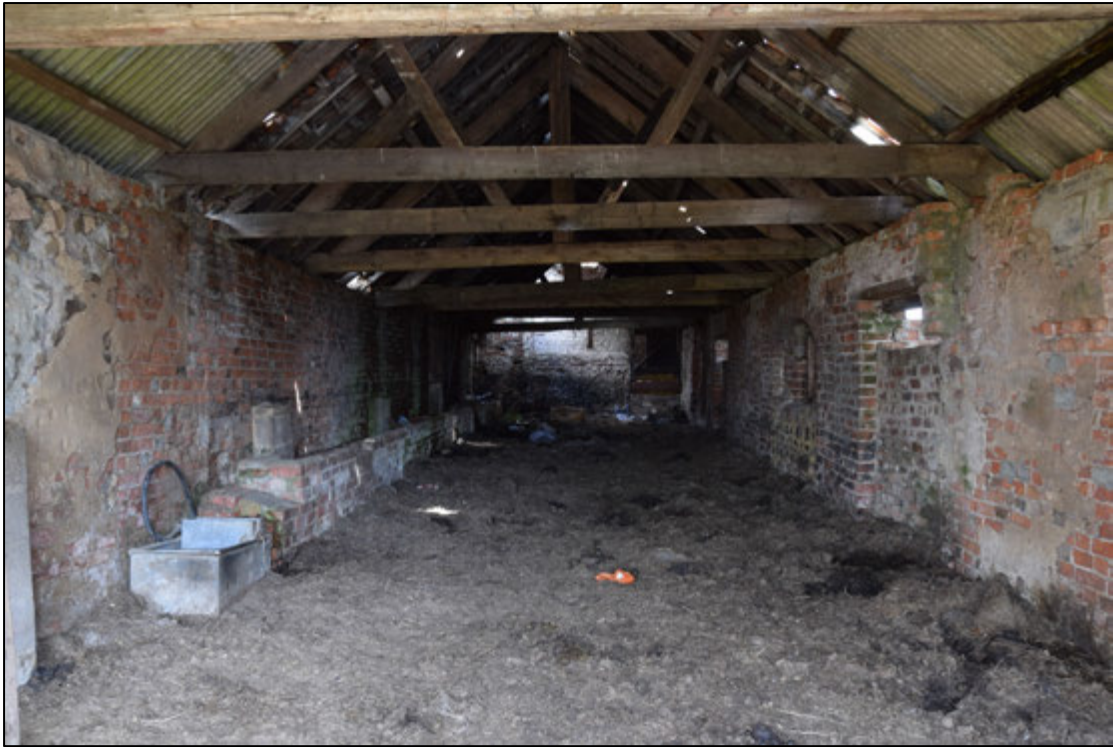
- 5.17 This building, at the centre of the western group, is a long single-storey shed that runs east-west (Photograph 74). The original pantile roof survives except at the west end, where it has been replaced by asbestos cement sheets. The earth-floored shed was probably originally a free-standing four-bay structure but it has been extended at either end. A change in wall thickness and roof truss form at the west end demonstrates this change (Photograph 75). A brick trough runs along the north wall, extending as far as the original west end; it runs across two blocked doors (Photograph 76). A thicker section of wall between these doors is probably part of a pier from the vanished gin-gang. A low door in the south wall leads to a modern feeding passage in the adjoining building G; beside this is the ragged stub of the old end wall (Photographs 77, 78). West of this, the south wall is thicker than in the end extensions and this thick section ends with another ragged stub that marks the west end wall (Photograph 79). In the thick wall there is a pair of arched openings of the sort often seen in cow byres; both are now blocked (Photographs 80, 81). As far as can be seen, these slightly low arches open at the level of the gangway in building G, which is well above the natural ground level. This suggests that the site was altered in the first half of the 19th century. In the old central section of the byre, the roof has typical agricultural king-post trusses; the extended west end has crudely nailed trusses with diagonal struts (Photograph 82).

Photograph 75: A view looking east along the length of the byre. The original west wall was near the drinking trough

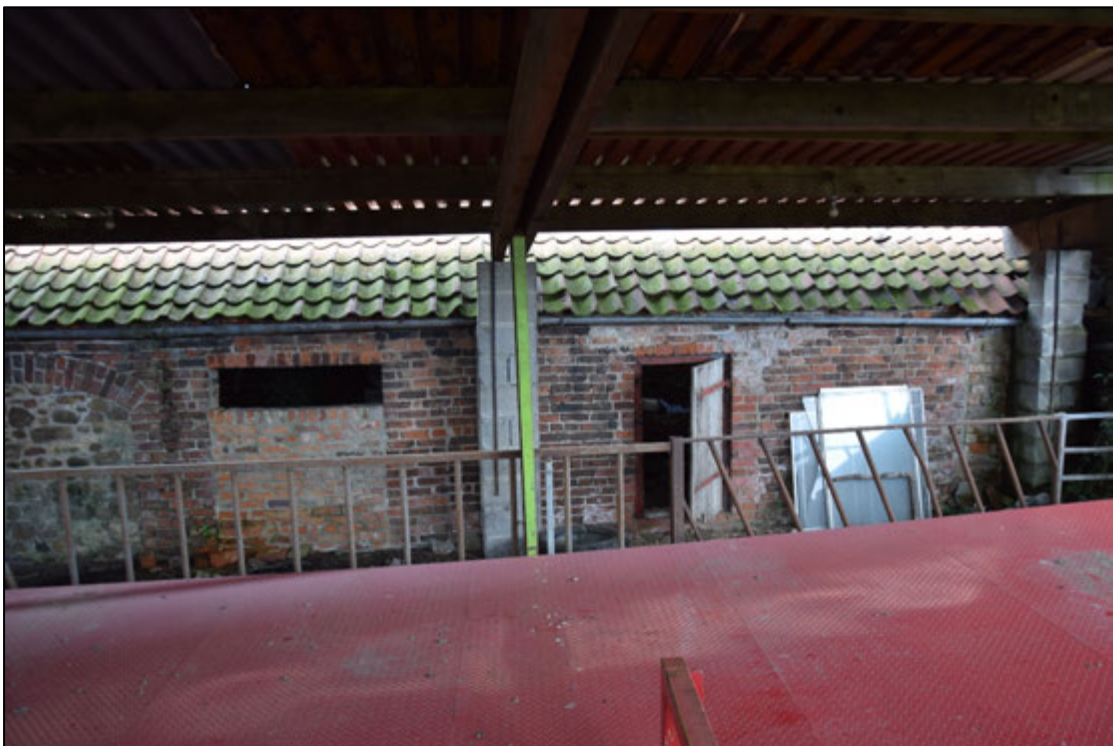
Photograph 78: The outside of the same section of wall, seen from building G

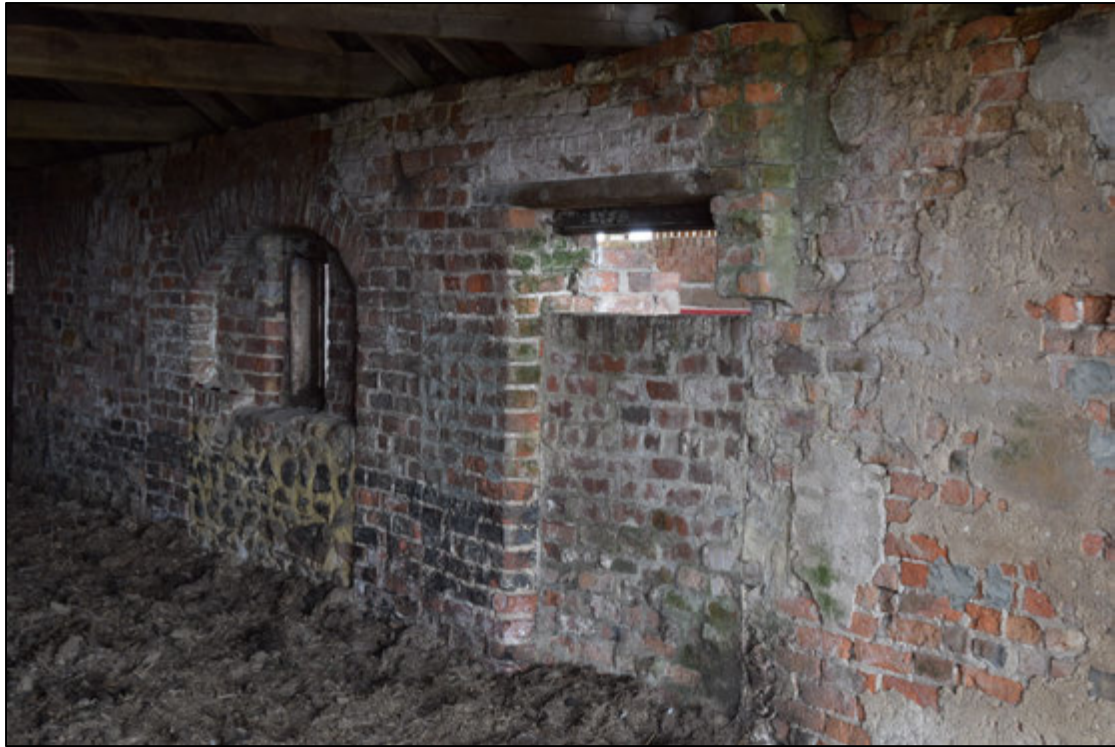
Photograph 79: The west end of the south wall. The thicker section, centre and right is part of the original building

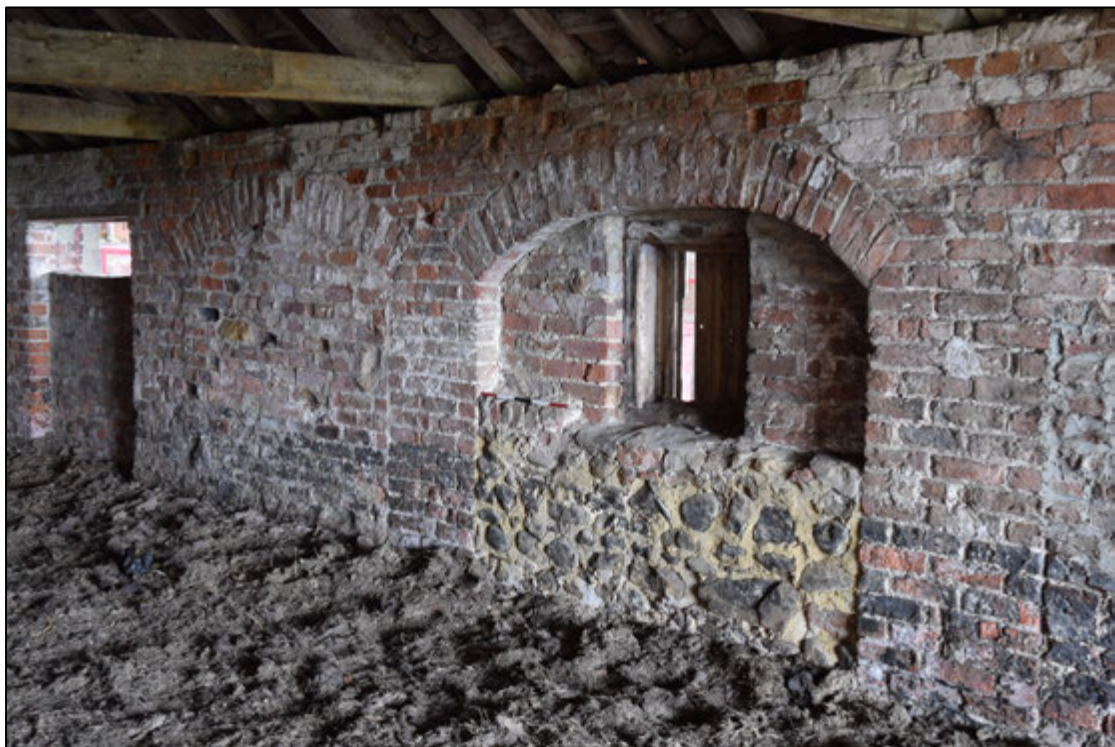
Photograph 80: The twin arched openings in the south wall of the byre. A view looking south-east

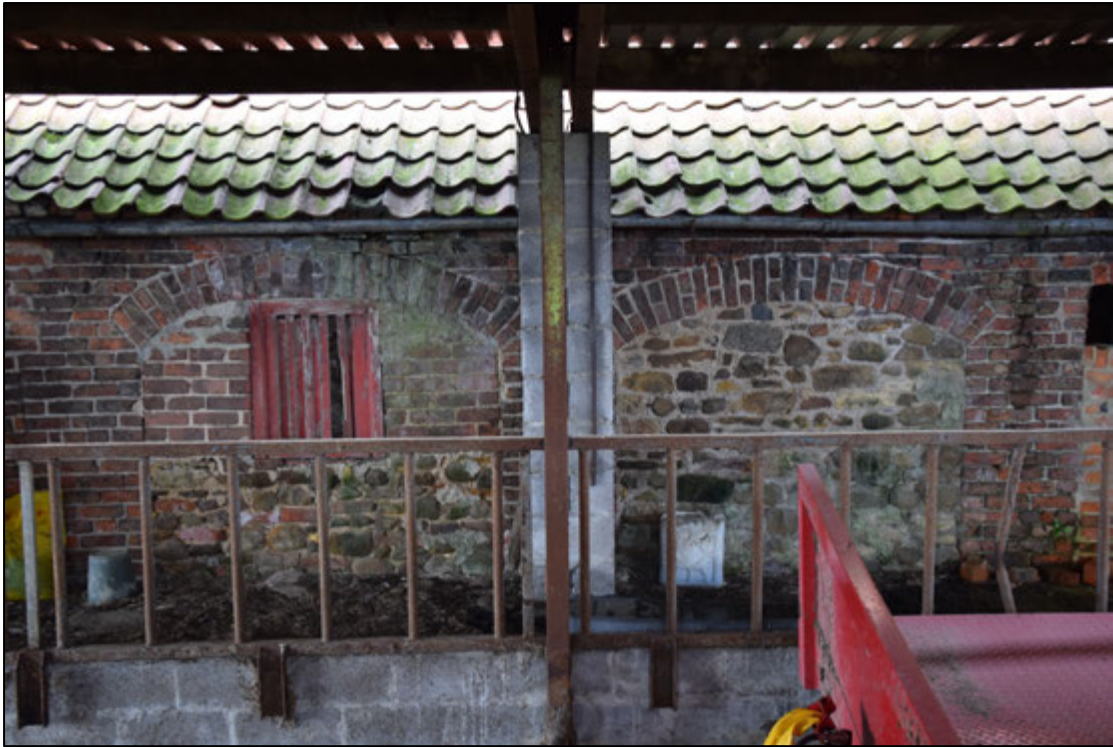
Photograph 81: The same openings seen from the outside

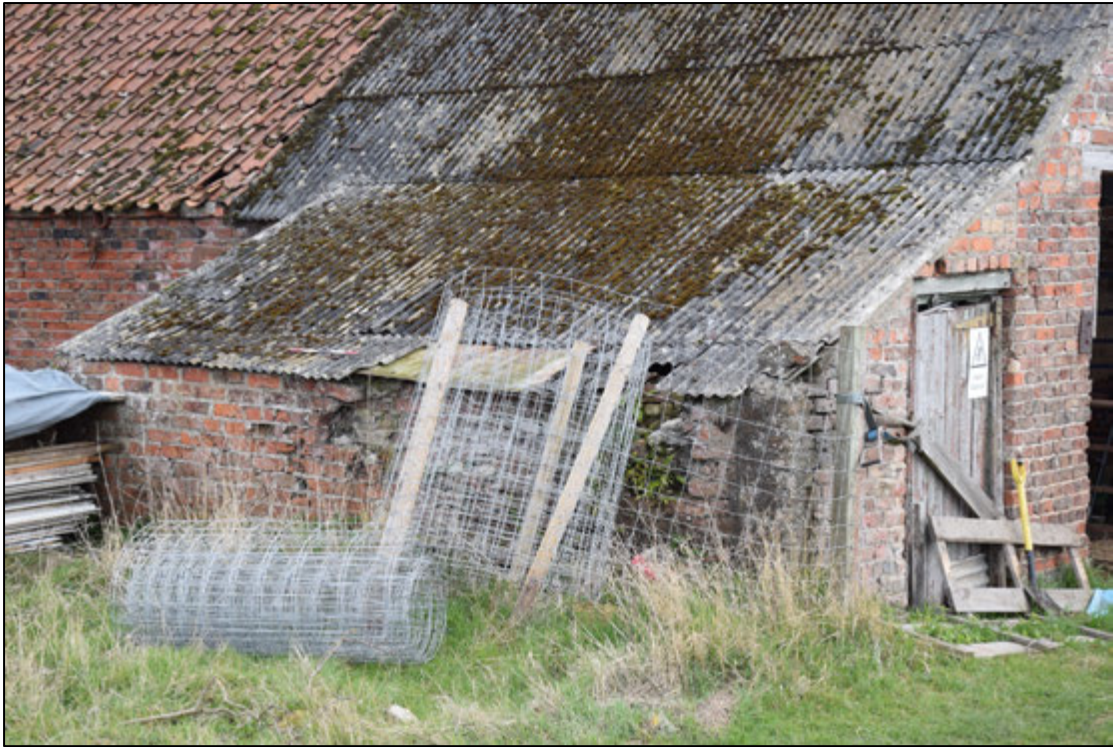
- 5.18 This small lean-to shed abutting the north wall of the byre is all that remains of the west range shown on the 1857 map (Photographs 83, 84). Its internal wall has recently been pierced to make a door for dogs (Photograph 85).

Photograph 83: The small shed F is all that remains of a west range shown on the 1857 Ordnance Survey map

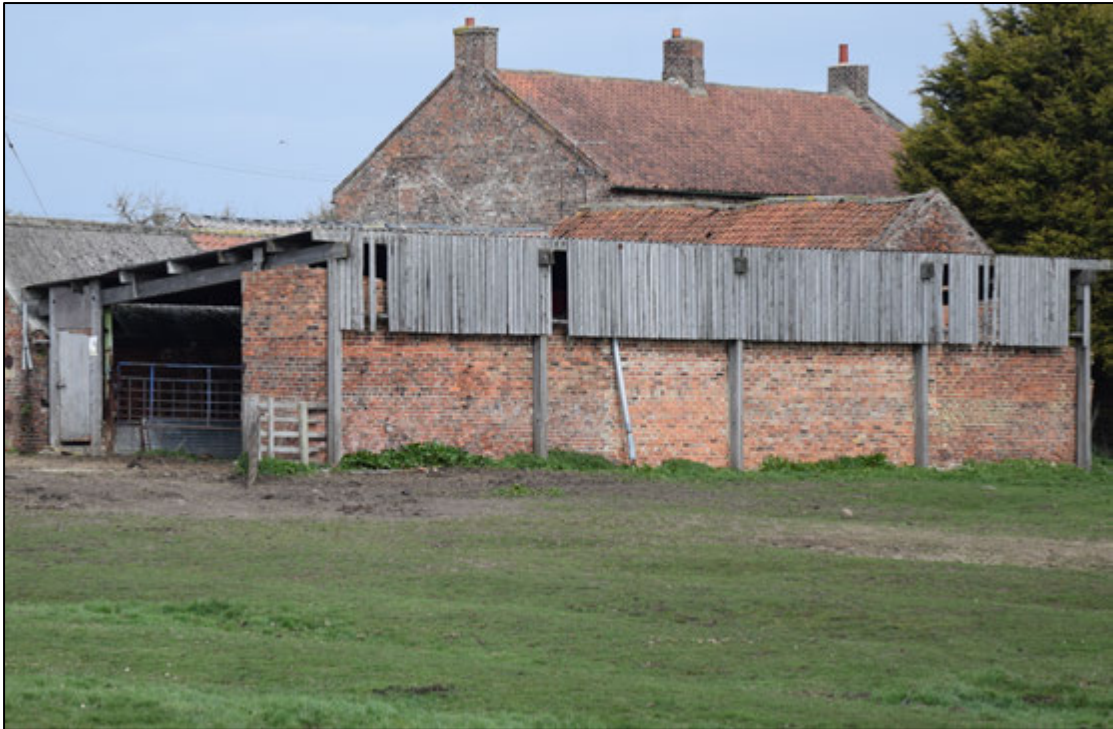
was added on the north side. Some variations in the brickwork mark the older fabric (Photographs 86, 87). The walls at the east end have been reinforced with concrete blocks; straight joints can be seen in places inside the shed (Photographs 88, 89).

Photograph 86: Building G retains some traces of the two brick buildings that stood here until after the Second World War

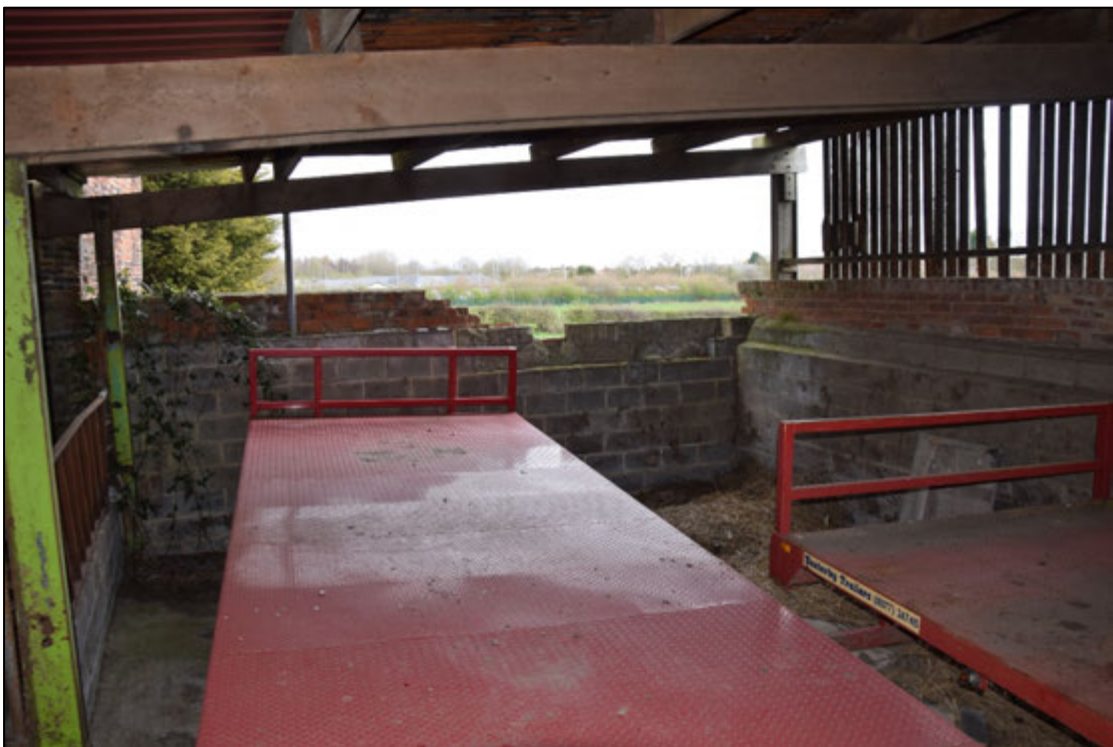
Photograph 87: Building G seen from the south-west

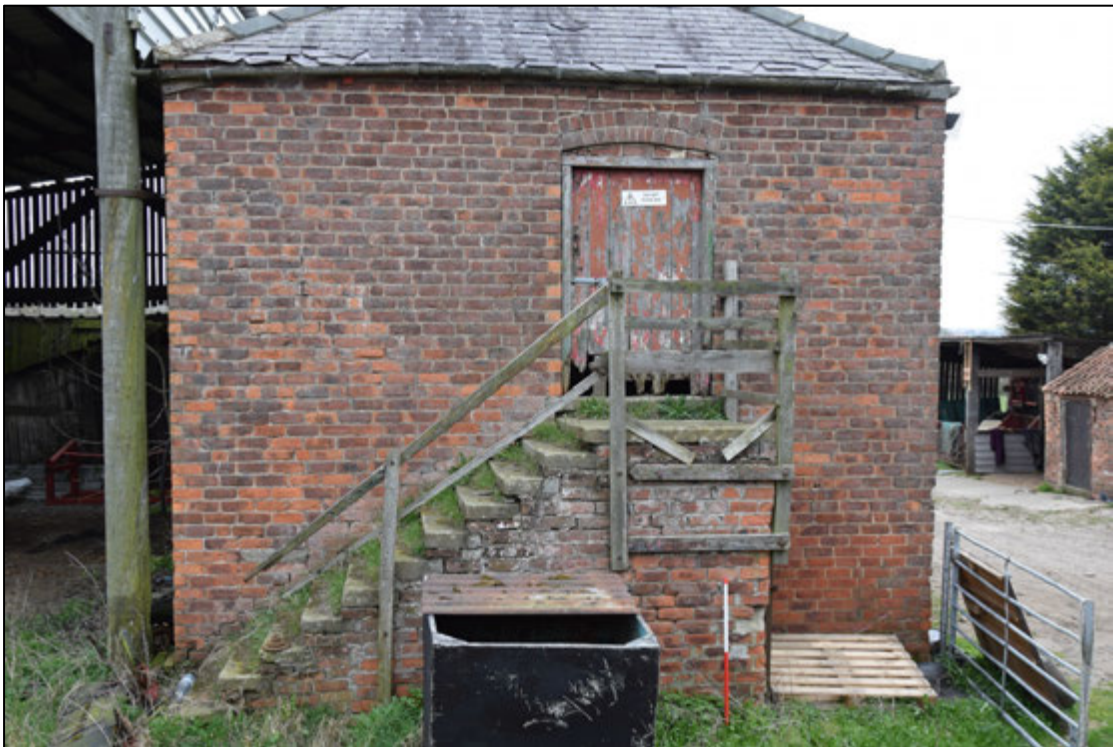
- 5.21 This detached building, east of the house, is a two-storey brick structure with a hipped slate roof (Photograph 93). The ground floor is a cart shed with three arched openings. An external staircase on the north wall, strongly built of brick and stone, gives access to a first-floor granary (Photograph 94). As is usual for buildings of this sort, the staircase and door are wide and there is a small shed or dog kennel below the stairs. The south wall, partly covered by a later lean-to, is blind. There are two windows in the west face and a loading door above the north arch (Photographs 95, 96). Two more windows in the west face are now covered by a recent shelter built to house a combine (Photograph 97). The cart shed is a single open space, the floor above supported by a long heavy timber beam carried on cast-iron columns (Photograph 98). The internal angles of the arches have rounded brickwork, a detail more usually used on external angles that might cause injury to stock or be vulnerable to damage (Photograph 99). The first-floor granary was not accessible but was viewed through a window. The walls are unplastered and there are no signs of grain bins (Photograph 100).

Photograph 93: The cart shed and granary, building I, seen from the north-west

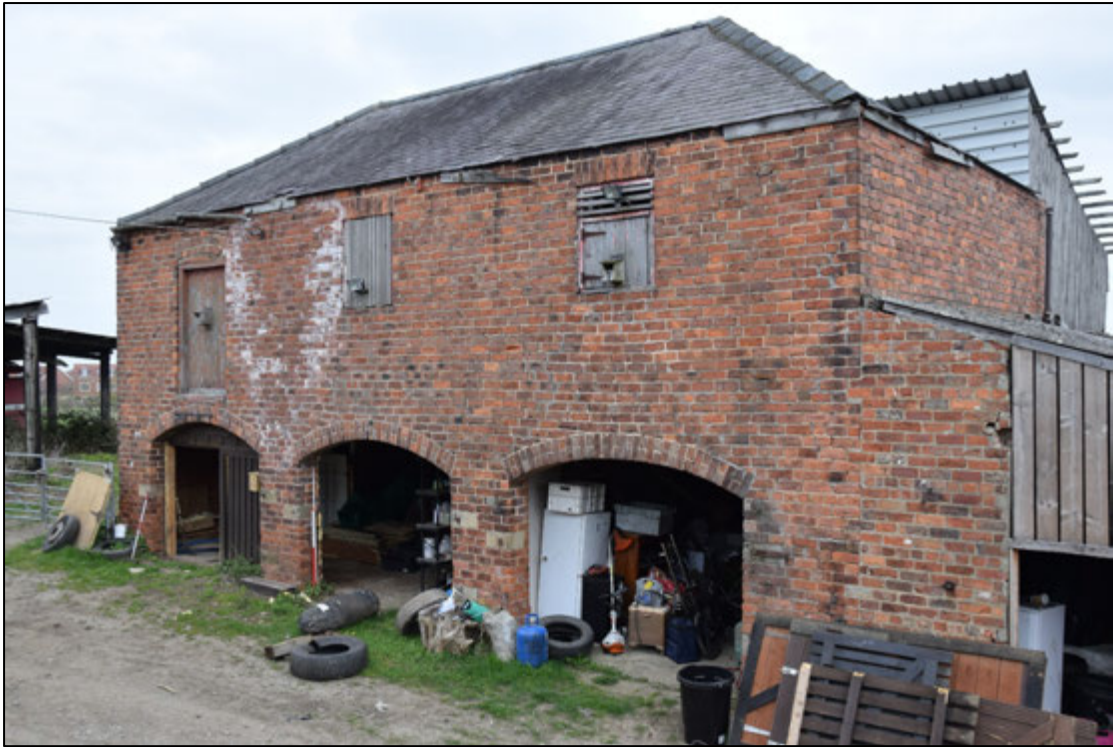
Photograph 94: The wide external stair at the north end is a typical feature of buildings of this kind

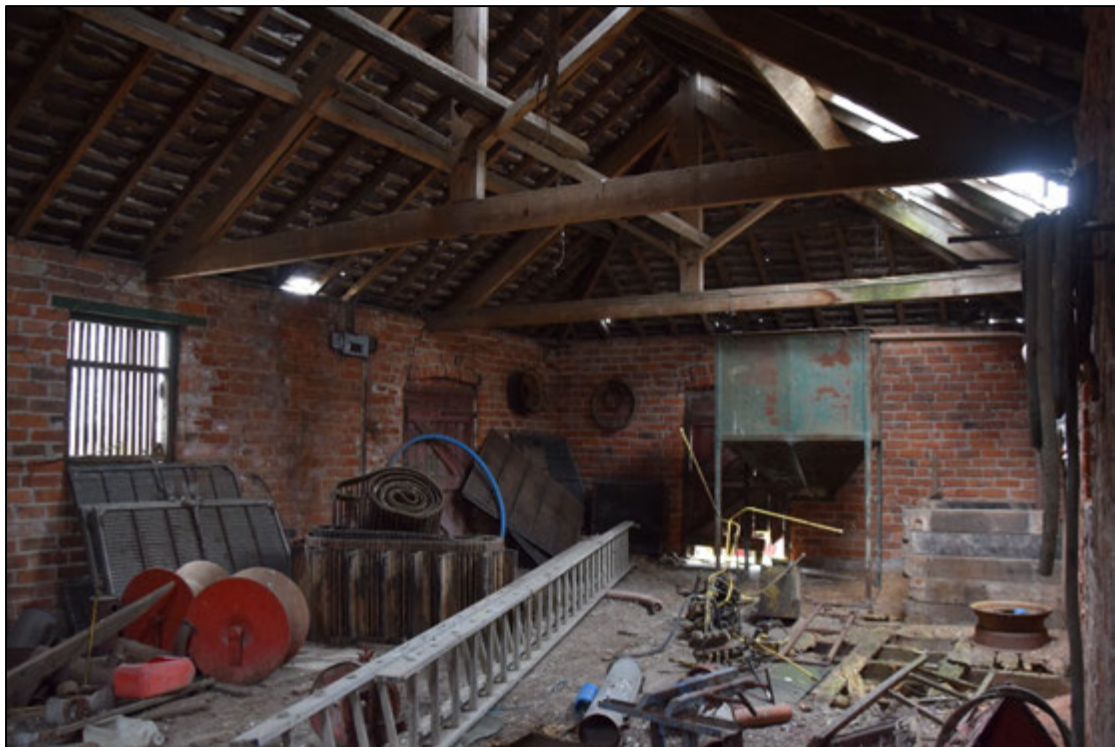
Photograph 100 (below): The interior of the granary, seen from the south-east window
