ARCHAEOLOGICAL  
SERVICES  
DURHAM UNIVERSITY

Sheraton Hill Farm  
Sheraton  
County Durham

archaeological building recording

report 5050  
May 2019

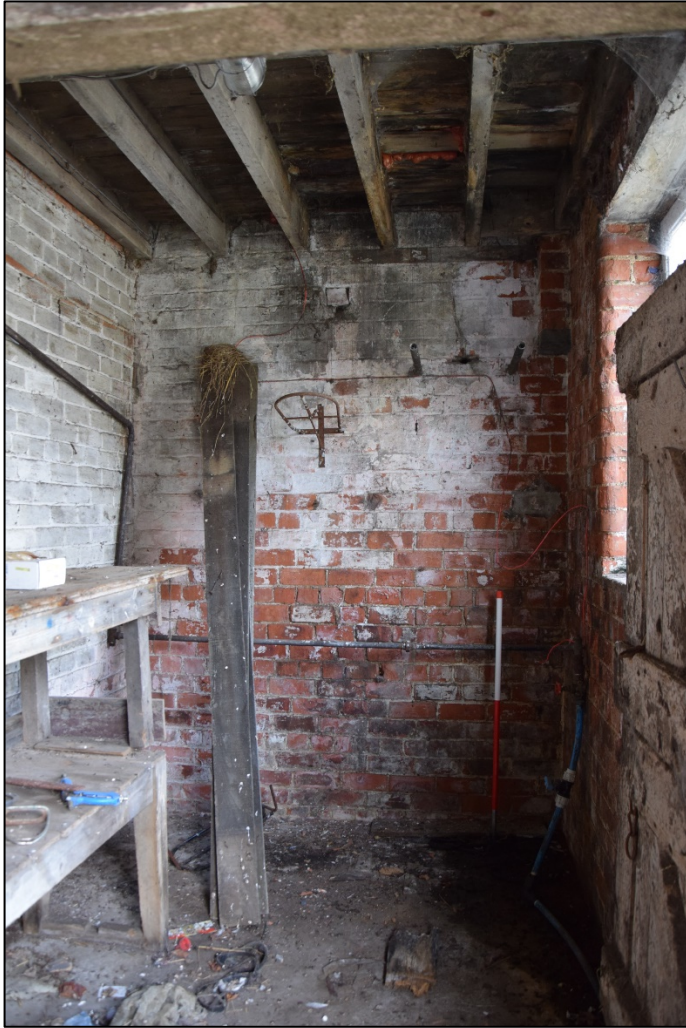
Photograph 19 (left): The small store room [5]. Note the bull-nosed brick around the window
