ARCHAEOLOGICAL
SERVICES
DURHAM UNIVERSITY

Buildings at East Field House
Mickleton
Co Durham

archaeological building recording

report 5173
October 2019

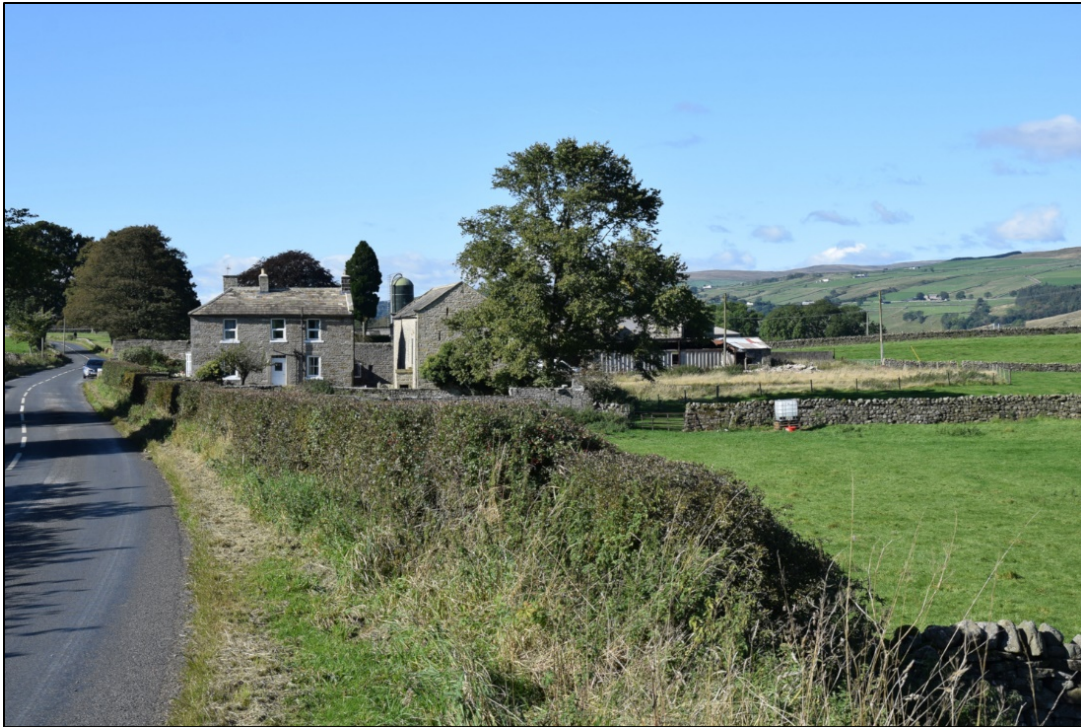
Photograph 1: The farmstead at East Field House seen from the Romaldkirk road just east of the site

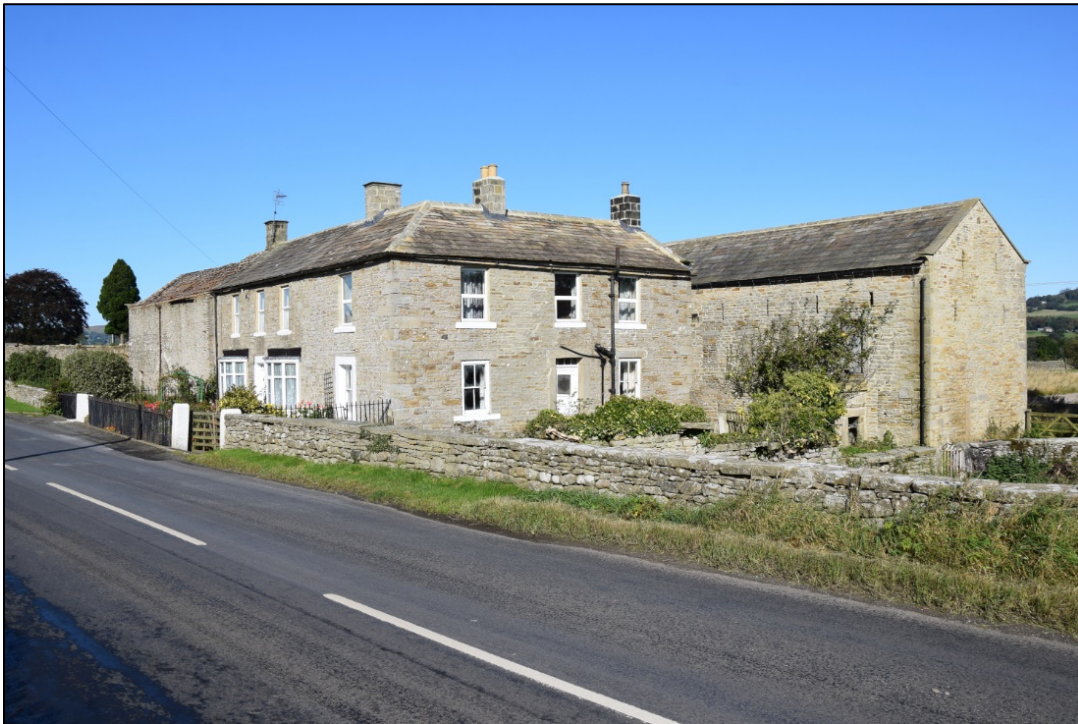
Photograph 2: The L-shaped houses at the east side of the site. Building 1 is at the right and building 2 continues the range at the left

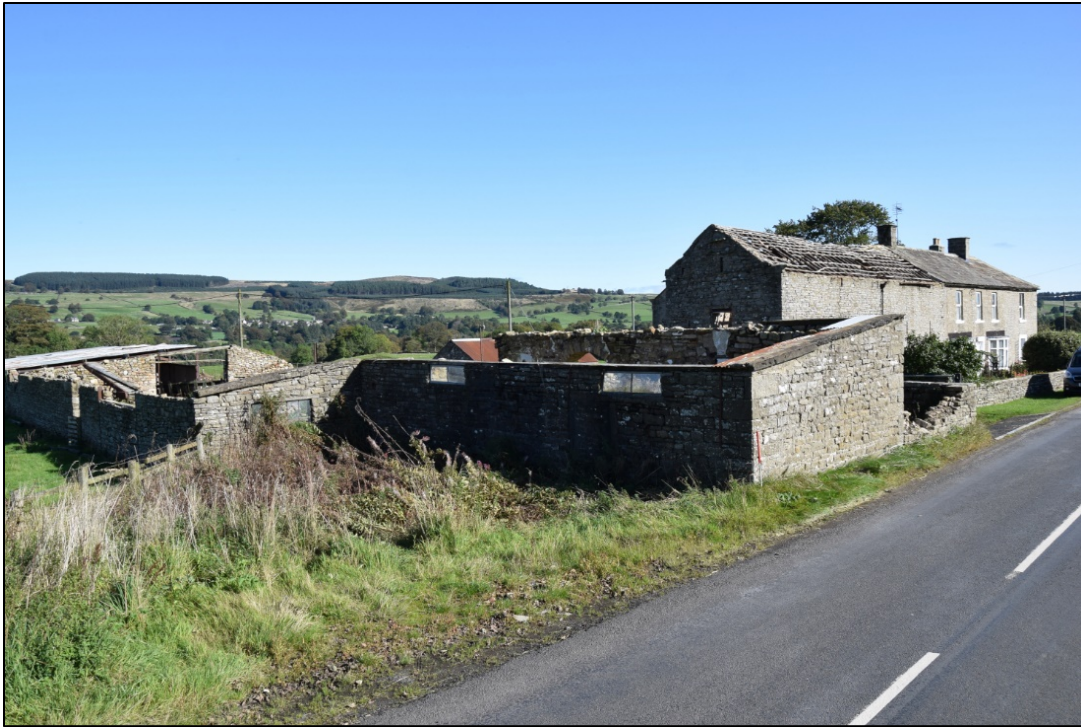
Photograph 3: The site from the south-west, with the truncated building 4 in the foreground

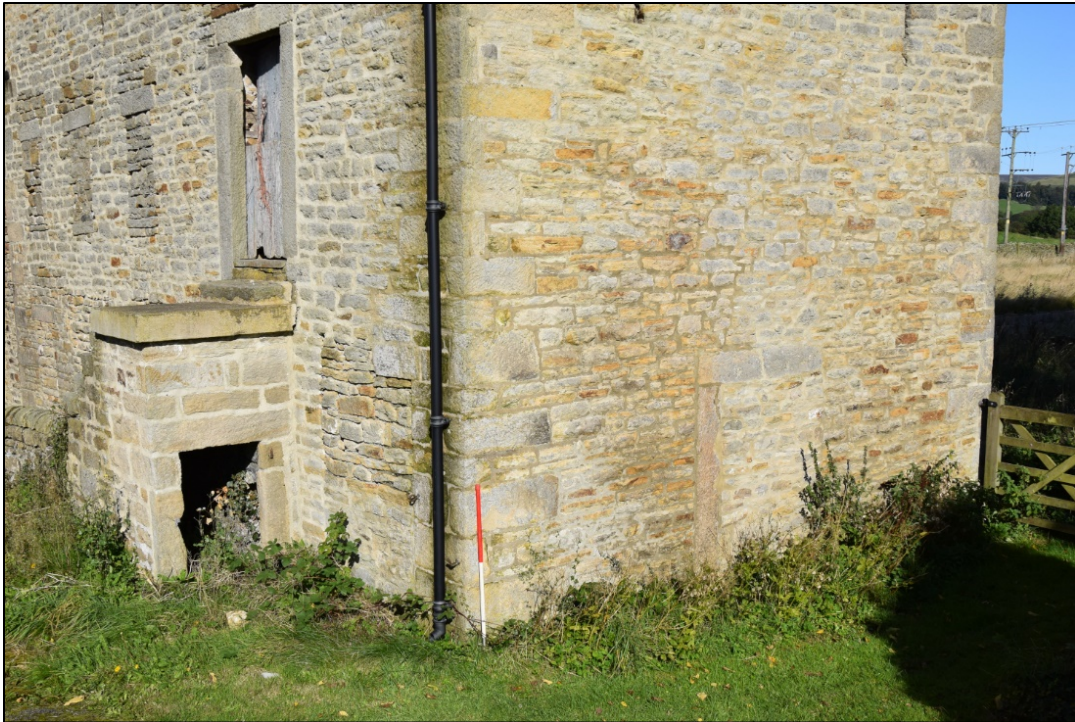
Photograph 5: The blocked opening at the east end of building 1. Recent repointing is apparent, as is the rebuilding of the stone staircase

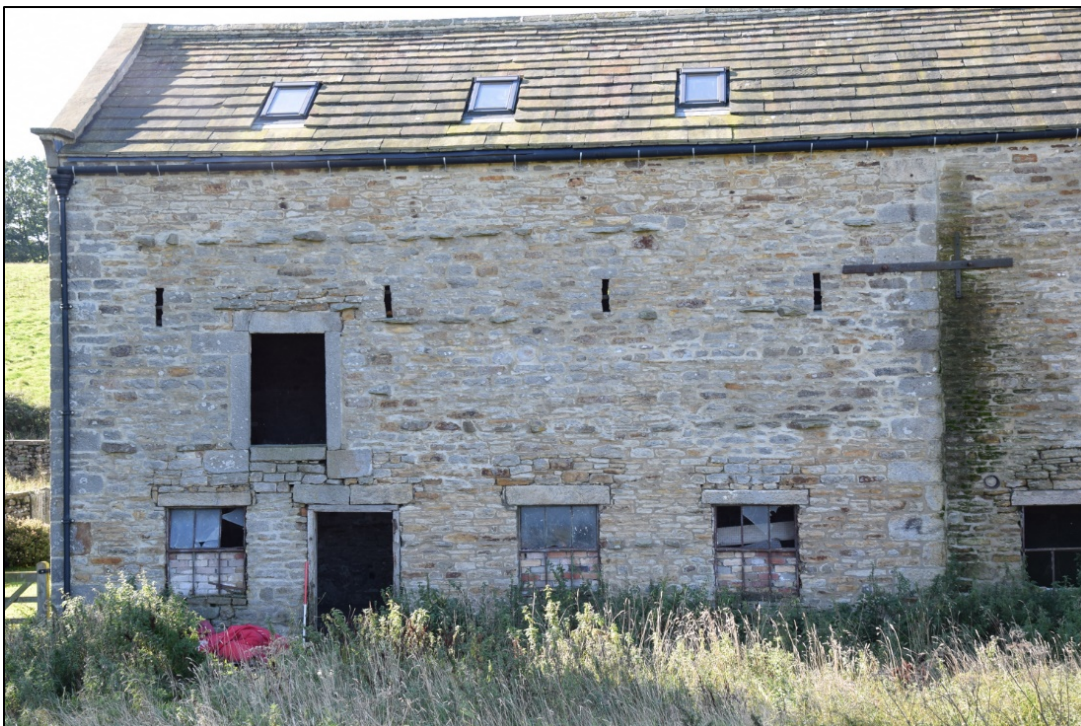
Photograph 10: The north face of the older part of the building

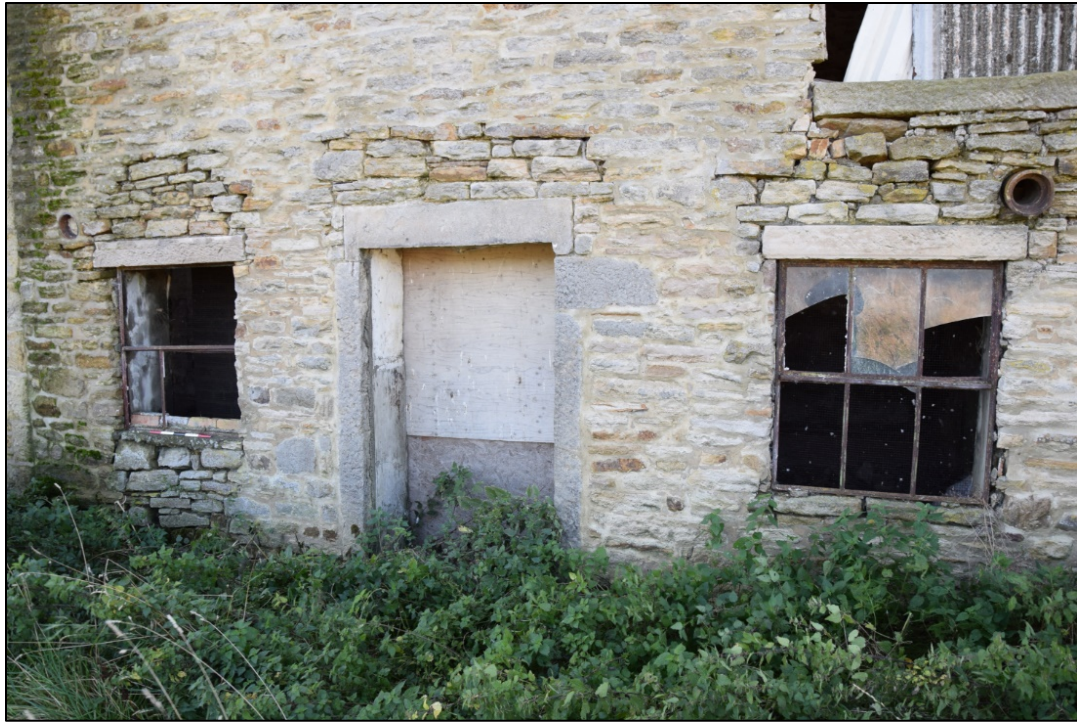
Photograph 13: The door and windows in the extension match those in the older block. The pipe is a ventilator for the cow byre

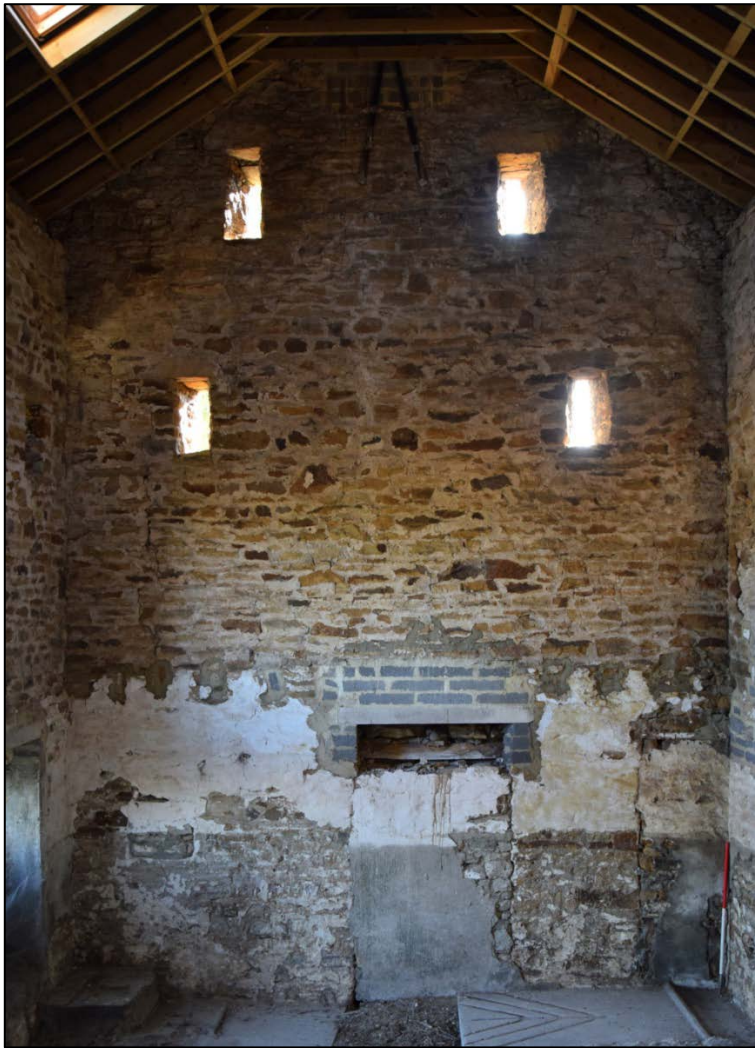
Photograph 17 (left):
The east end of building
1, showing the wall
finishes restricted to
the byre. There is no
sign of a loft; the roof is
new

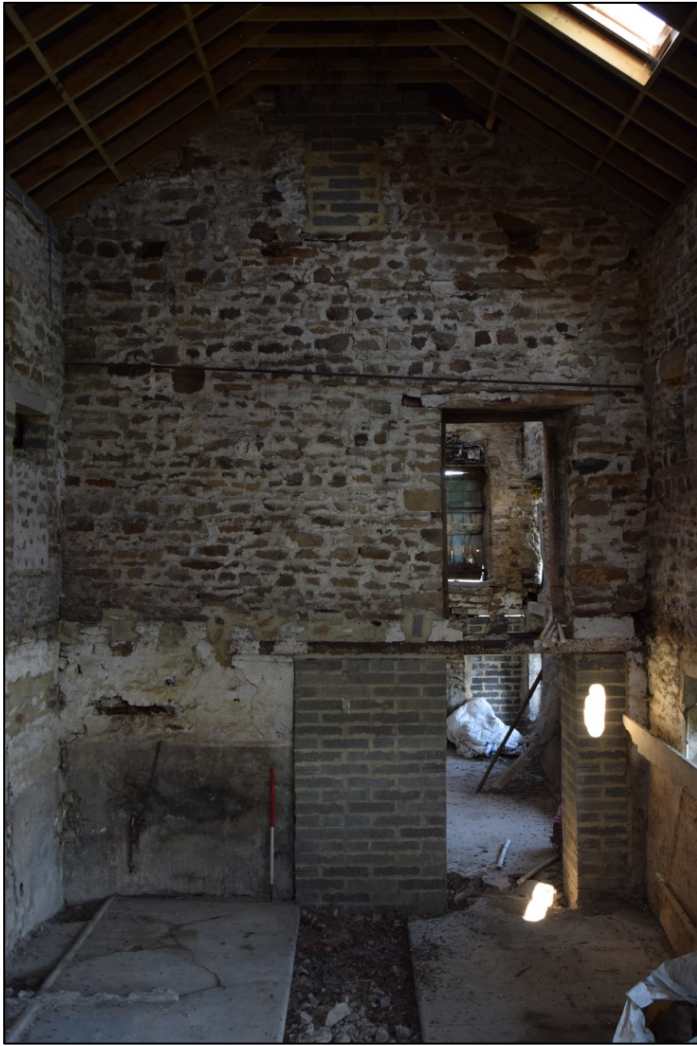
Photograph 19 (left): The old west end, now an internal wall, has been rebuilt at the base. The open door above would have been used for loading hay

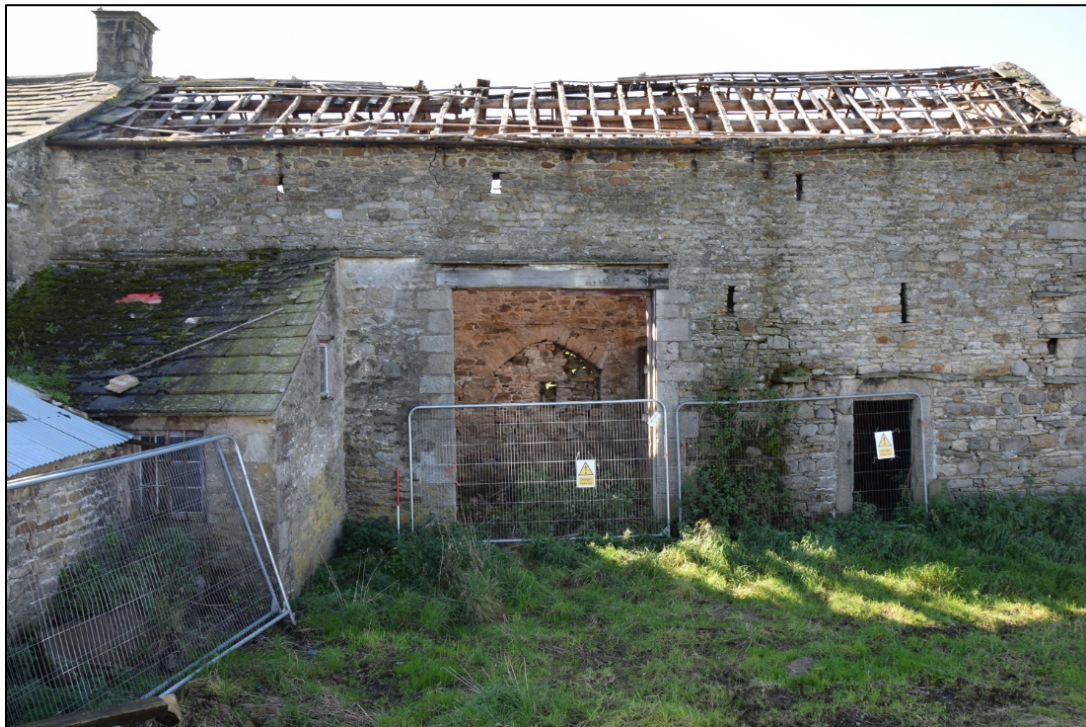
Photograph 28: The north face of building 2. Note the row of projecting throughs above the small door

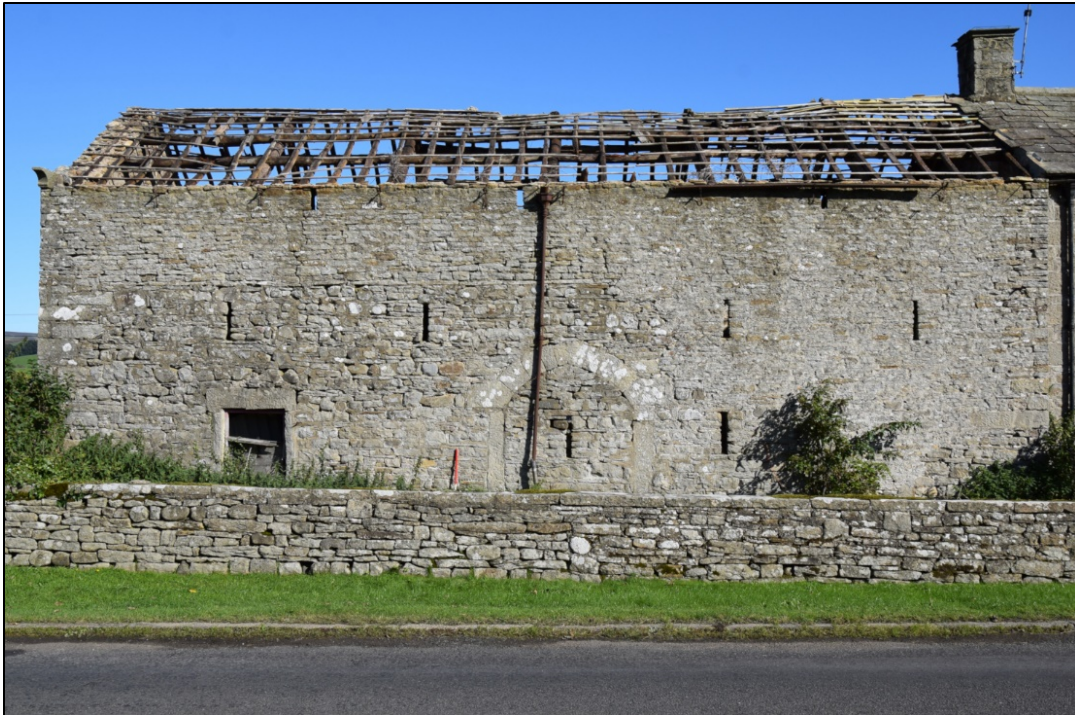
- 5.10 The south face has a large central door, older than the one on the north wall; it has a pointed stone arch (Photograph 31). It is now closed up and there is a breather in the middle of the blocking. A row of four breathers slits run across the middle of the face and there is a smaller door at the west end. Above the slits, the change in masonry is very clear. From the west end to the centre, the whole of the upper third

Photograph 31: The south face of building 2. The change in fabric can be seen as a neat horizontal line above the left-hand pair of breather slits

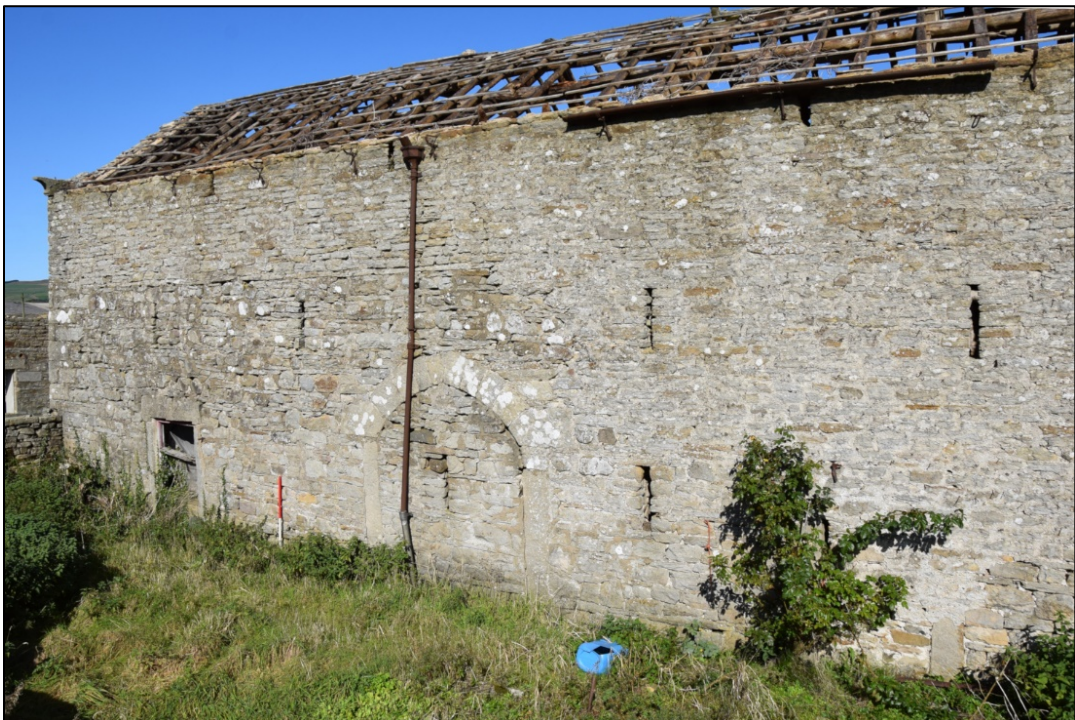
of the face has been rebuilt in thin courses of stone. The newer masonry extends to almost the full height of the wall east of the central door and it cuts across the lower part of a small door, the twin to the surviving example at the west end (Photograph 32). The difference between the two phases of masonry is very clear on either side of the main door (Photograph 33). The small west door has monolithic jambs and lintel and was partly blocked to create a window (Photograph 34); only the lower parts of the jambs of the east door survive (Photograph 35).

Photograph 32: The small door at the far end was matched by another at the east; the lower jambs can be seen below the shrub at the right

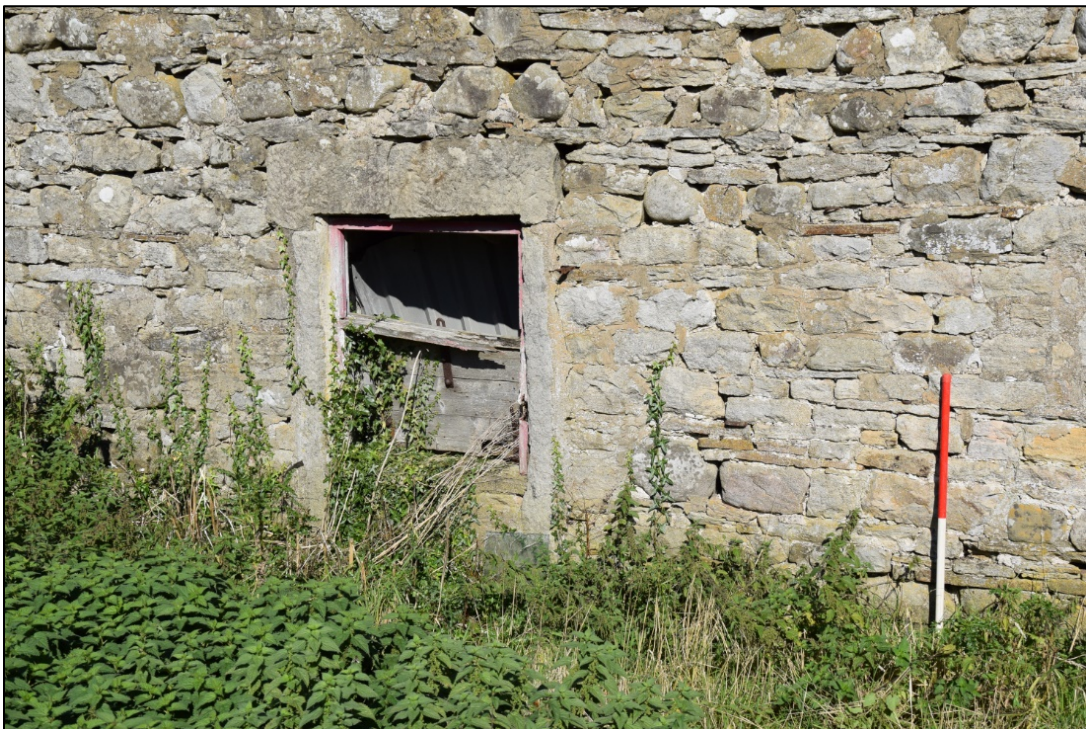
Photograph 34: The west door is partly blocked to form a window for the byre

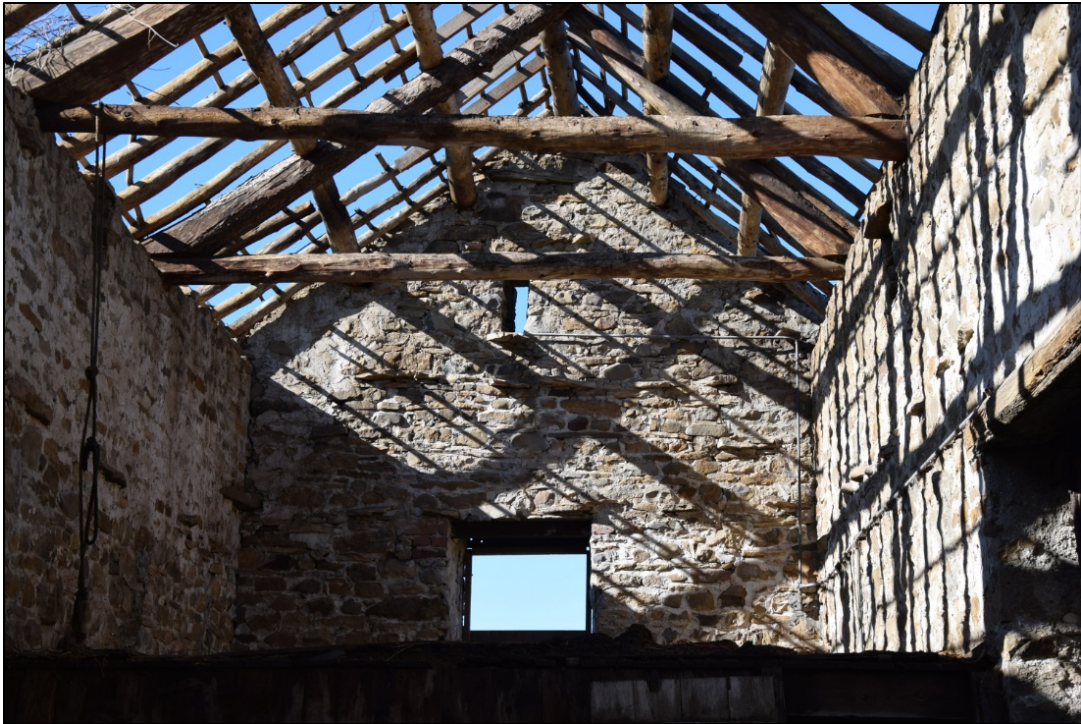
Photograph 37: The hay loft at the west end. There are more through stones here than on the outside faces of the walls. Note the crude roundwood timber of the replacement roof

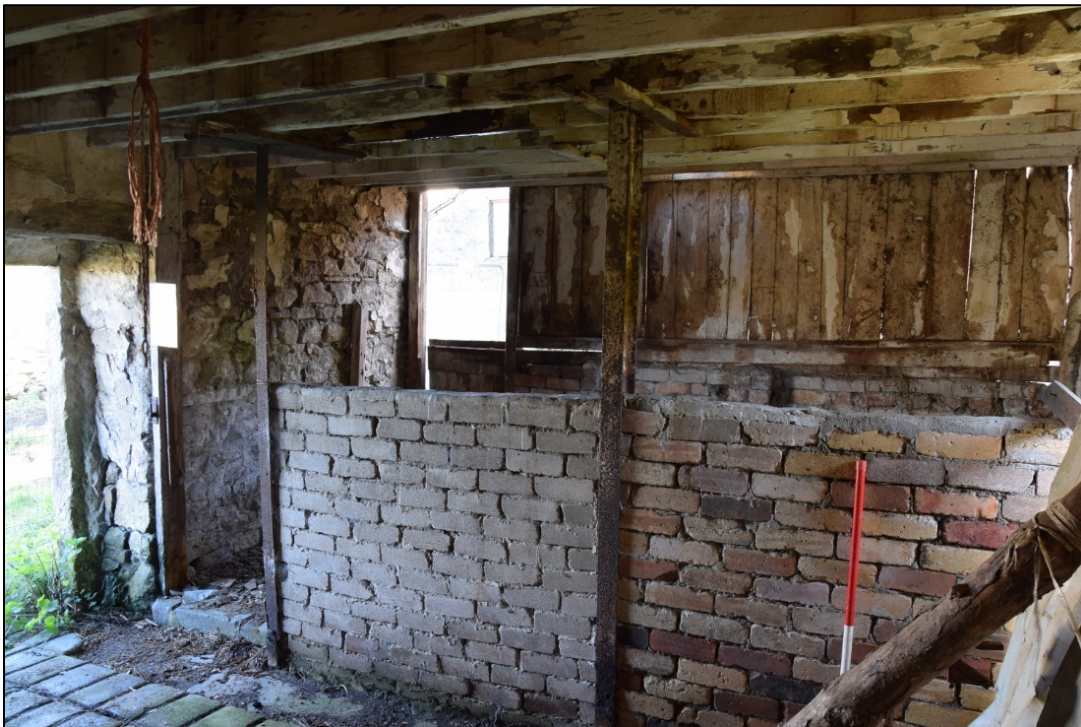
Photograph 38: A view looking north-east in the byre, with steel beams supporting the ceiling

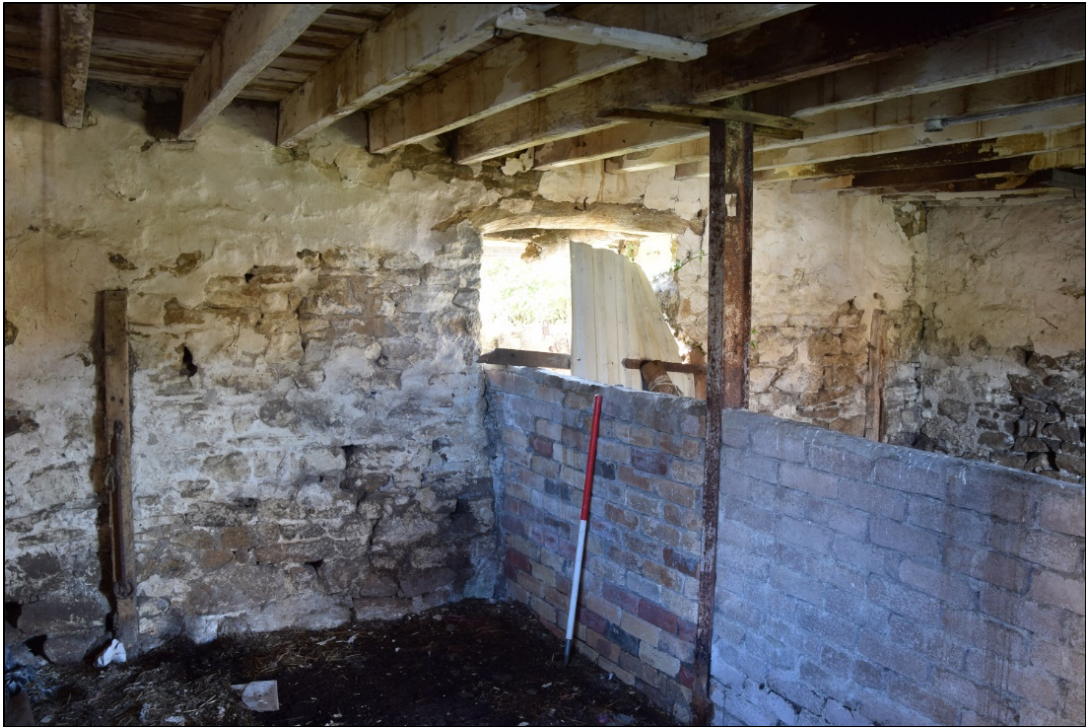
Photograph 39: This view, looking south-west across the byre, shows the old south door and a pair of tethering posts

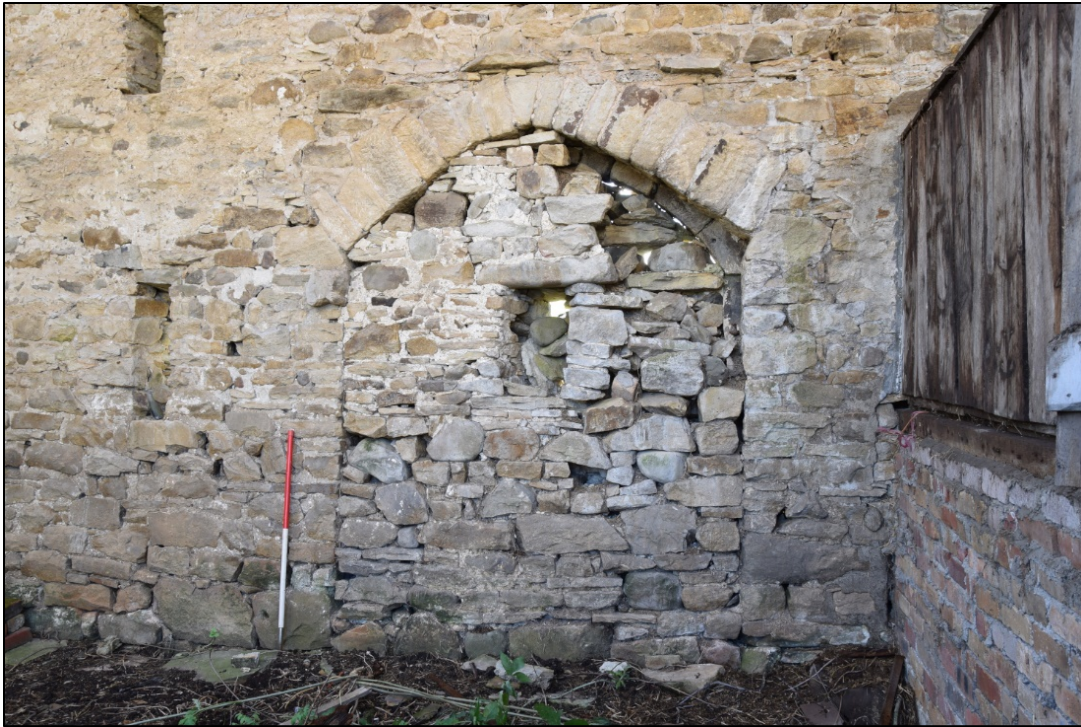
Photograph 41: Detail of the central door, showing the rebate and hinge pin

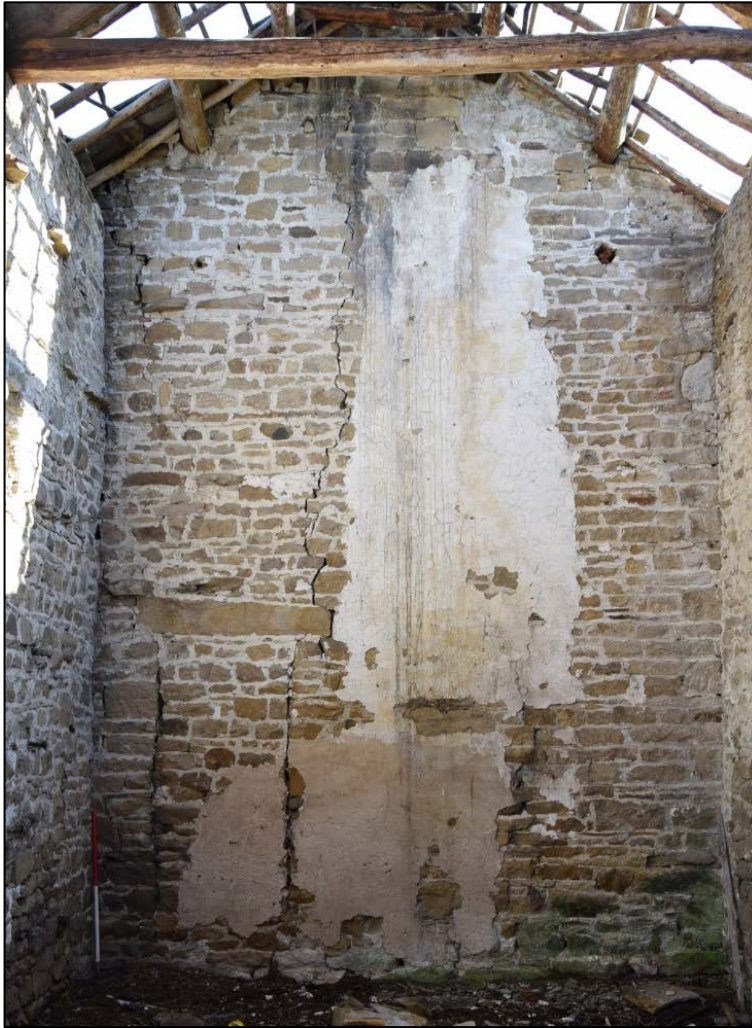
Photograph 43 (left):
The east end of building
2 has a door into the
adjoining house

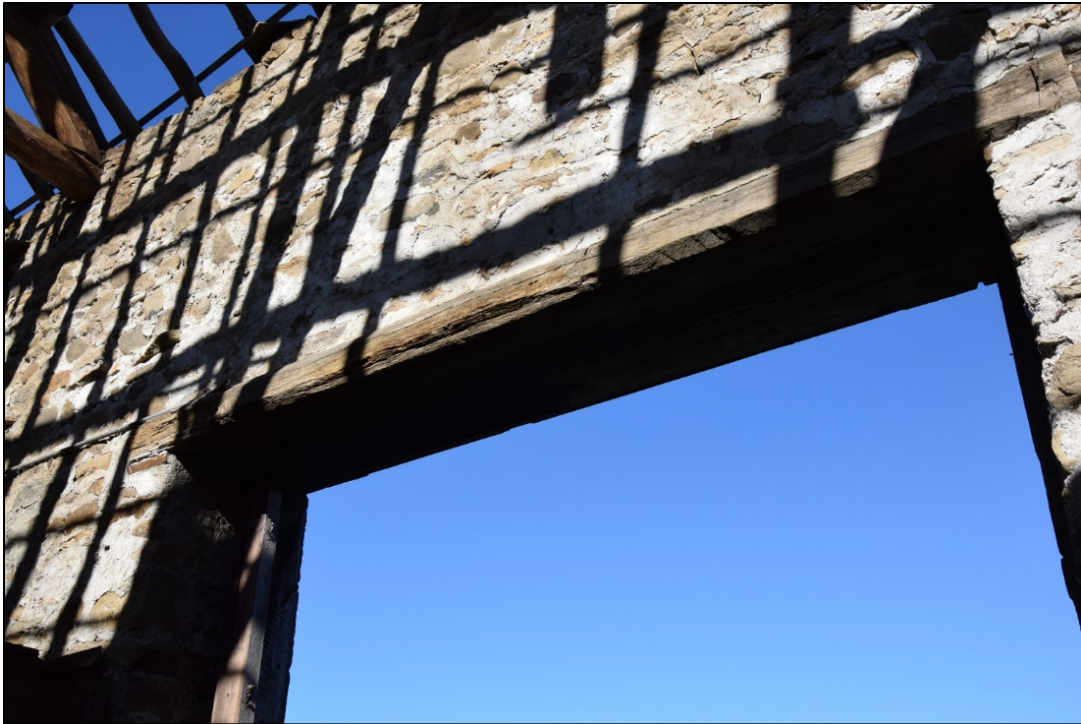
Photograph 45: The centre of the north wall and the later door

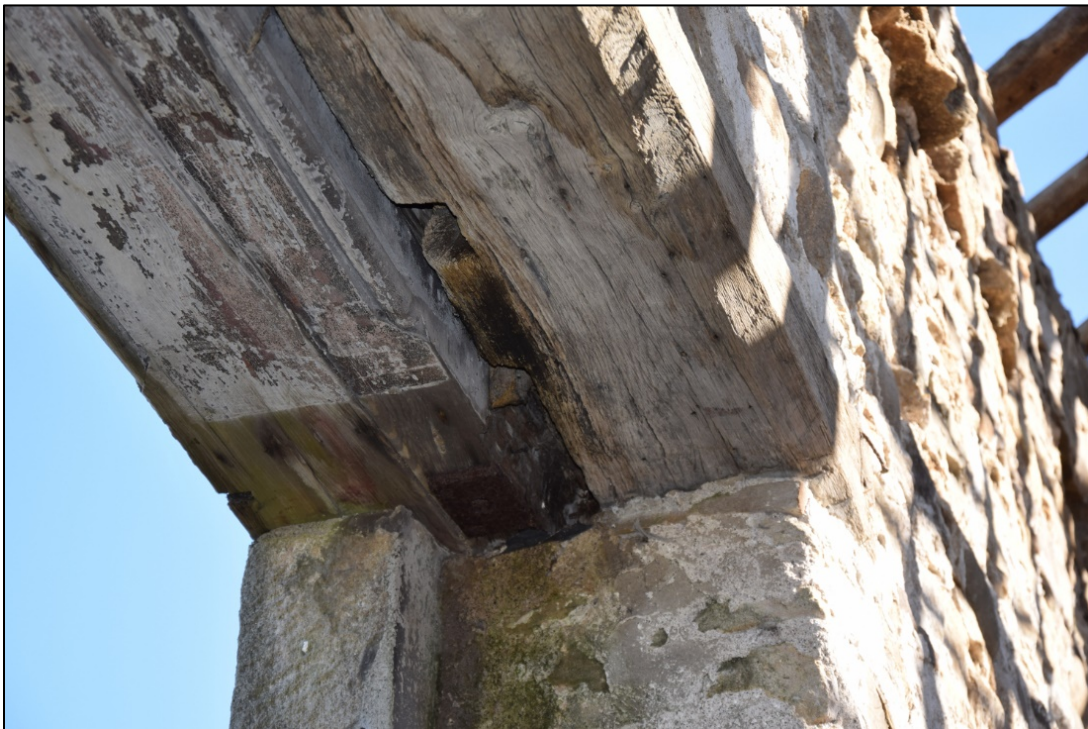
Photograph 46: Re-used timber in the lintel of the 20th-century door on the north side of building 2

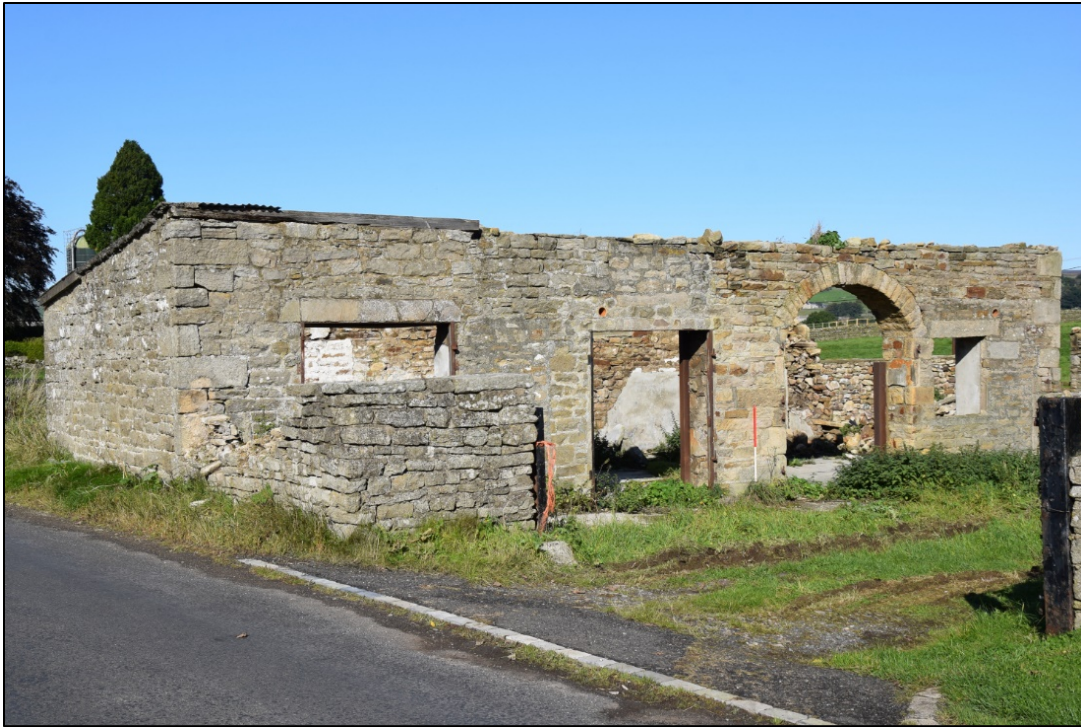
- 5.12 This small building is now a roofless shed (Photograph 47). A photograph of the site in 1964 shows it as a two-storey building with a windowless gable end facing the road (Tucker 2018, 2). The structure shows significant alterations. The two large doors at the south end of its east face are supported by steel beams (Photograph 48); a larger arched door to the north is also a recent construction, with a window to its north (Photograph 49). Most of the north end has been demolished, as has a later single-storey shed that adjoined it (Photograph 50). There are modern windows at the head of the west wall, one of which abuts an older blocked door (Photographs 51, 52). Four low breather slits, all blocked up, can be seen in the south wall (Photograph 53). Like the buildings already described, this was last used as a cow byre; one of the stall partitions remains in place and the marks of another four can be seen on the floor and the west wall (Photographs 54, 55). The stubs of two floor joists for a low ceiling can be seen at the north end of this wall; they are not matched on the opposite side of the building, showing that the upper wall at the north-east corner has been rebuilt (Photographs 56, 57). The same is true of the upper wall above each of the eastern doors (Photographs 58-61). Mid-20th-century plaster and a tethering staple remain on the south wall (Photograph 62).

Photograph 47: Building 4 seen from the south-east

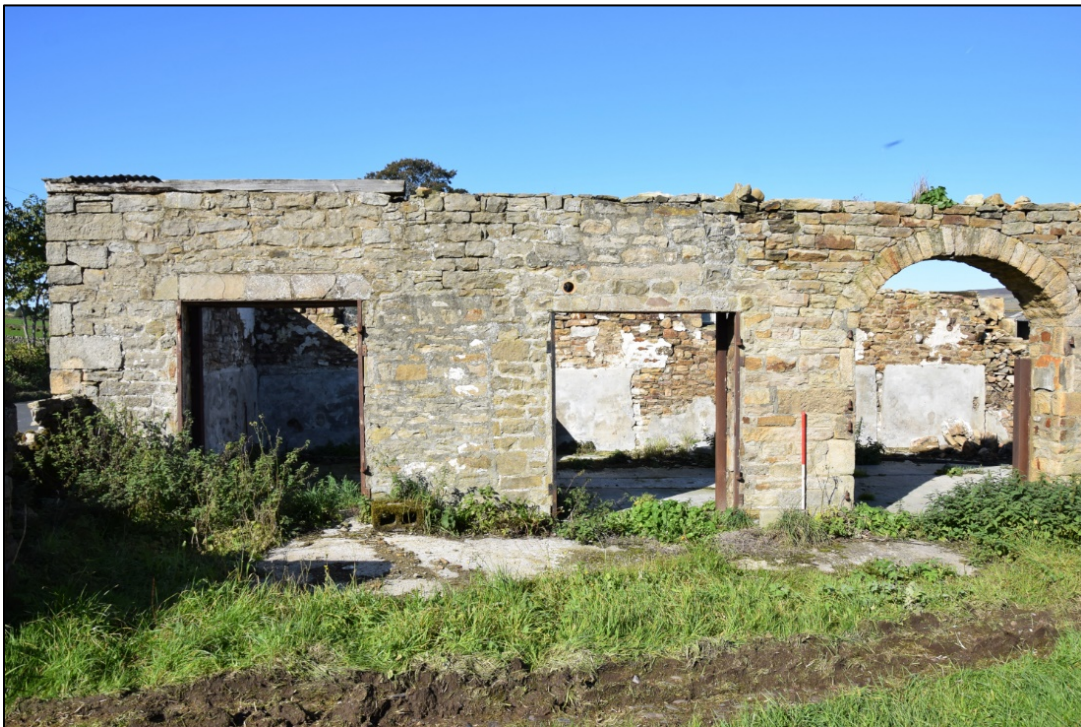
Photograph 48: Steel frames support the doors at the south end of the building's east face

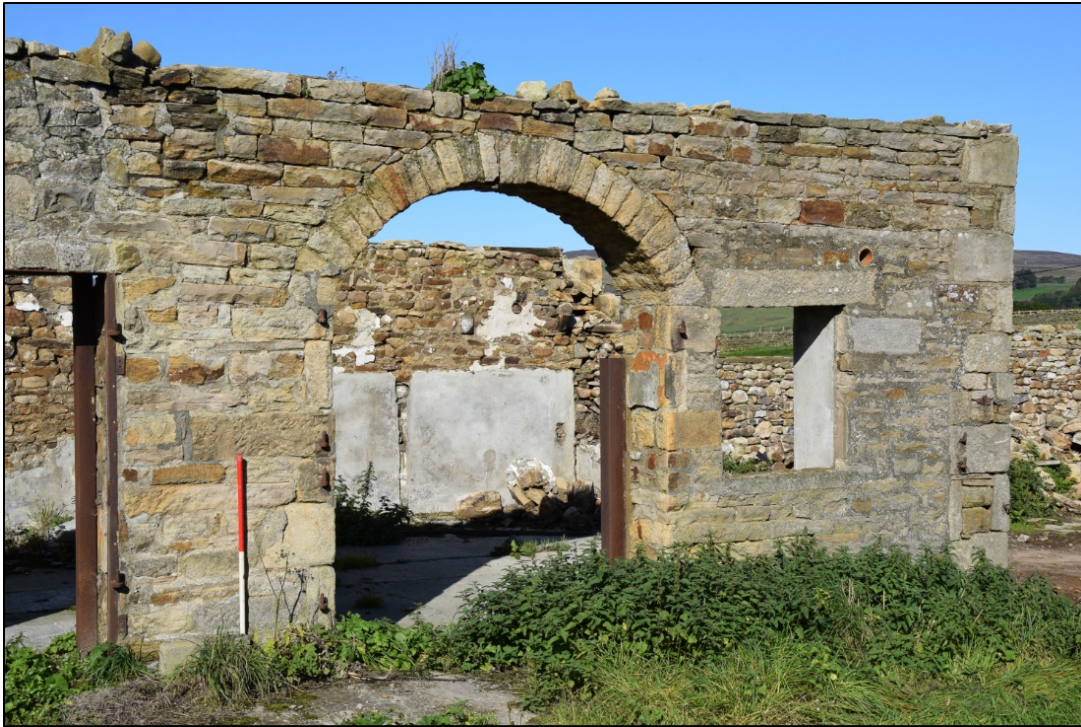
Photograph 49: The arched opening, superficially similar to a hemmel door, is a later addition to the building

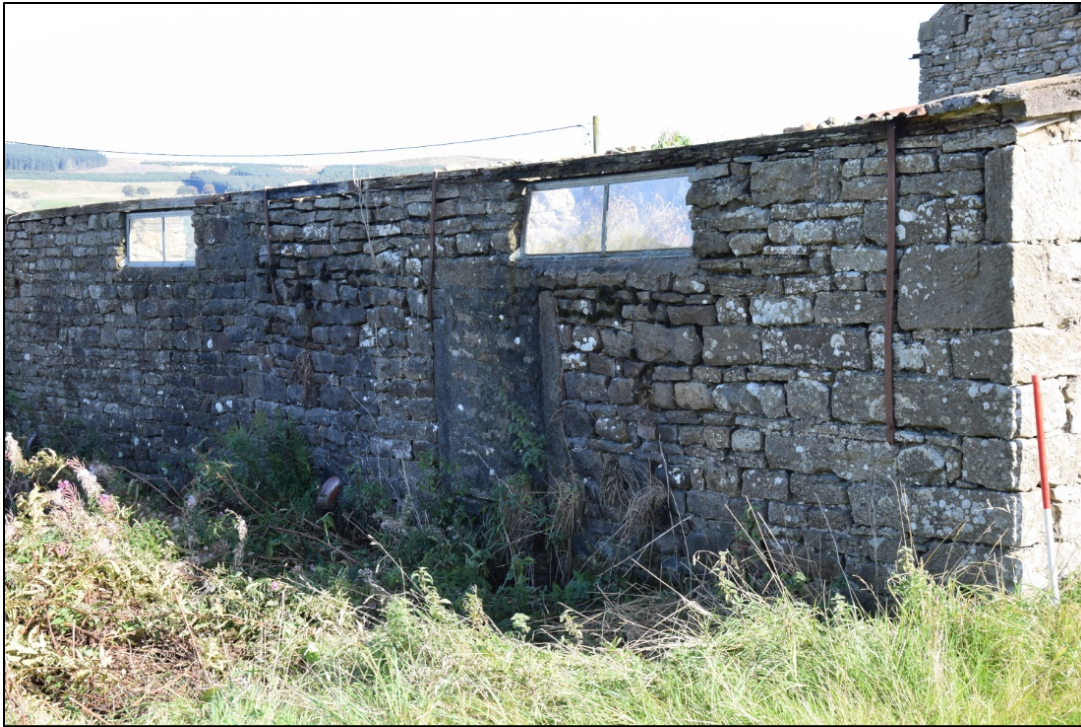
Photograph 51: The west face of building 4, with recent high windows above a blocked door

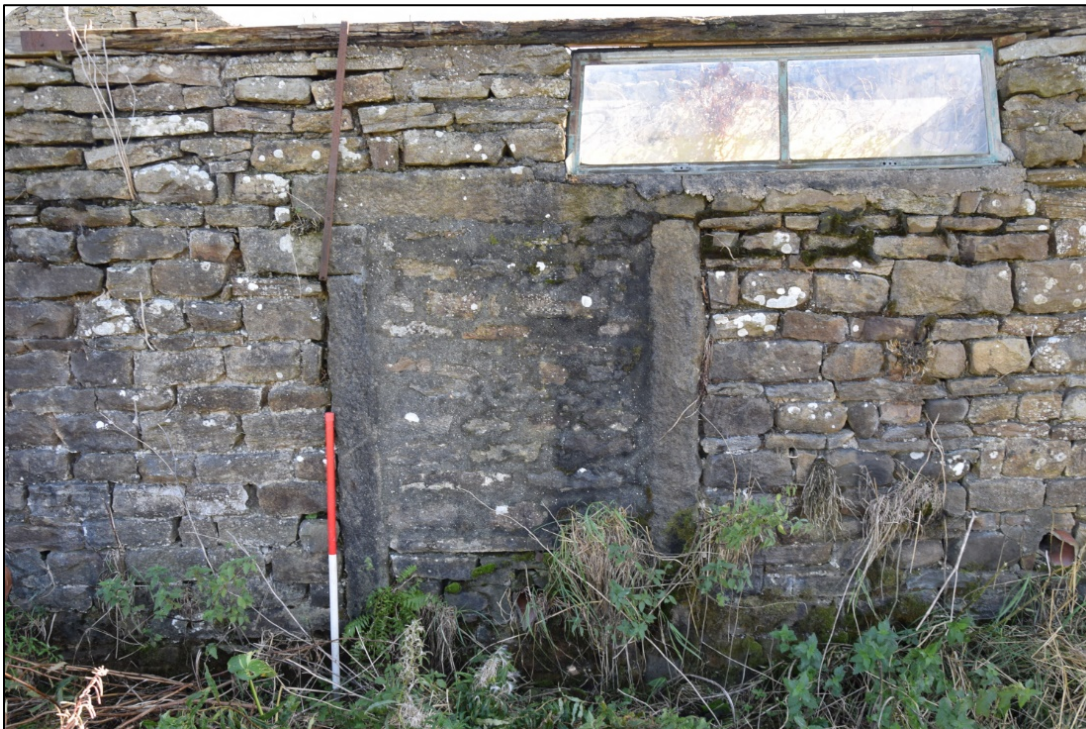
Photograph 52: Detail of the blocked door, later reduced to a window, in the west face of building 4

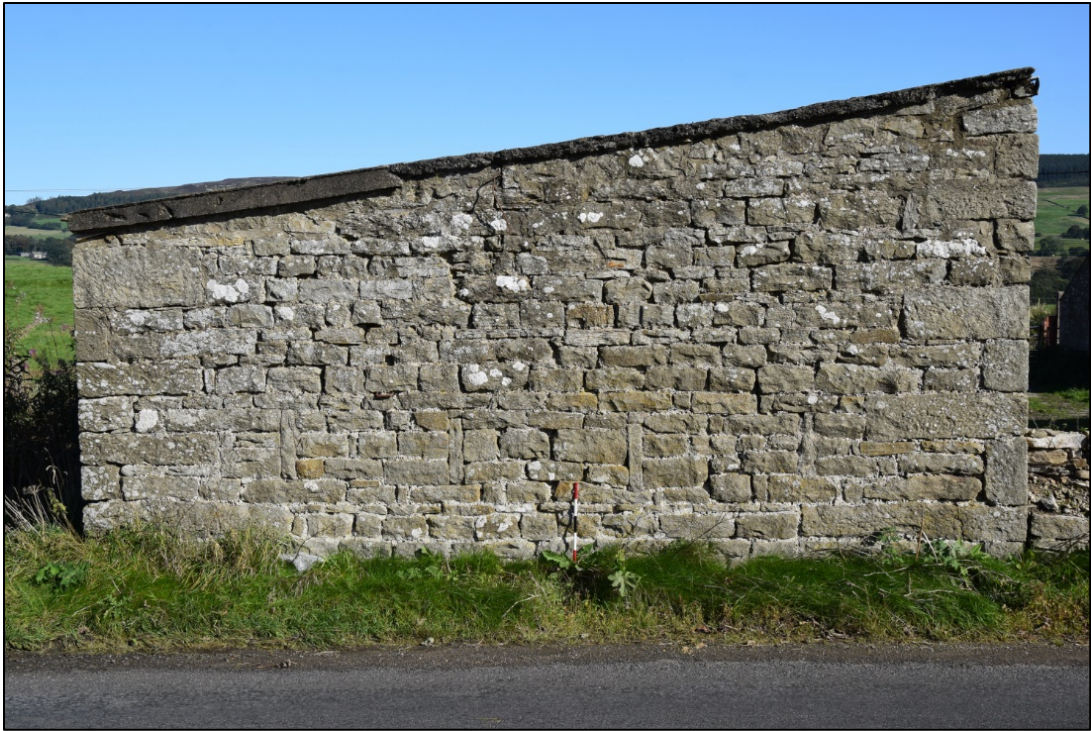
Photograph 53: Three blocked breather slits can be seen in the south end of the truncated building 4

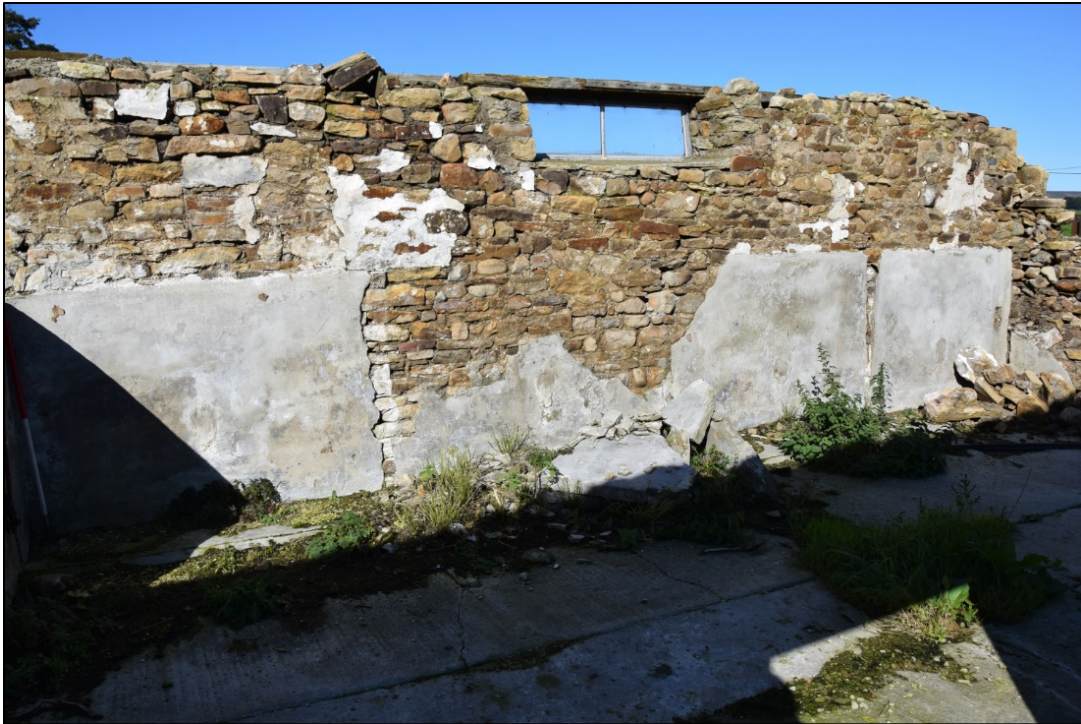
Photograph 55: The row of concrete stalls ran the full length of the small shed

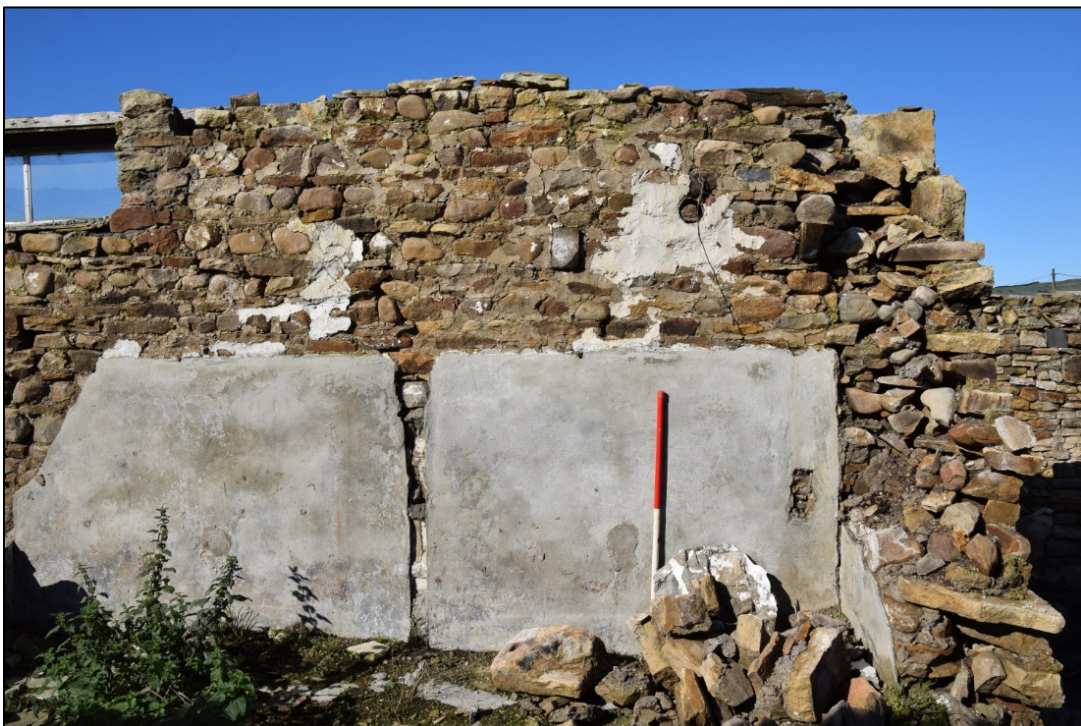
Photograph 56: The stubs of two joists can be seen above the cement render at the north-west corner of building 4
