ARCHAEOLOGICAL
SERVICES
DURHAM UNIVERSITY

Buildings at East Field House
Mickleton
Co Durham

archaeological building recording

report 5173
October 2019

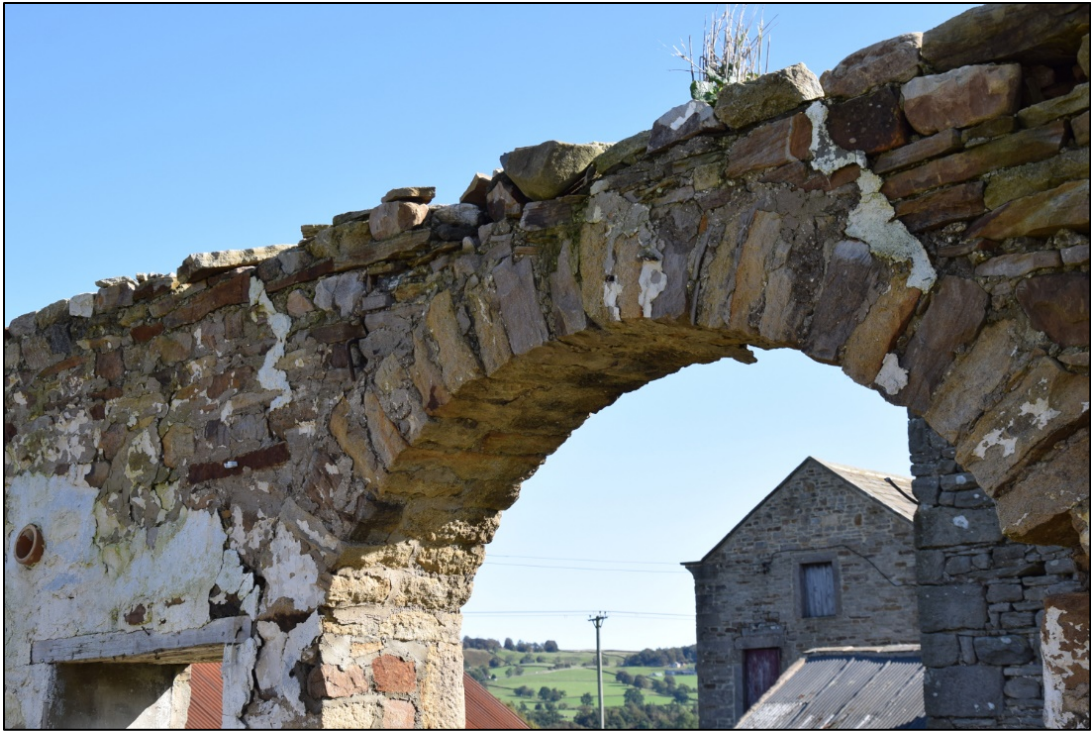
Photograph 61: The arched door is also a recent alteration. There are no traces of similar arches on the rest of the wall

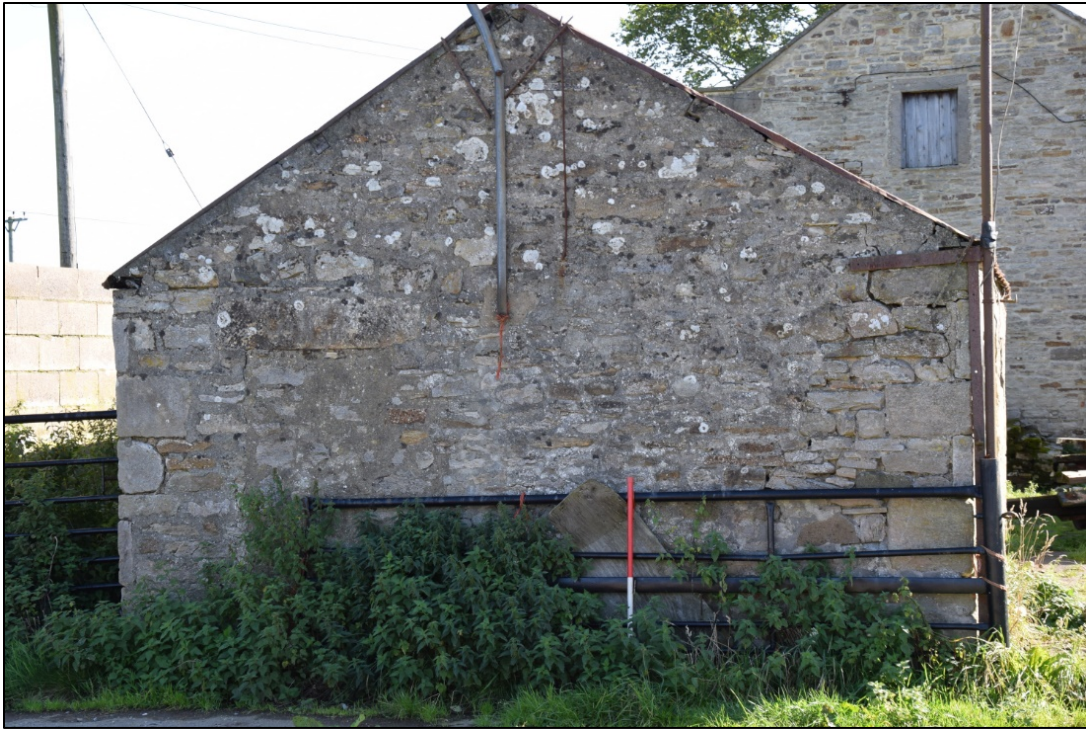
Photograph 65: The west end of the shed. A blocked door is faintly visible near the right-hand end

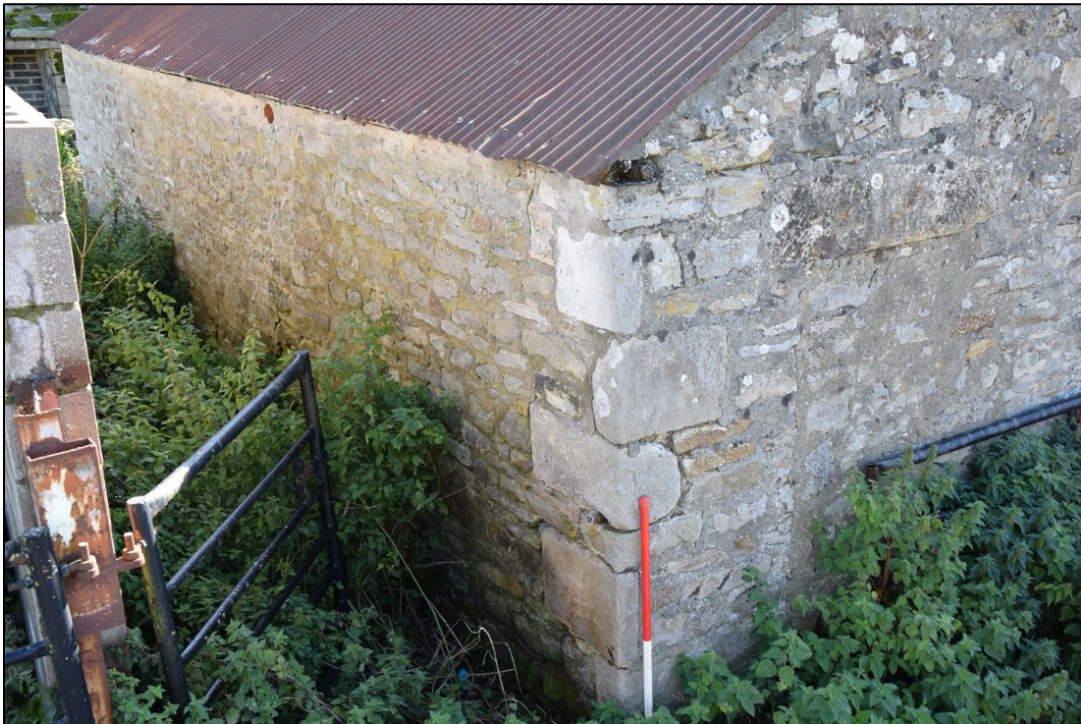
Photograph 66: The north-west corner of the shed, showing the blocked door (right of the scale) and the windowless north face

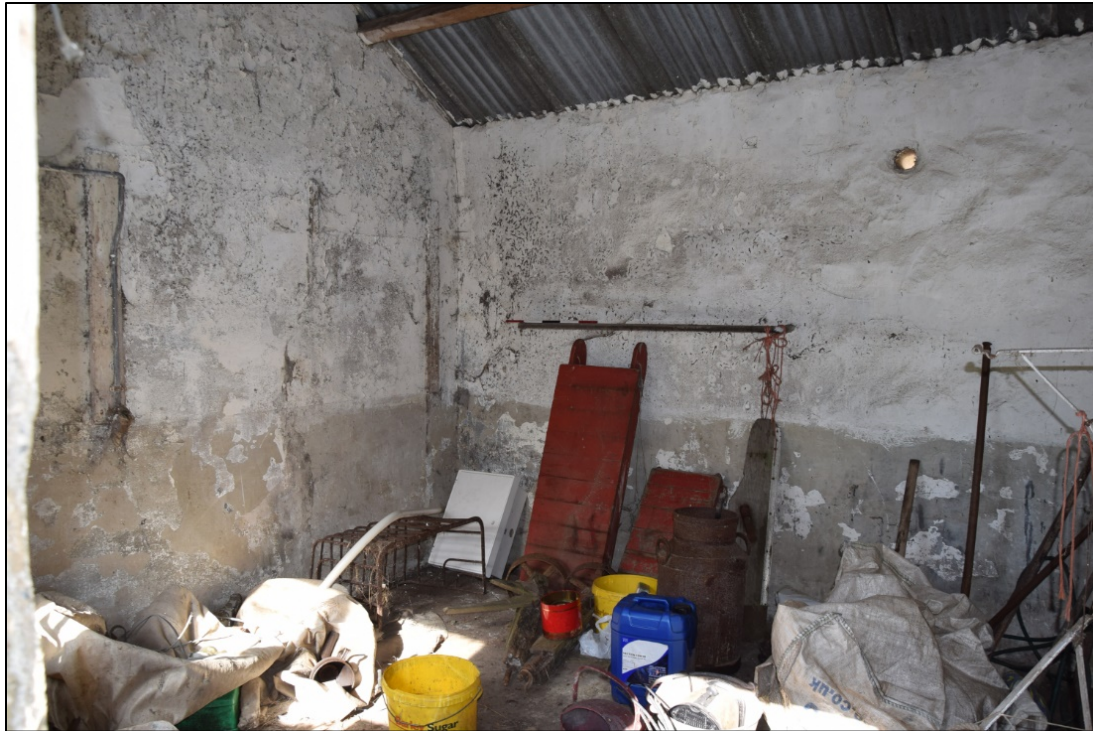
Photograph 67: The interior of the west room has traces of the old door near the far corner

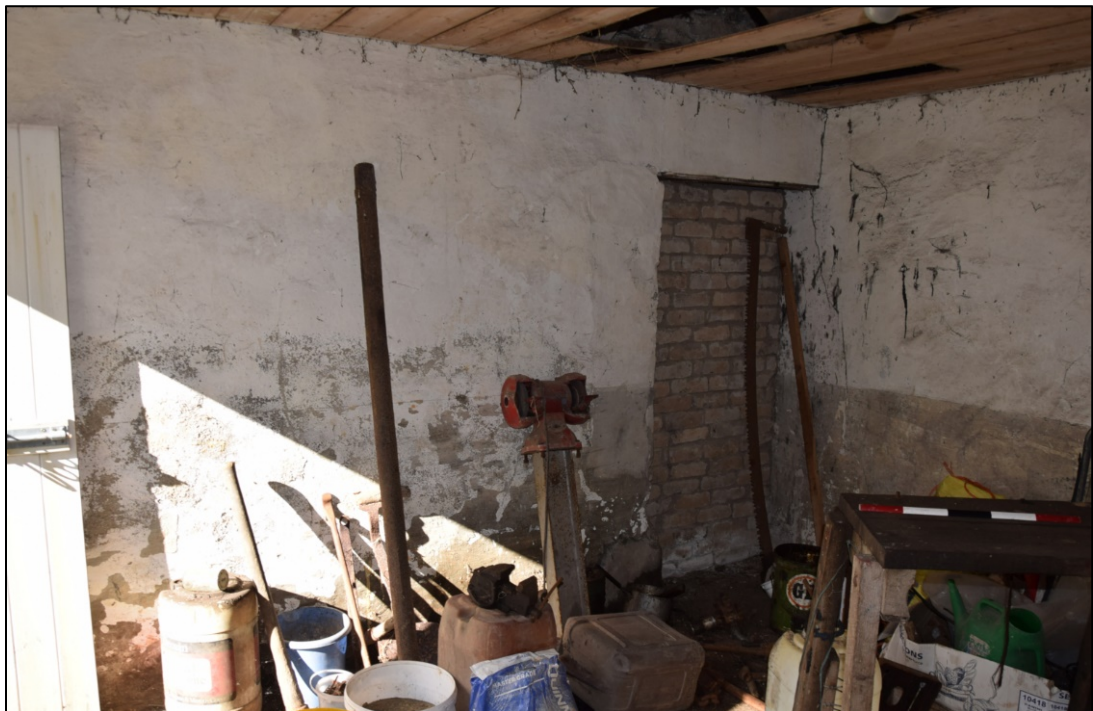
Photograph 68: A view looking north-west in the east room, with the blocked internal door
