ARCHAEOLOGICAL
SERVICES
DURHAM UNIVERSITY

The west curtain wall and mural tower
Auckland Castle
Bishop Auckland
County Durham

archaeological monitoring and recording

report 5175
October 2020

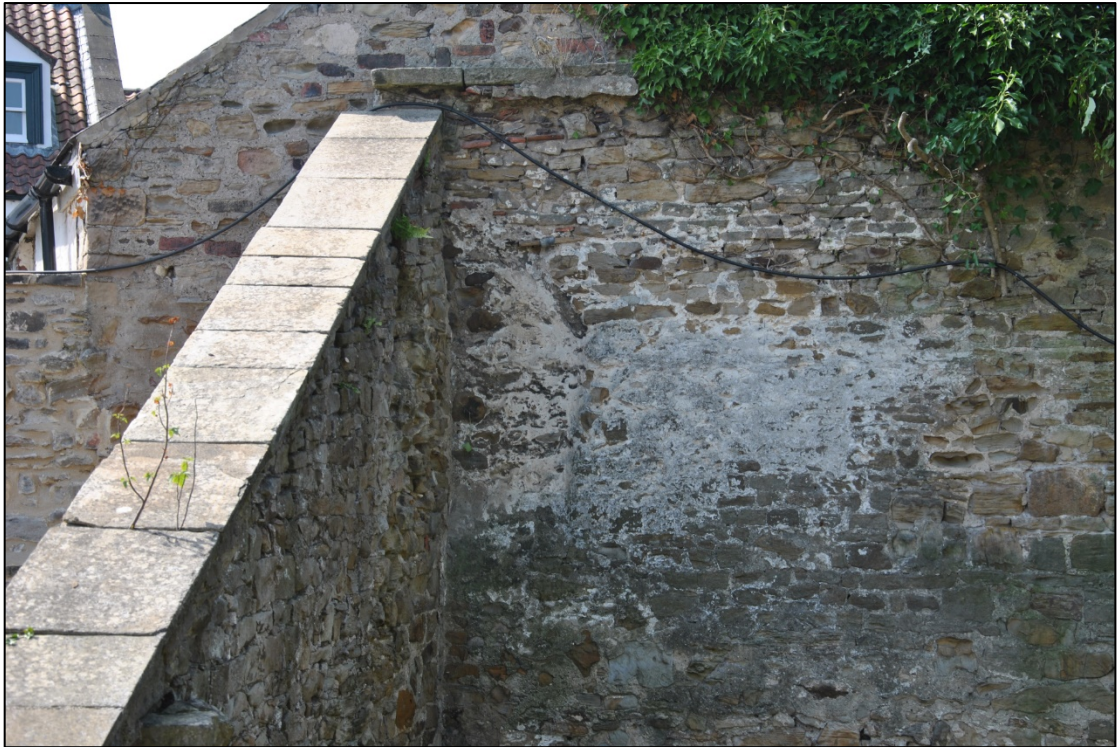
Photograph 9: The west wall and its junction with the gable of the neighbouring house. The possible blocked opening [3] is at the centre under a row of coping slabs and a few pantiles

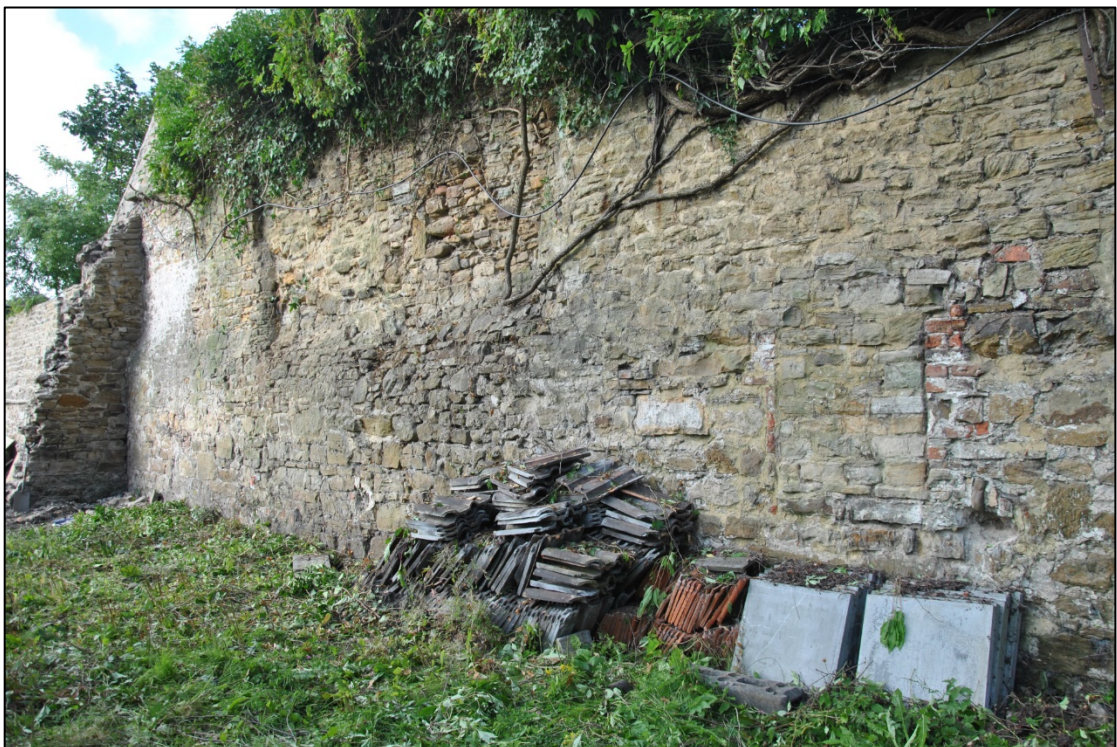
Photograph 10: The recessed section [5] with the blocked opening [6] near its right-hand end. The southernmost [8] of five square blocked openings can be seen at the right. At the far left, the sloping wall is partly demolished

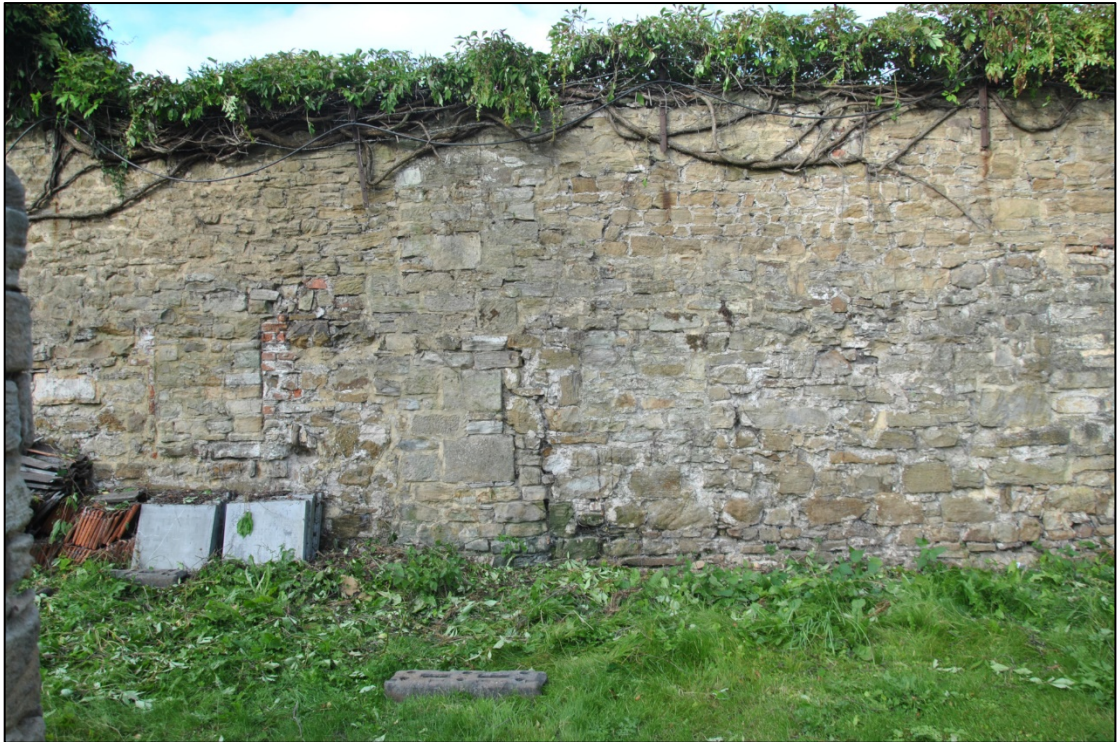
Photograph 11: Blocked openings [8] and [9] flank an anomalous vertical section of dressed stone [13], just left of centre. There is a ragged straight joint [14] just to the right. Note the yellowish stonework in the upper part of the wall here

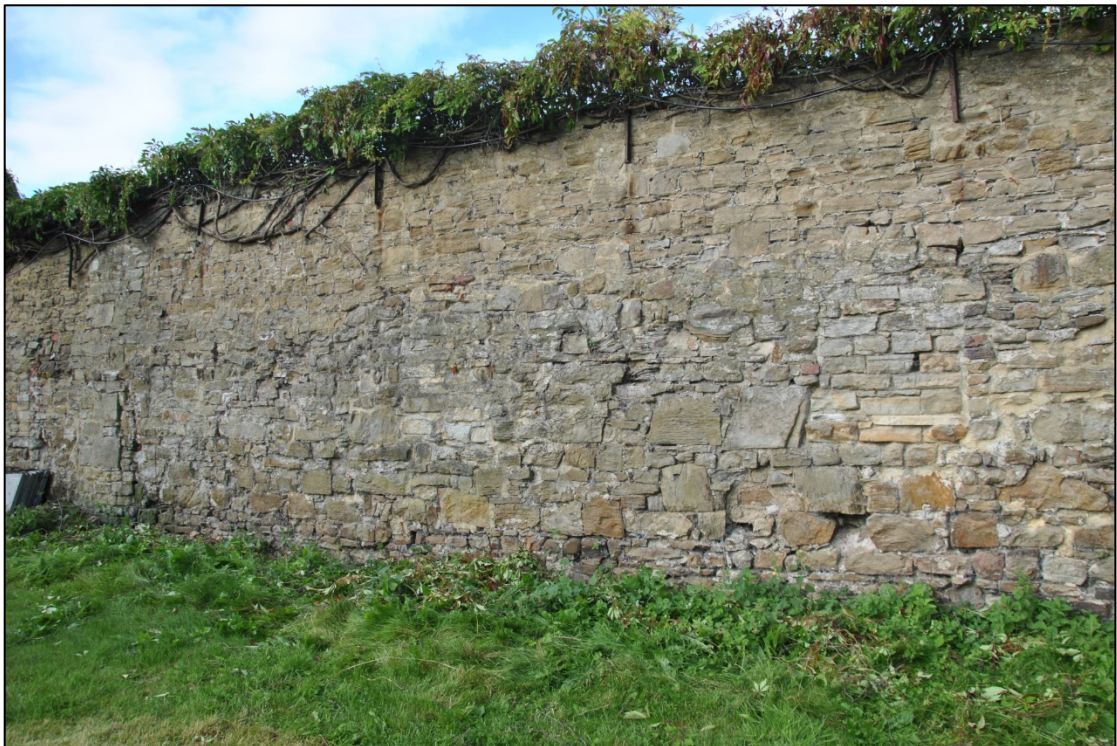
Photograph 12: The change in masonry [16] is visible above blocked openings [9] and [10] here

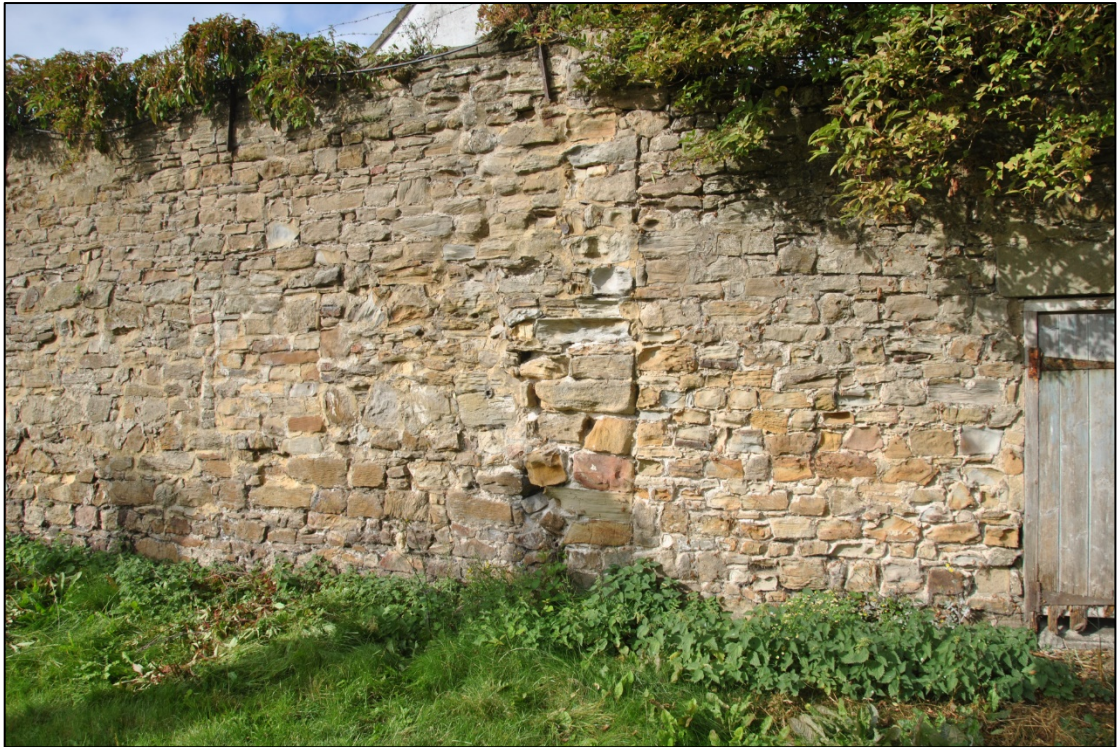
Photograph 13: The northern blocked window [12] and the wall [17] that filled the gate beside the tower

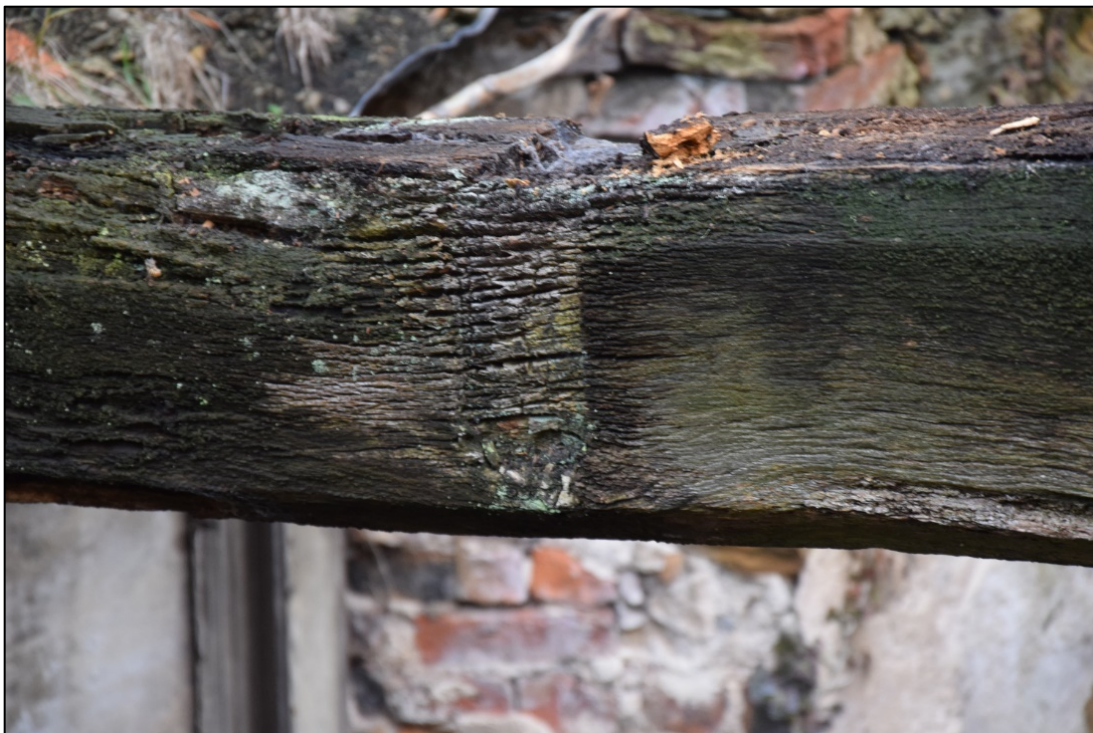
- 6.6 The low-pitched roof was founded on three very large and slightly curved cross- or tie beams, one at the centre and one at either end (Photograph 17). The eastern beam was altered many years ago when the chimney was installed near the middle of the east wall. These heavy timbers supported a single row of purlins at either side of the roof. None of these purlins survived in place when restoration work began; the photographs show timbers recovered from the floor of the building. Each purlin section was fitted into shallow housings that ran through almost the full height of each tie beam (Photographs 18, 19). A shallow rebate above the housings created a

Photograph 18: The housing for the south purlin, cut into the west face of the middle tie beam

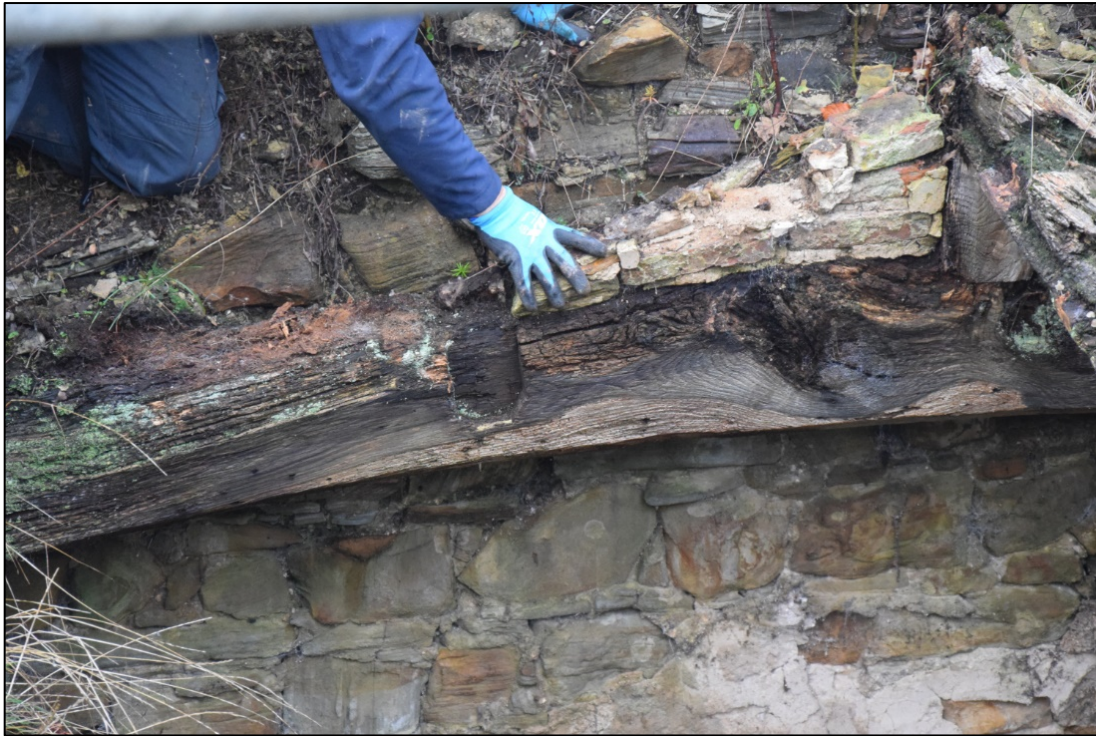
Photograph 19: The south limb of the western tie beam has a similar housing. The masonry that filled the space between the tie and the common rafter is being removed. At the top left, the ridge beam rests on a short vertical muntin

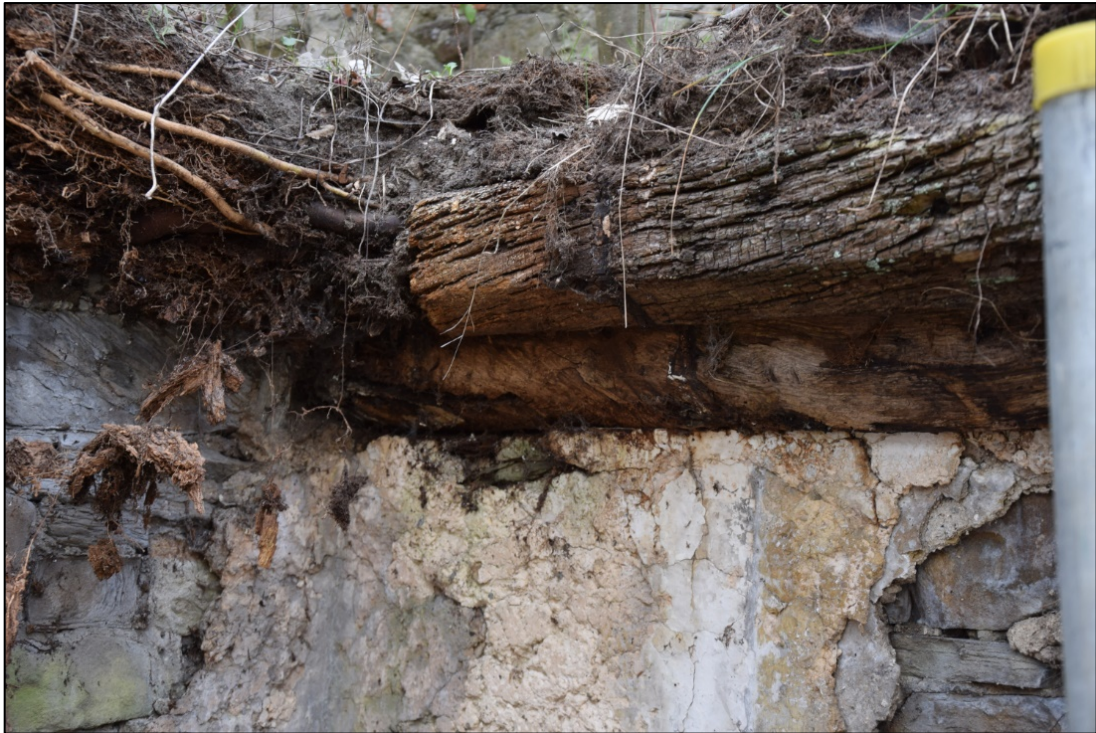
Photograph 25: Detail of the wall plate and closer at the south-east corner of the tower. Note the gap for the eastern tie beam, removed when the chimney was added to the building

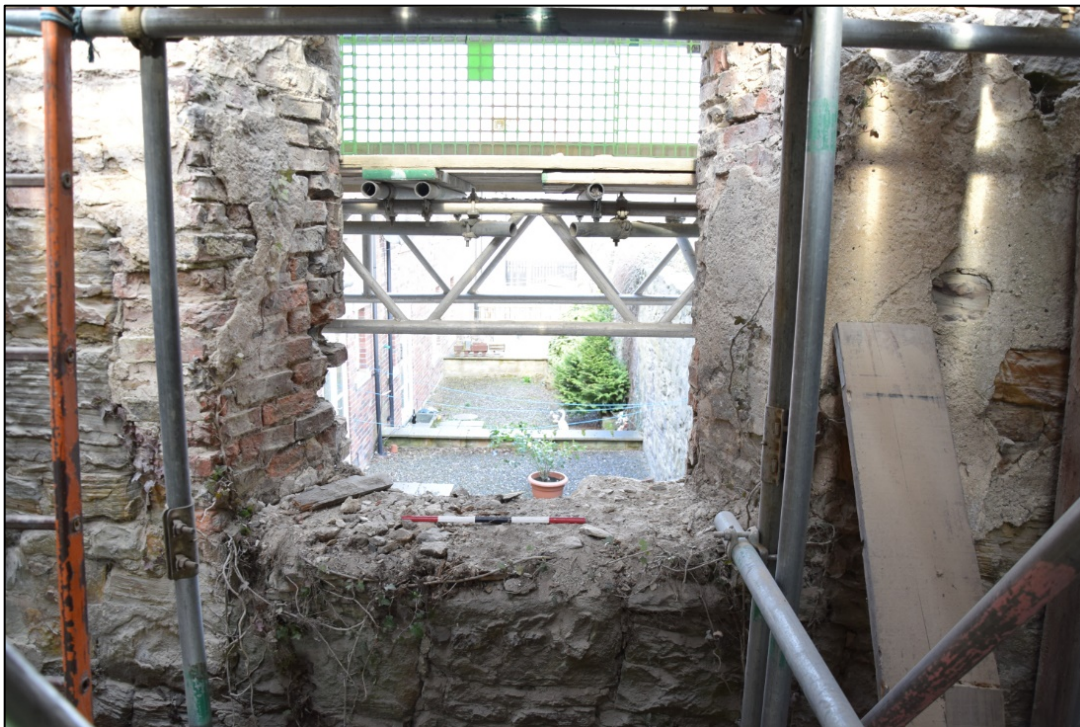
- 6.11 The boarded-up first floor window was opened, revealing plastered brick jambs (Photograph 30). On the west side the brick extends to the stone jamb of an older window about 0.25m from the existing splay. The plaster in the east side extends along the inside face of the wall and there is no sign of a corresponding stone jamb. On the ground floor below this is a smaller splayed loop, an original feature of the building, beside a door with brick jambs that was probably inserted in the 18th

Photograph 30: North wall, first floor. Left of the left-hand brick jamb is the side of an older stone window

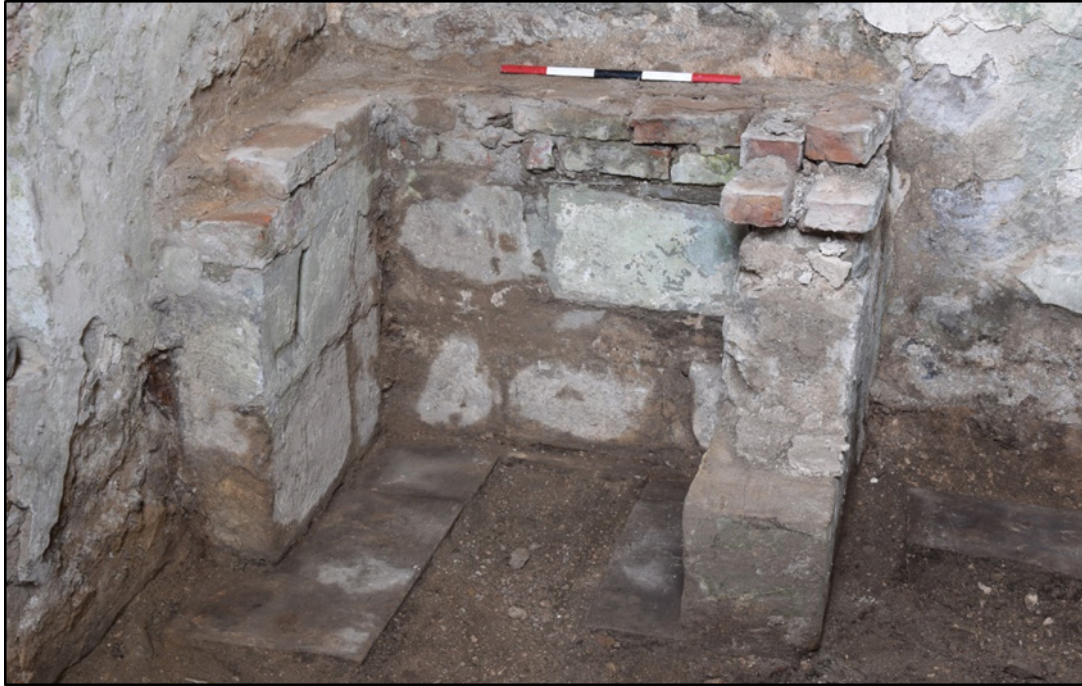
century (Photographs 31, 32). Some plaster remains on the wall at either side of these openings, and extends into the recess at the north-east corner. Against the wall at the north-west corner was a U-shaped stone and brick structure built to support a sink or a counter (Photograph 33).

Photograph 33 (above): A later structure for a stone shelf or a sink, at the north-west corner of the ground floor

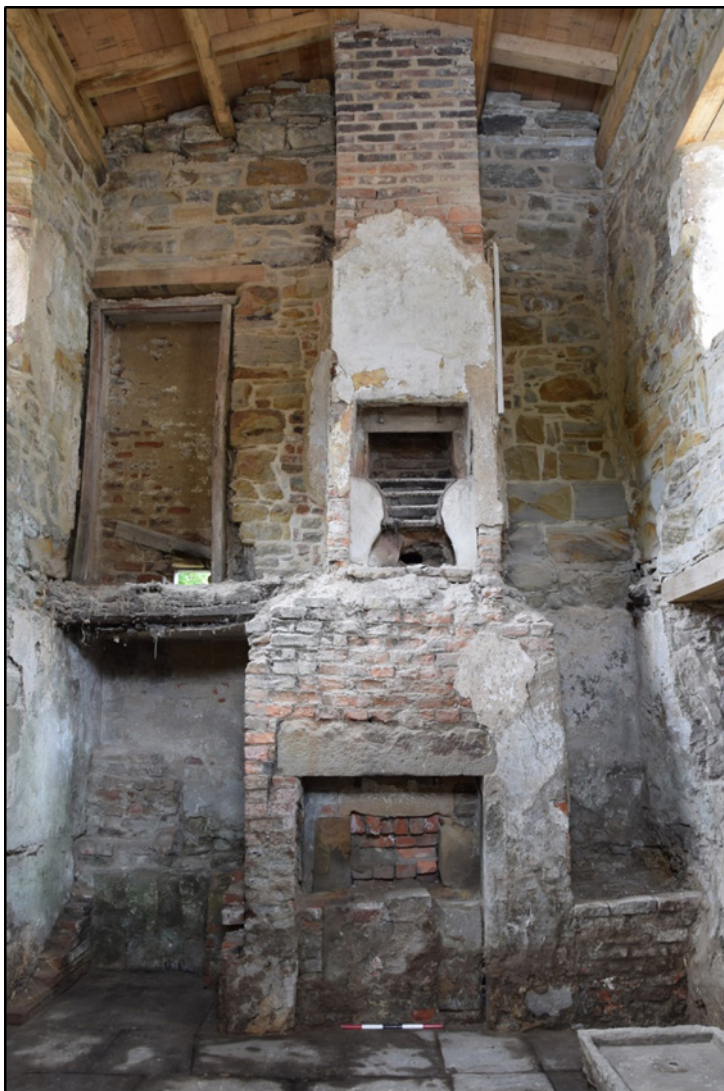
- 6.12 This end of the building is dominated by the brick chimney (Photograph 34) which was probably inserted in the late 18th or early 19th century. There are fireplaces on both floors. The upper one is unaltered but the ground-floor one has been reduced in size (Photographs 35, 36). Some early features can be seen in the recesses at either side of the chimney breast. On the ground floor, the wall at the back of the north recess has been significantly altered and the masonry in its upper part is very thin. Below this, one stone from the south jamb of a door remains. Late 19th-century brick walls stand in front of the old jamb. These were interpreted by Ryder and Degnan as supports for shelves, but the clearance work found that they were built for a copper or set pot. The hearth for heating the water was revealed when the flagged floor was lifted in this corner (Photograph 37). On the floor above, the same recess contains a blocked opening with some large stones on its south side; these suggest that there was an old window in the space later occupied by a brick-backed cupboard (Photograph 38). On the south side of the chimney there are large blocks low in the wall with a straight joint close to the chimney (Photograph 35). The position of these suggests that there might have been a fireplace set into the wall here. On the ground floor, the lower part of the south recess is blocked with brick and rubble.

Photograph 34 (left): The east wall and inserted chimney. On the ground floor, space left of the chimney breast was probably the original door. Note the large stones at either side of the chimney on the first floor. The shallow stone sink, bottom right, was placed on the floor in recent times

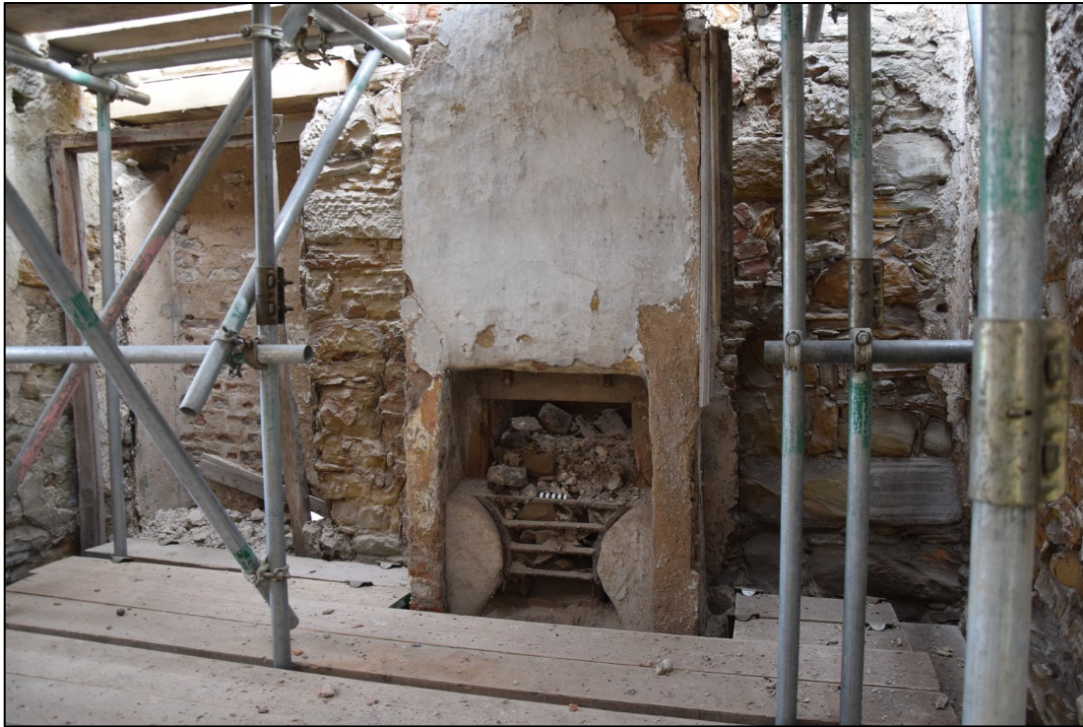
Photograph 35: The first-floor fireplace. There is a straight joint marked by plaster immediately right of the chimney breast; this may be what remains of an earlier fireplace

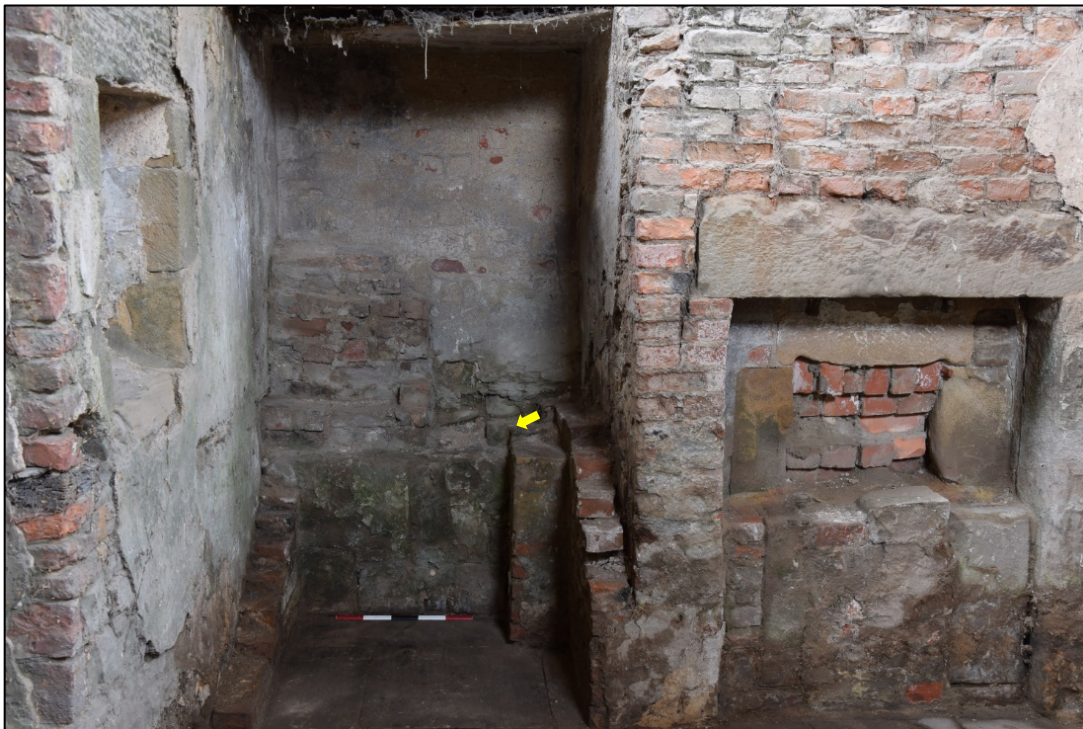
Photograph 36: The recess north of the ground-floor fireplace contains one rebated stone, arrowed, suggesting the this was an early doorway. The later brick and stone structure was built to support a copper

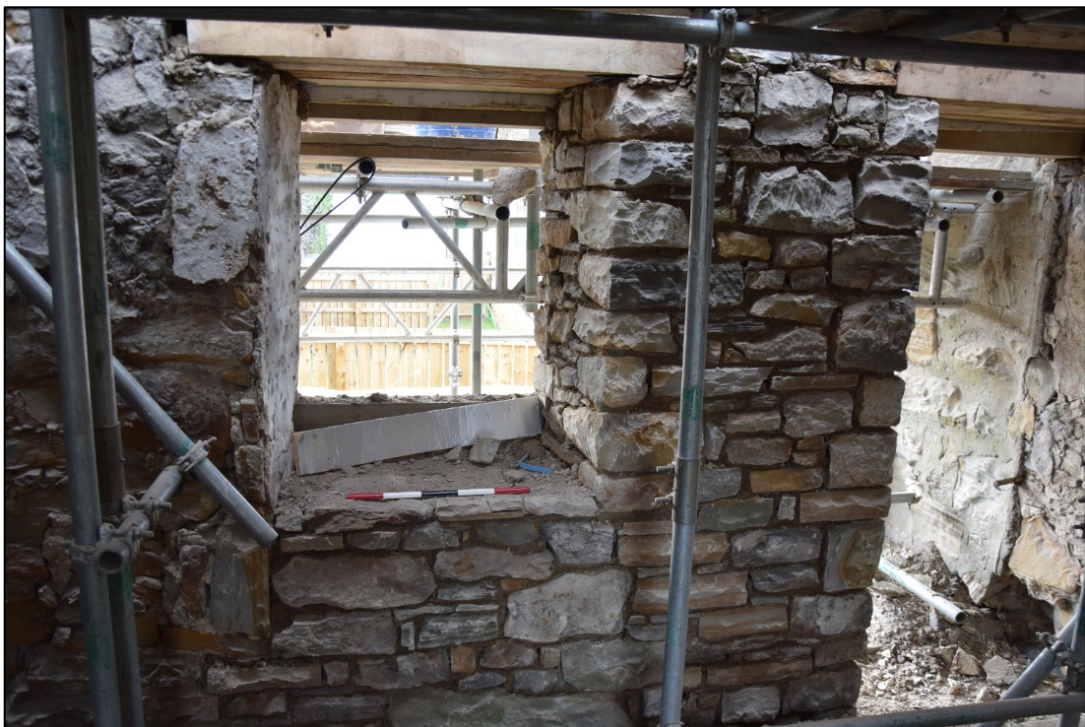
Photograph 44: The same wall after rebuilding, with a smaller window. The straight joint at the left continues below the new sill

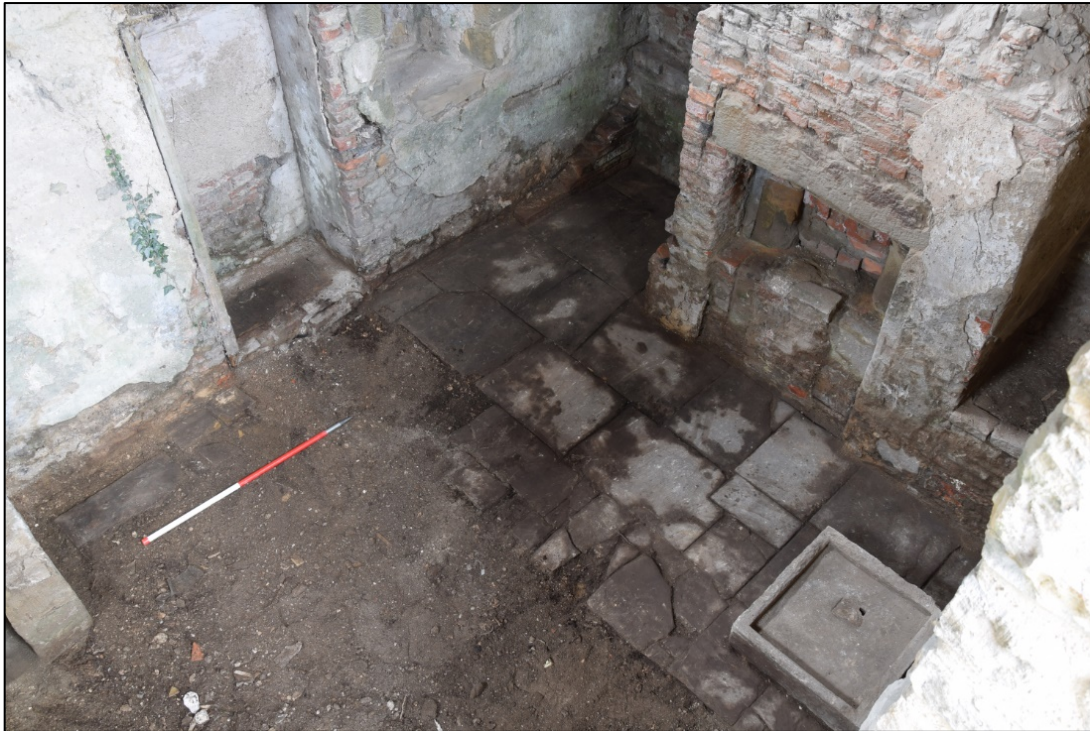
- 6.15 The ground floor had a slightly irregular flagged surface that survived at the east end and in the corners (Photograph 47). The flags cover the hearth of the copper at the north-east corner, so this part of the floor, at least, must be a fairly recent alteration. The flags had been laid on yellowish brown sand, 0.2m deep, over a compact black soil deposit. The hearth at the north-east corner consisted of mortared brickwork set on sloping flat stones. In the south-west corner, a lead pipe bedded in sand ran north-west. This is the pipe that fed the tap inside the tower and ran on towards the former School of Industry on Silver Street.

Photograph 47: Flagstones survived at the east end of the tower, at the north-west corner and in the small south block

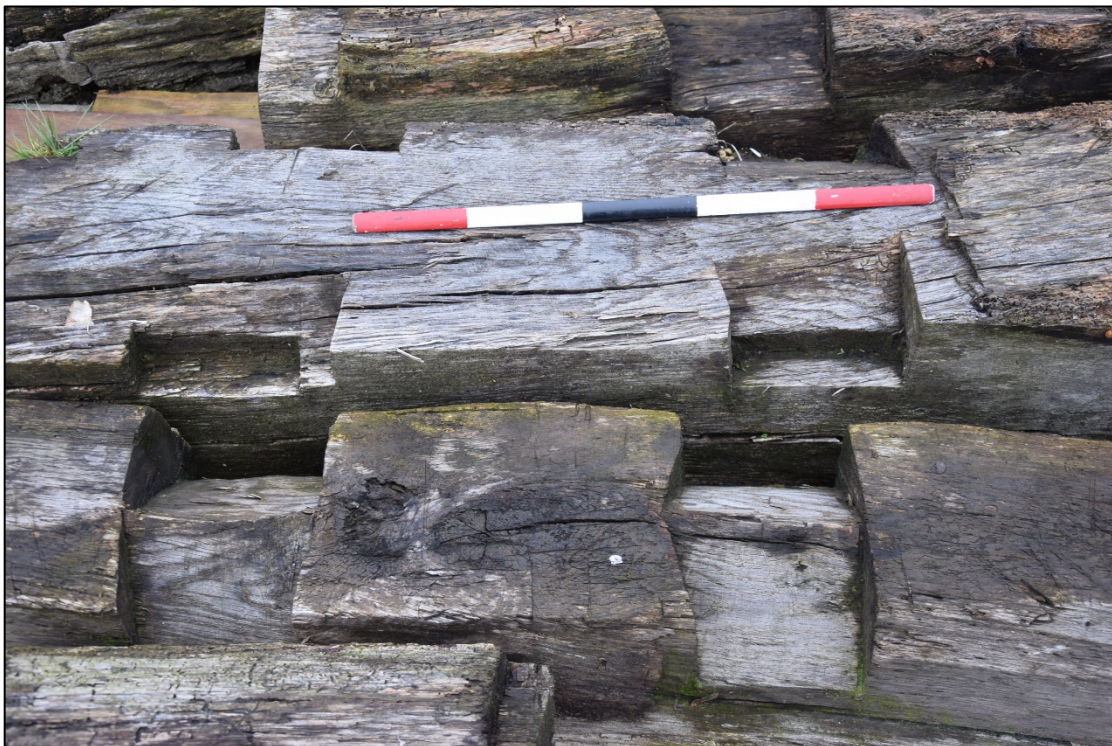
- 6.16 At the time of this survey the first floor frame had completely collapsed but the sockets for its three large joists could be seen in the north and south walls. The end timbers, recovered when the supporting scaffold was inserted in 1999, have close-set haunched rebates for the large joists (Photograph 48). Peter Ryder noted that 'between the western beam and the west end wall were four more widely-set joists; a sloping cut in the face of the beam between the southern two joists may have indicated a former stair position'.

Photograph 48: Timbers of the floor frame, recovered during the first clearance of the tower. Note the large size and close spacing of the rebates for the joists

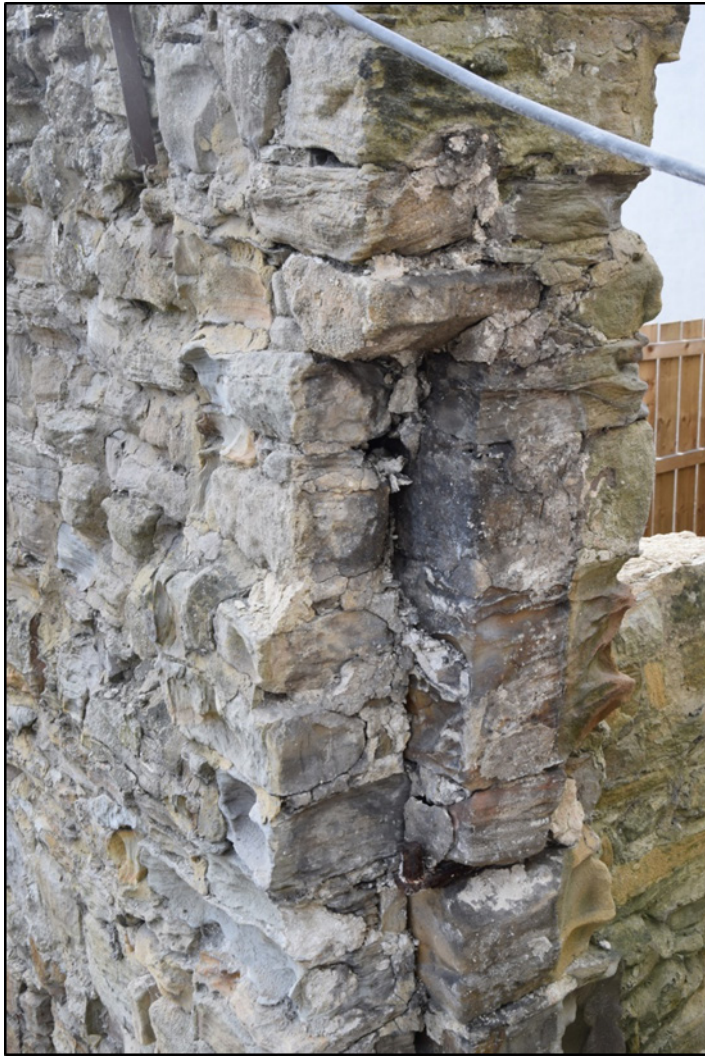
- 6.17 The blocking wall at the east side of the yard was removed, revealing the rebates and some of the pintles for the inner gates (Photographs 49, 50). Clearance work inside the yard revealed a cobbled surface a little higher than the floor of the tower (Photographs 51, 52). This ran slightly downhill from the south-west corner of the yard. The line of a narrow modern service trench was seen in the cobbles.

Photograph 49 (left): The rebate on the south side of the gateway; compare with Photograph 14. An iron hinge pintle can be seen towards the bottom of the picture

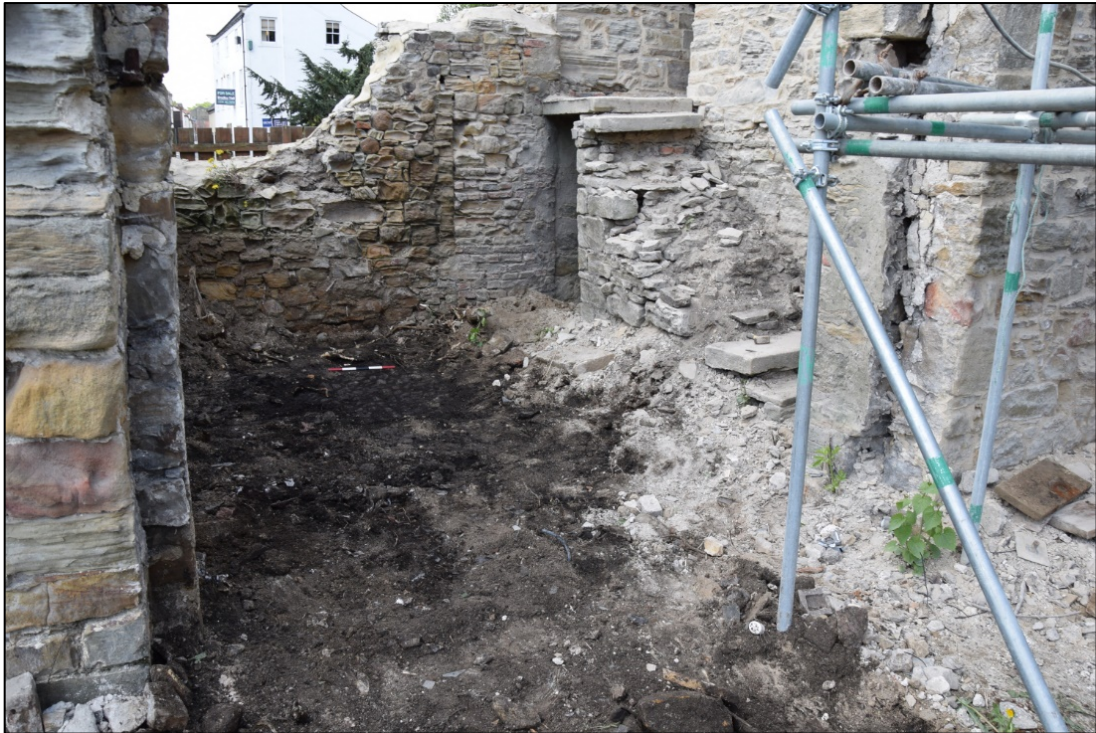
Photograph 51: The yard and external stair after the gate was re-opened. The straight joint marking the north side of the outer gate can be seen in the far wall. A view looking north-west

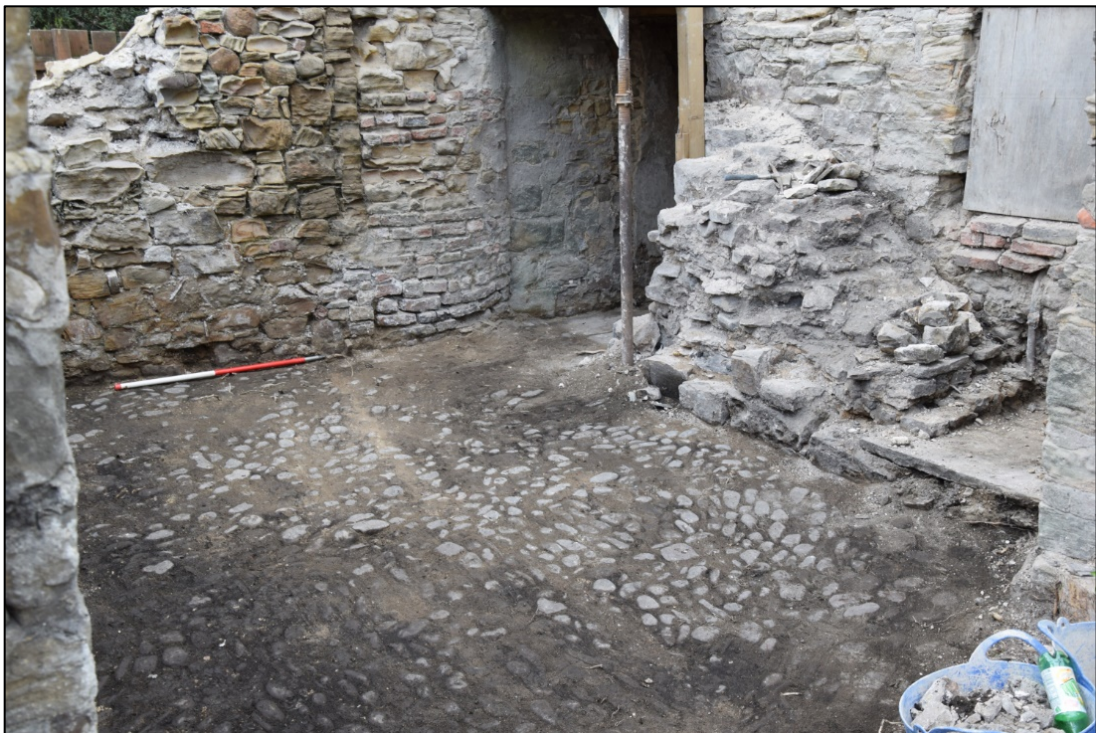
Photograph 52: The cobbled surface of the yard is above the level of the floor in the tower
