The Whitecross Monument  
Whitecross  
Hereford  
(NGR SO 493 407)

*Archaeological recording and monitoring of a Scheduled Ancient Monument.*

H.A.S 729  
SMR 5567  
August 2006

*Archaeological Investigations Ltd were commissioned by Hook Mason Architects on behalf of the client Herefordshire Council Environment to carry out archaeological recording and monitoring of repair works being carried out on the Whitecross monument. The monument had been damaged by a car crashing into it.*

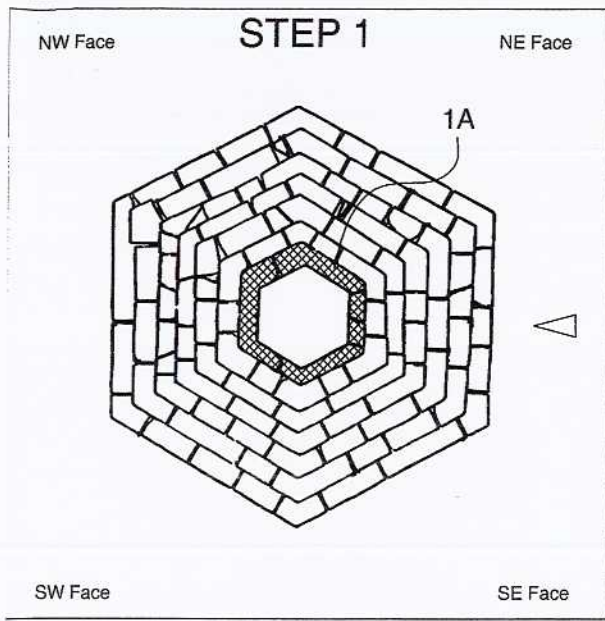
The top set of steps (step 1) consisted of a solid layer of six stones with no core work. The central stone (1E, 1F) on the top layer had to be cut to remove it (Fig 9). When the stone was removed a square socket hole was revealed cutting through it. The socket was less than 10cm square, and located centrally below the pedestal base (plate 2).

Square cut socket location point.

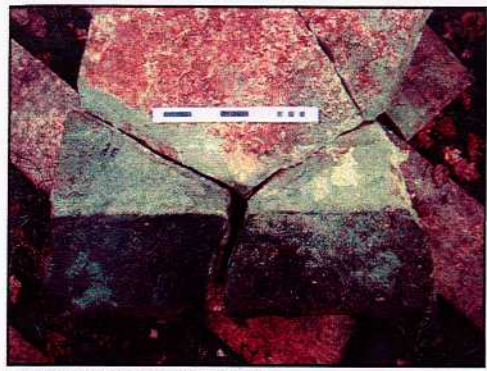
Plate 6 Stone 1E & 1F.

Plate 2, Broken "key stone" 1E/1F, with 10cm square socket hole in the centre.
