Mortimer's Cross Mill, Lucton Herefordshire

Archaeological survey and recording
November 2008

**Mortimer's Cross Mill, Lucton, Herefordshire:
an archaeological survey of the sluice gates, 2008**

For: English Heritage

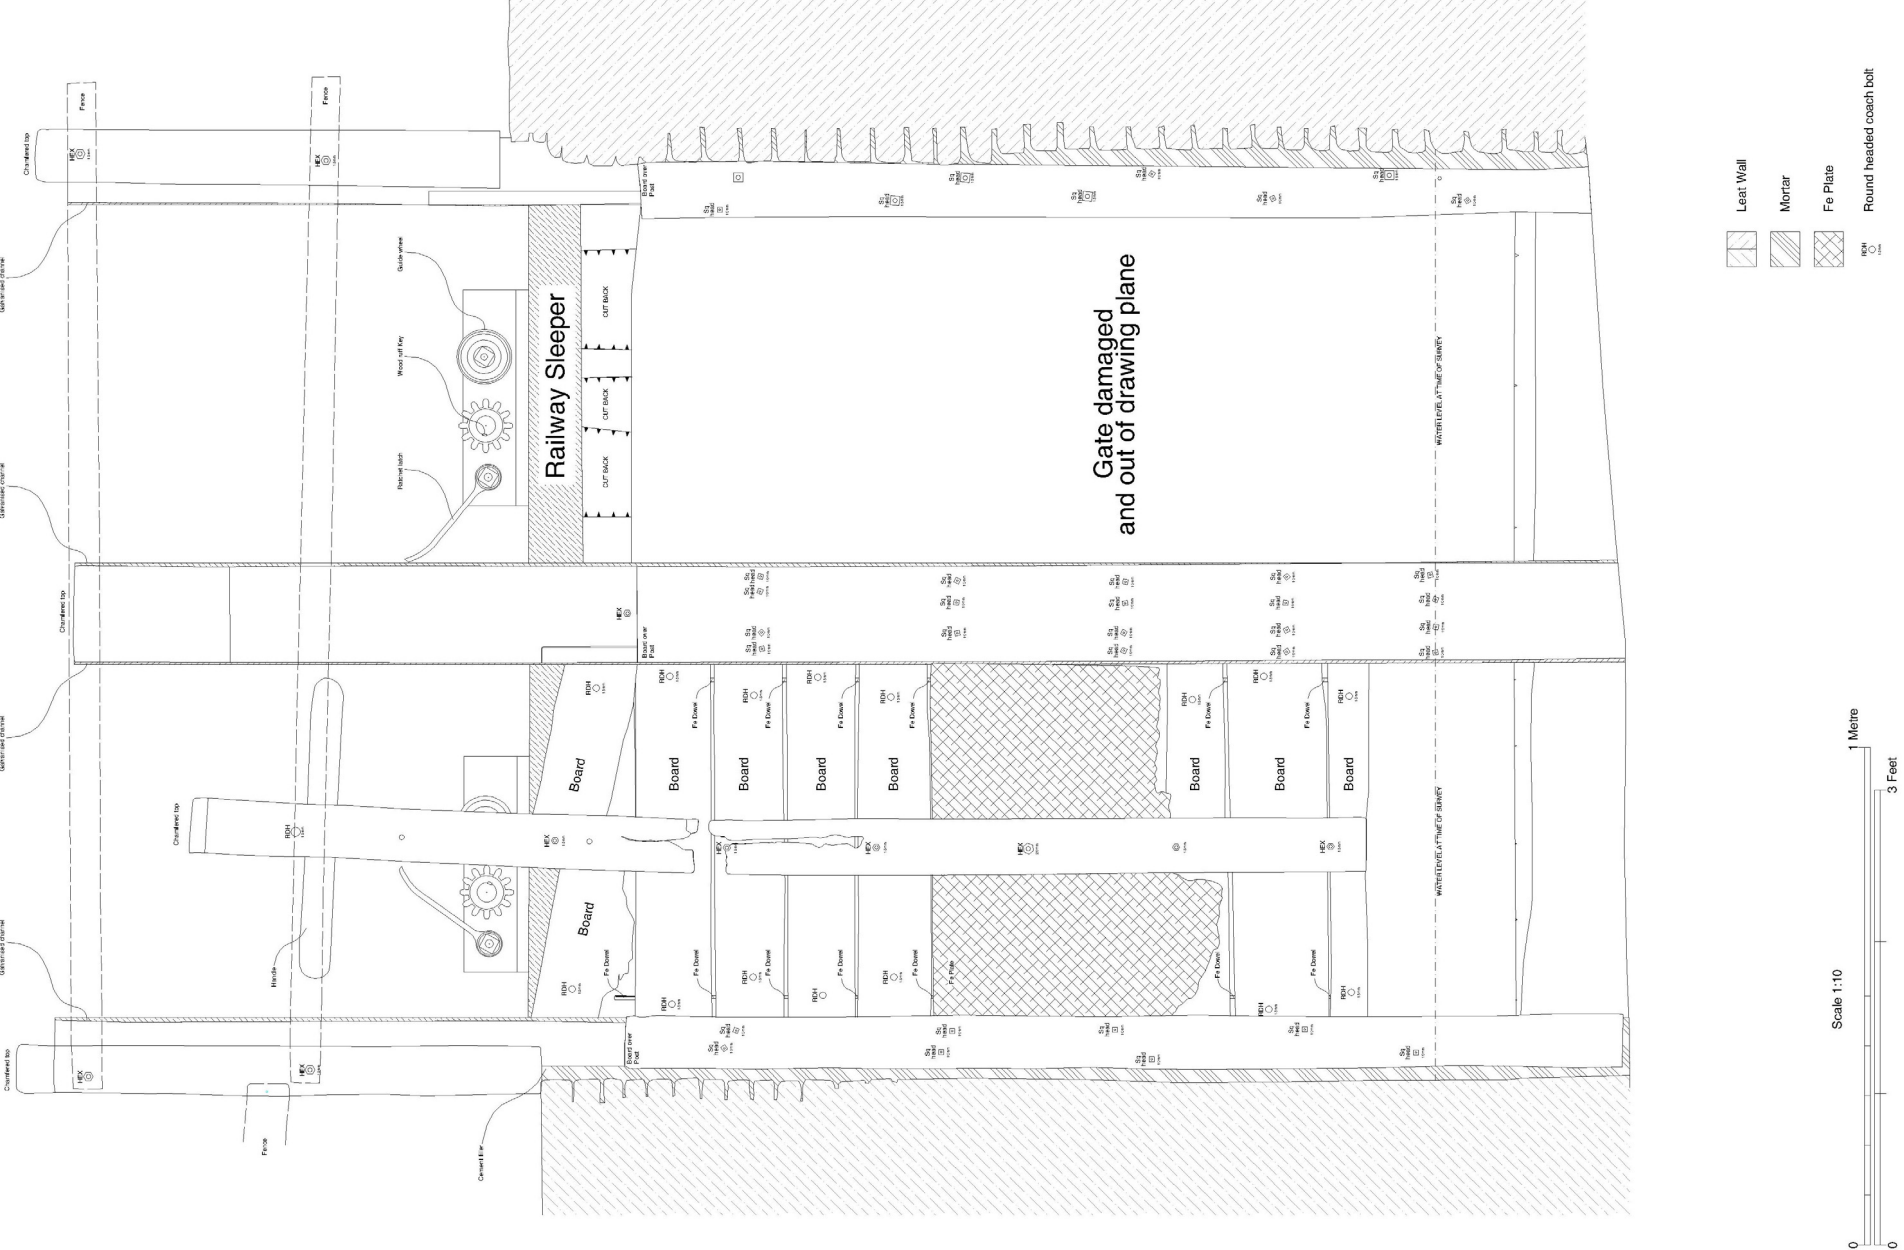
Figure 10: Up-stream elevation of the double sluice gate

The sluice gate was in a very poor condition when surveyed and displayed many repairs to the frame work and gates with the addition of inserted upright planks on the upstream face, replacing rotten parts of the frame work. The central post had completely rotted away from the lower beam and was held in place through the addition of a secondary bolted support block on the down stream face, embedded into the bed of the sluice (see thumbnail 222 & 439).

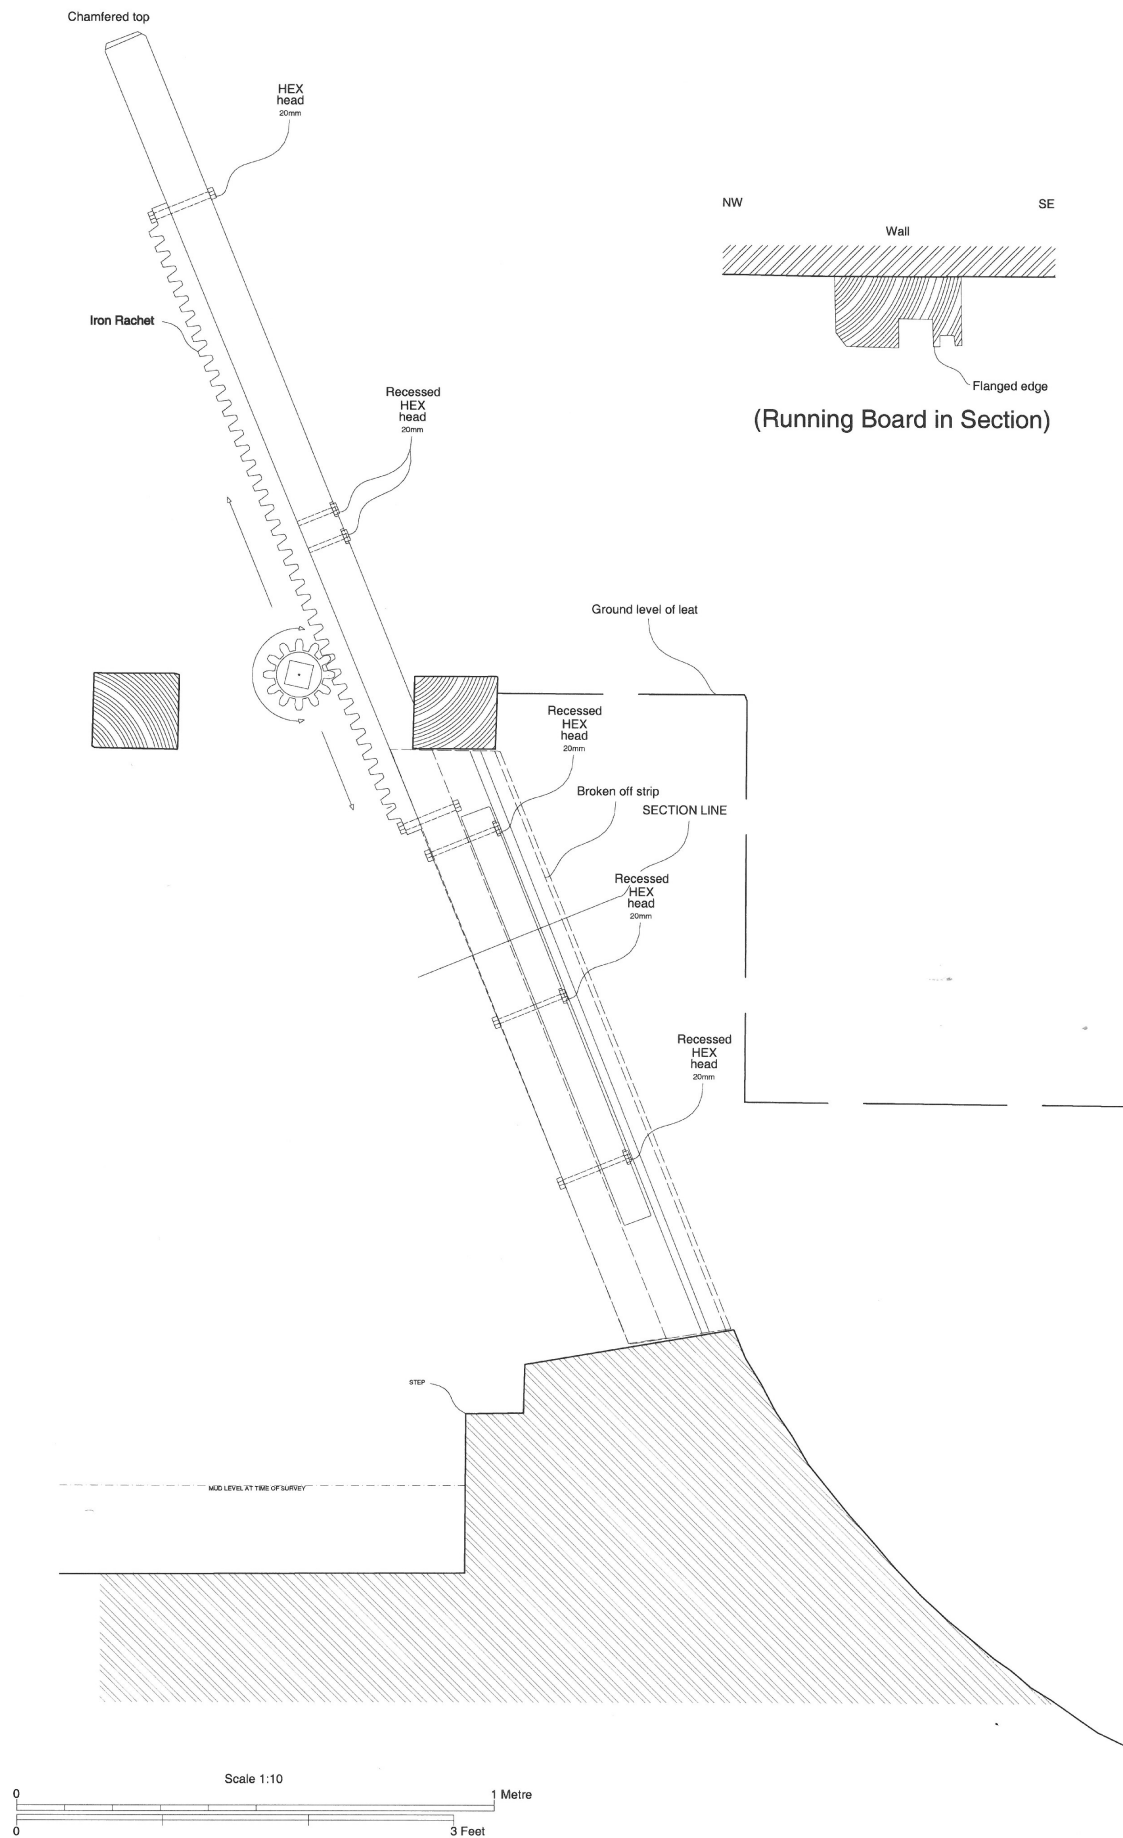
Figure 12: cross-section through the penstock gate

The penstock, a sluice operated from inside the mill, controlled the flow of water onto the wheel. The gate (see Figure 11) is controlled in a similar way to that of the double sluice gate through a rack and gear mechanism operated on a spindle controlled from within the mill building. The penstock consists of a sliding door, which moves over an aperture in a frame, which in turn is secured onto a wooden structure inserted before the water wheel (see Figure 11). A similar arrangement of galvanized channels were cut into the main frame support the gate and allowed free movement. Unlike the upper sluice gate the penstock gate sits at an angle of 21° off vertical on a sealing head to the flow of the race.

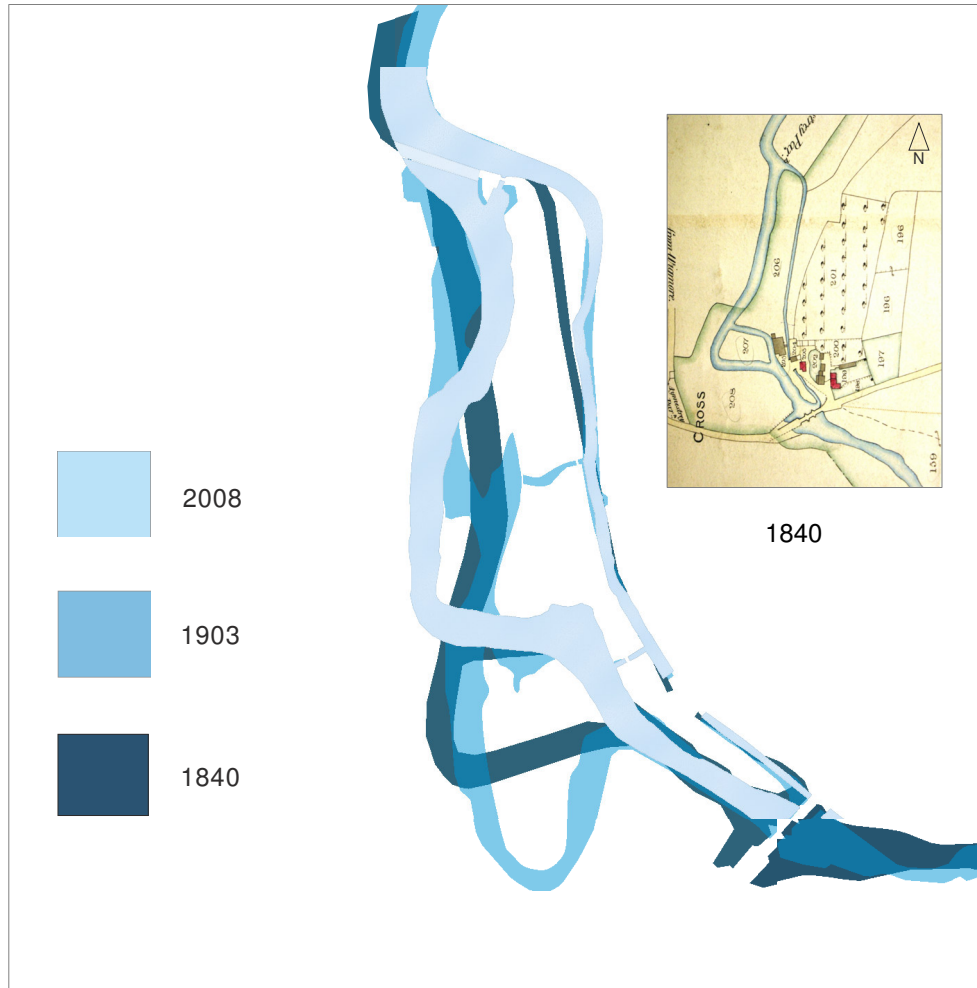
Figure 15: the changing course of the river from 1840 Tithe map

It is not only the sluice gates that have been affected by the flow of the river. The map regression below (Figure 15) shows the changing course of the river from the 1840 Tithe map. At that time an island exists in the river between the main course and a smaller channel that may have been associated with the now vanished paper mill. By 1903 the course of the river had migrated so far south that it was in danger of washing away the east to west road that crossed the river.

At some stage after 1903 the course of the river must have been deliberately changed. The main channel was blocked and the flow diverted into the smaller channel that flowed north of the island. This change to the river has preserved the road and the bridge.
