**Archaeological recording of the cascade  
and brewhouse at Upper Lodge, Bushy Park,  
London Borough of Richmond, 2002-04**

**NGR: TQ 1462 7020**

**Report to the Royal Parks**

**October 2004**

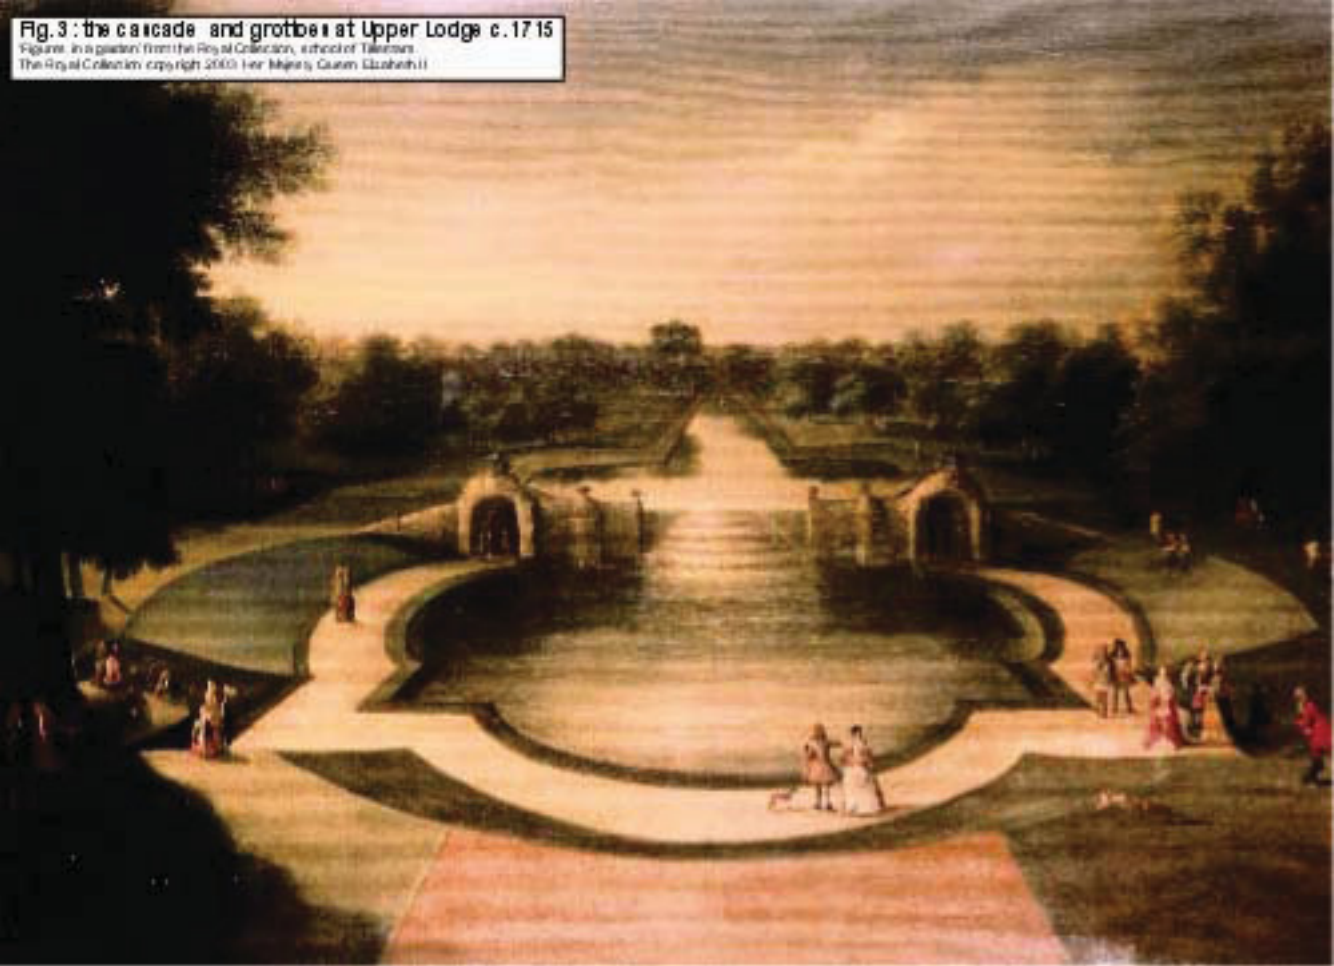
**Fig. 4: Upper Lodge from OS map of 1897**  
Showing brew house and cascade ponds. North is at the top of the page

After 1771 parts of the water gardens were much altered, and many of the remaining original features became dilapidated. During the 19<sup>th</sup> century or early 20<sup>th</sup> century, the cascade was partly rebuilt, possibly following a long period of neglect (Fig. 4). During this phase it is thought that the grottos were removed, and the south revetment wall and part of the north was rebuilt in London 'stocks'. Upper Lodge was empty during the First World War, and George V gave it to the Canadian Red Cross for use as a convalescent home. Between the Wars the house was used as a school, but at the outbreak of the Second World War the house was requisitioned for military use. It remained on lease to the Ministry of Defence until 1994, when it was returned to the Crown Estates (White & Foster 1997, 18-28). Much of the area within the Crown Estate's fence line had been built over by a large number of Ministry of Defence buildings since 1945. These were removed between 1997 and 1999 as part of the present planning application.
