THE FORMER GARIBALDI PUBLIC HOUSE  
6, THE GREEN, CHALVEY  
SLOUGH SL1 2SN

AN HISTORIC BUILDING RECORD

Planning Application Reference: P/11098/003

COMPASS ARCHAEOLOGY  
250 YORK ROAD  
LONDON SW11 3SJ

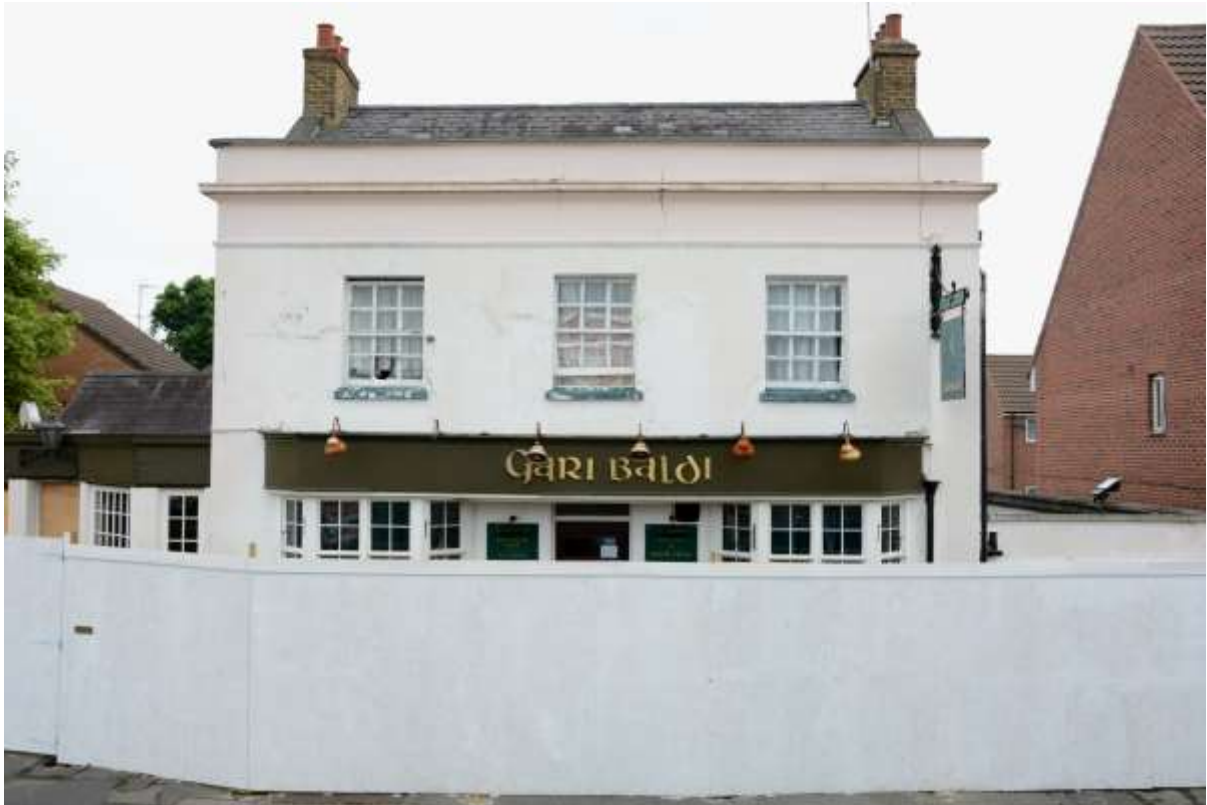
Fig.12: *The building frontage, looking northeast*

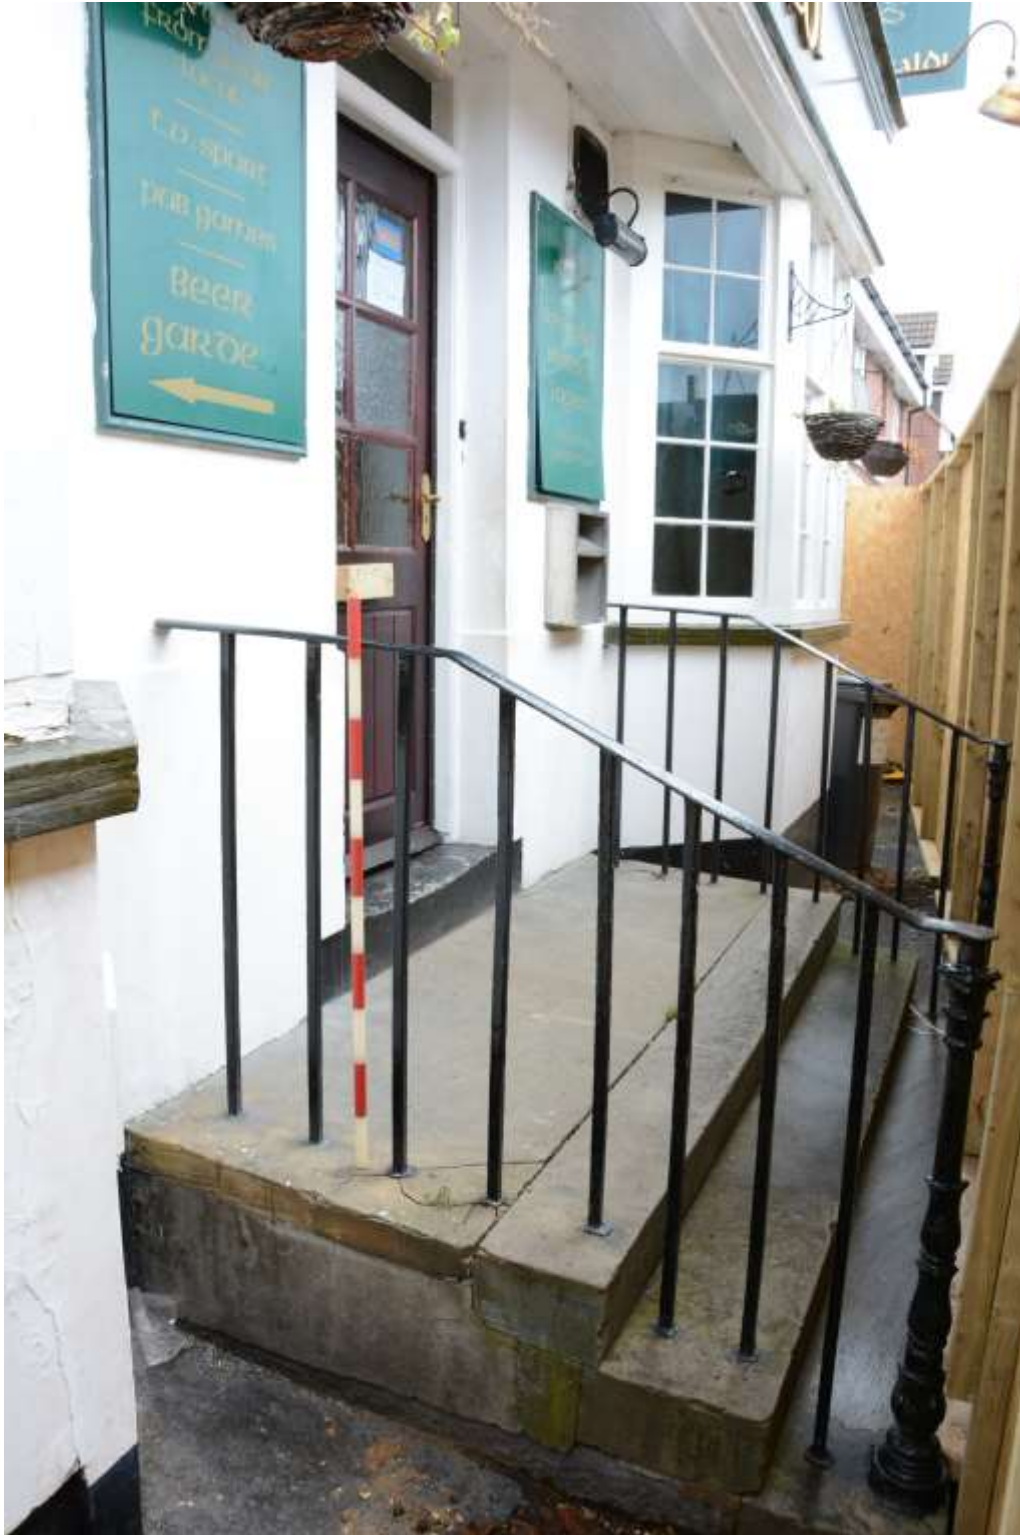
Fig.21: *Front entrance steps and railings (1m scale)*

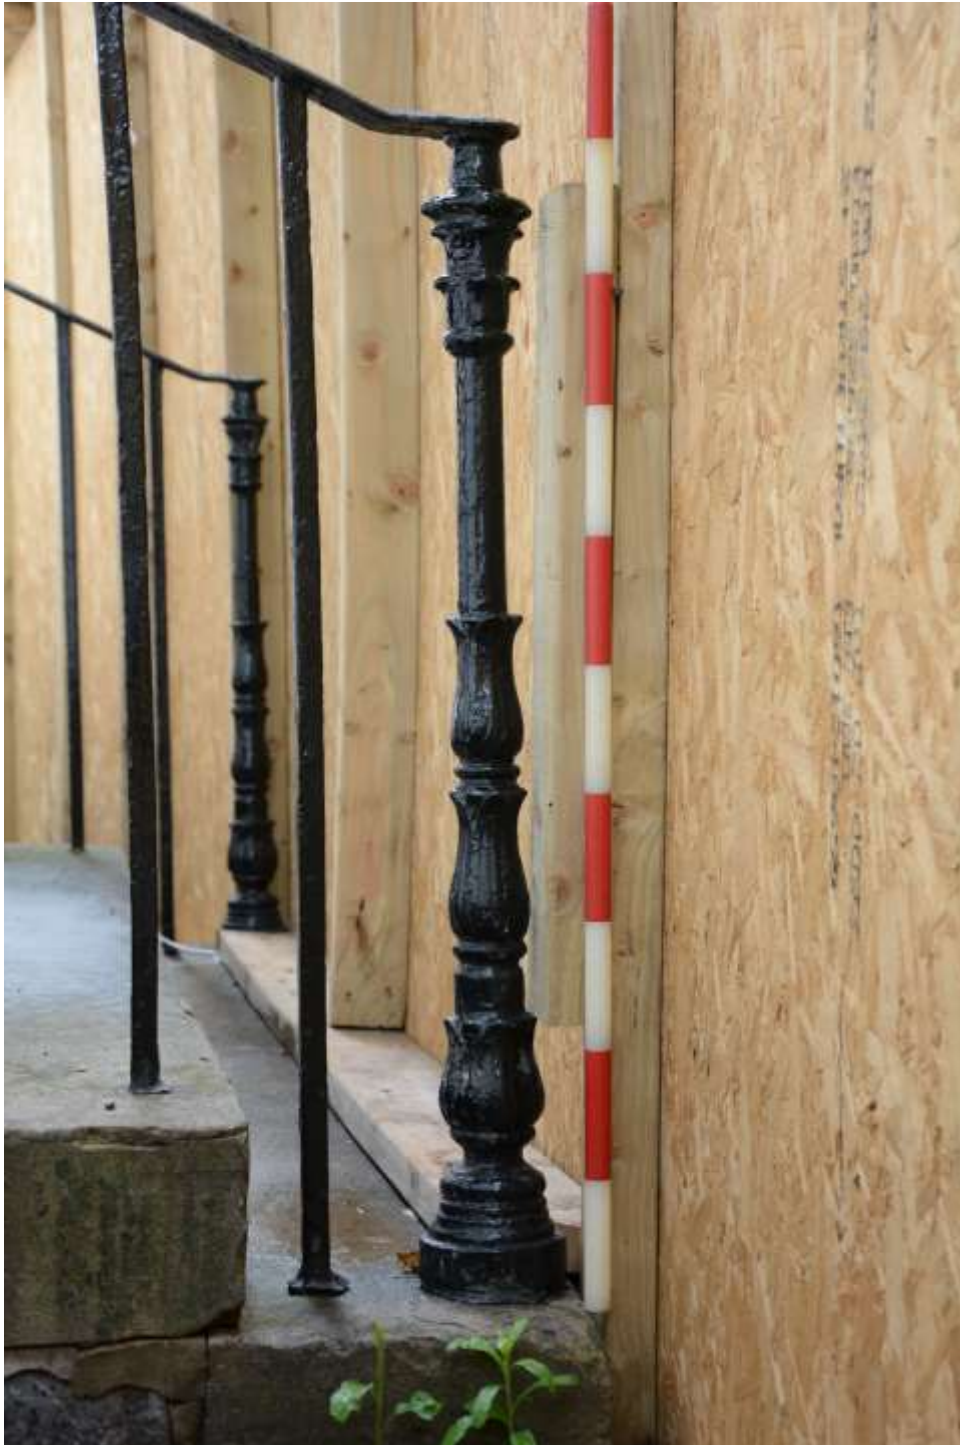
*Fig.22: Close-up view of decorated cast iron post at the foot of the entrance steps (1m scale)*

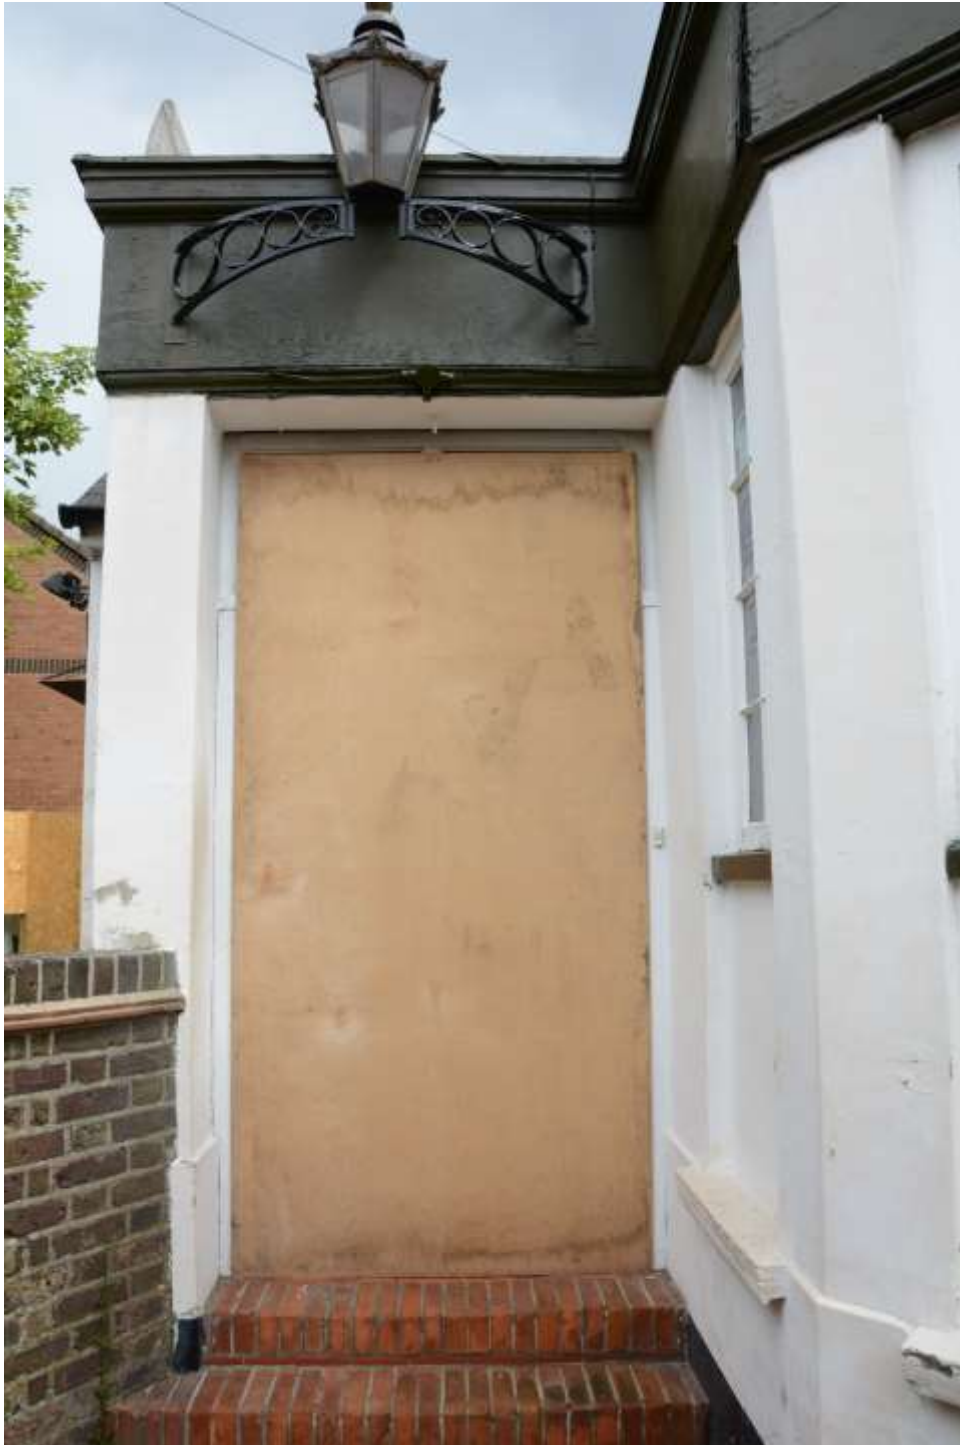
Fig.27: *The secondary front entrance doorway, with partially blocked windows to the right*

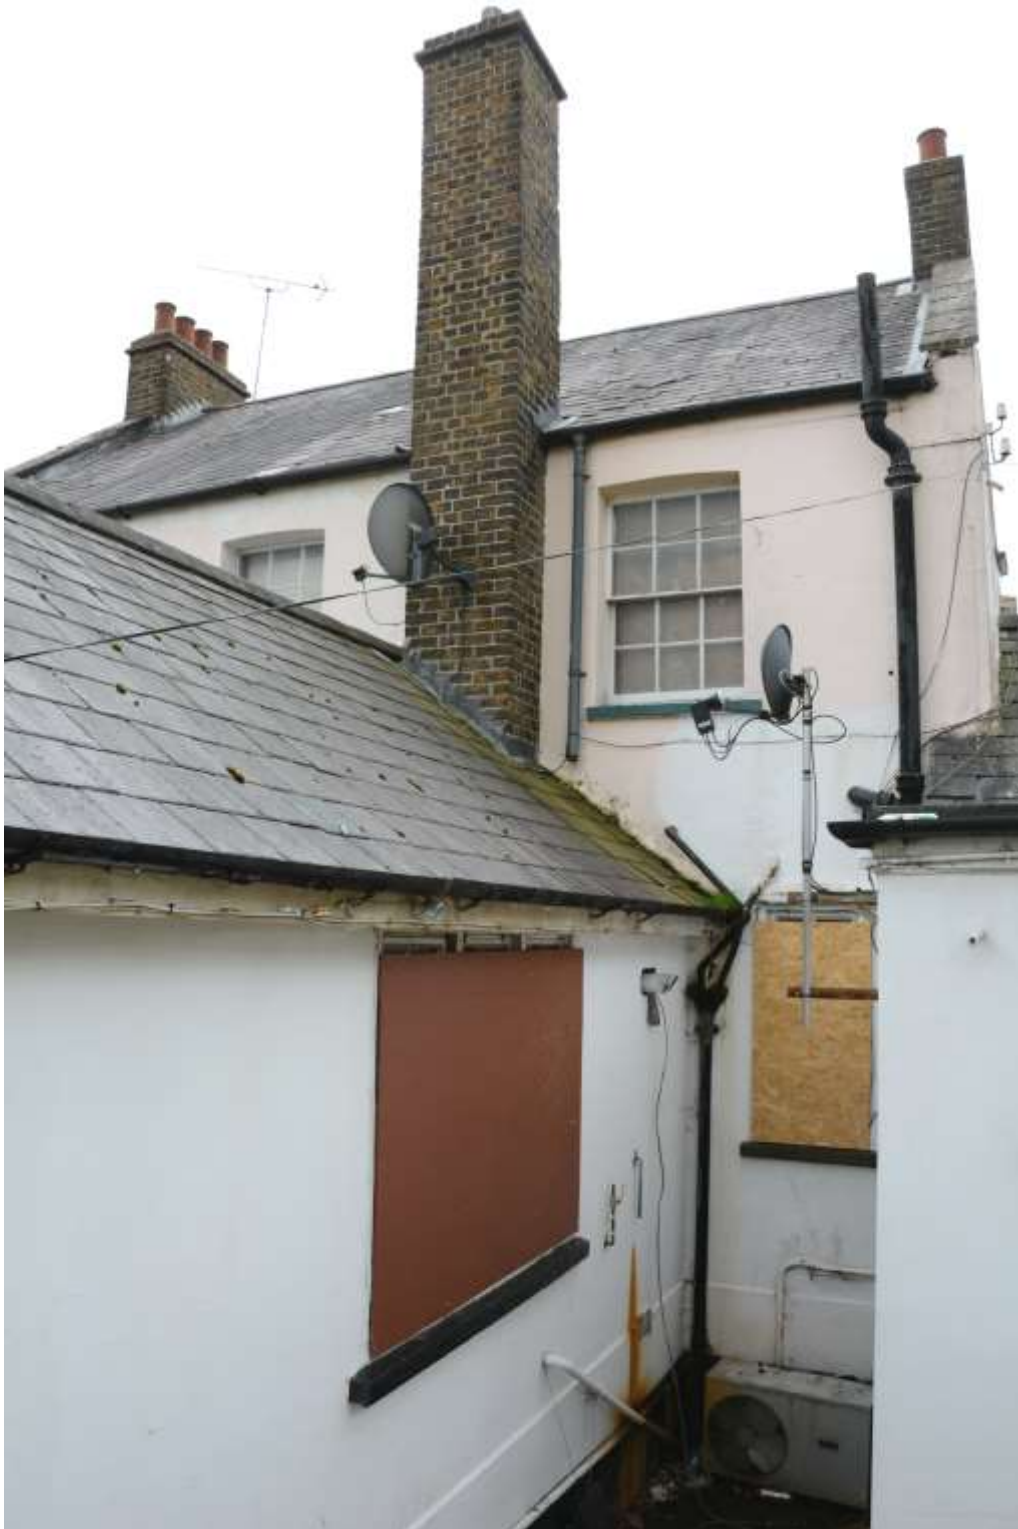
Fig.29: *The rear of the building with extensions to its original northern corner, looking SSW*

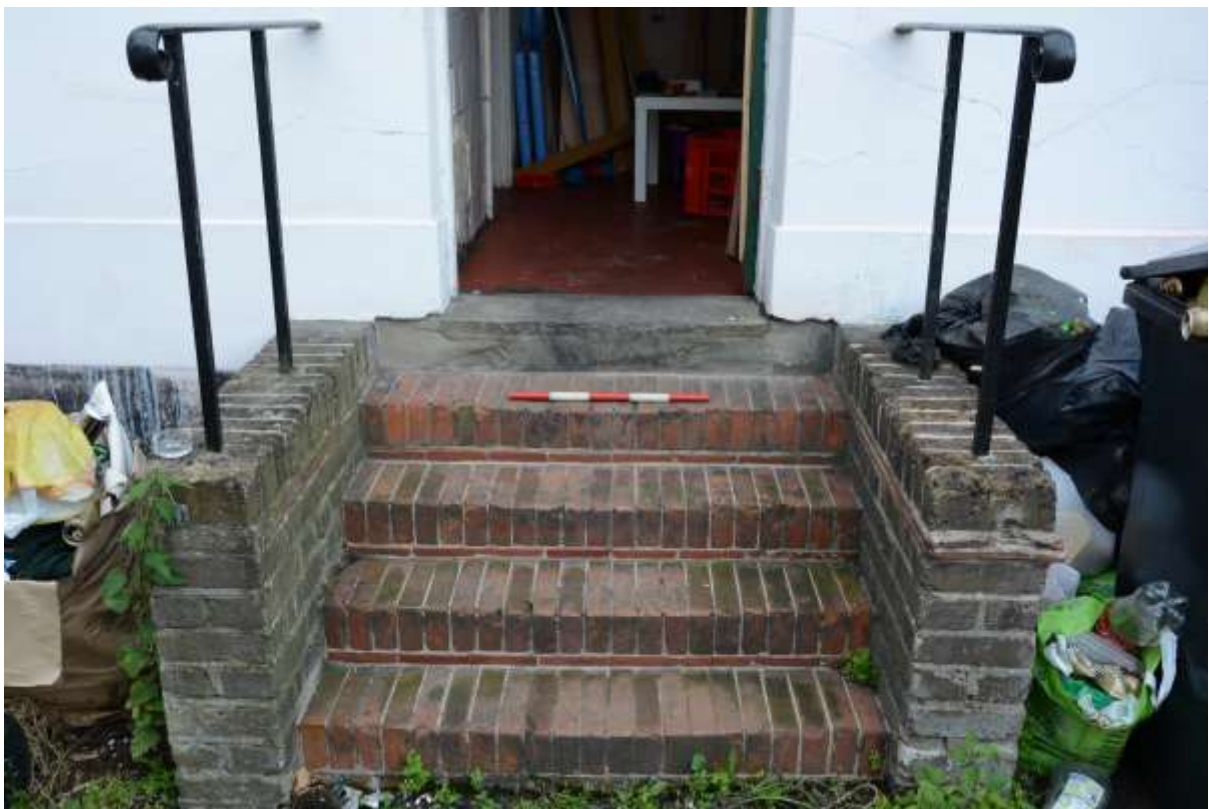
common to all areas – notably the layered tile sill construction, also found on the front bays (*cf.* Figs.32-35), and at the front and back entrances the brick steps (Figs.30-31).

Fig.31: *Steps to the main rear (kitchen/scullery) entrance, almost certainly contemporary with those above*

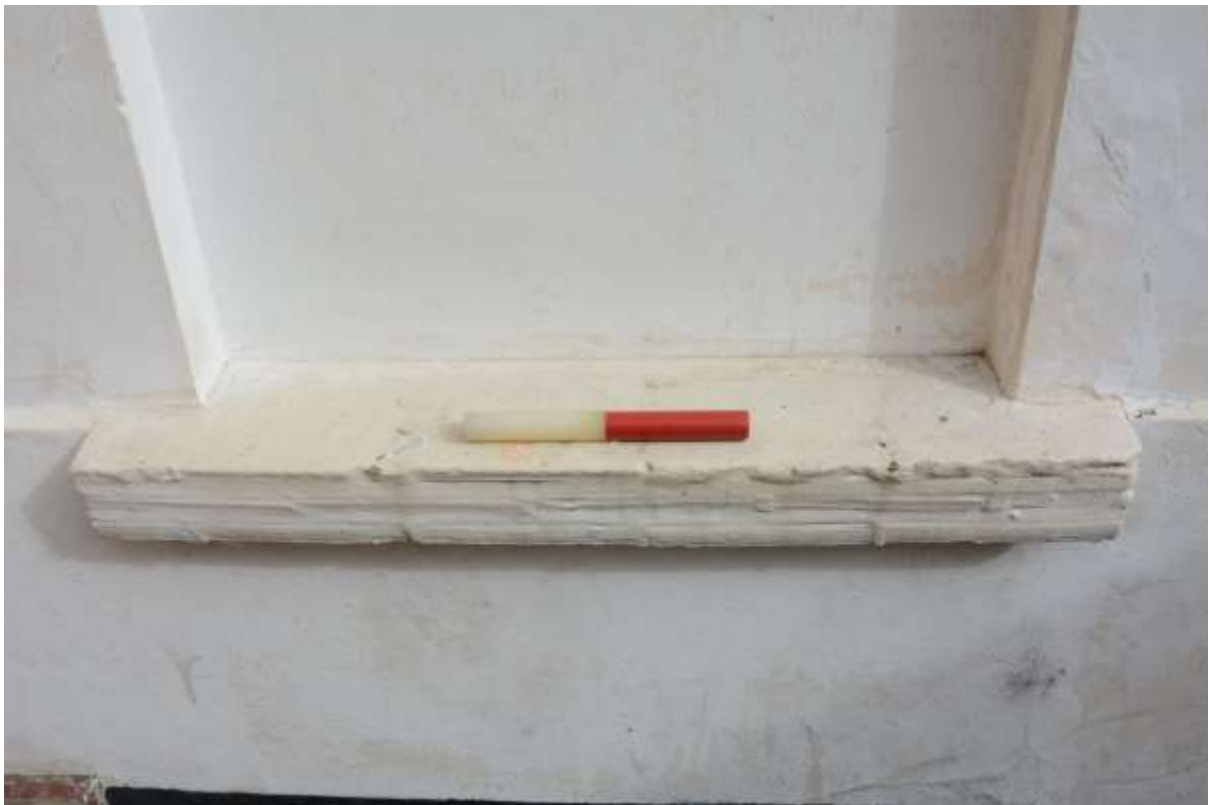
Fig.33: *The same sill construction seen on the blocked lower section of the window to the right of the secondary front entrance*

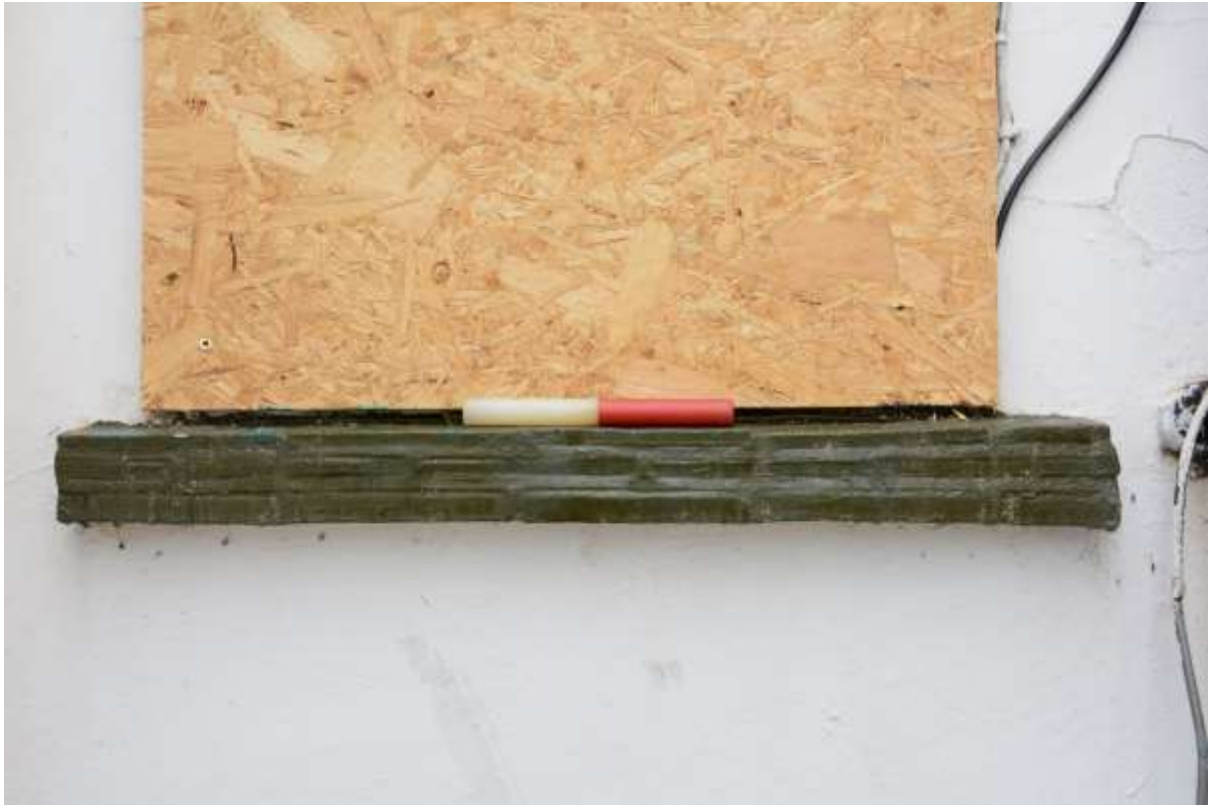
Fig.34: *Sill construction at the rear/northern part of the building reiterating that seen at the front (0.2m scale)*

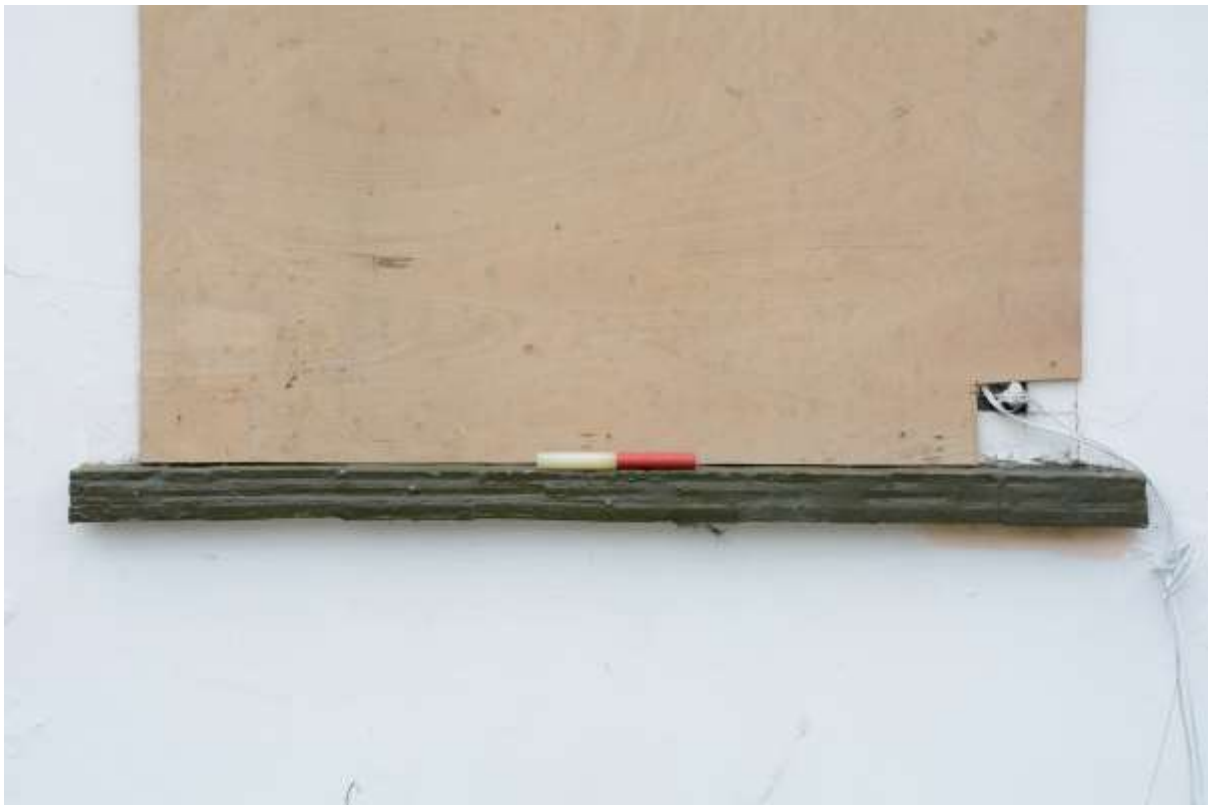
Fig.35: *The same sill construction at the projecting centre/rear of the building*

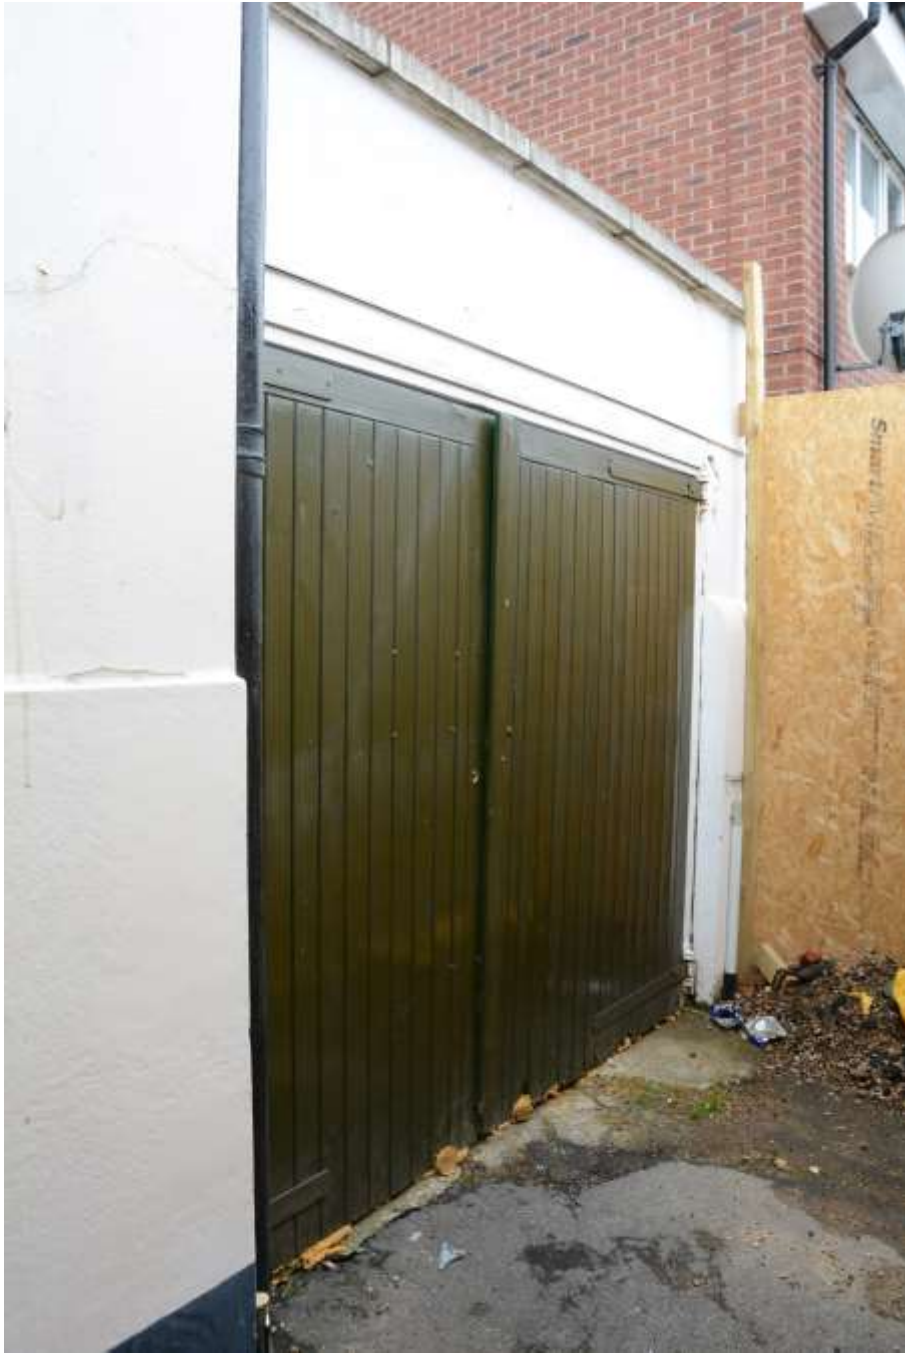
*Fig.37: Modern double garage doors at the southern end of the building frontage*

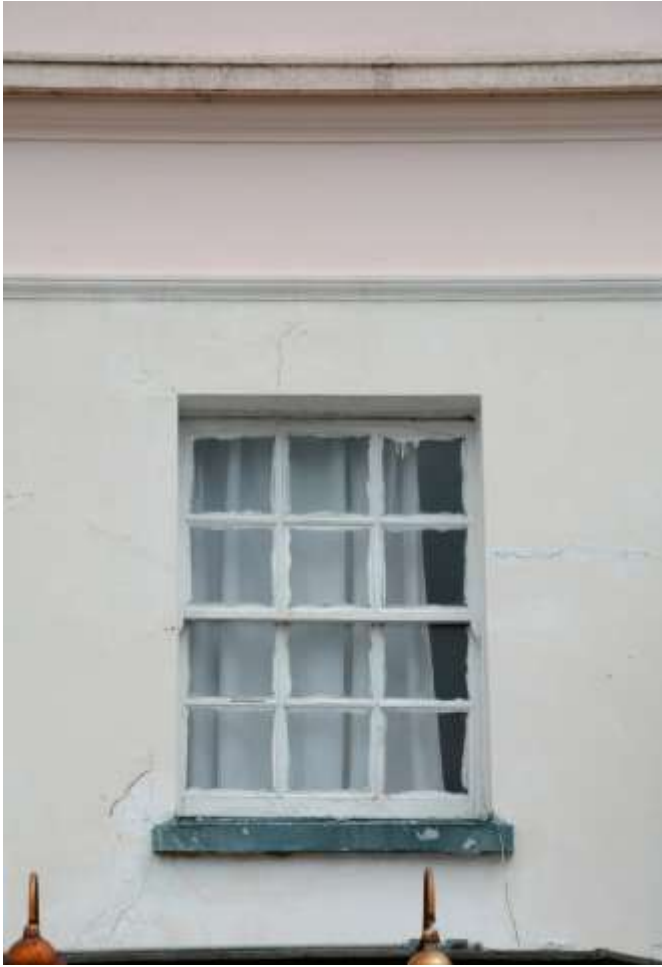
*Fig.39: The southernmost sash window on the building frontage, with stone sill below*

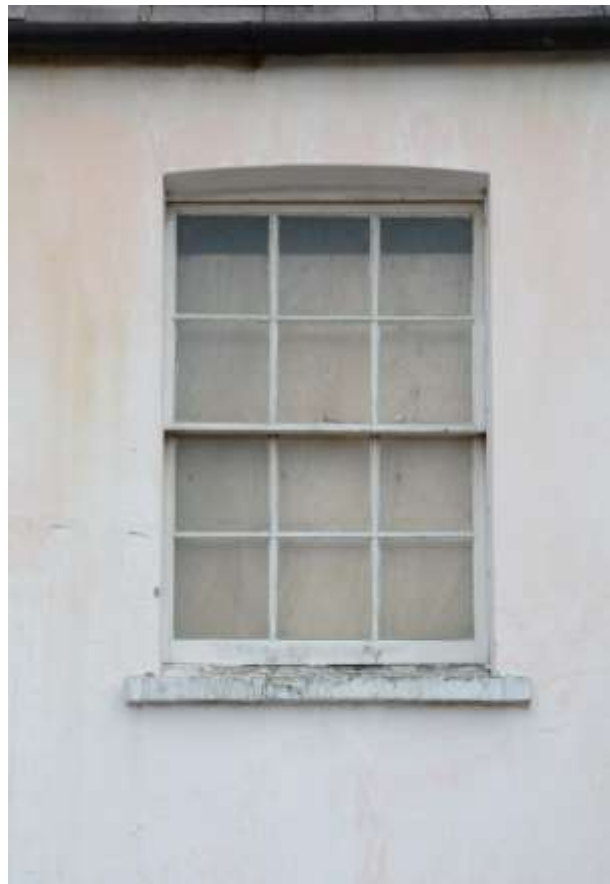
*Fig.40: The southernmost window at the rear of the building, similar to that above but slightly rounded headed*

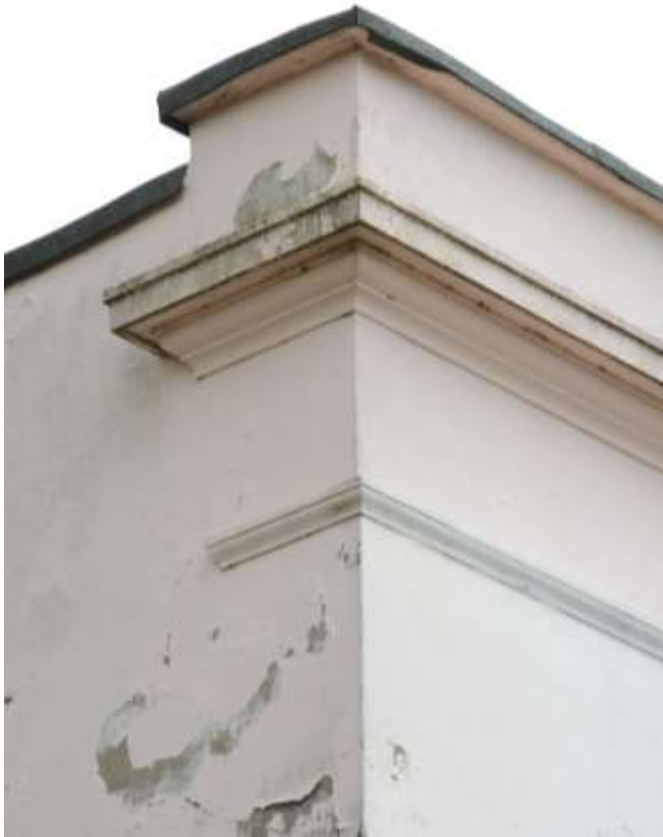
*Fig.41: Detail of the northwestern end of the front parapet*

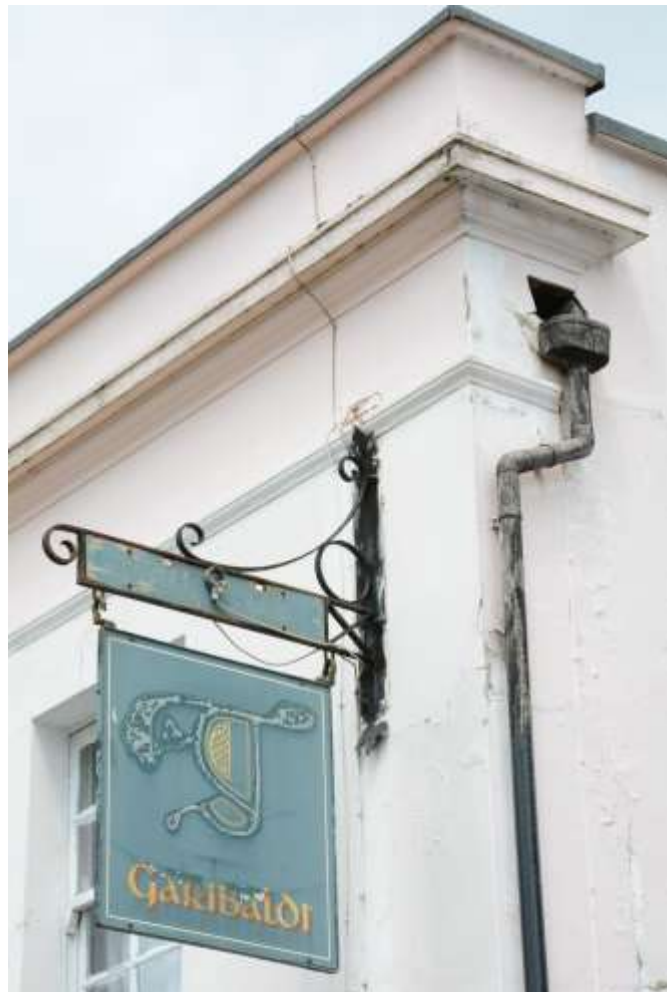
*Fig.42: The southeastern end of the parapet, actual roof level clearly indicated by the downpipe*

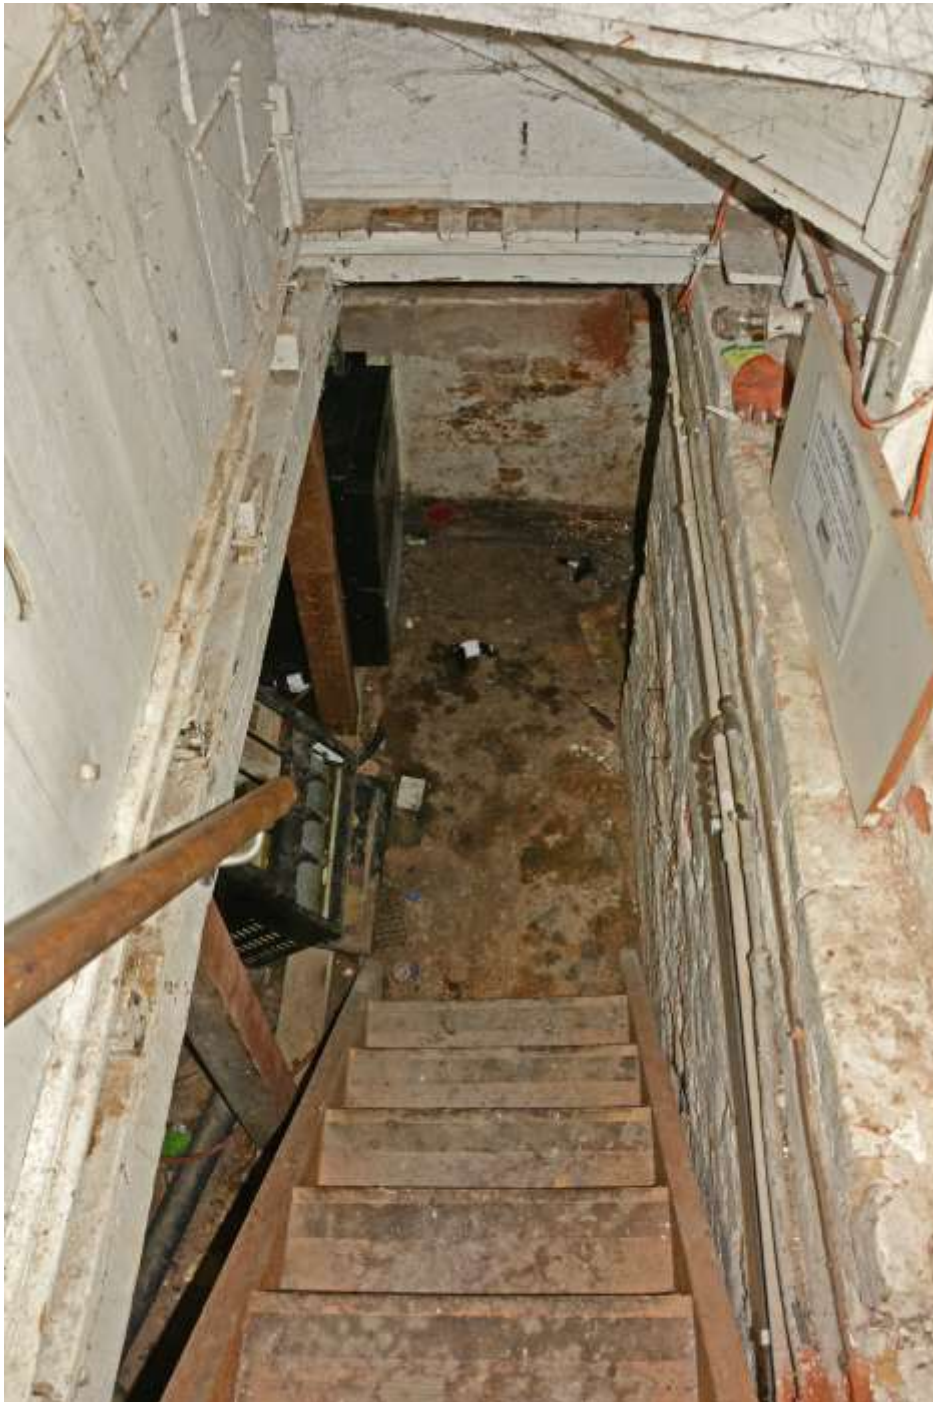
Fig.45: *Wooden steps giving access to the cellar*

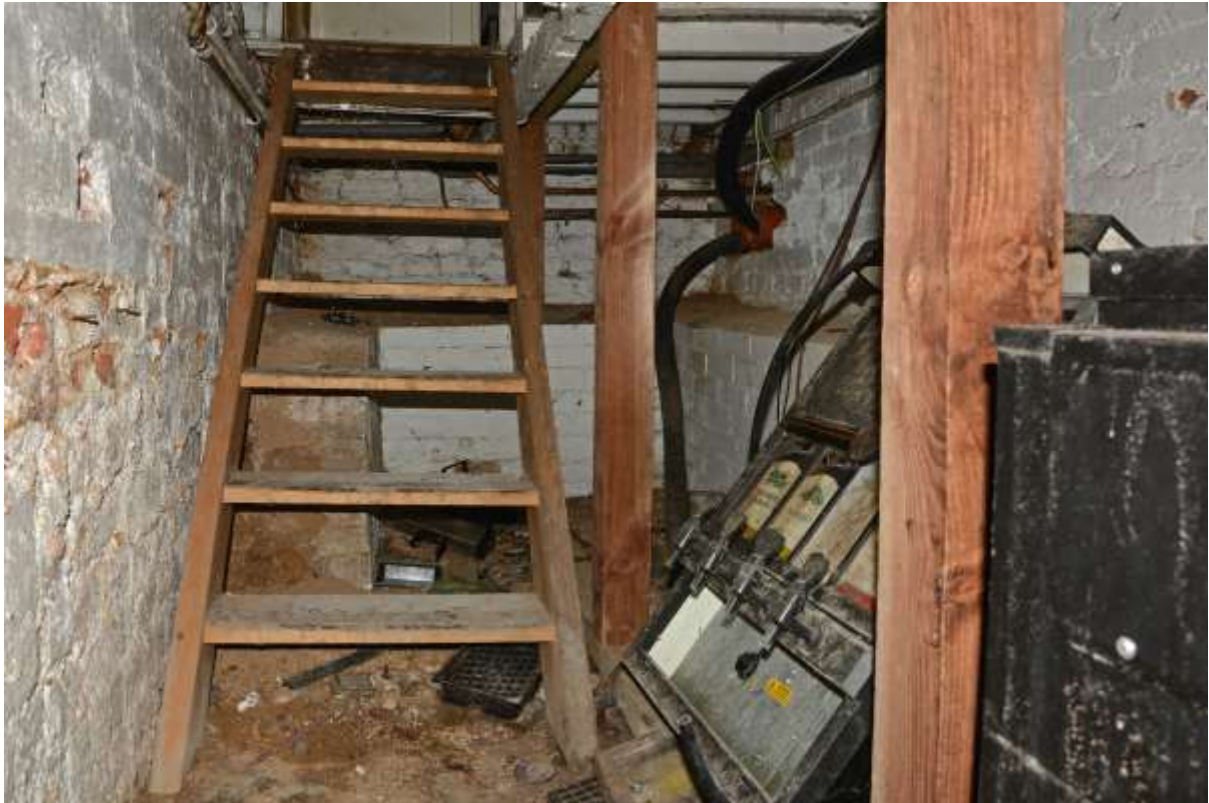
Fig.46: *View of the cellar steps from below*

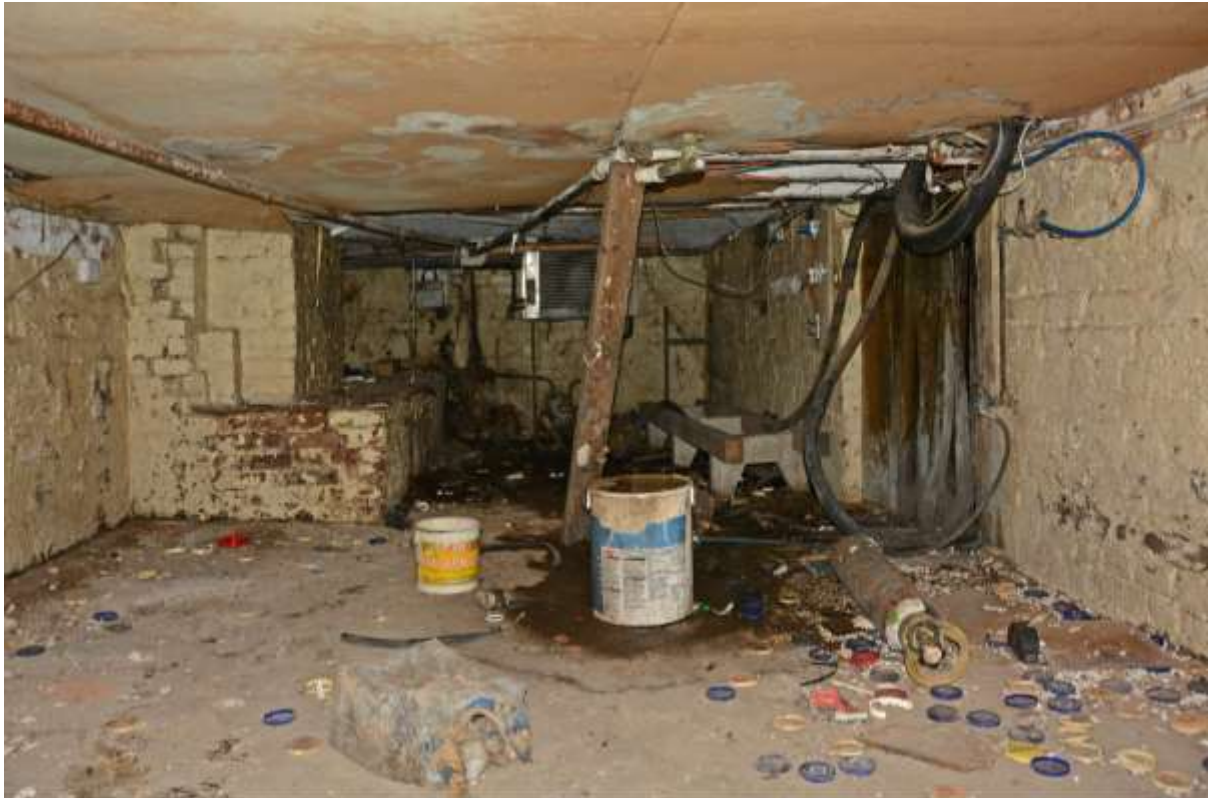
Fig.48: *The main cellar, looking towards the rear of the building*

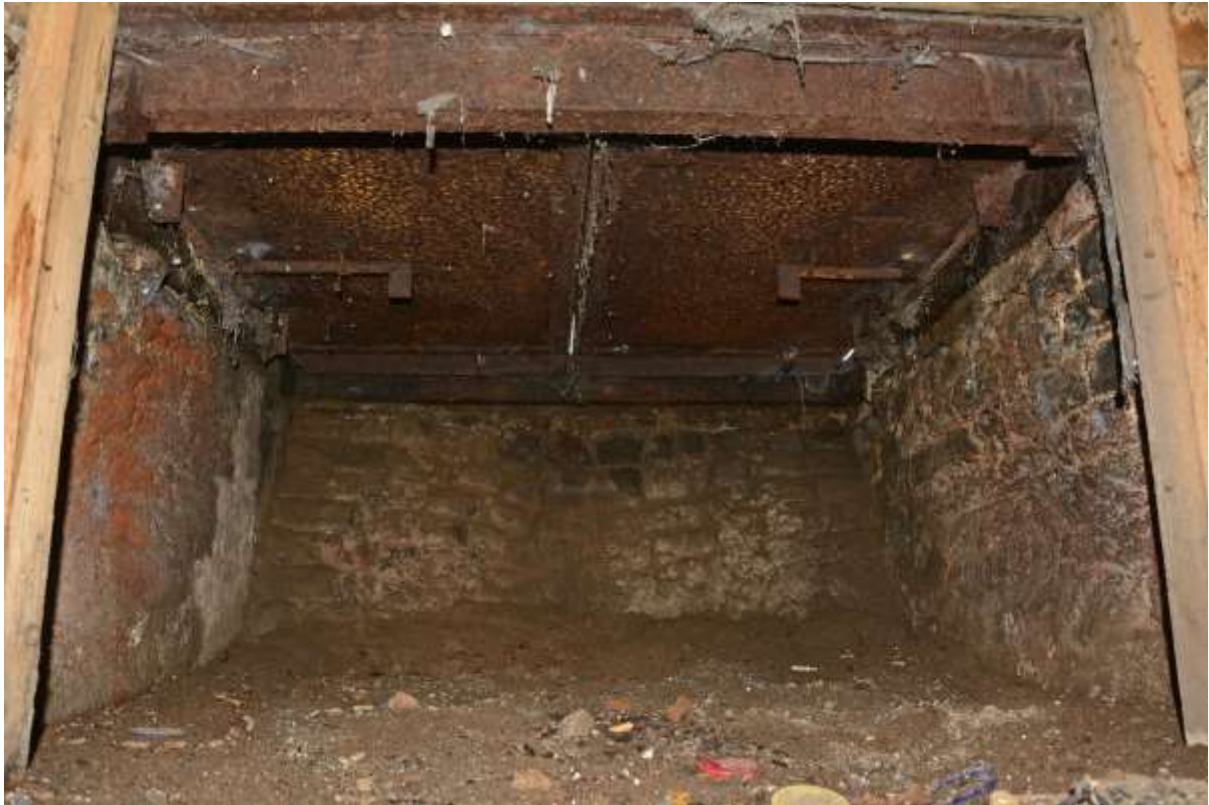
*Fig.50: Detail of the external access hatch at the front of the building. The two metal doors with retaining latches can be seen, joining in the centre of the picture*

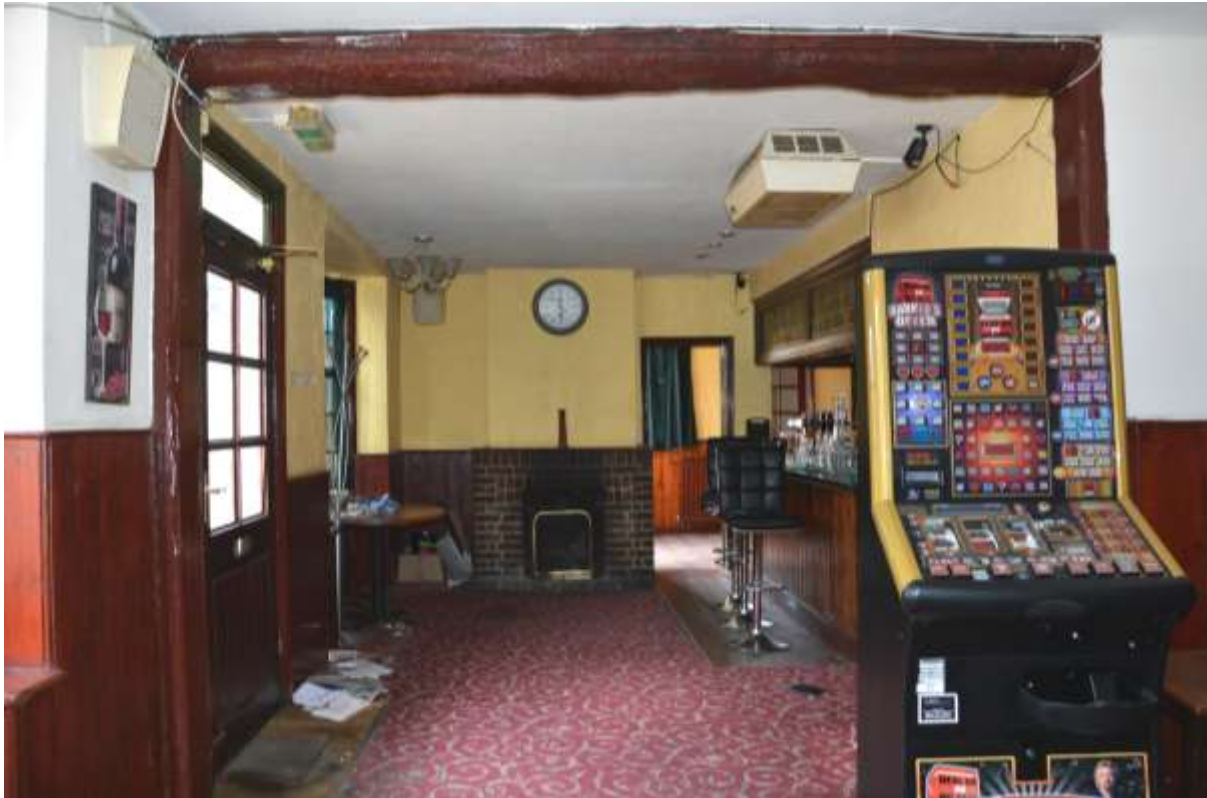
Fig.52: General view along the main bar at the front of the building, looking northwest. The timber beams presumably mark the division between the original entrance hallway and a separate room in the foreground

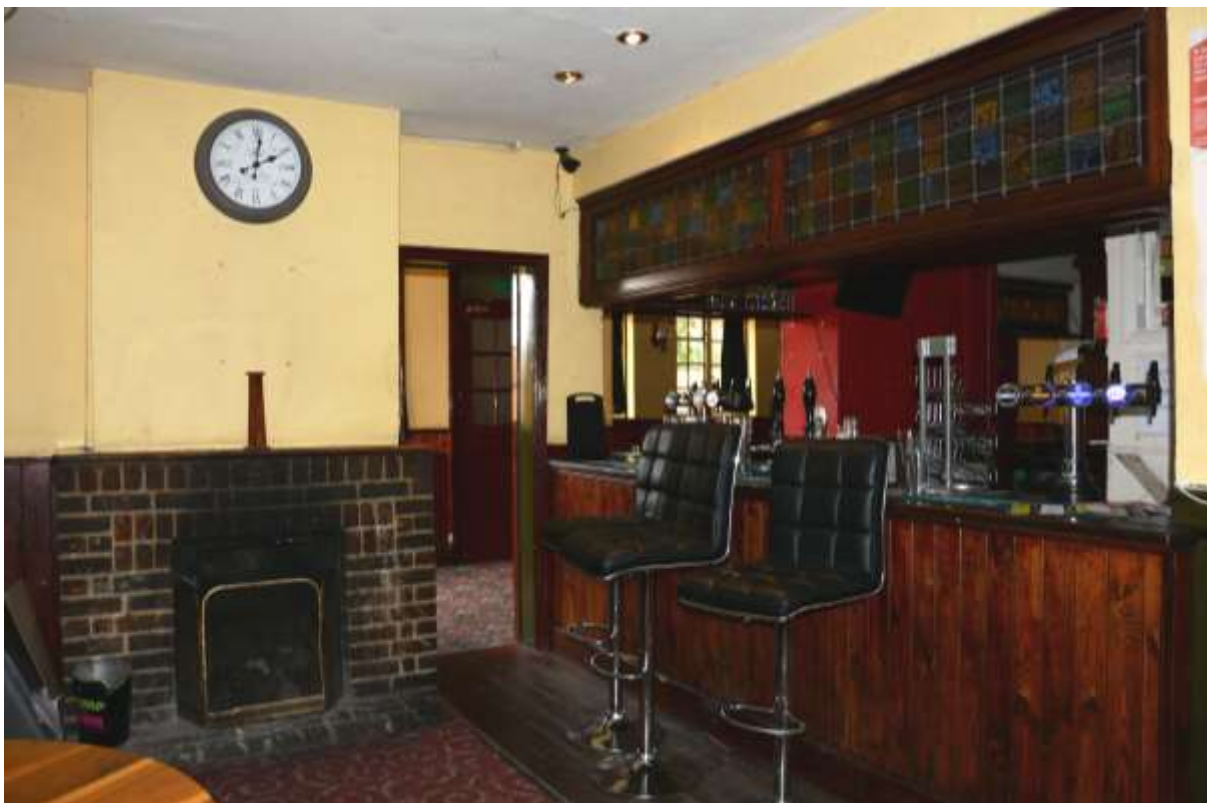
Fig.53: Closer view of the bar and adjacent 20<sup>th</sup> century fireplace. Similarly to the previous picture, the plastered beam or girder above the bar is assumed to mark the original division of this area into two separate rooms

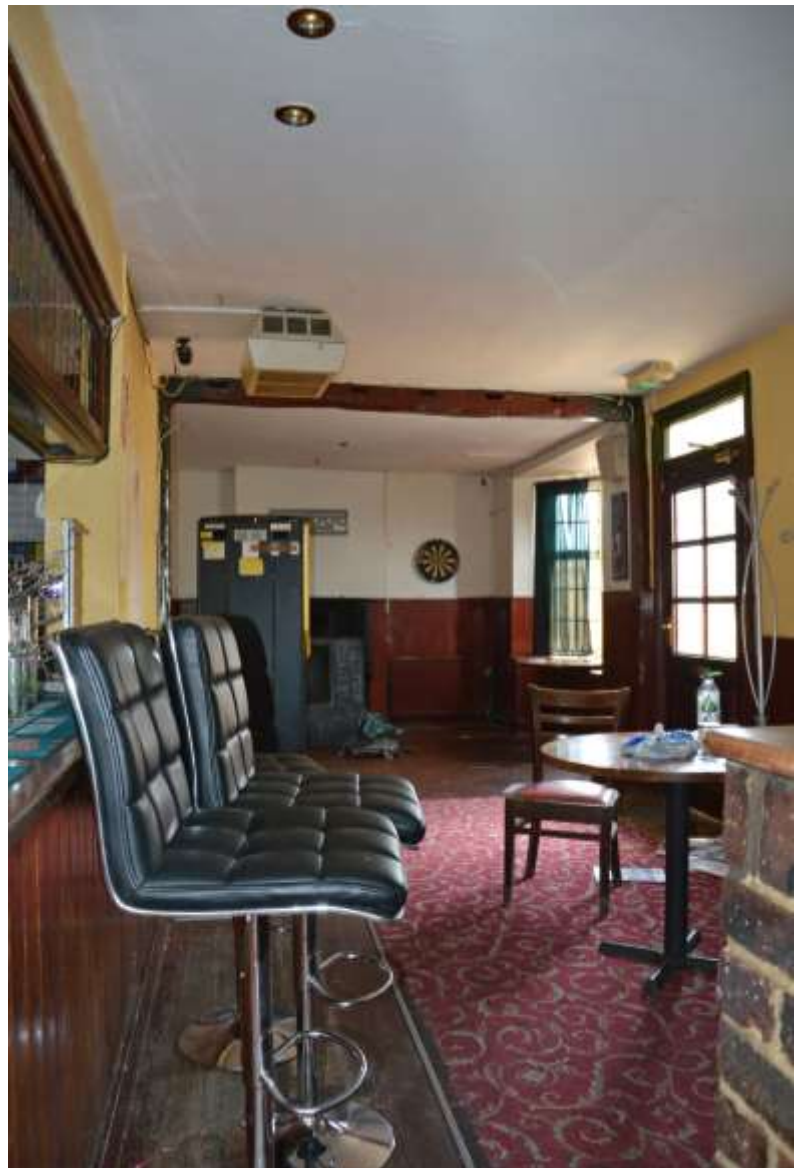
Fig.56: *The southeastern end of the bar. It is not clear whether the ceiling beam in the foreground (with mortice holes on this side only) is original, though it is assumed to follow the line of an original division*

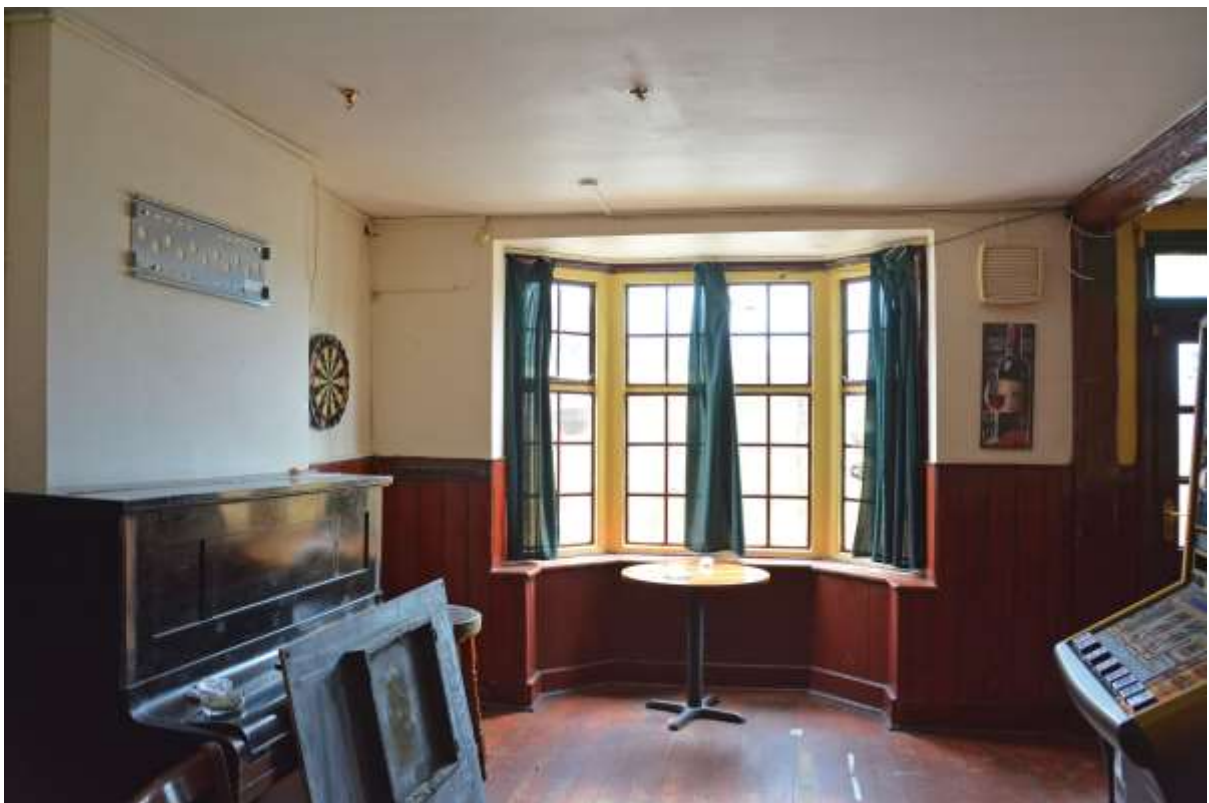
Fig.59: *The southeastern bay window, with the disused and sealed chimney breast*
