THE FORMER GARIBALDI PUBLIC HOUSE  
6, THE GREEN, CHALVEY  
SLOUGH SL1 2SN

AN HISTORIC BUILDING RECORD

Planning Application Reference: P/11098/003

COMPASS ARCHAEOLOGY  
250 YORK ROAD  
LONDON SW11 3SJ

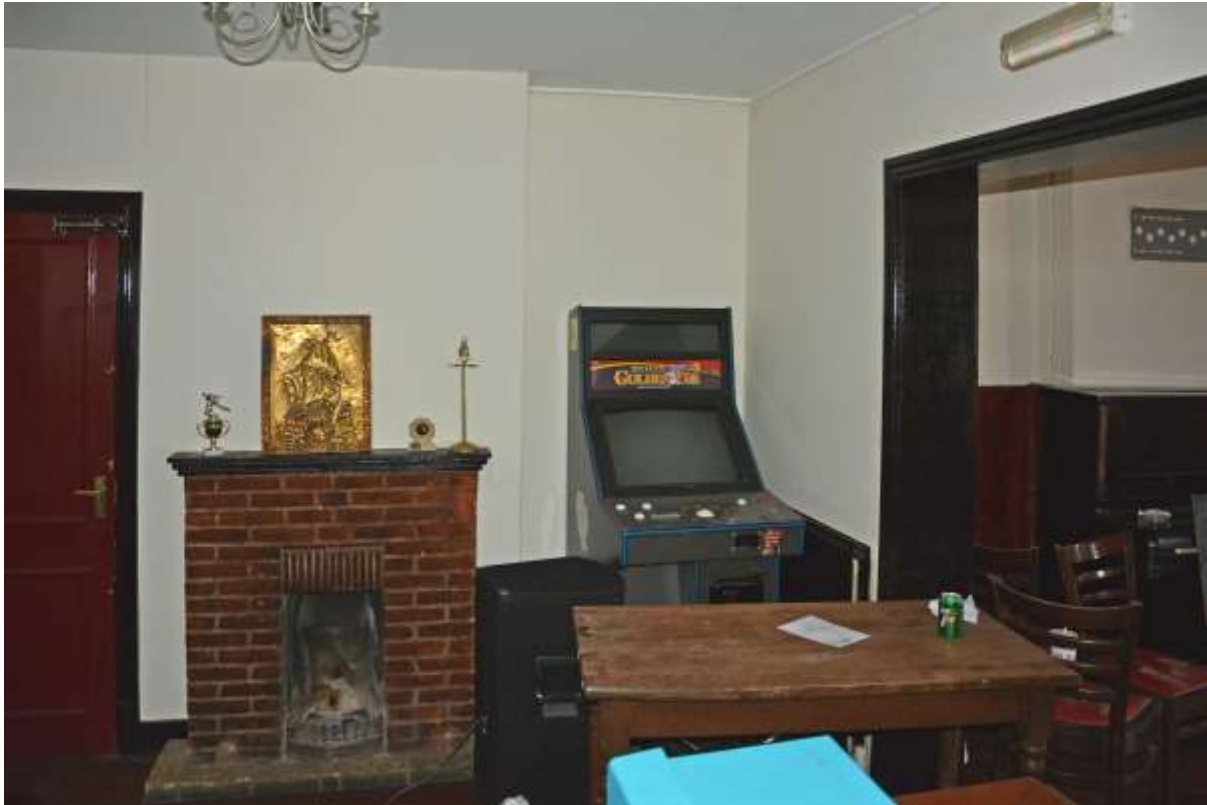
Fig.60: *The rear (eastern) room, with replacement fireplace and to the left the door to the storeroom and garage*

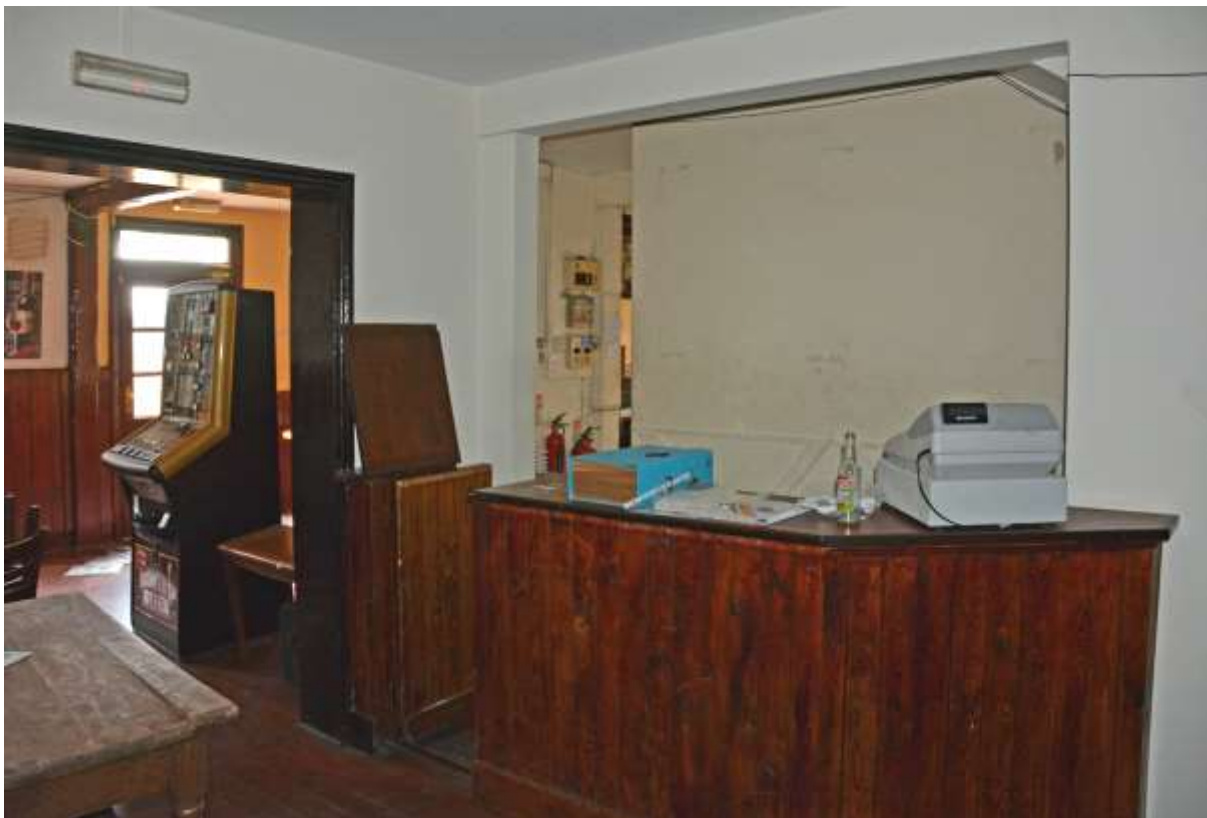
Fig.61: *The rear (eastern) room, looking towards what were probably originally solid walls*

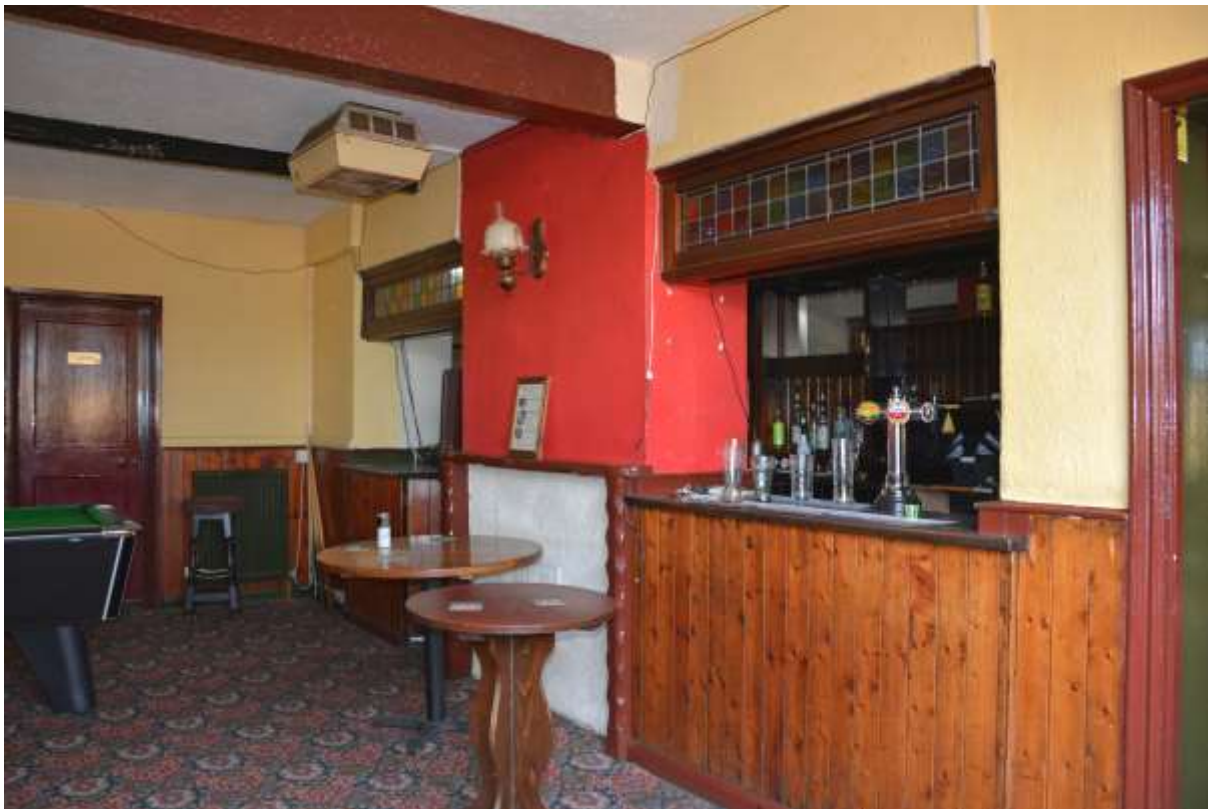
Fig.64: *View of the bar from the northwestern extension, including (partly in red) the original external face and one side of the chimney*

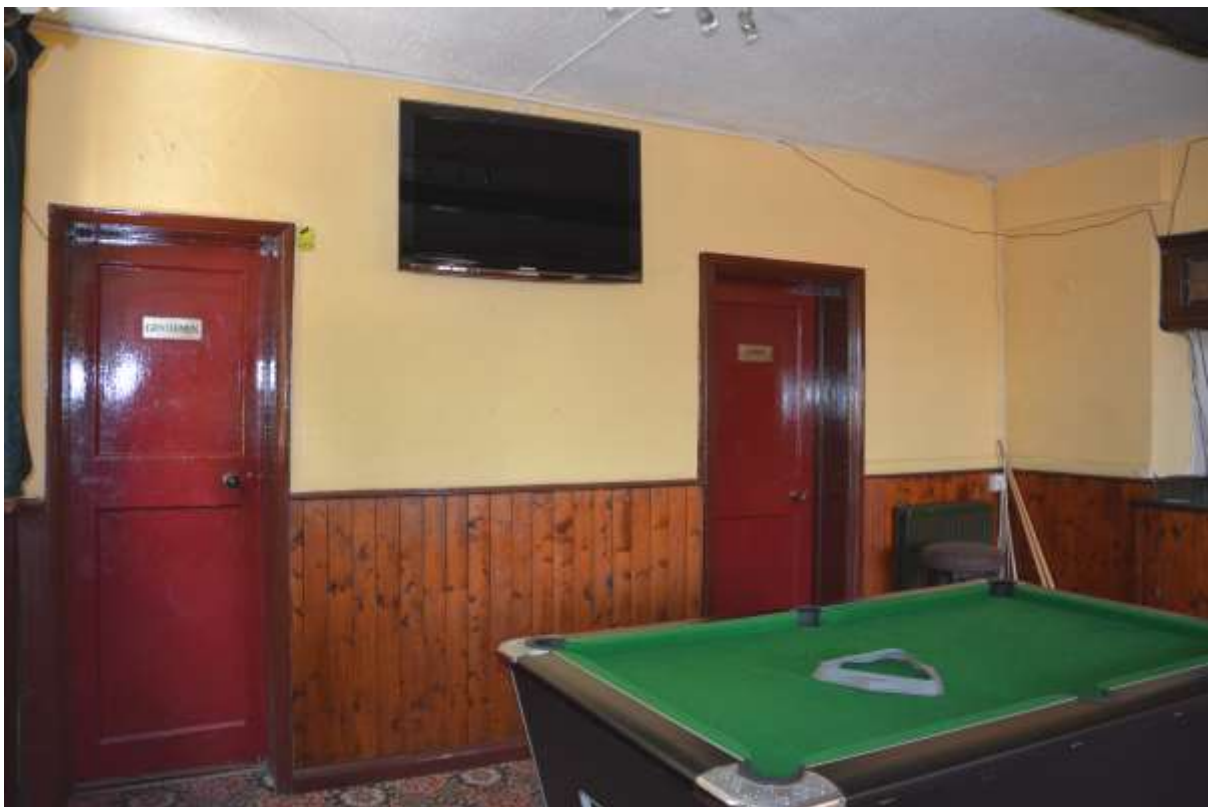
Fig.66: *The rear wall of the main northwestern area, with toilets beyond in what is probably a separate & slightly later extension (cf. Fig.17)*

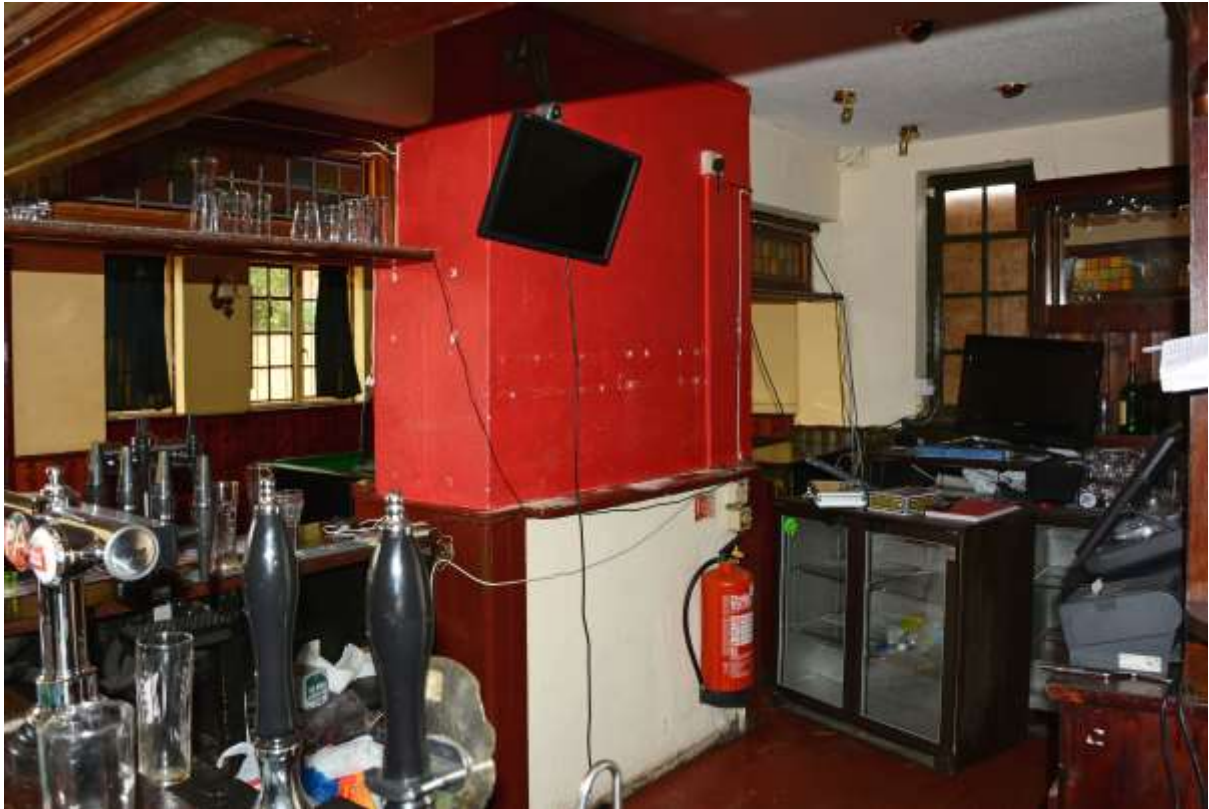
Fig.69: View from behind the bar, including (at centre) the original chimney breast and blocked fireplace opening

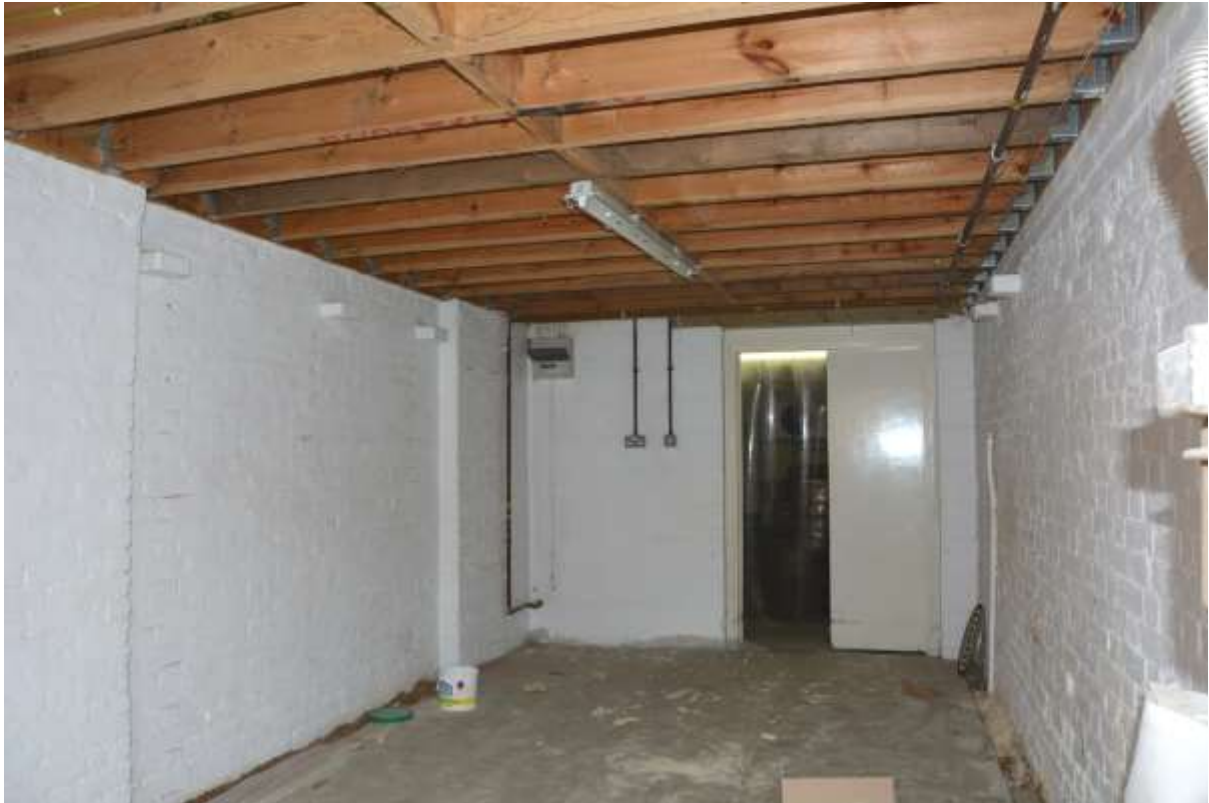
*Fig.73: The single-storey garage to the southeast, with the main building (& projecting chimney breasts) to the left. The roof and end wall /doorway are modern but the outer wall (on right) is probably 19<sup>th</sup> century, and both side walls retain stone corbels for an earlier roof*

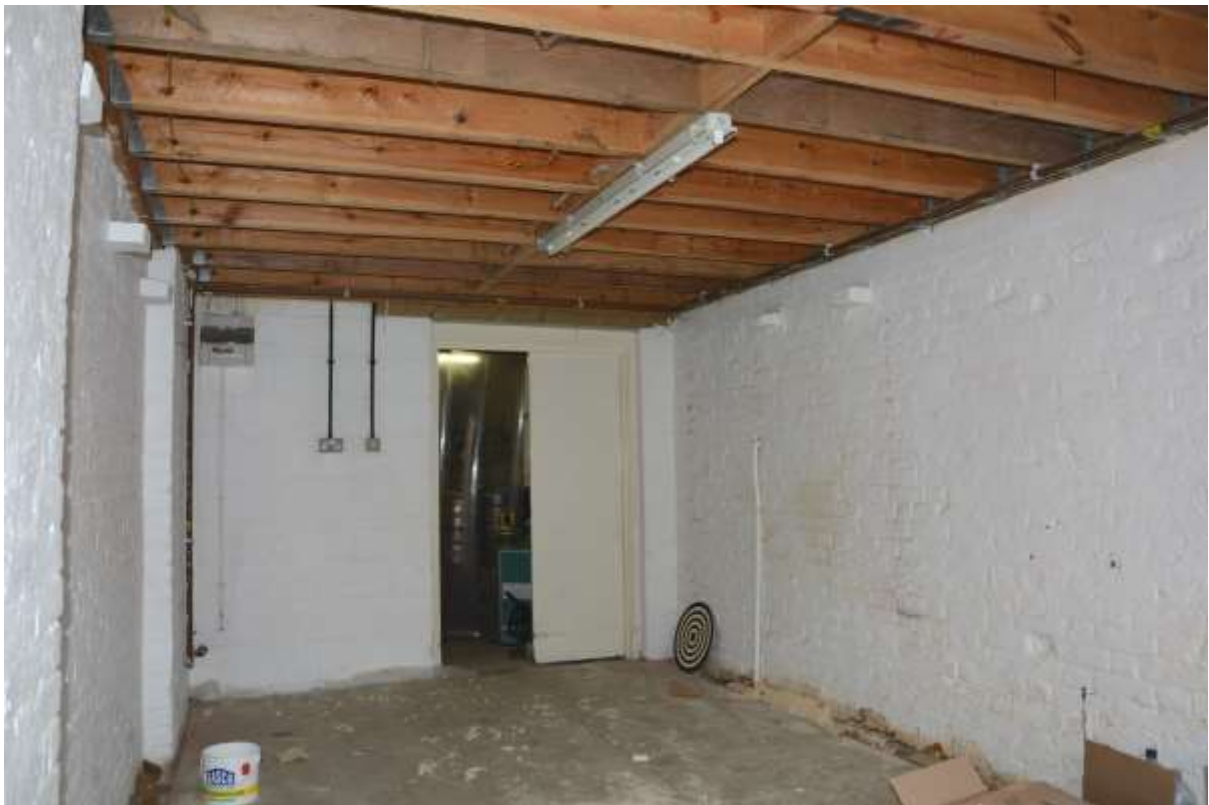
*Fig74: A similar view to the above, the main building (& three corbels) once again to the left of the frame*

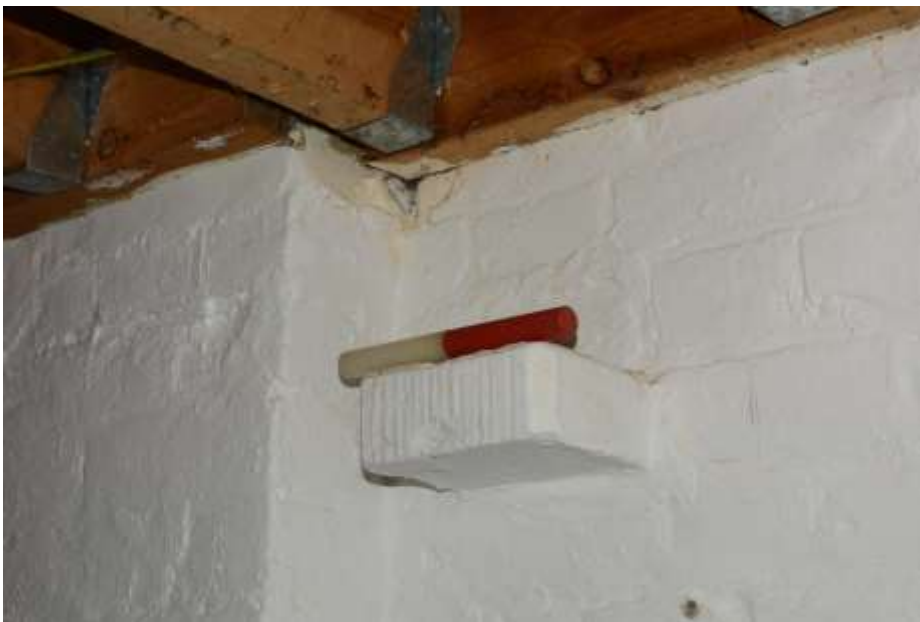
Fig.77: *Close-up view of stone corbel on the main wall, adjacent to the SW chimney stack (0.2 m scale)*

Fig.78: *Close-up of corbel on the main wall, adjacent to the NE chimney stack. The brick coursing around (& particularly above) the corbels was slightly disturbed, suggesting that they been set into the wall after construction*

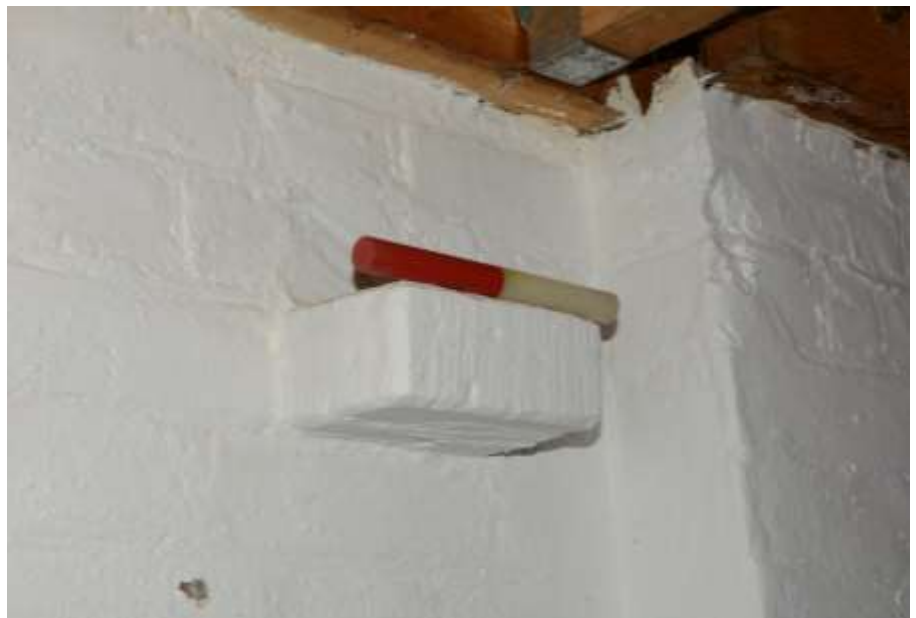
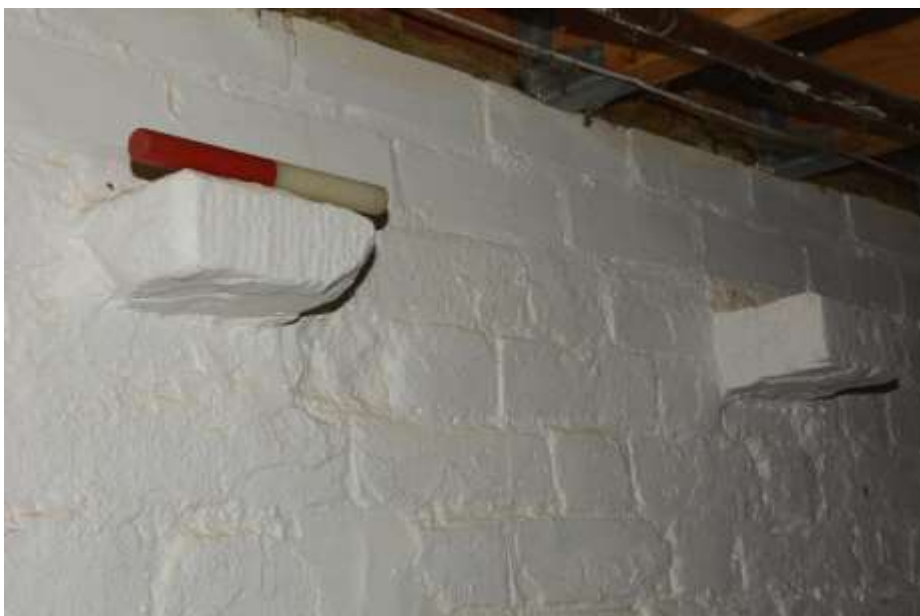
Fig.79: *Two of the corbels on the outer wall (a third being located at the SW end). The upper two brick courses are modern*

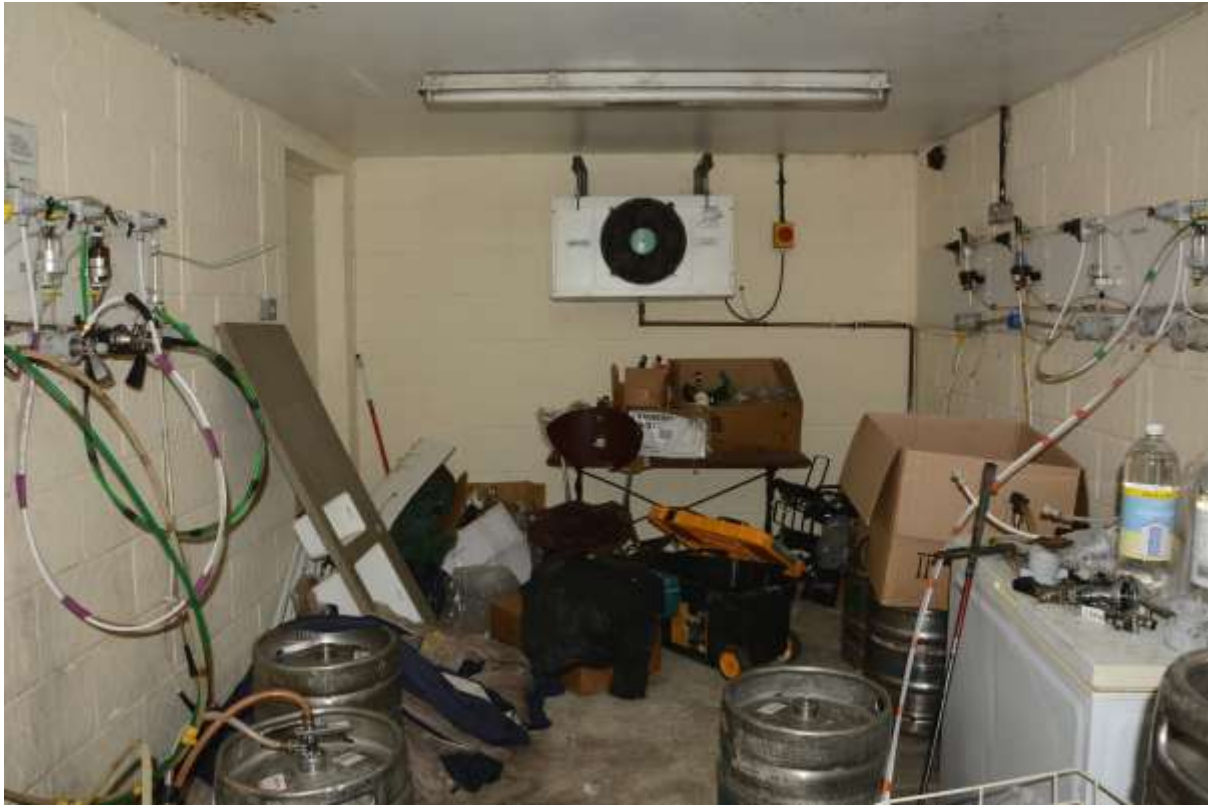
Fig.80: *The modern single-storey storeroom at the southeast corner of the property, external door to the left (see Fig.36 for the outside view)*

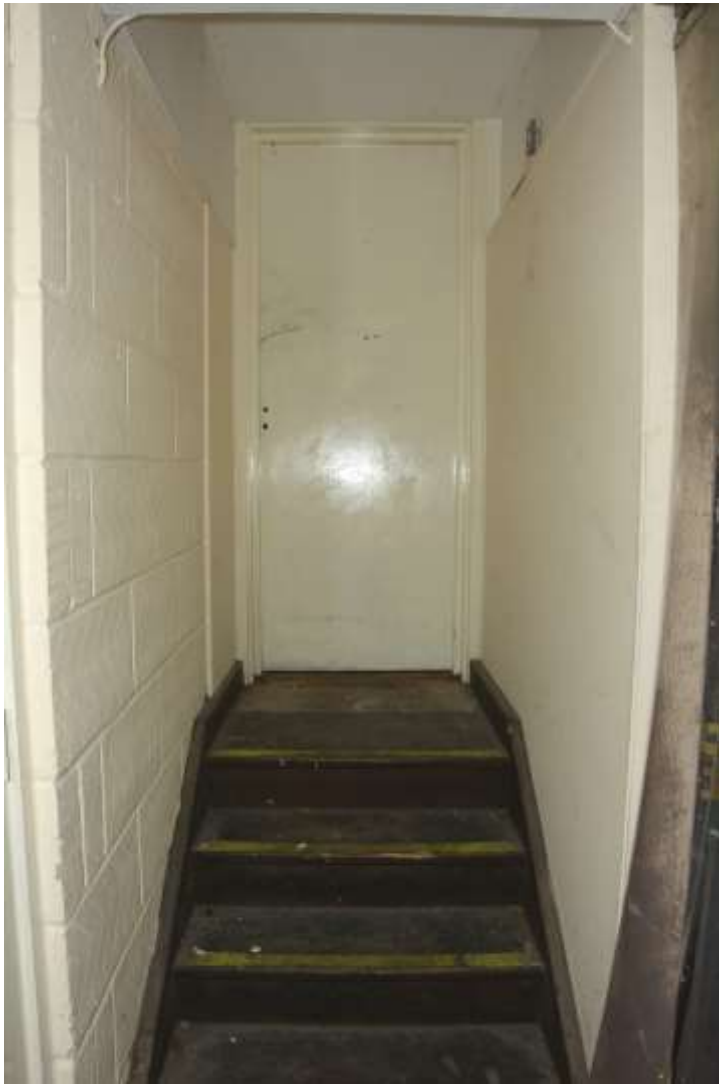
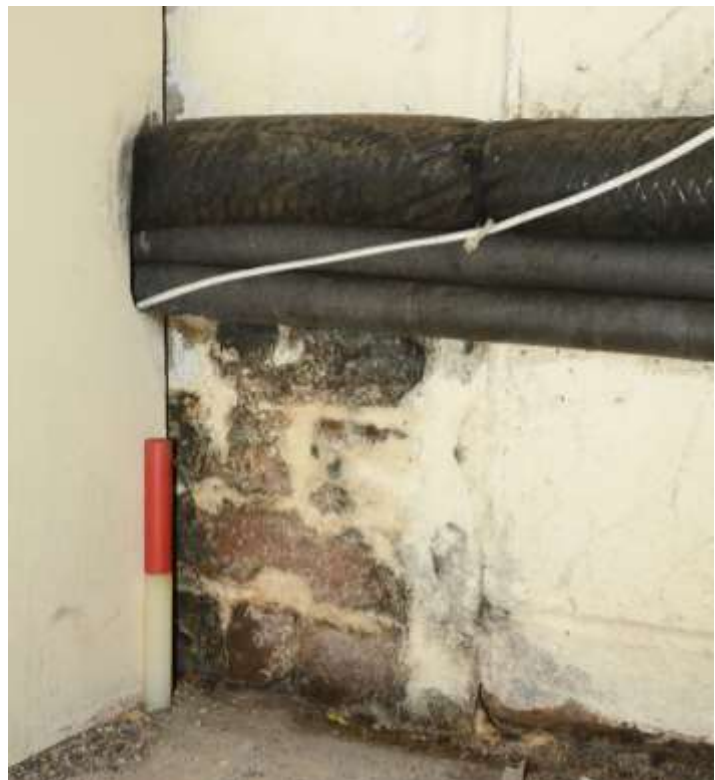
*Fig.82: Stairs and doorway into the main building (see Fig.60 for the other side)*

*Fig.83: Close-up of the junction between the storeroom breeze-block extension and to the left the original eastern corner of the main building (0.2m scale)*

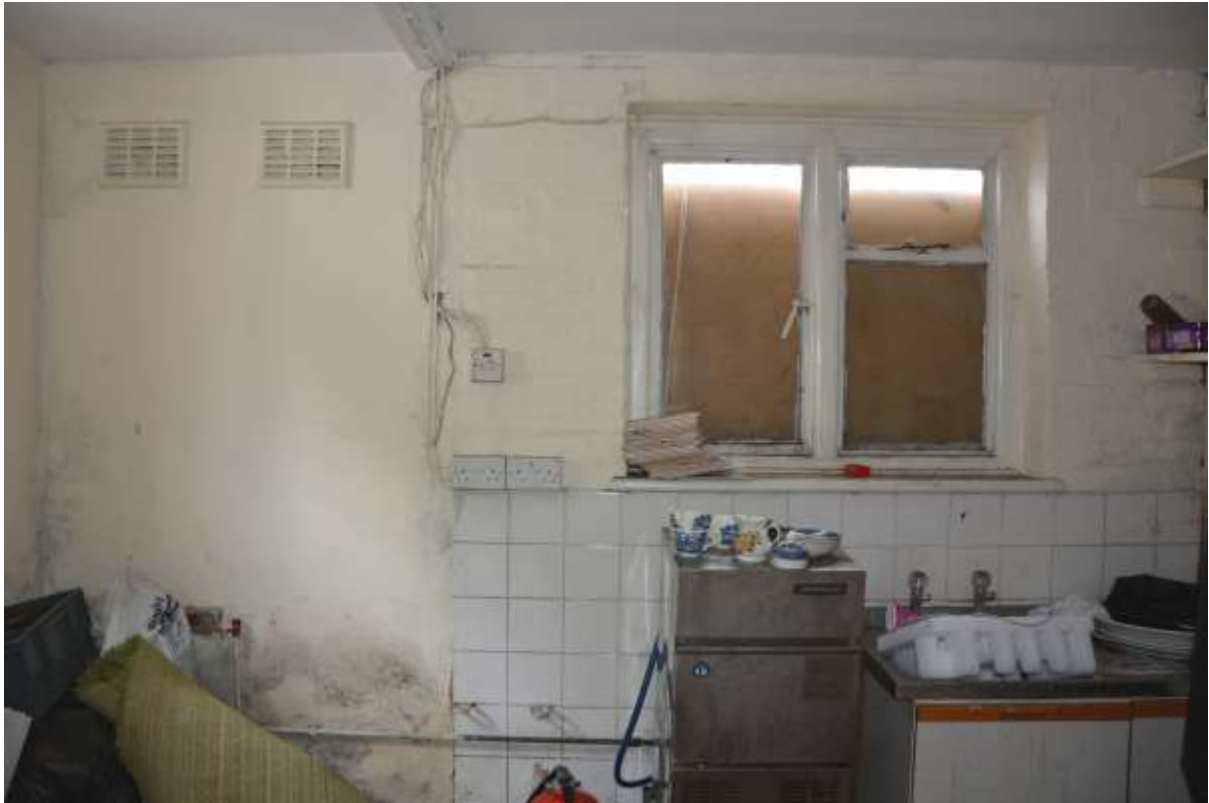
Fig.86: *The smaller utility room/scullery behind the main kitchen. Only at the NW end and extending c 1.2m is the brickwork rendered (as shown to the left of the frame: the ventilators here indicate that this was originally a separate larder*

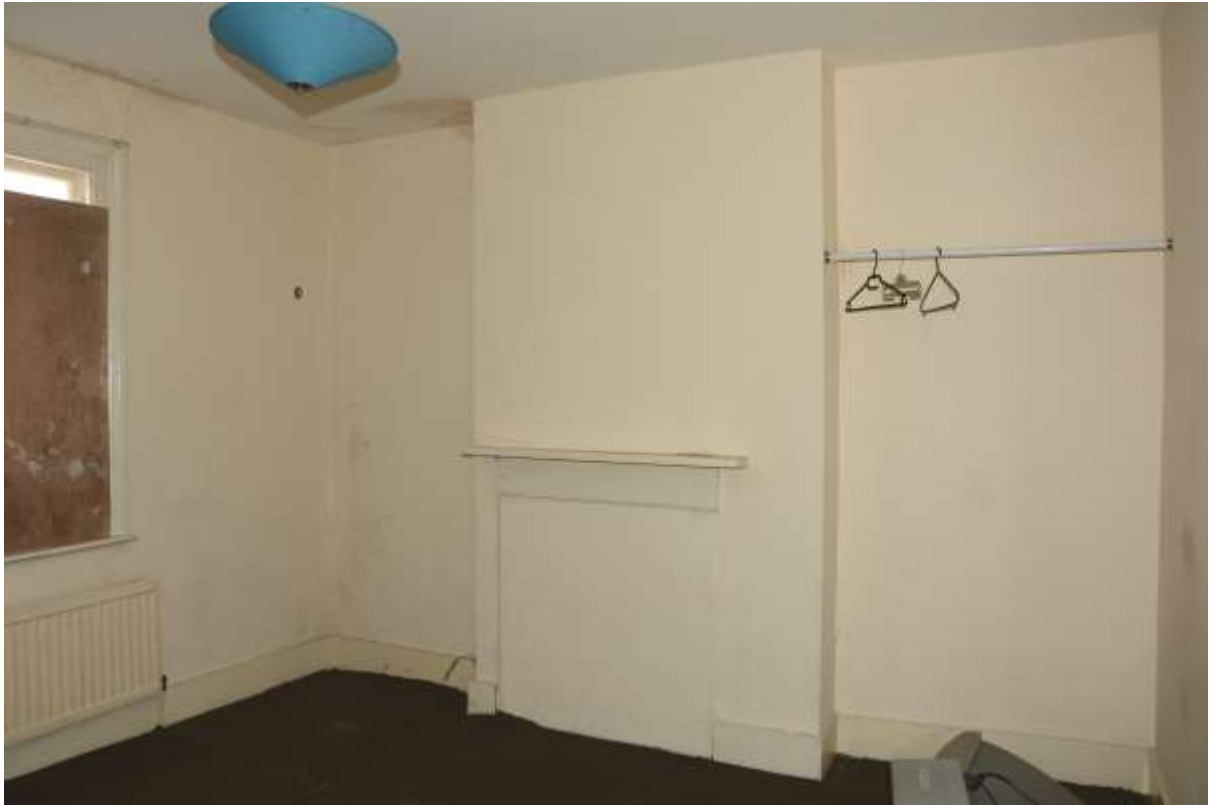
Fig.97: *The rear (SE) bedroom, showing the chimney breast, the blocked and very basic fire surround, and adjacent plain skirting board*

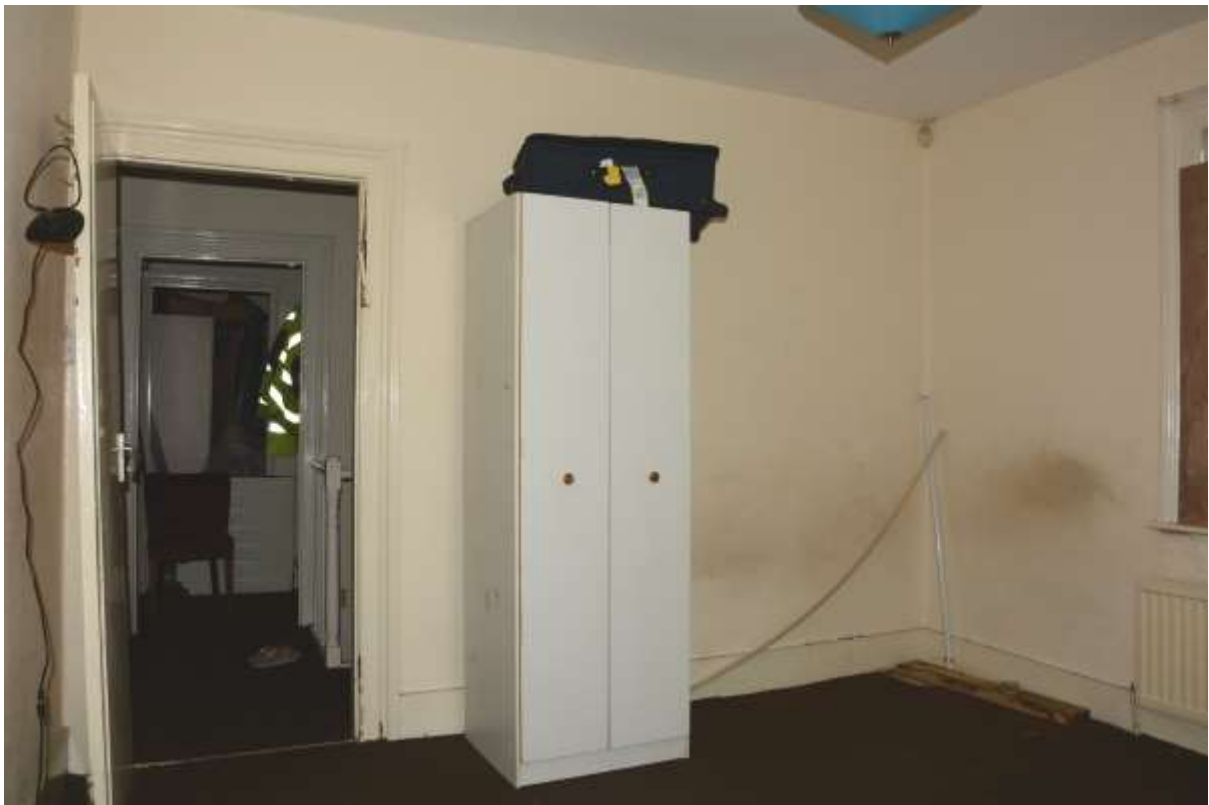
Fig.98: *A further view of the bedroom, looking back onto the landing*

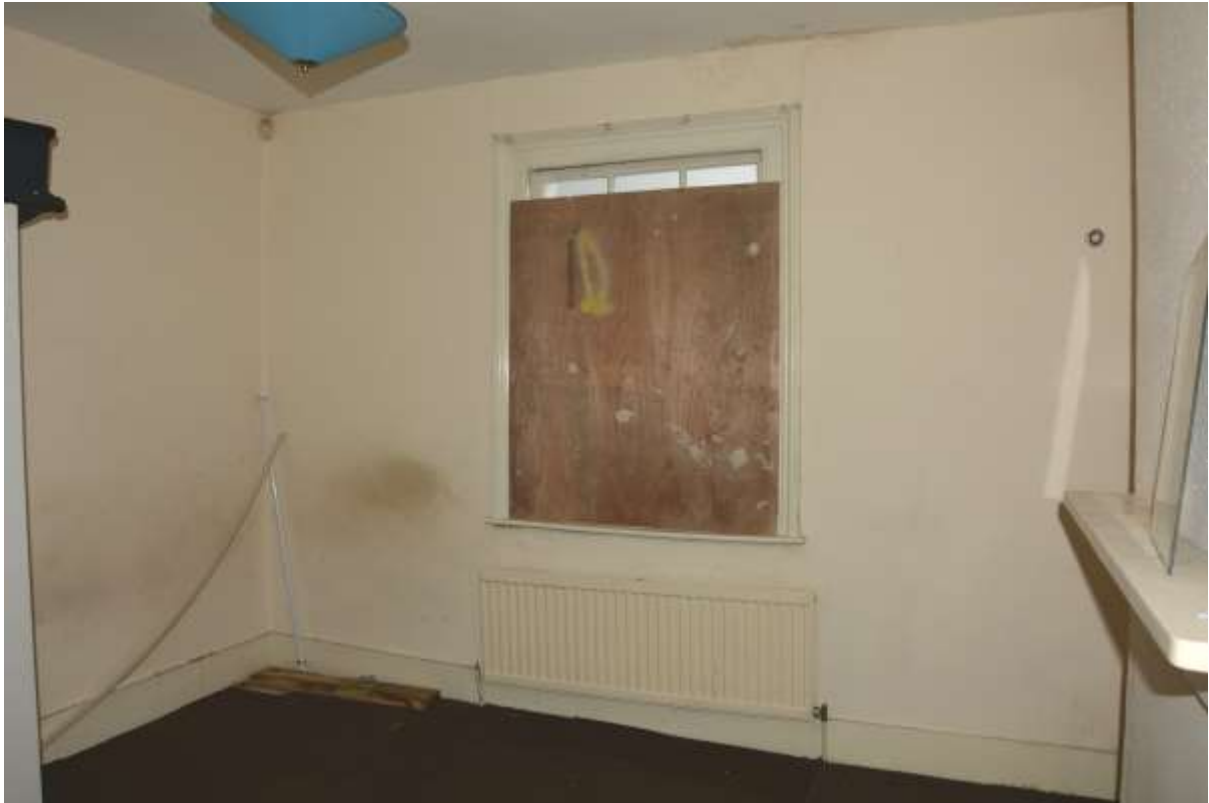
Fig.99: *The boarded up back bedroom window (see Fig.40 for exterior view)*

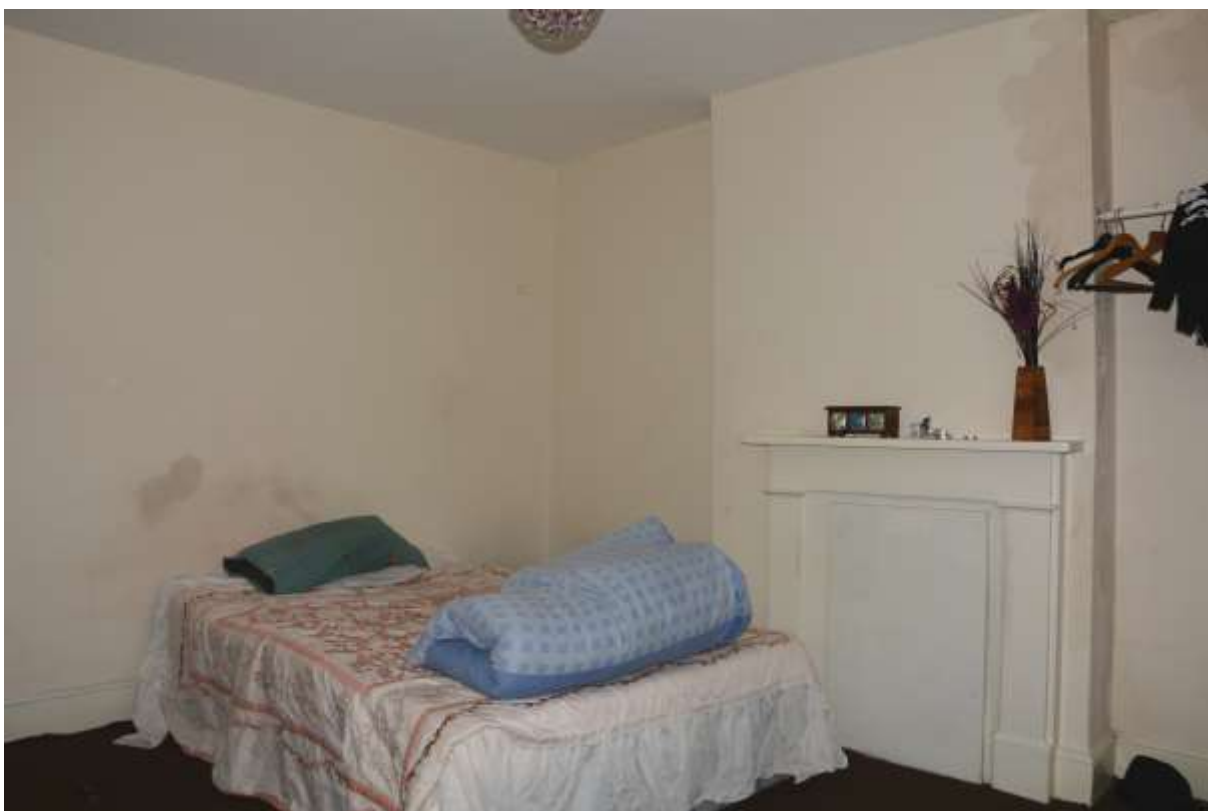
Fig.100: *The front (southern) and principal bedroom. Apart from size the fireplace surround here is more elaborate than those in either of the two other rooms (cf. Figs.96 & 105), and the skirting has a moulded top not present in the back room*

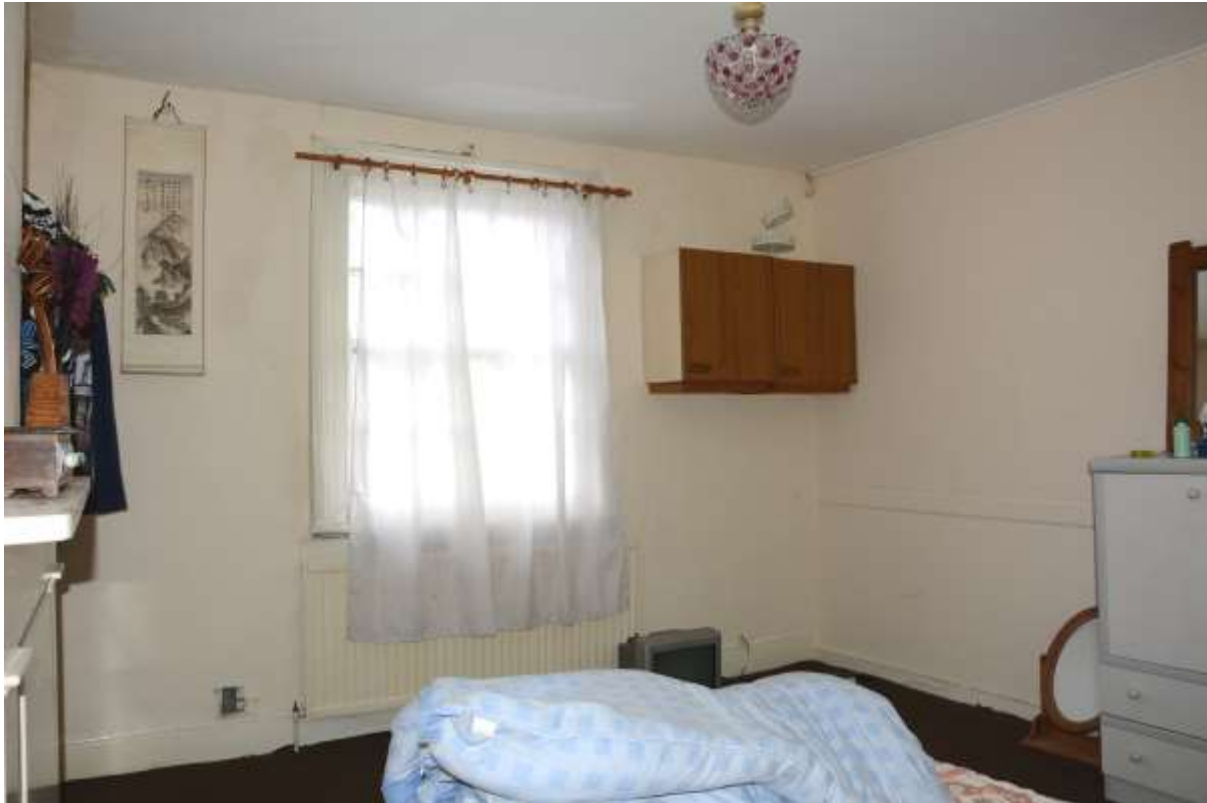
Fig.101: *The sash window in the principal front bedroom (see Fig.39 for exterior)*

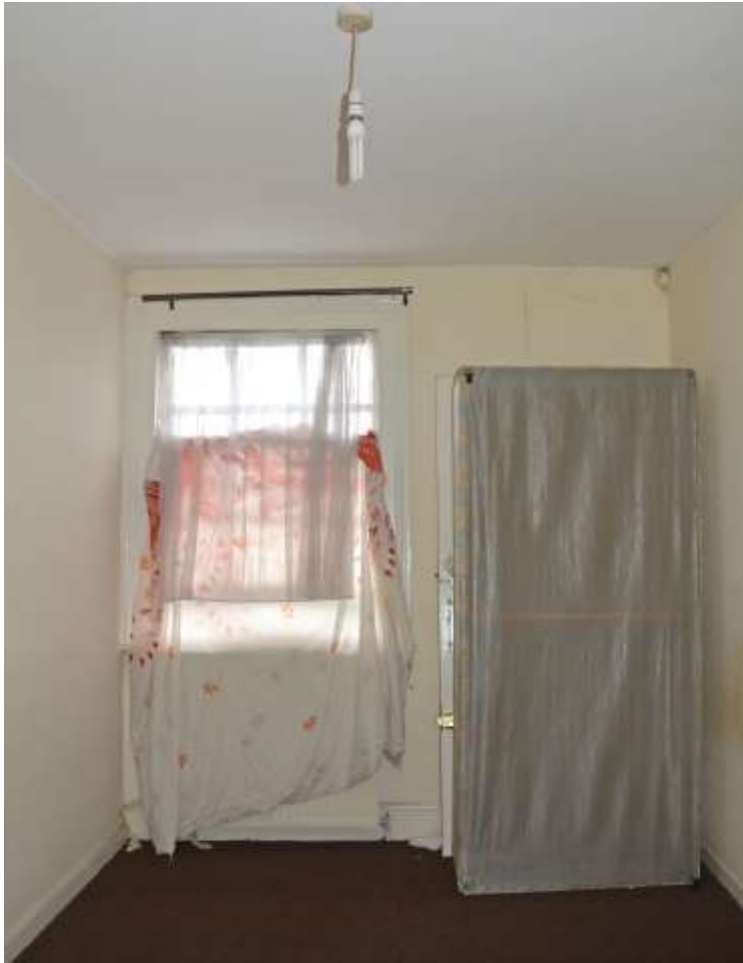
*Fig.103: The small central front room, evidently created out of two originally larger rooms. The side walls are thin (c70mm) and the skirting board here is quite unlike that below the window, half the height and without moulding*

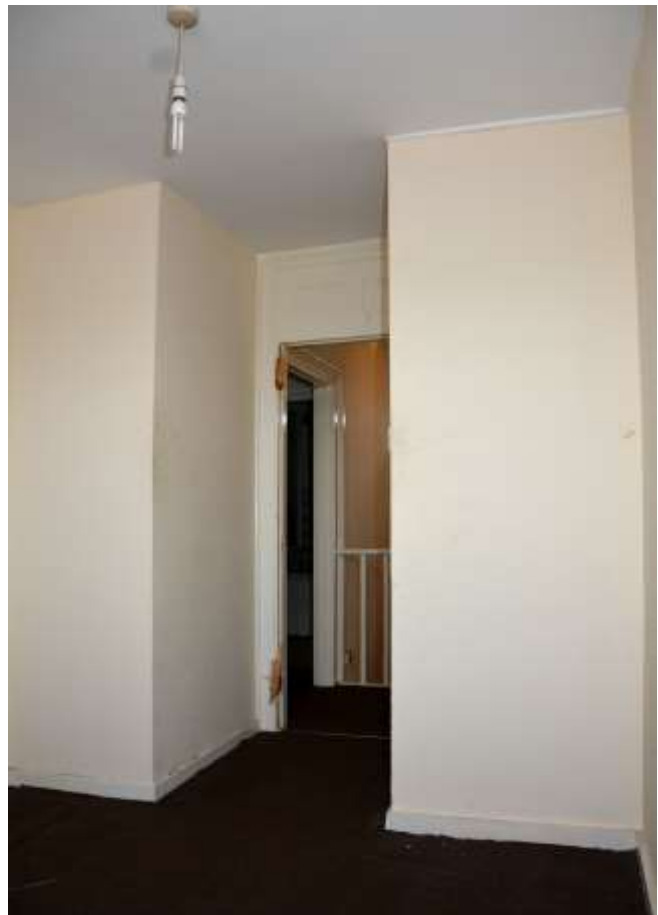
*Fig.104: View of central front room looking back towards the landing, the side walls cut in to maintain access to the adjacent rooms*

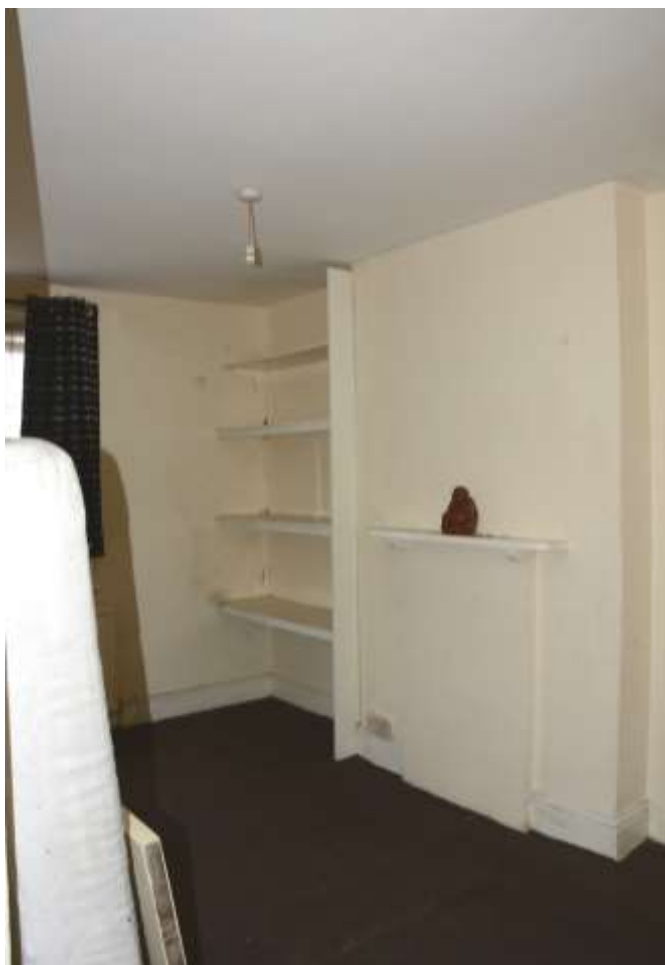
*Fig.105: The northwestern bedroom. The moulded skirting on three walls matches that in the other main room, but the fire surround is much closer to that in the rear bedroom and embellished only by simple brackets supporting the shelf*

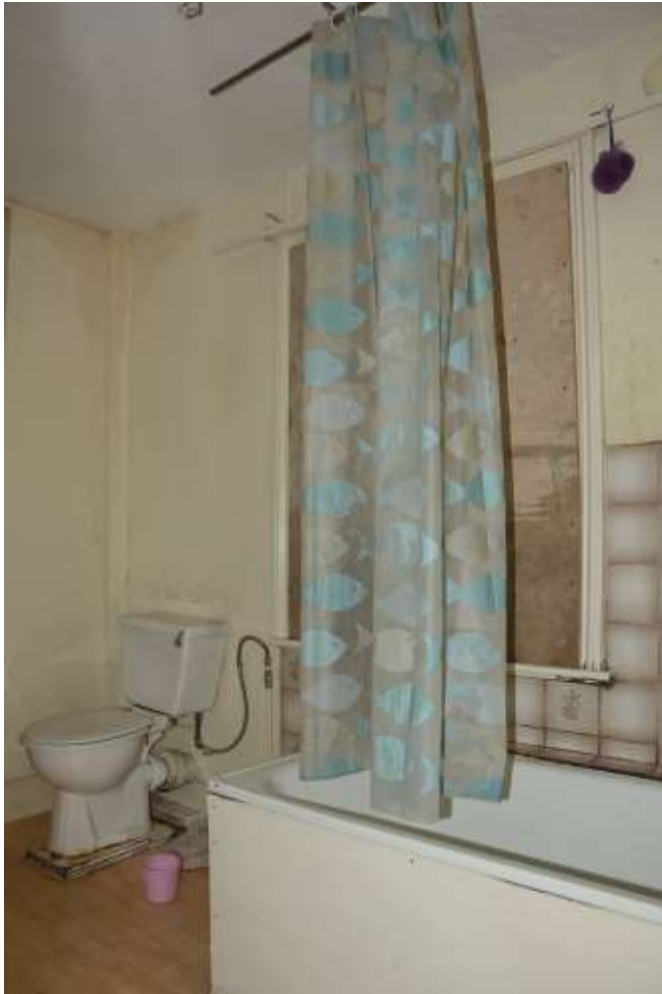
*Fig.108: View of the bathroom and boarded up rear window*

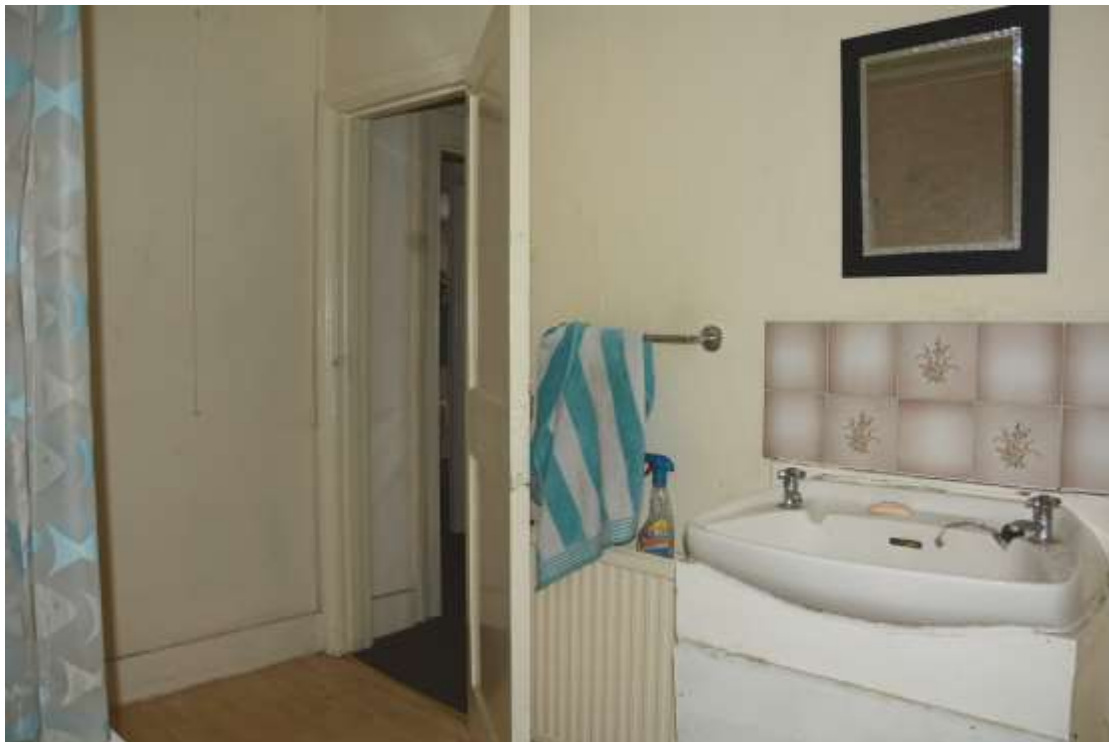
*Fig.109: The bathroom, looking back towards the door and landing*

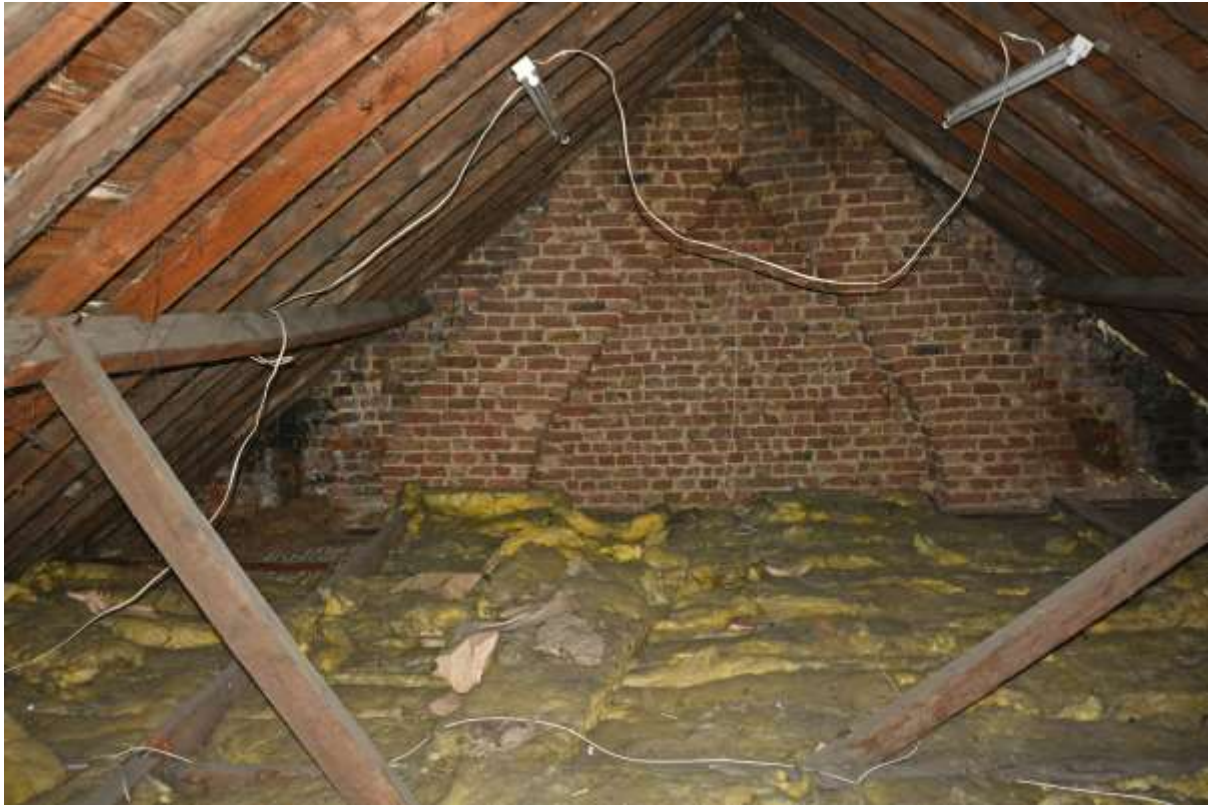
**6.9.1** The roof was of quite simple cut construction between the two brick gables. Common rafters were supported by a purlin on either side and held against the ridge board at the apex of the roof. Each purlin was in turn supported at two points along its length by braces to the joists. On the front (southwest) side of the roof there were two differently angled struts at each position (*cf.* Fig.112), and to the rear a single strut at each position.

Fig.111: *Looking towards the southeastern end of the roof and illustrating the differing angle of support struts for the purlins on either side. The chimney breasts are also visible in the gable end, narrower than those on the external face of the wall (cf. Fig.43)*

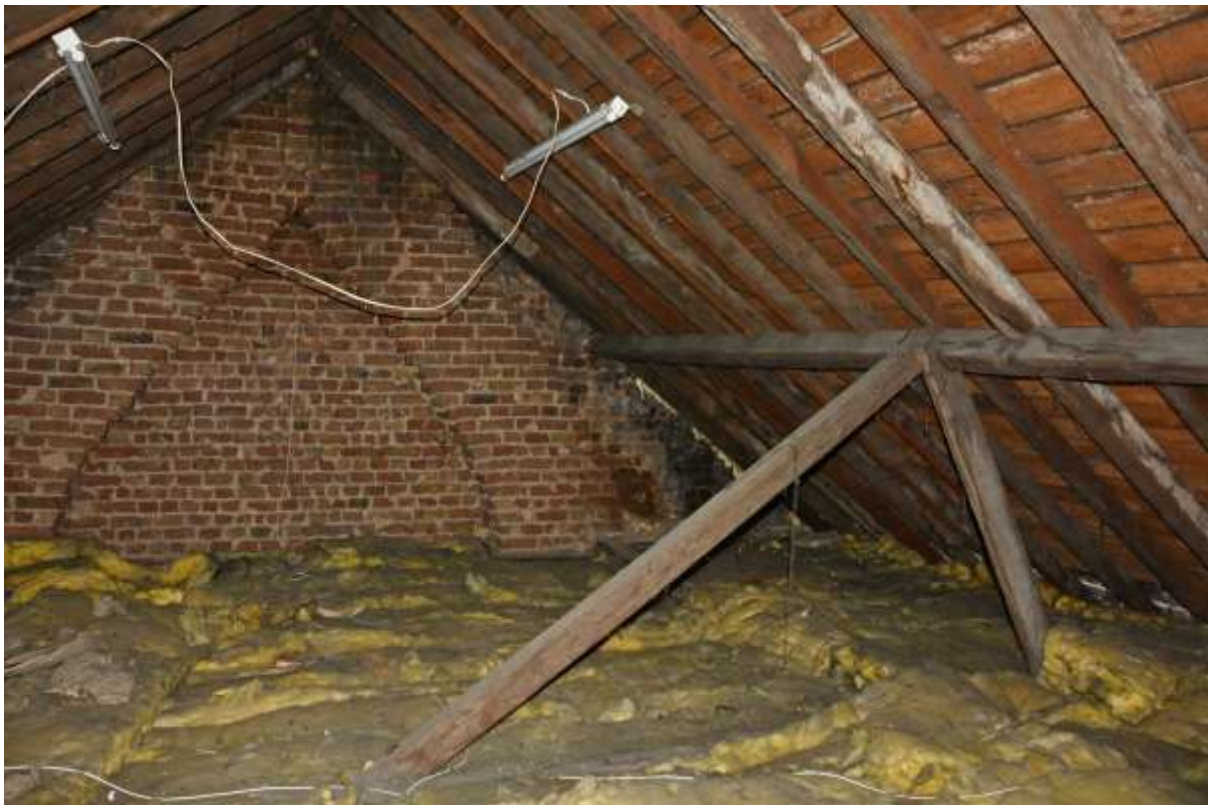
Fig.112: *A similar view to the above, orientated SSE*
