THE FORMER GARIBALDI PUBLIC HOUSE  
6, THE GREEN, CHALVEY  
SLOUGH SL1 2SN

AN HISTORIC BUILDING RECORD

Planning Application Reference: P/11098/003

COMPASS ARCHAEOLOGY  
250 YORK ROAD  
LONDON SW11 3SJ

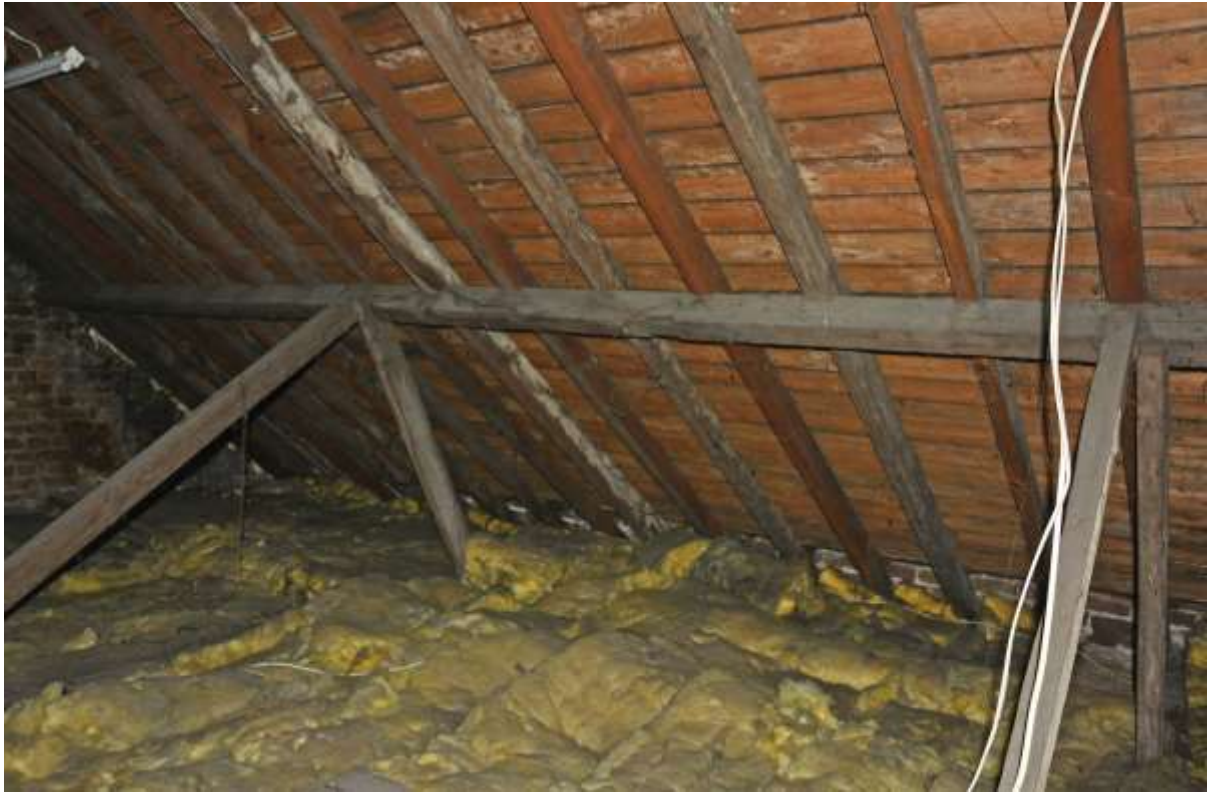
*Fig.113: The southwest side of the roof space, highlighting the double strut arrangement here, and also a cut-out on the purlin for what may have been a further intermediate support*

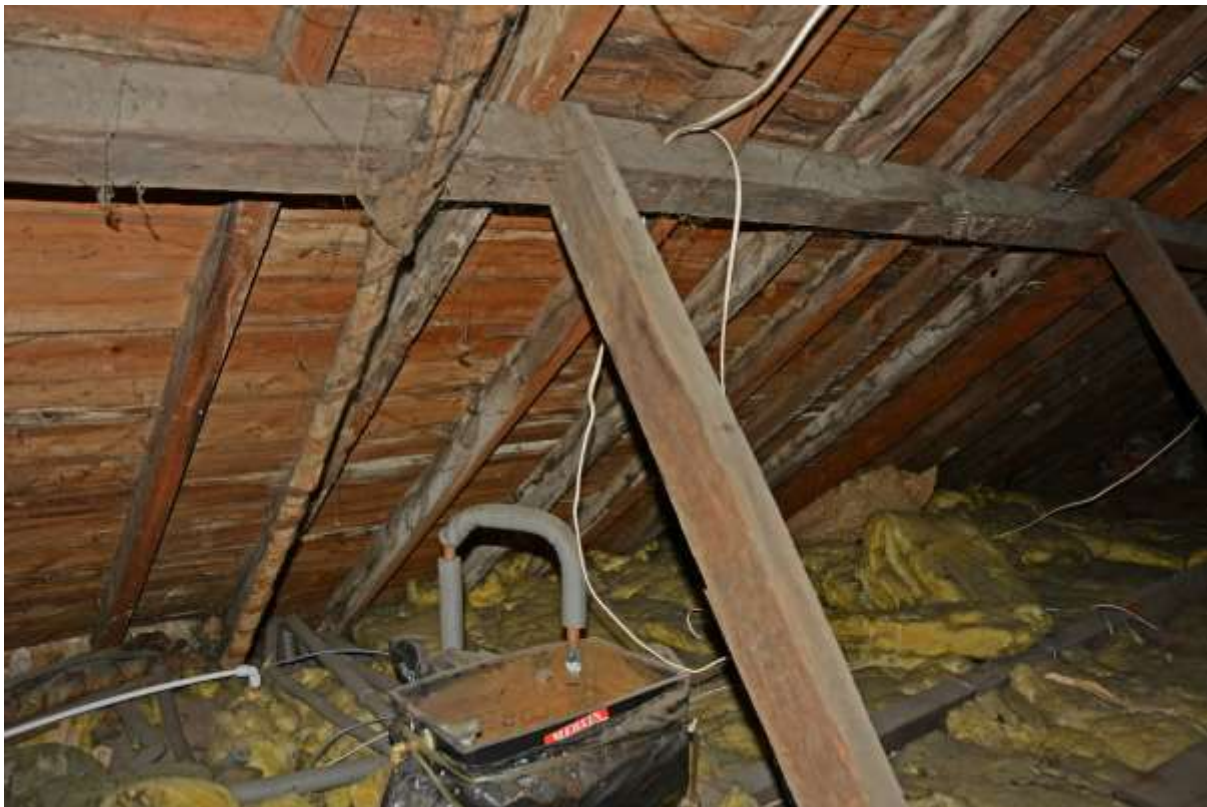
*Fig.114: The northeast side of the roof space, detail of purlin and single supporting strut*

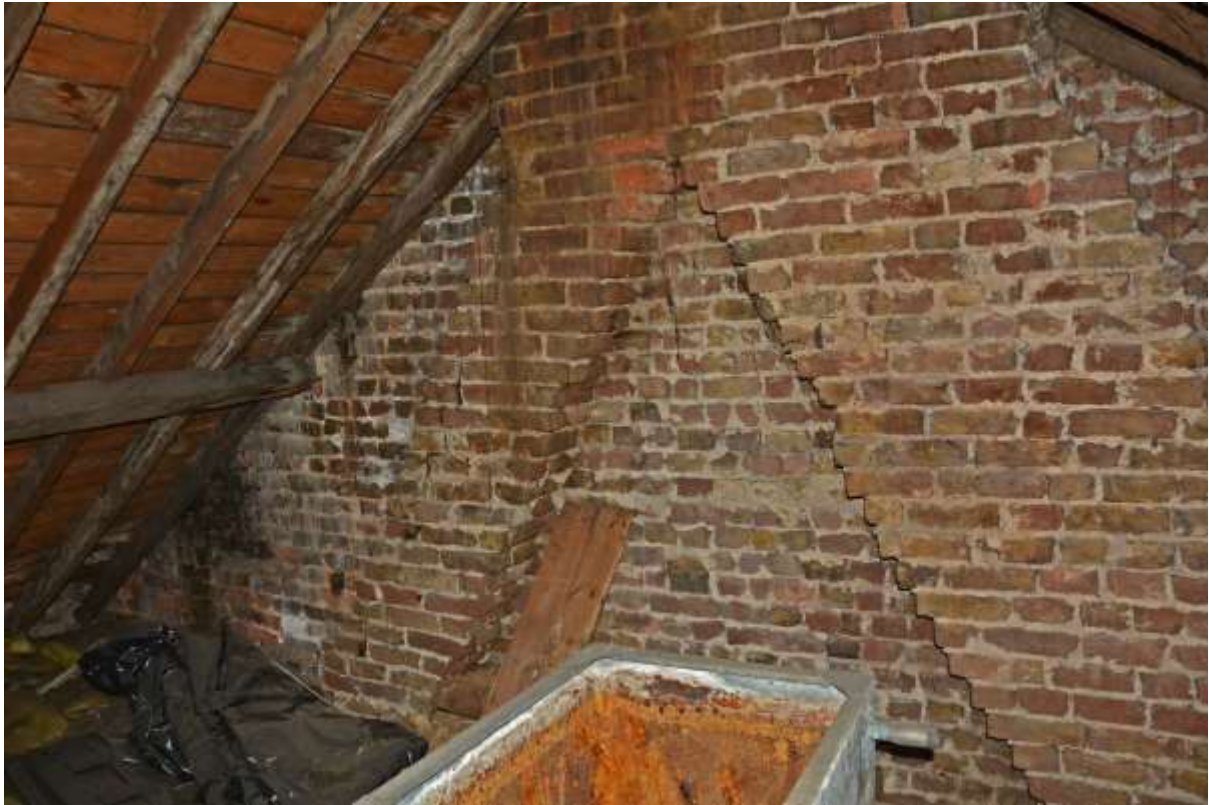
Fig.115: Interior of the northwest gable end and showing the chimney breasts, which are not visible on the exterior wall. The breast in the foreground (& at the rear of the building) is approximately twice the width of that to the SW

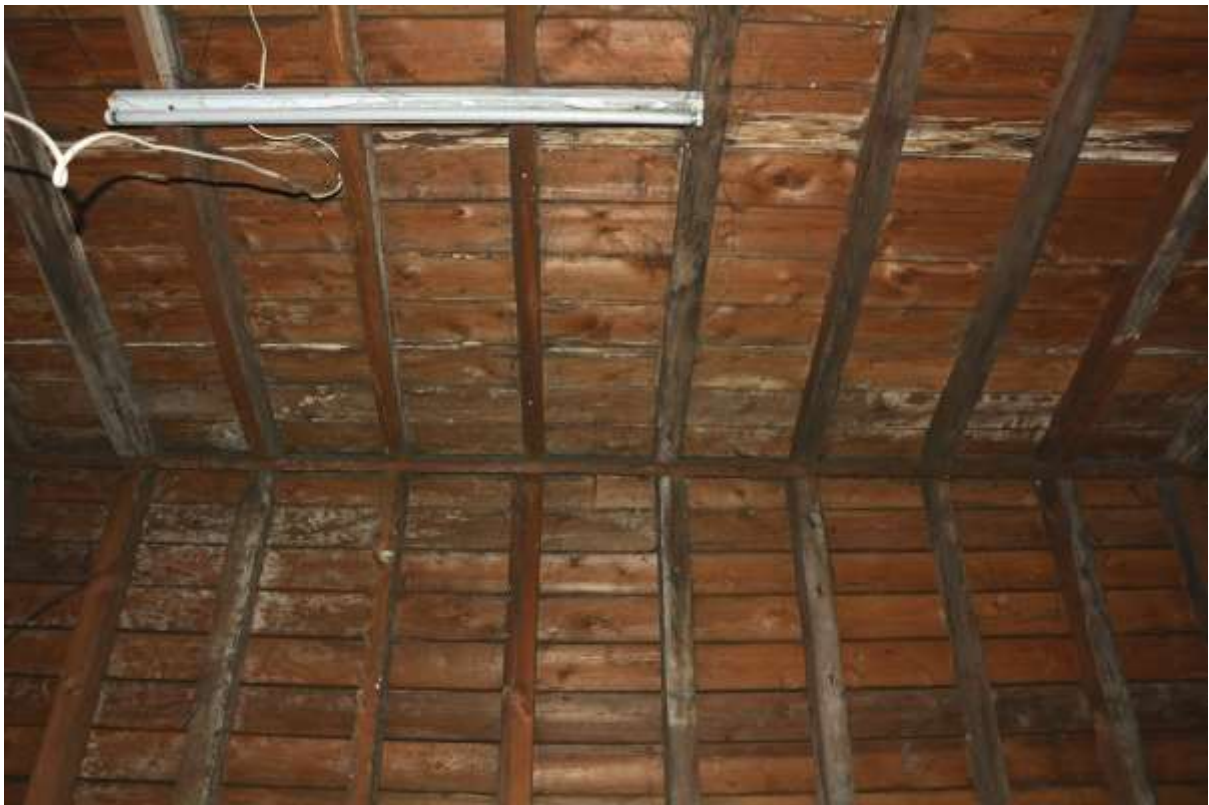
Fig.116: View looking directly up to the ridge board, towards the NW end of the roof
