**THE DOVECOTE, BREAKSPEAR HOUSE,
BREAKSPEAR ROAD NORTH, HAREFIELD,
HILLINGDON, LONDON, HA6 1BN**

A LEVEL 3-4 HISTORIC BUILDING SURVEY

September 2011

Author: Emma Jeffery

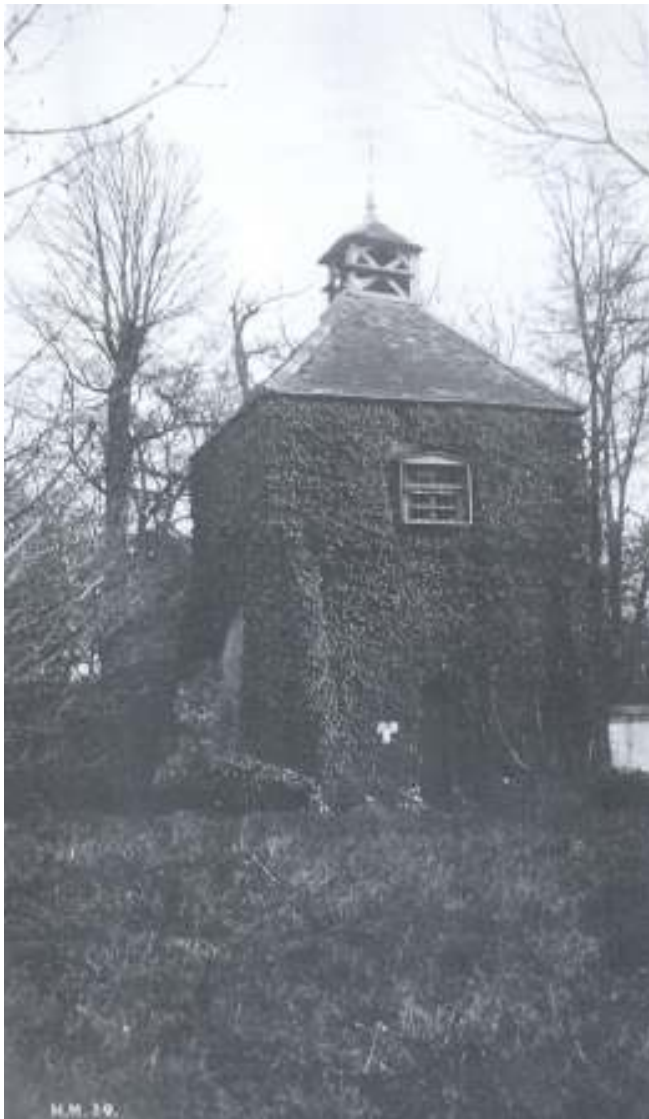
3.3.3.1 A series of three photographs of the dovecote from 1923 (figs. 7 – 9; RCHME Record Card, NMR) depict the structure in broadly the same way as it remains today – with the same square structure, buttresses, timber roof, clock, cupola, doorways, and windows. This shows that the dovecote that stands today existed from at least 1923, and that the major changes and modifications discussed below must have taken place before this date.

Fig. 7: 1923 photograph of the western side of the dovecote, clearly showing the existing western door and window; timber roof; cupola; and buttresses.

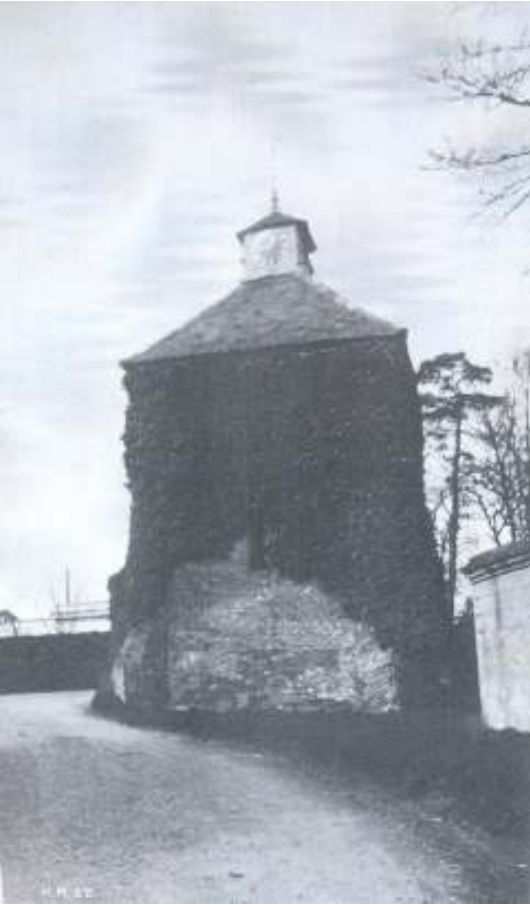
Fig. 8: 1923 photograph of the southern side of the dovecote, clearly showing the existing southern window; roof; cupola; and clock-face.

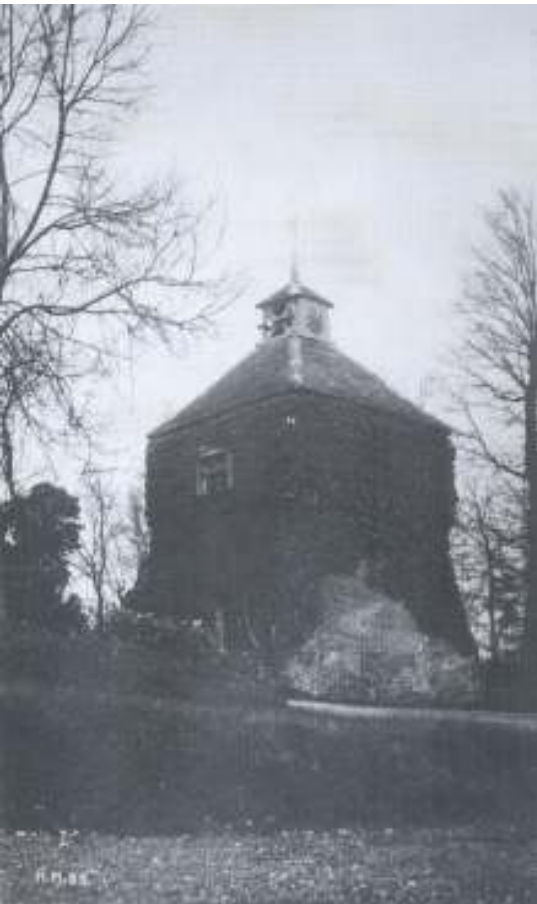
Fig. 9: 1923 photograph of the south-western corner of the dovecote, clearly showing the southern and western walls of the structure roughly as they remain today.

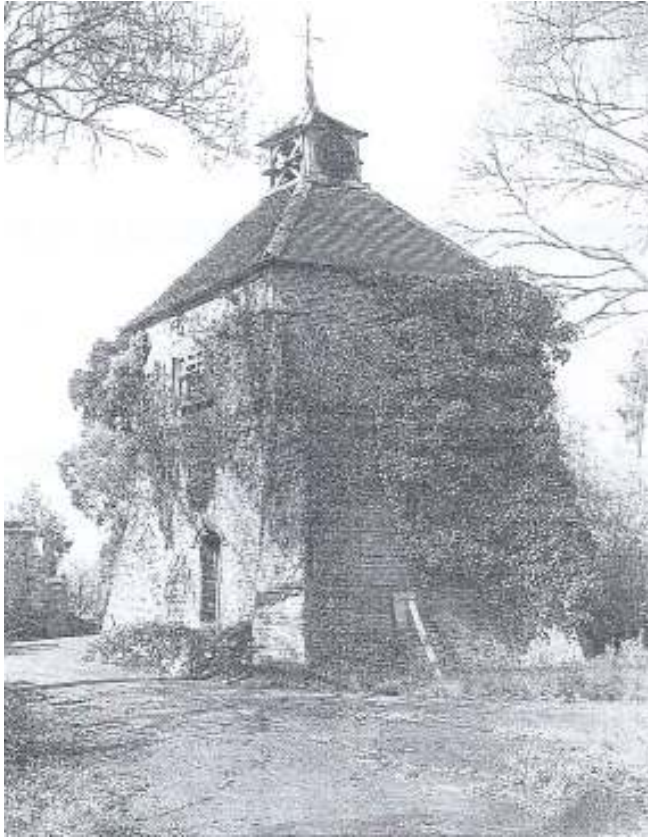
3.3.3.2 Another image of the dovecote (fig. 10) shows it in broadly the same way as it is today and as it was in 1023. The date of this image is unknown. It must have been after 1894 (when the clock was inserted), and there is no indication of the stables, so it probably dates from some point in the earlier 20th Century.

Fig. 10: Image of the south-western corner of the dovecote (from E.M. Bowlt, "Ickenham and Harefield Past", 1996).

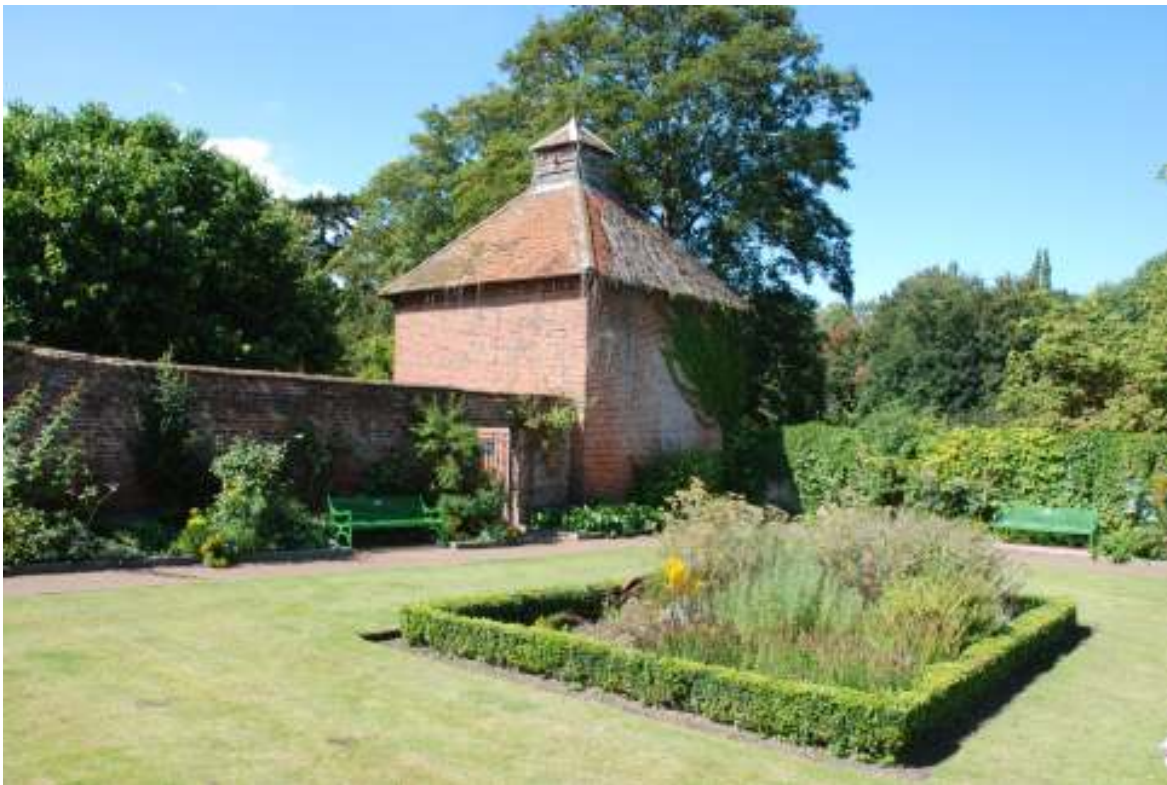
The dovecote at Eastcote is significantly larger in plan than that at Breakspeare (approximately 5.55m square, in comparison with Breakspeare which is approximately 3.8m square). It is also significantly shorter than the Breakspeare dovecote, c.5.48m (height of wall), in comparison with c.6.60 – 7.6m at Breakspeare. It is not, however, of a similar height to the presumed earlier phase of construction at Breakspeare (c.3.85 – 4.65m), and, furthermore, the present structure at Eastcote dates to the 18th Century and so is not a direct comparison with the earliest phase of construction of the Breakspeare dovecote.

Fig. 11: Photograph of the dovecote at Eastcote House

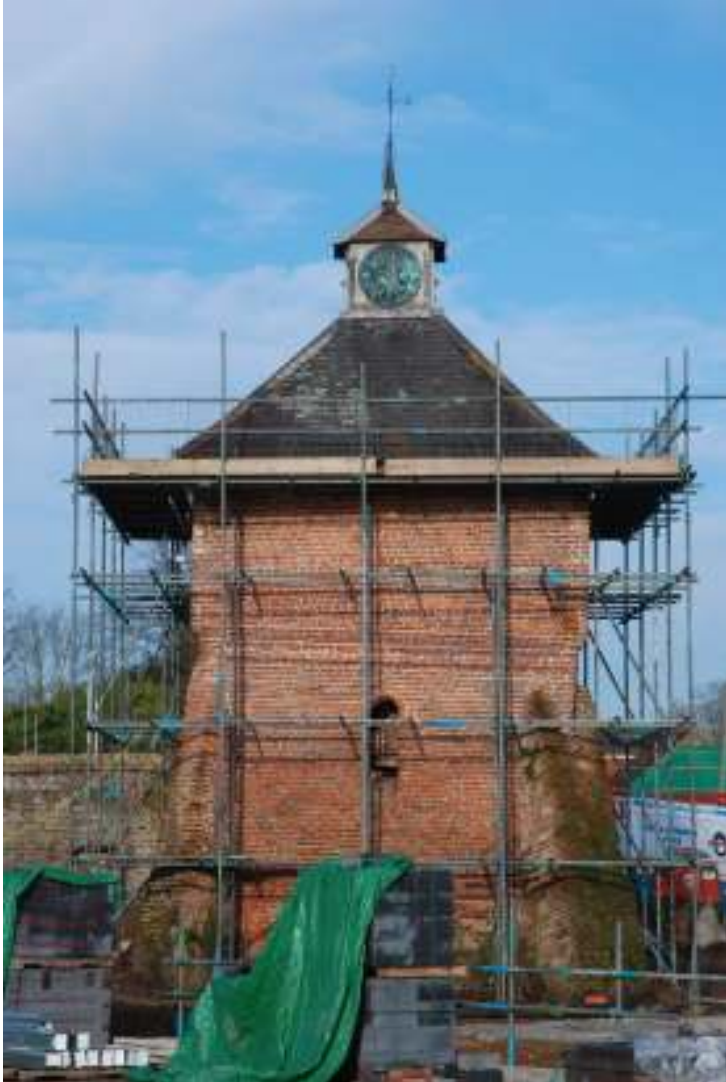
Fig. 18: Photograph of the exterior southern wall of the dovecote. The original build was up to the lower part of the moulded courses of brickwork, and included the southern window.

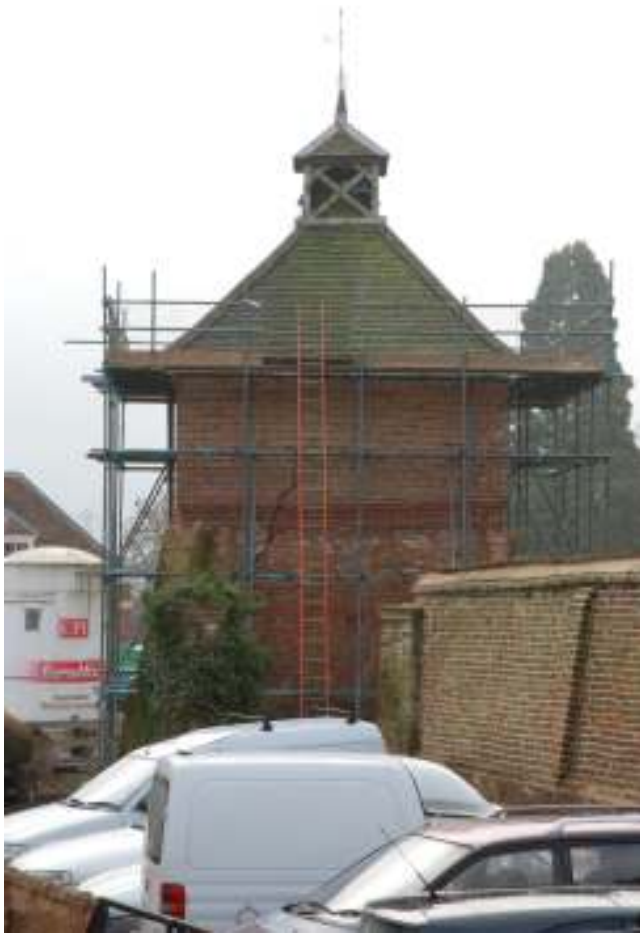
Fig. 19: Photograph of the exterior northern wall of the dovecote. The original build was up to the lower part of the moulded courses of brickwork.

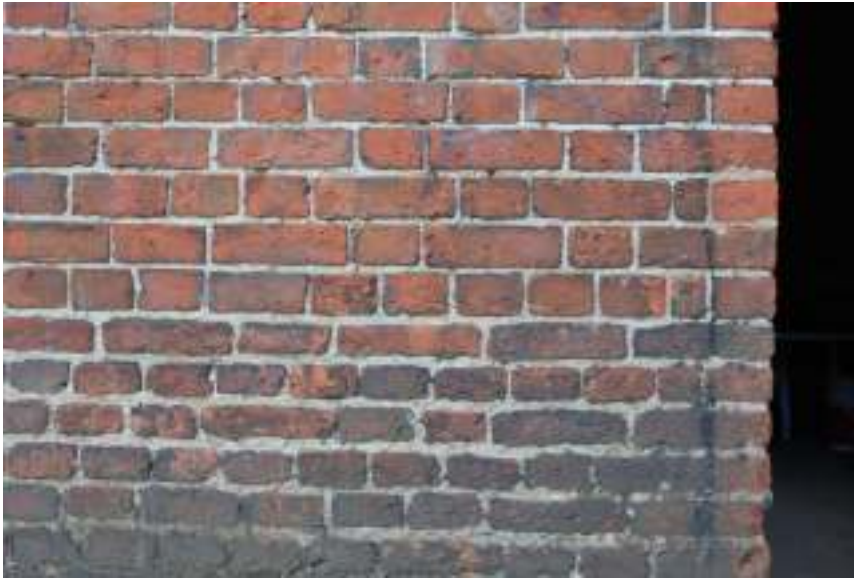
- 7.2.5 This brickwork is similar to that observed in the lower courses of the Eastcote dovecote (c.9 courses). They are not regularly bonded, but, instead, are a mix of headers, stretchers, and $\frac{3}{4}$ bricks. They are thinner bricks, and set within a grey mortar – similar to that at Breakspear. The original dovecote at Eastcote was thought to have been constructed in the 16th Century, thereby fitting with that at Breakspear.

Fig. 21: Photograph of the lower (16th Century?) courses of brickwork on the Eastcote dovecote, overlain by the larger and more regular brick of the 18th Century rebuild.

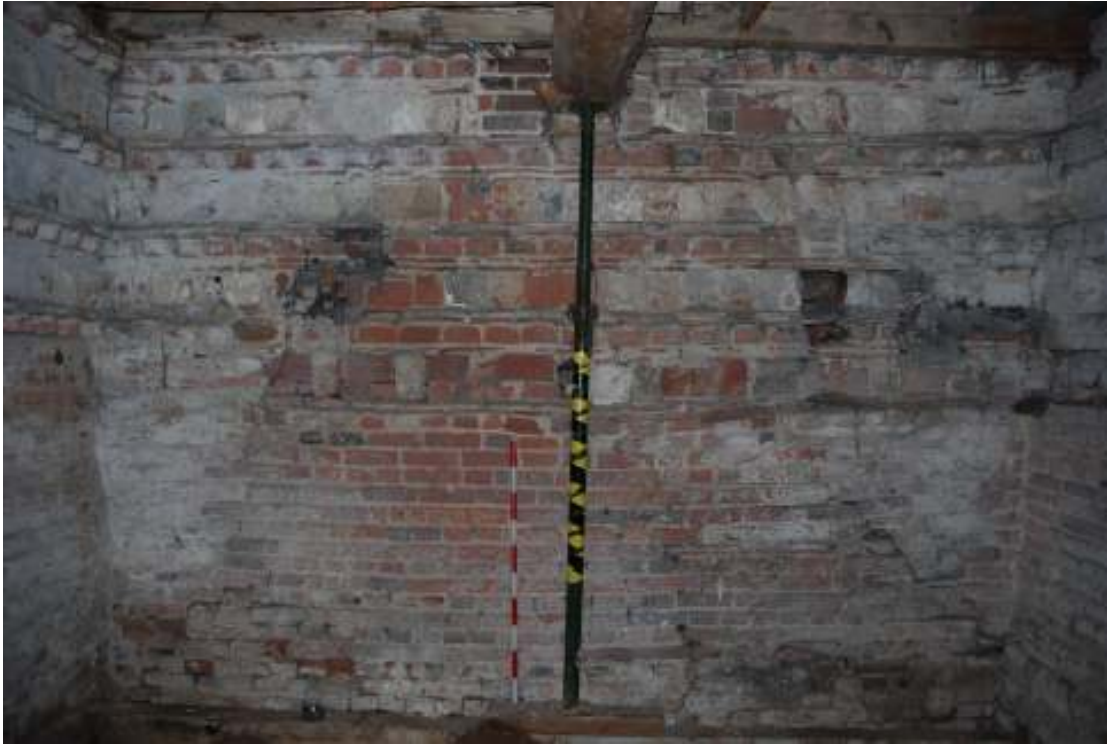
Fig. 22: Photograph of the interior southern wall of the dovecote – ground floor. Original build visible from c.100mm above the scale (battered re-facing below this). Rows of nesting-boxes are visible, although the holes themselves have almost all been blocked.

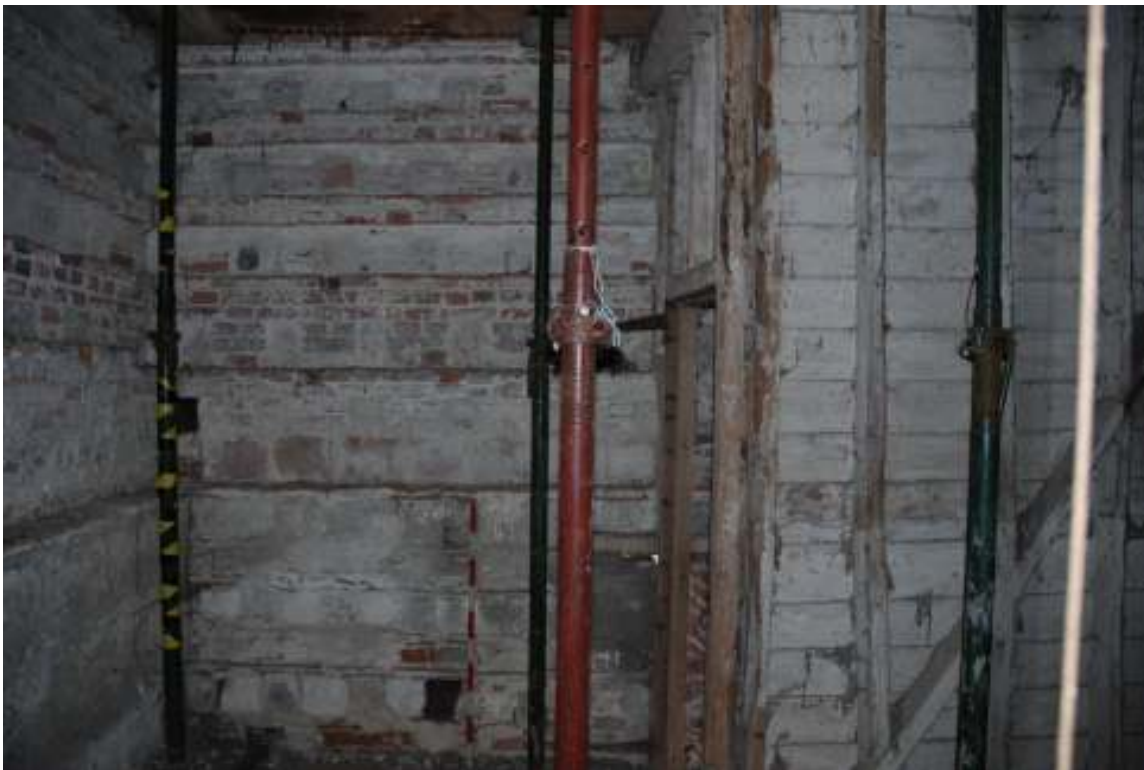
Fig. 23: Photograph of the interior southern wall of the dovecote – first floor. Original build up to c.200mm above the top of the scale, after which the blocked nesting-boxes are distinctly different.

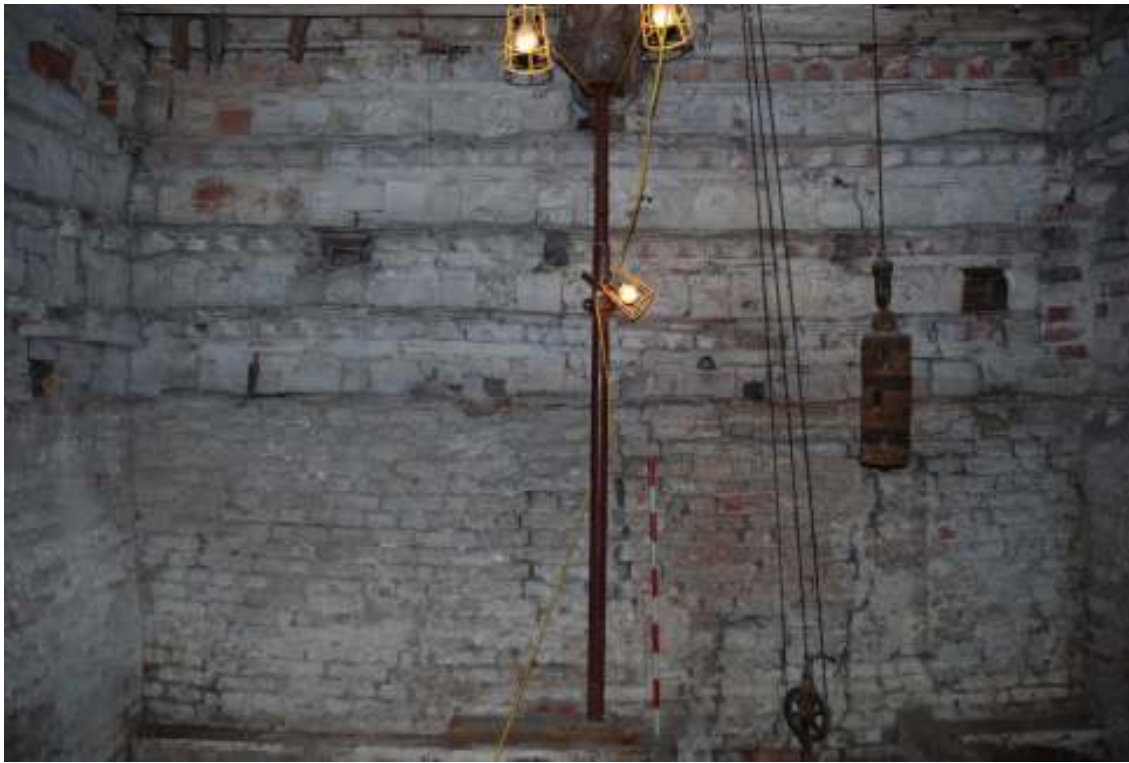
Fig. 24: Photograph of the interior northern wall of the dovecote – ground floor. Original build visible from c.100mm above the scale (battered re-facing below this). Rows of nesting-boxes are visible, although the holes themselves have almost all been blocked.

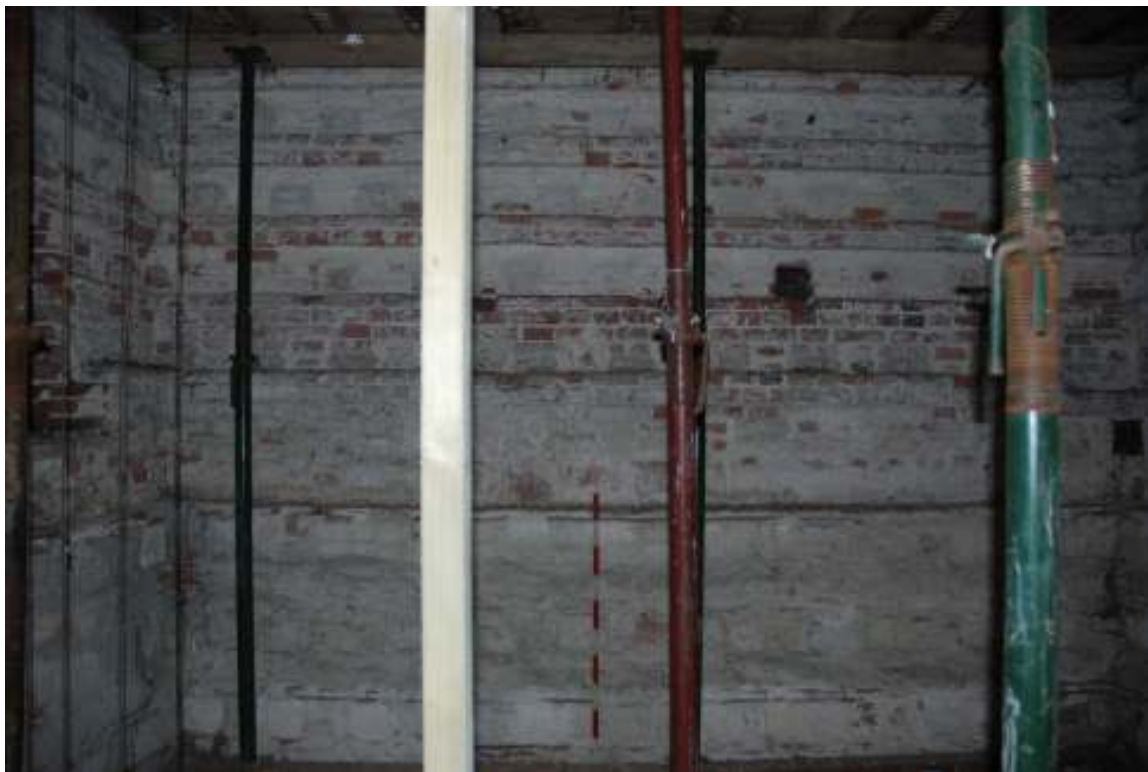
Fig. 27: Photograph of the interior eastern wall – first floor. Original build up to c.50mm above the top of the scale, after which the blocked nesting holes are distinctly different.

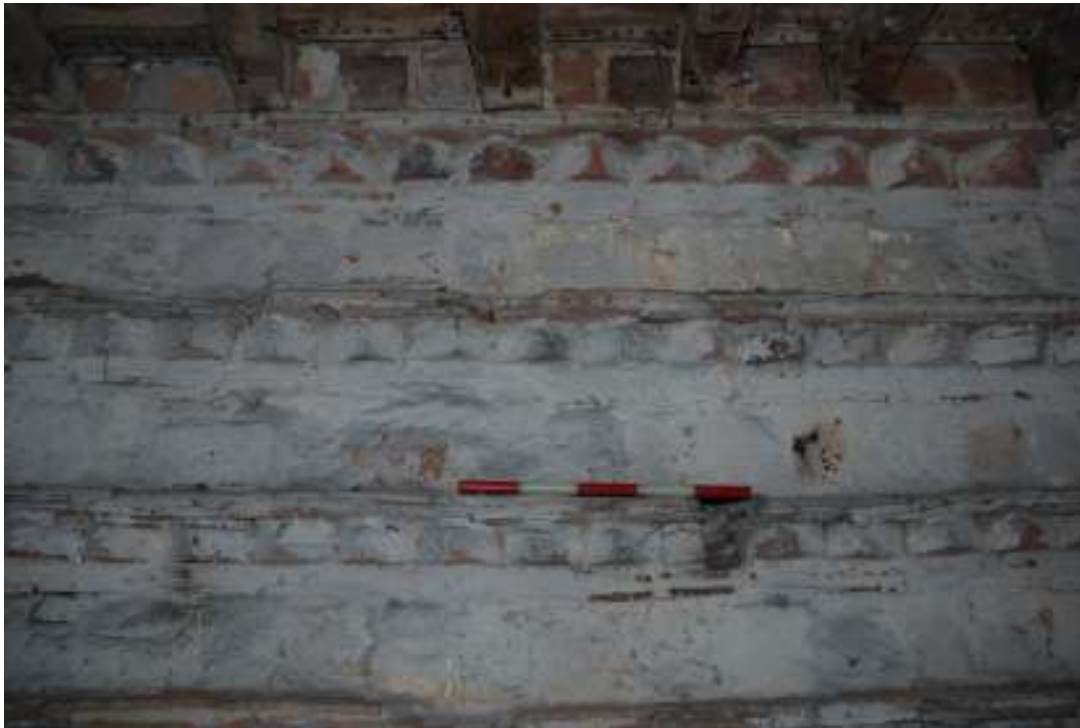
Fig. 28: Photograph of blocked nesting holes in the original build (eastern wall, ground floor). These are sandwiched between two tile courses and a dentil course of brickwork.

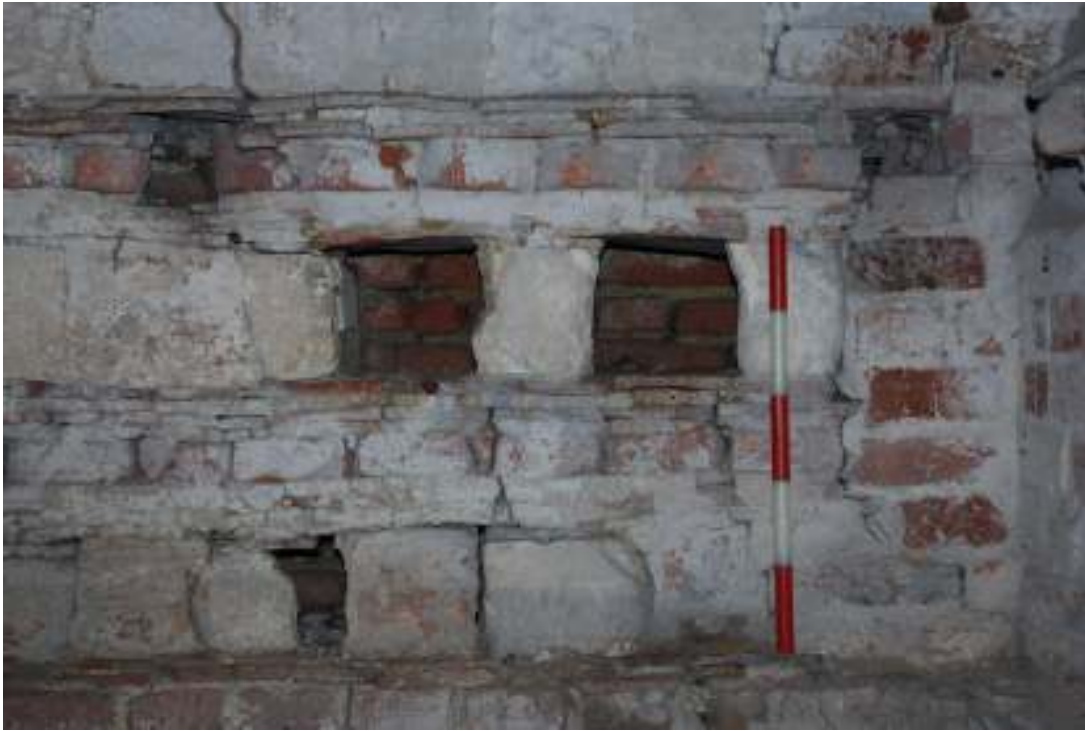
Fig. 29: Photograph of nesting holes in the original build (eastern wall, ground floor) – with some of these opened up to show the interiors.

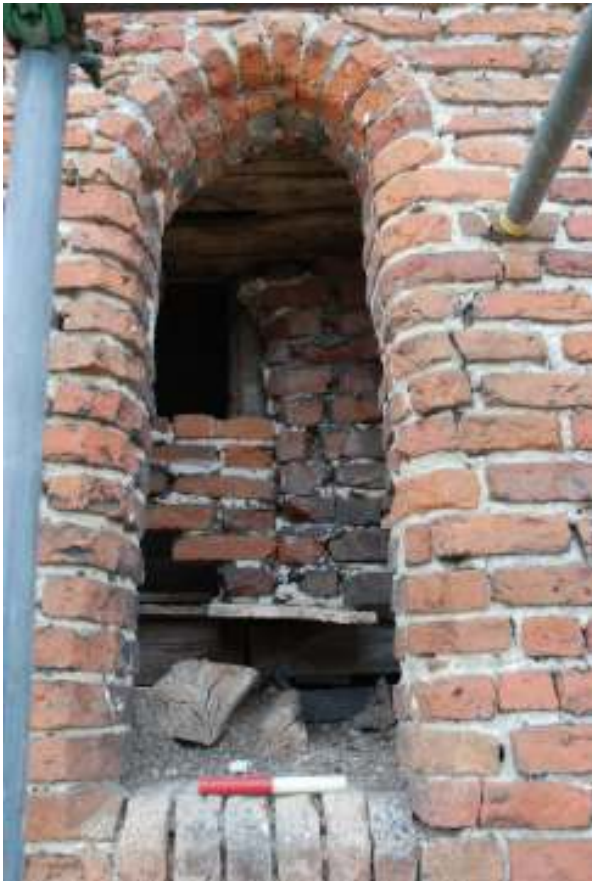
Fig. 32: Photograph of the window in the southern wall of the dovecote (from the outside). This shows its construction, including the Tudor arch with chamfered bricks.

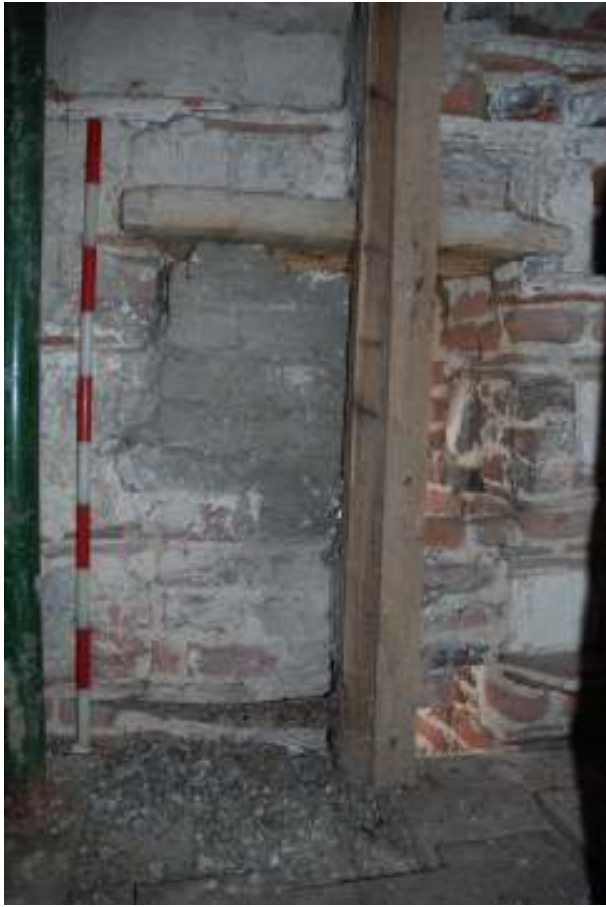
Fig. 33: Photograph of the window in the southern wall of the dovecote (from the inside). This clearly shows the timber lintel, going into the nesting holes either side of it, with no indication that the window (or lintel) was inserted at a later date.

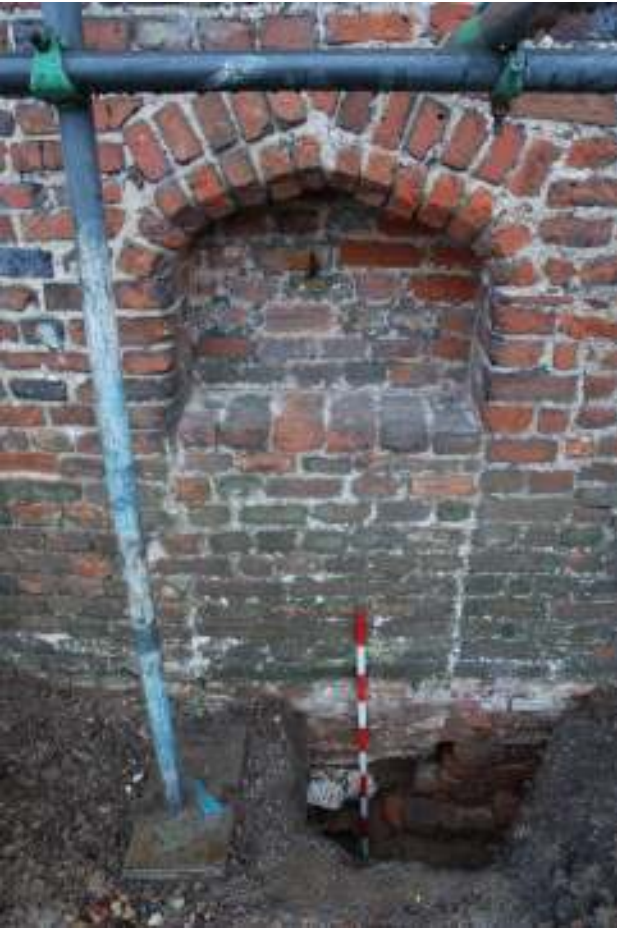
Fig. 35: Photograph of the exterior eastern doorway (now blocked-up).

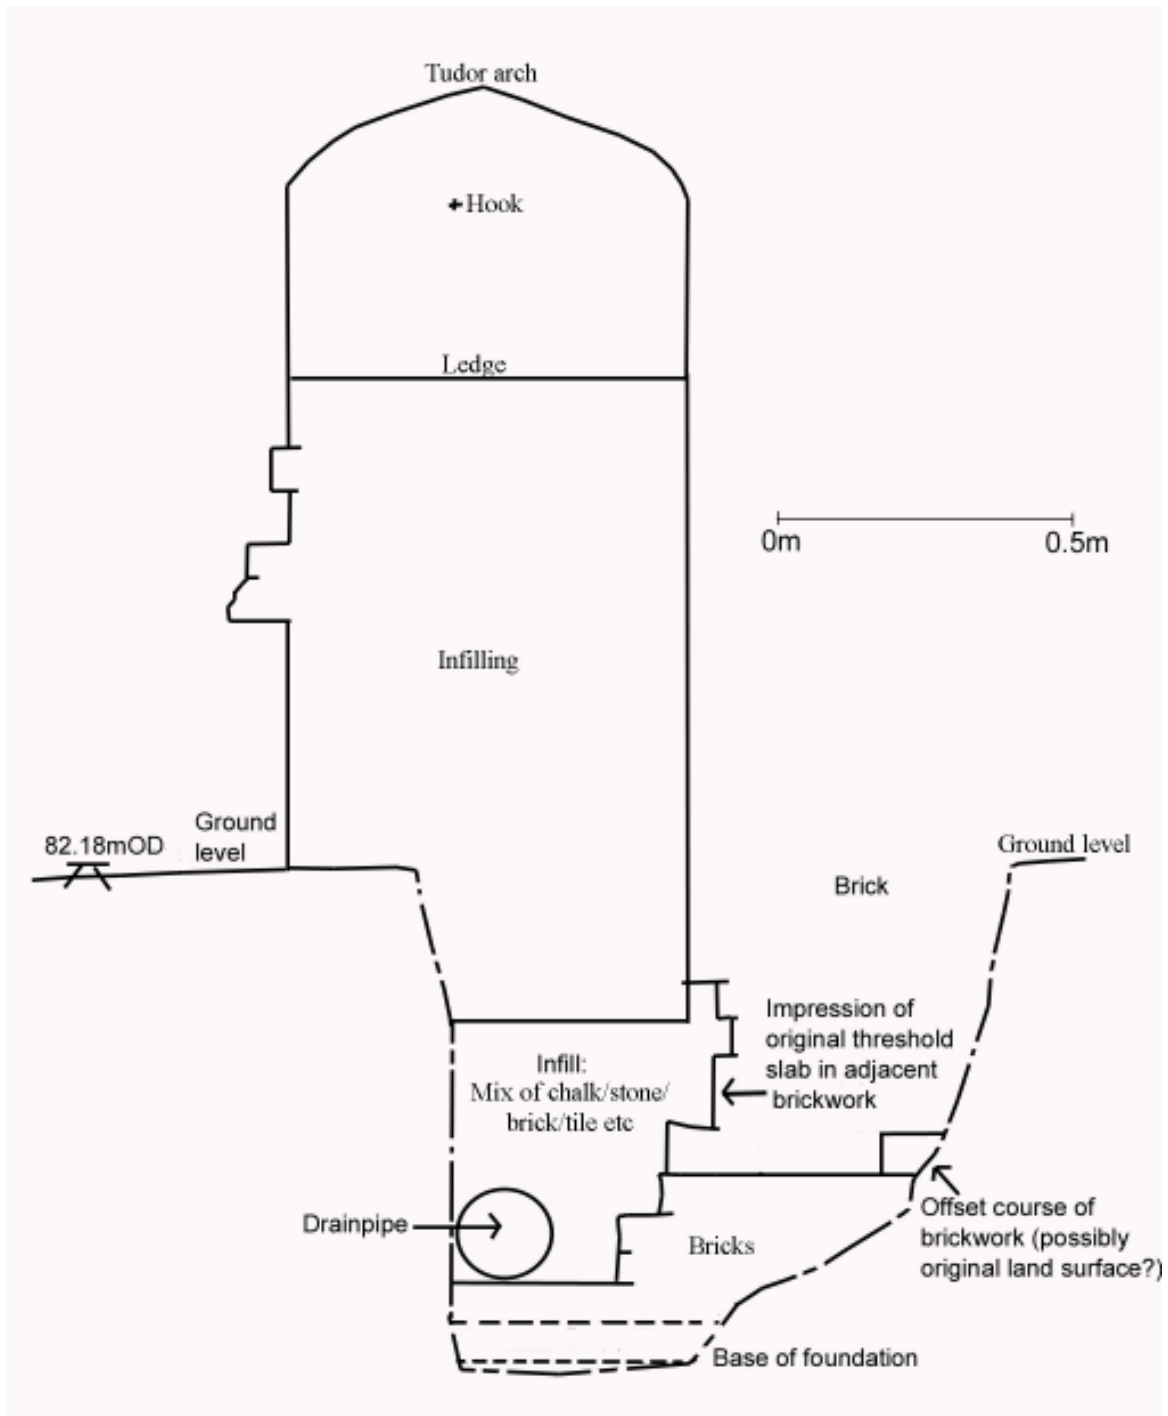
Fig. 37: Section of the exterior of the eastern doorway. This shows the brick foundations and possible threshold of the doorway. This also shows how the ground-surface may have been far lower than it is today.

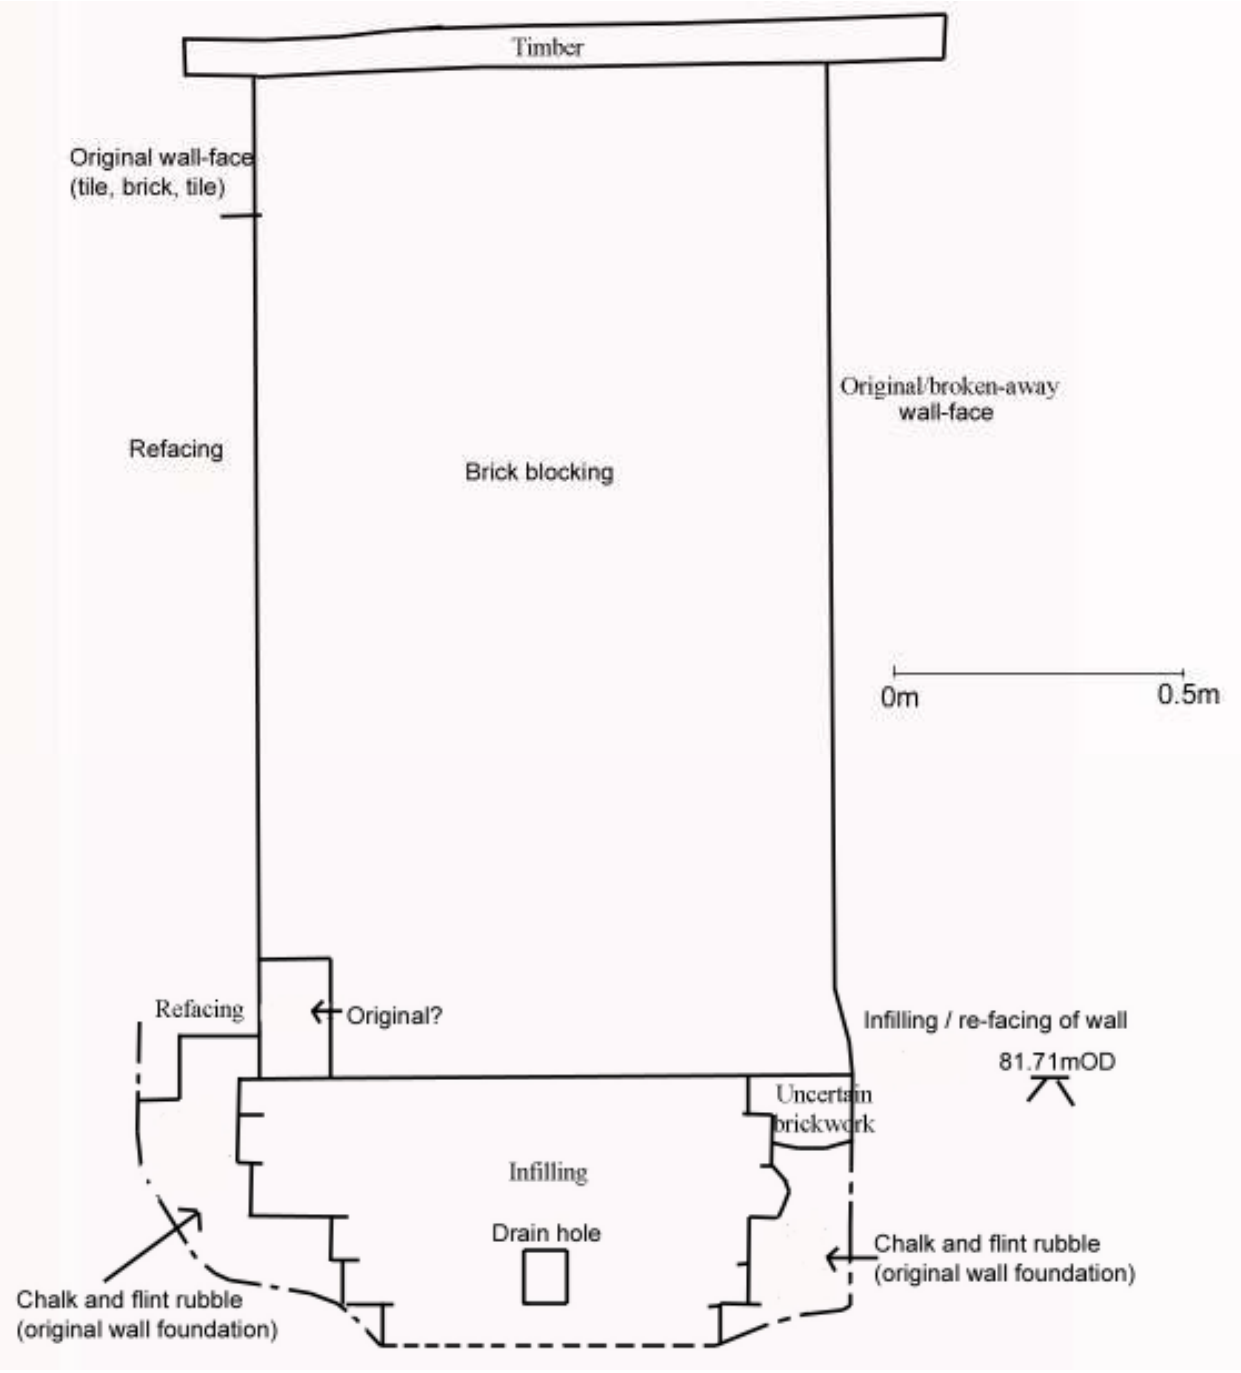
Fig. 38: Section of the interior of the eastern doorway. This shows the infilling of the doorway, and the rubble foundations.

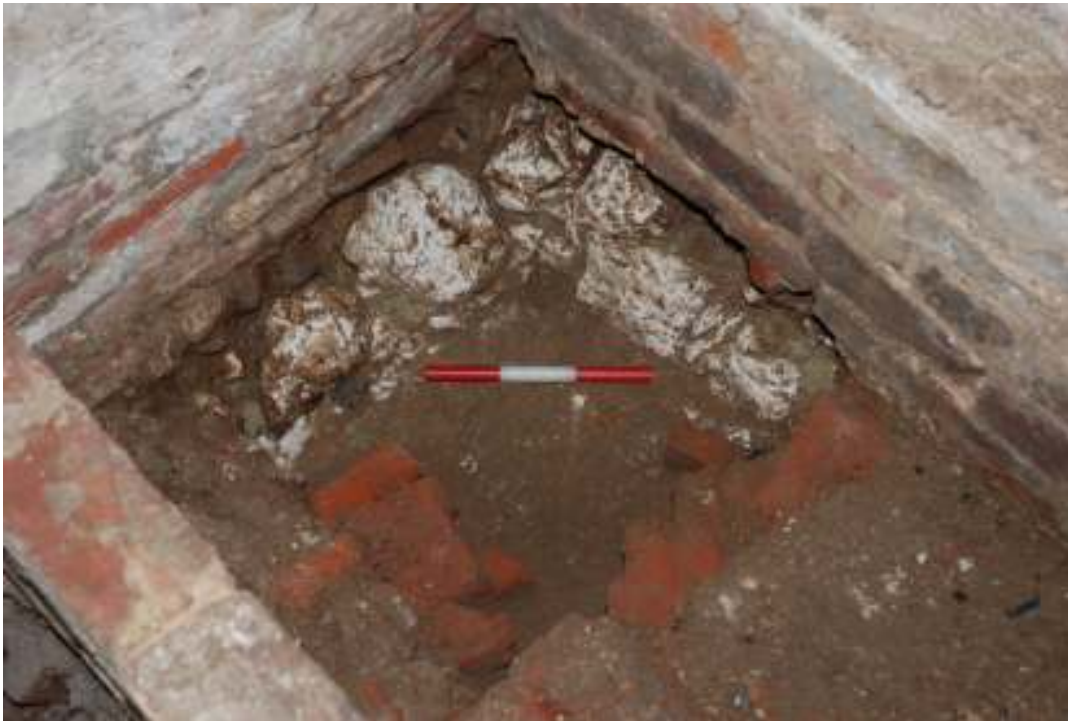
Fig. 41: Photograph of the chalk foundations observed in the north-west corner of the dovecote.

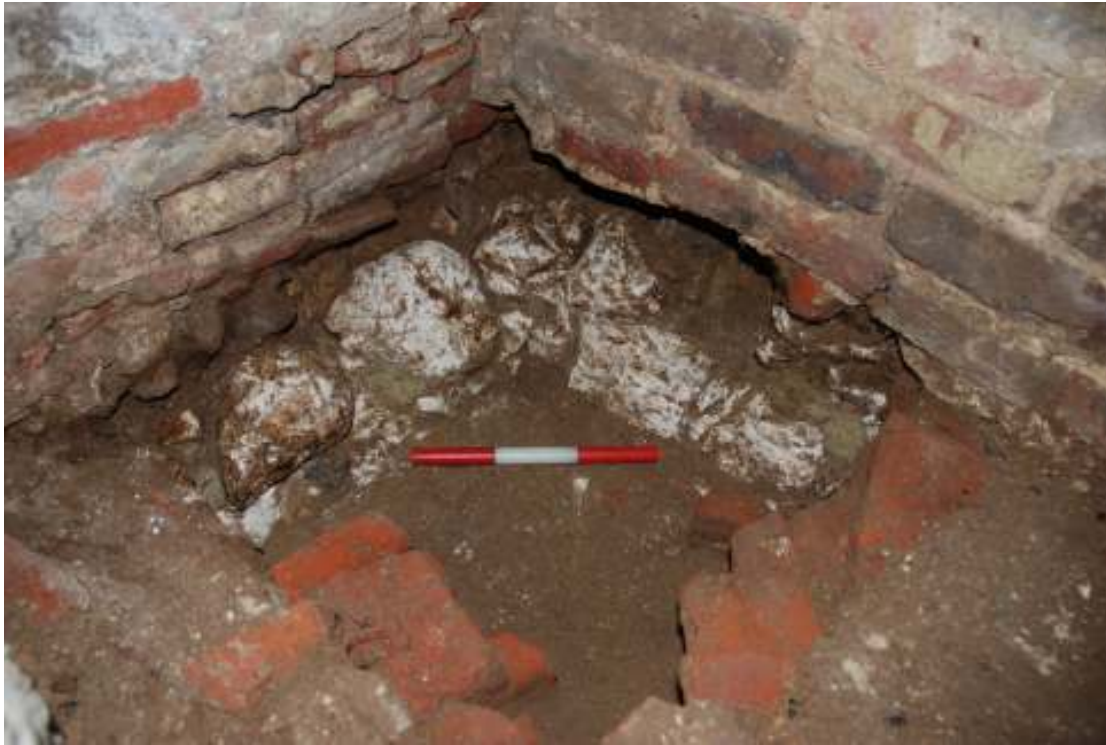
Fig. 42: Photograph of the chalk foundations observed in the north-west corner of the dovecote.

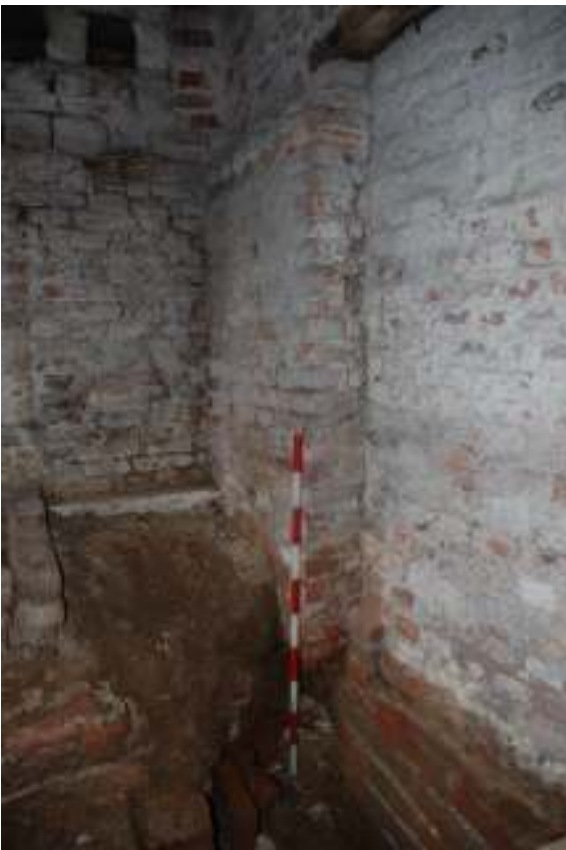
The extent to which this later re-facing / buttressing of the wall battered the wall out from the original wall-line is particularly noticeable just to the north of the blocked-up eastern doorway. Investigation in this area revealed the earlier wall 50mm between the present wall (i.e. the refaced part) at the top, out to 120mm at the base. In this particular area, therefore, the interior re-facing was of a thickness of 50-120mm.

Fig. 44: Photograph of the northern side of the blocked-up eastern doorway. This shows the 'gap' between the existing (re-faced) wall and the earlier wall.

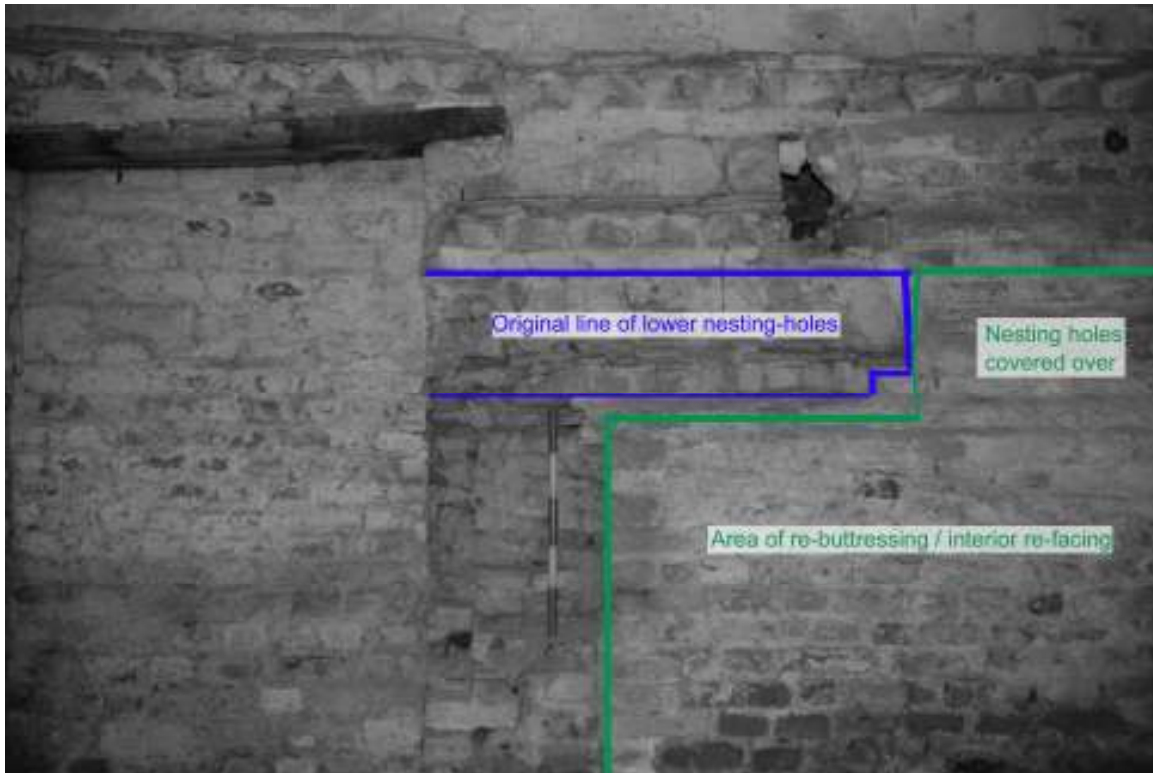
- 8.3** This re-facing covered up some of the lower nesting-holes. This was most apparent in the line of lower nesting-holes observed running along the eastern wall just to the south of the blocked-up eastern doorway, which are approximately 1.35m above the brick floor. They spread for c.1.07m (possibly because this small area of the dovecote was not internally re-faced / thickened) before disappearing behind the re-facing. This therefore suggests that there was once a continuous lower line of nesting-holes, not only on this wall but also the adjacent northern and southern walls, which have since been covered up by the interior re-facing / thickening of the walls.

Fig. 47: Annotated photograph showing the original lower line of nesting-holes, and the area of buttressing / re-facing covering this line of nesting-holes.

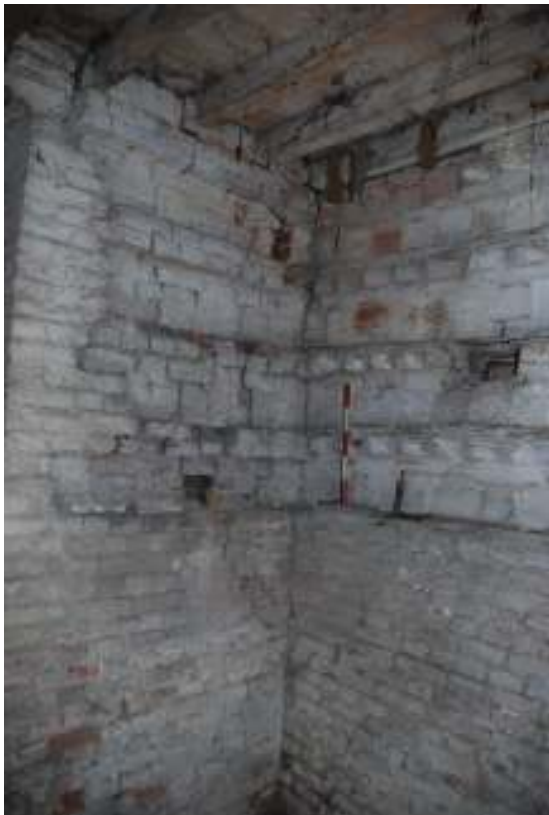
- 8.5** In terms of the possible time at which this happened, it is important to note that the re-facing of the northern and southern walls appears to go behind the lower section of the western wall, suggesting that the re-facing of these walls took place before the construction of the lower part of the western wall. Investigations behind the existing lower western wall-face did not reveal any definitive evidence for an earlier build, although this was slightly ambiguous. The most likely explanation, therefore, is that the re-facing of the northern, eastern, and southern walls took place before the construction of the western wall – which was then constructed in one phase with a slightly battered-out base (see section 9). This therefore places this interior re-facing / buttressing as happening before the second major phase of rebuilding.

Fig. 48: Photograph of the corner of the northern and western walls (ground-floor). This shows how the lower re-facing of the northern wall runs behind the lower part of the western wall.

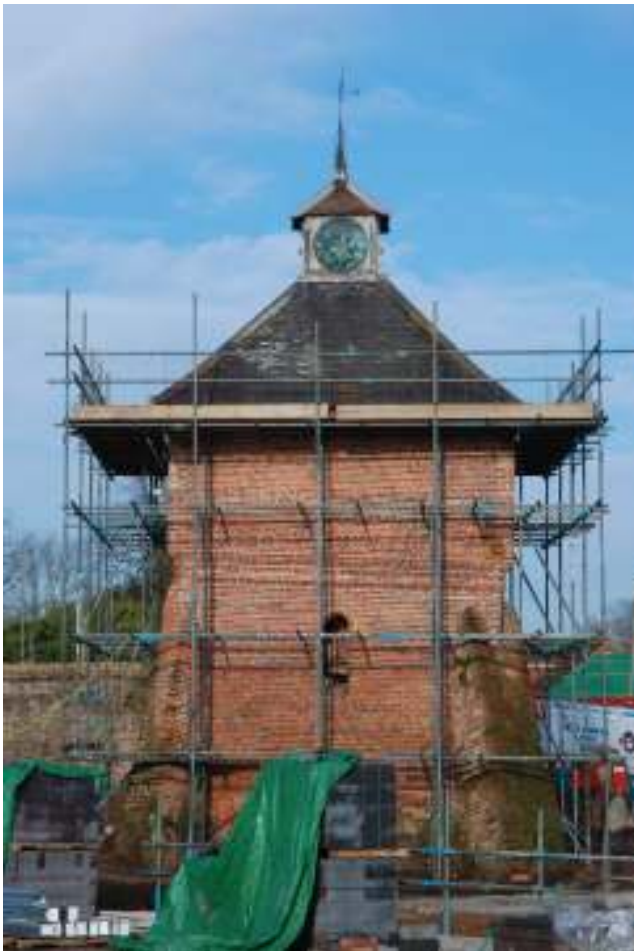
Fig. 49: Photograph of the exterior of the southern wall of the dovecote. The new build is above, and including, the moulded course of brickwork.

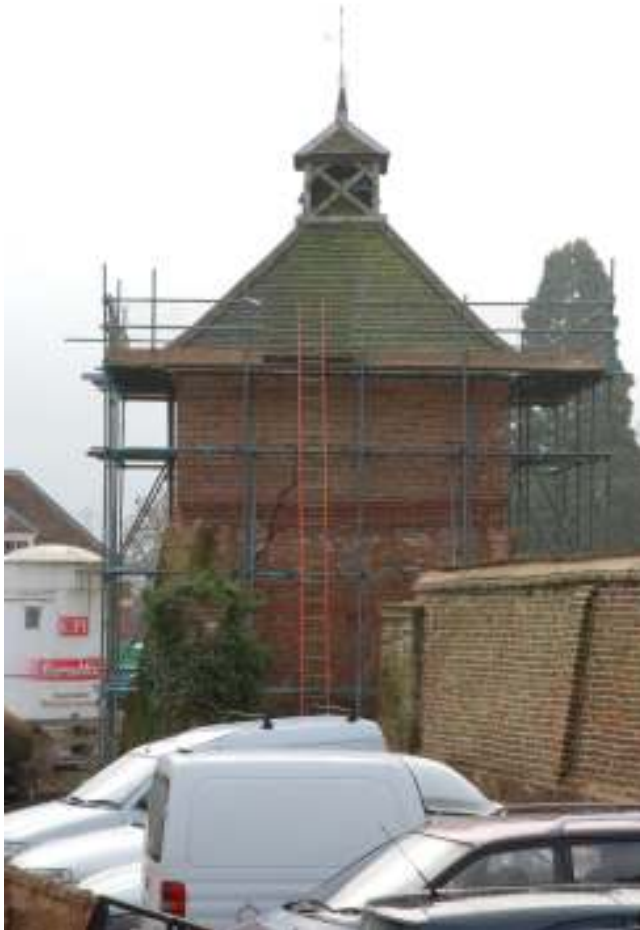
9.2.5 Although this upwards extension was brick-built, one large timber was observed within the northern wall (above the moulded course of brickwork, just above the collapsed area of brickwork). This measured at least 1.52m in length, and was back into the interior of the wall by at least 0.3m. It was located directly above (at least) four nesting-holes. It is possible that such large pieces of timber were built into the wall in some way, and possibly used to form a roof to such nesting-holes.

Fig. 50: Photograph of the exterior of the northern wall of the dovecote. The new build is above, and including, the moulded course of brickwork.

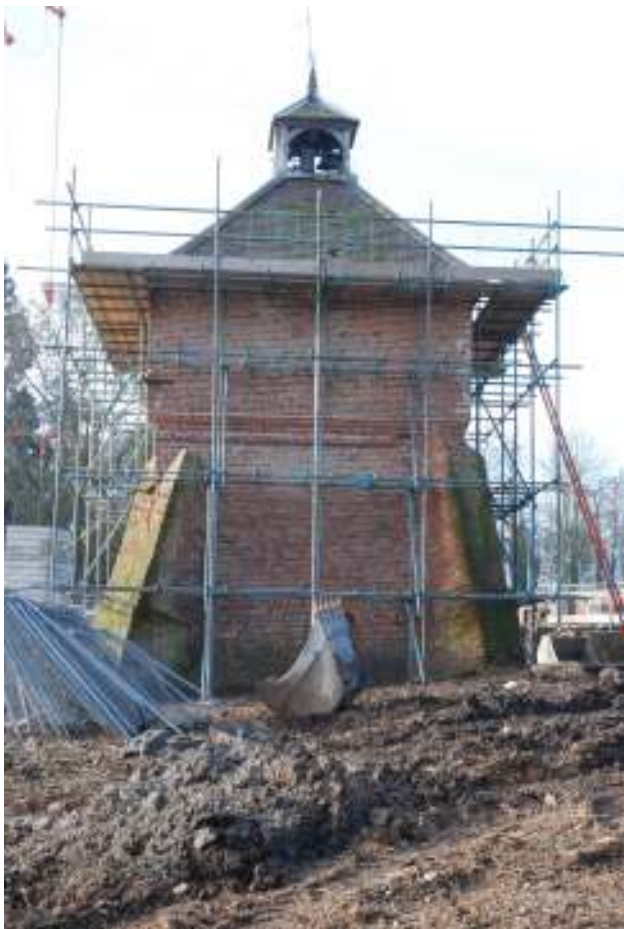
Fig. 51: Photograph of the exterior of the eastern wall of the dovecote. The new build is above, and including, the moulded course of brickwork.
