**THE DOVECOTE, BREAKSPEAR HOUSE,
BREAKSPEAR ROAD NORTH, HAREFIELD,
HILLINGDON, LONDON, HA6 1BN**

A LEVEL 3-4 HISTORIC BUILDING SURVEY

September 2011

Author: Emma Jeffery

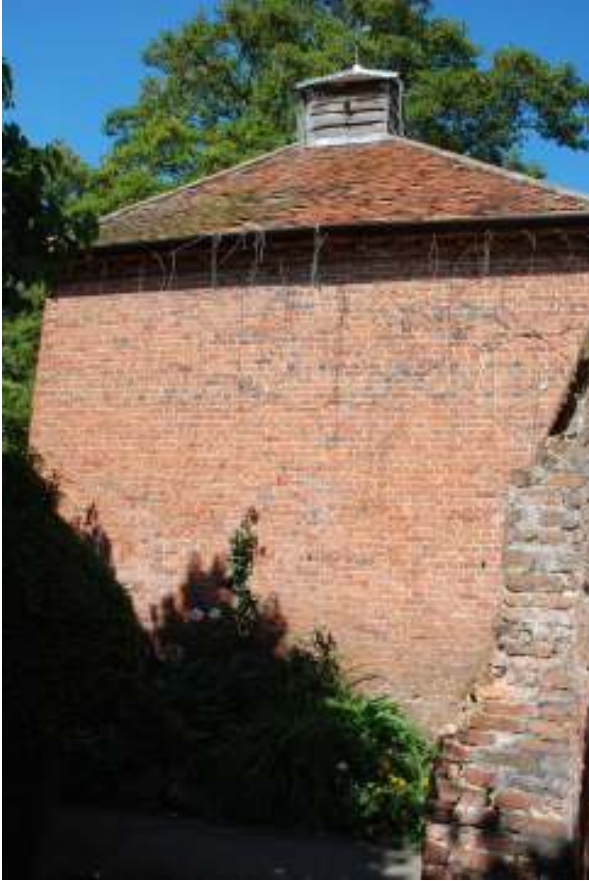
Fig. 52: Photograph of the exterior of the dovecote at Eastcote, clearly showing its regular 'Flemish' bond.

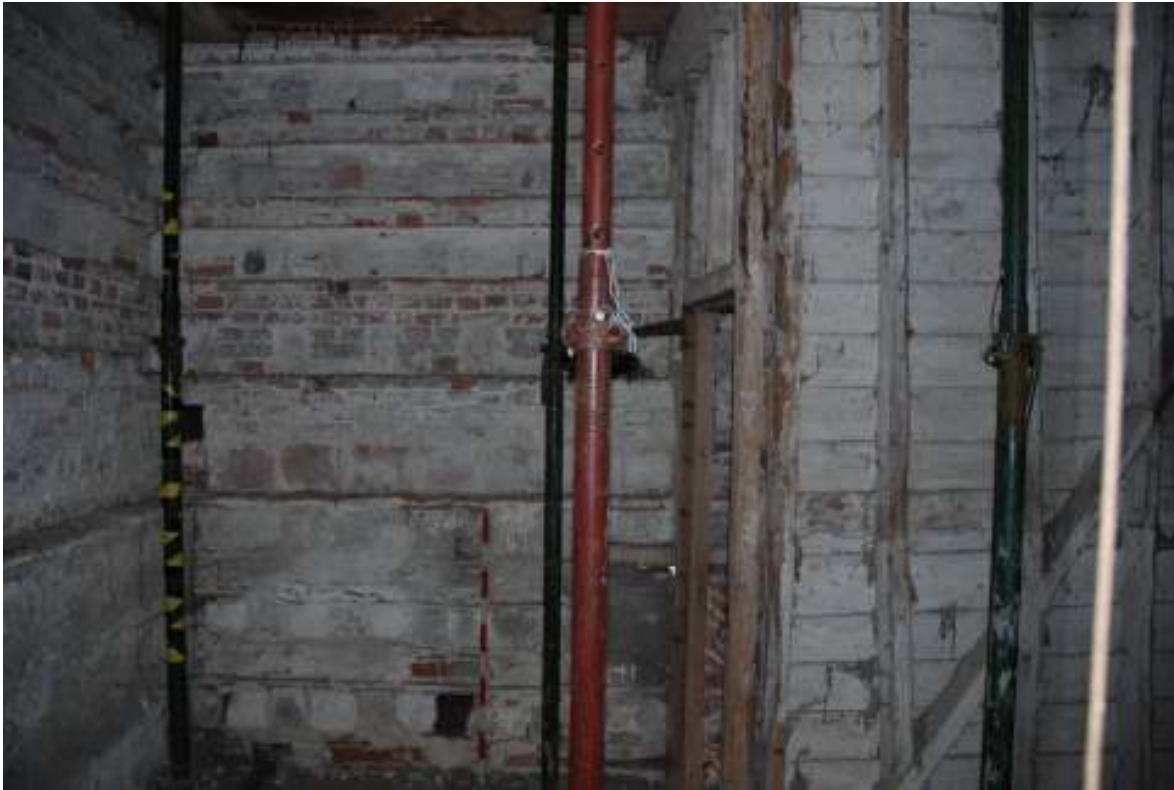
Fig. 53: Photograph of the interior southern wall – first floor.

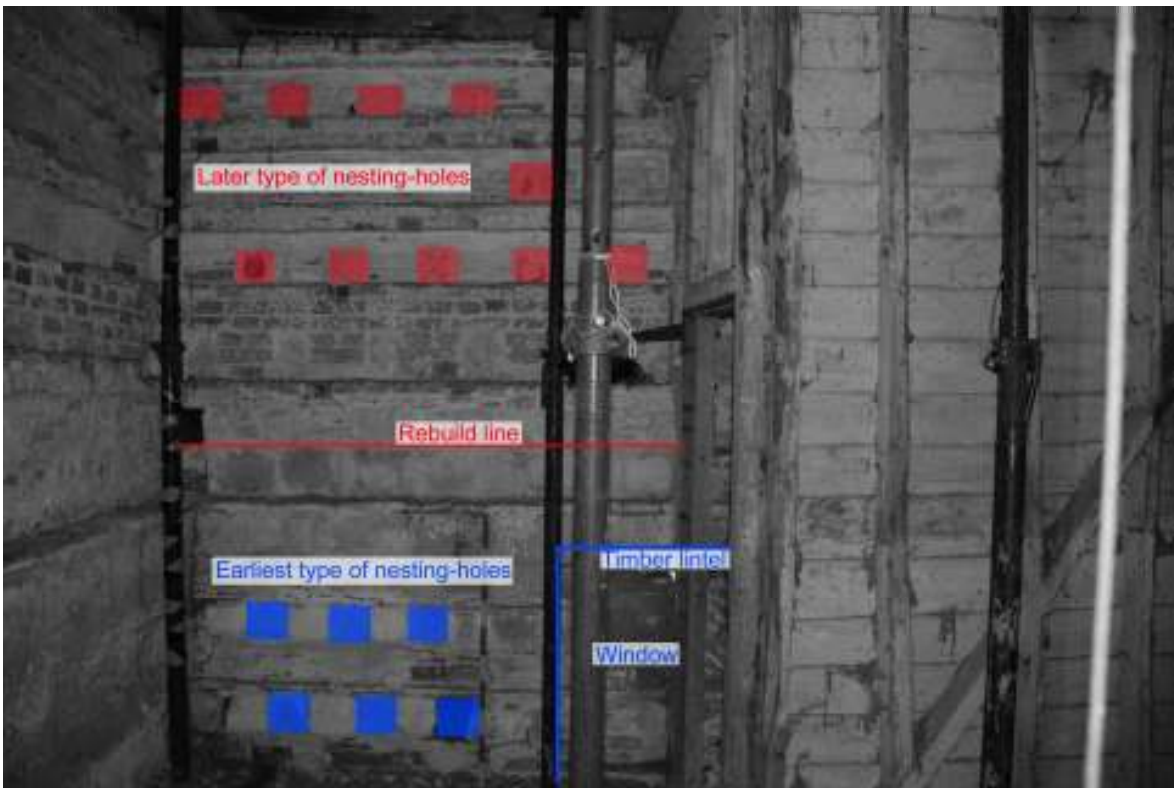
Fig. 54: Annotated photograph of the interior southern wall – first floor. This shows the earlier construction (in blue – windows and nesting-holes); rebuild line and later construction (in red). The location of some of the blocked nesting-holes are highlighted.

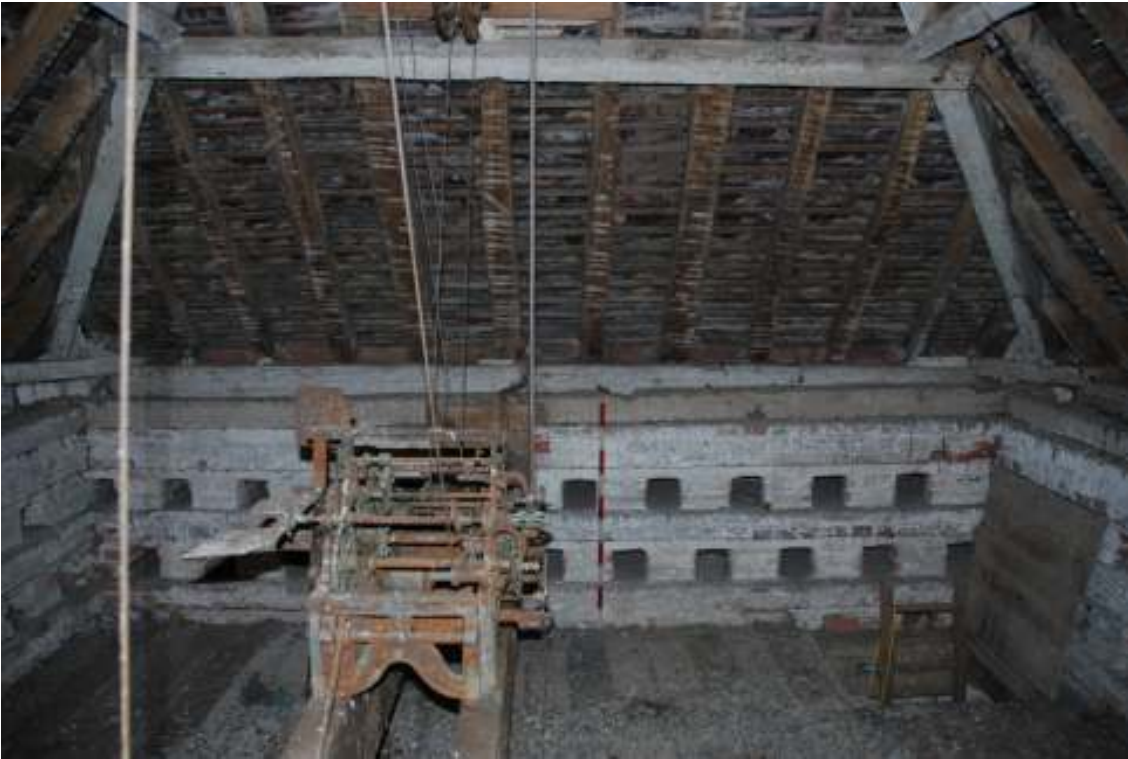
Fig. 55: Photograph of the interior southern wall – second floor, with nesting-holes still open. This is all part of the rebuild.

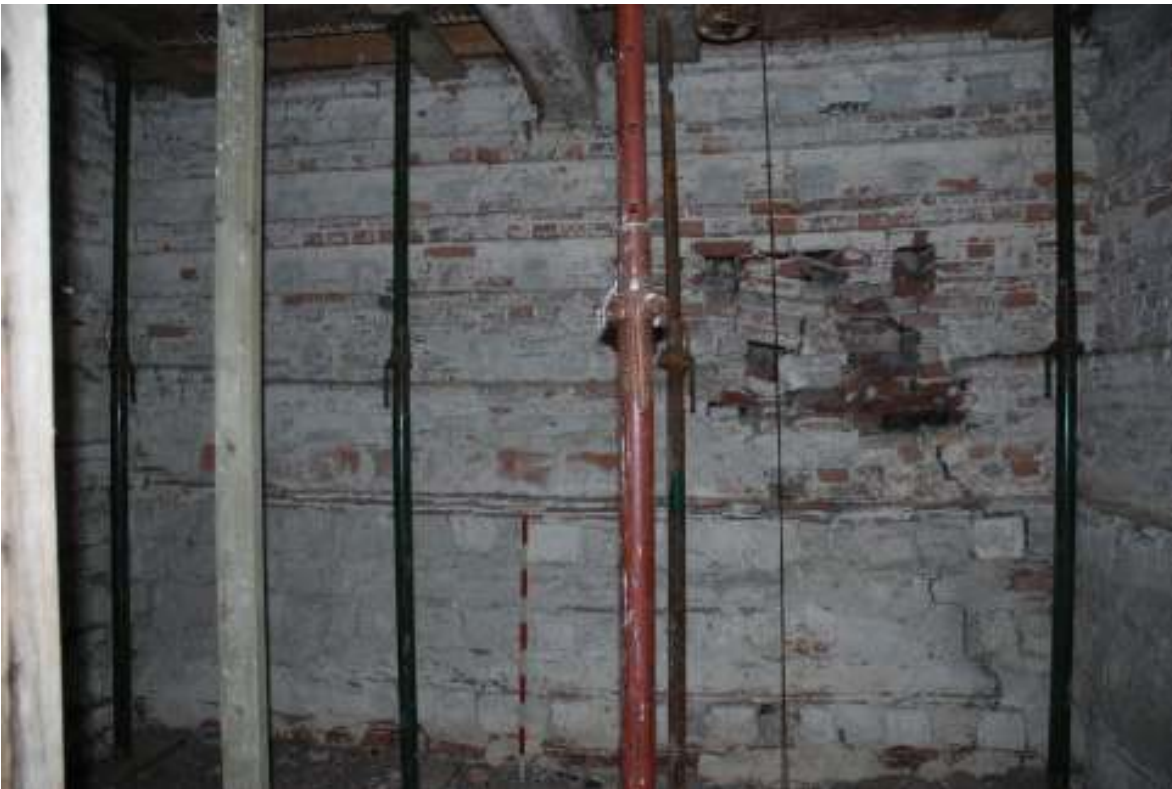
Fig. 56: Photograph of the interior northern wall – first floor. The rebuild is from c.0.2m above the top of the scale, where the nesting holes are different.

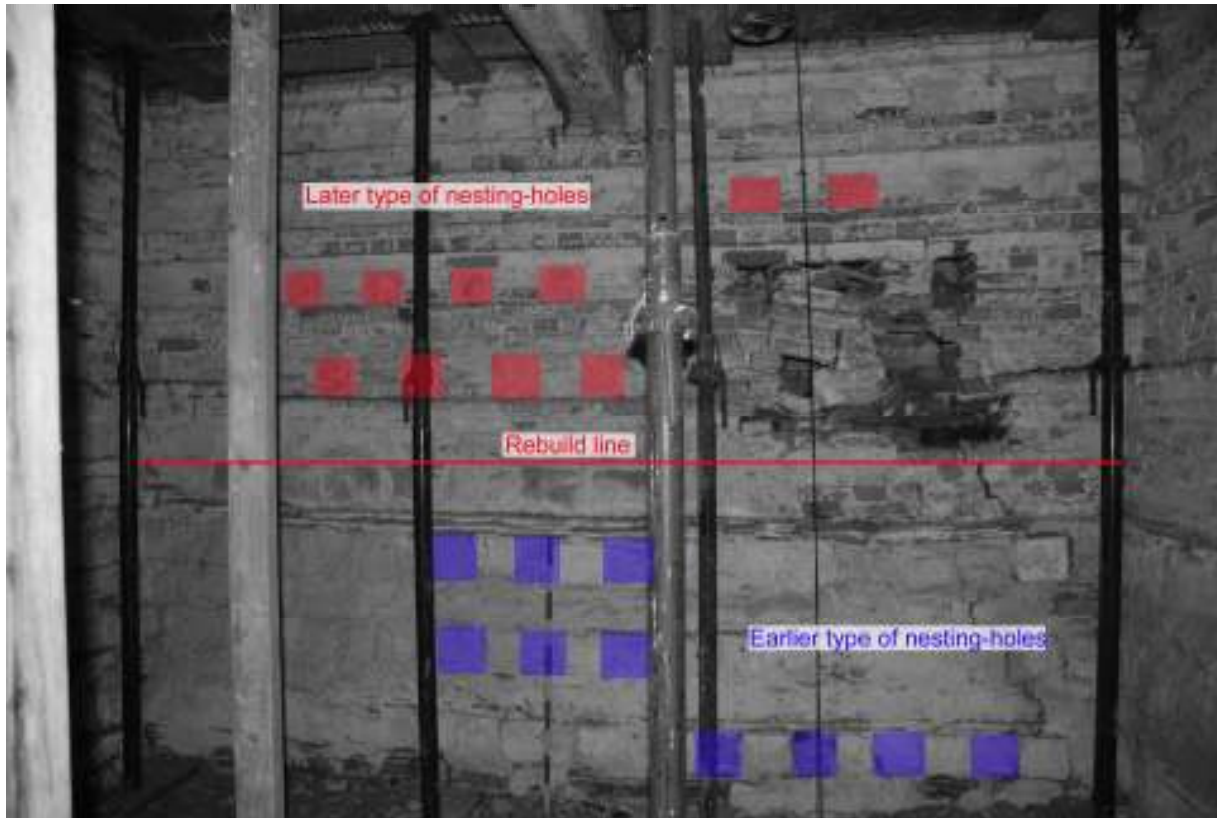
Fig. 57: Annotated photograph of the interior northern wall – first floor. This shows the earlier construction (in blue); rebuild line and later construction (in red). The location of some of the blocked nesting-holes are highlighted.

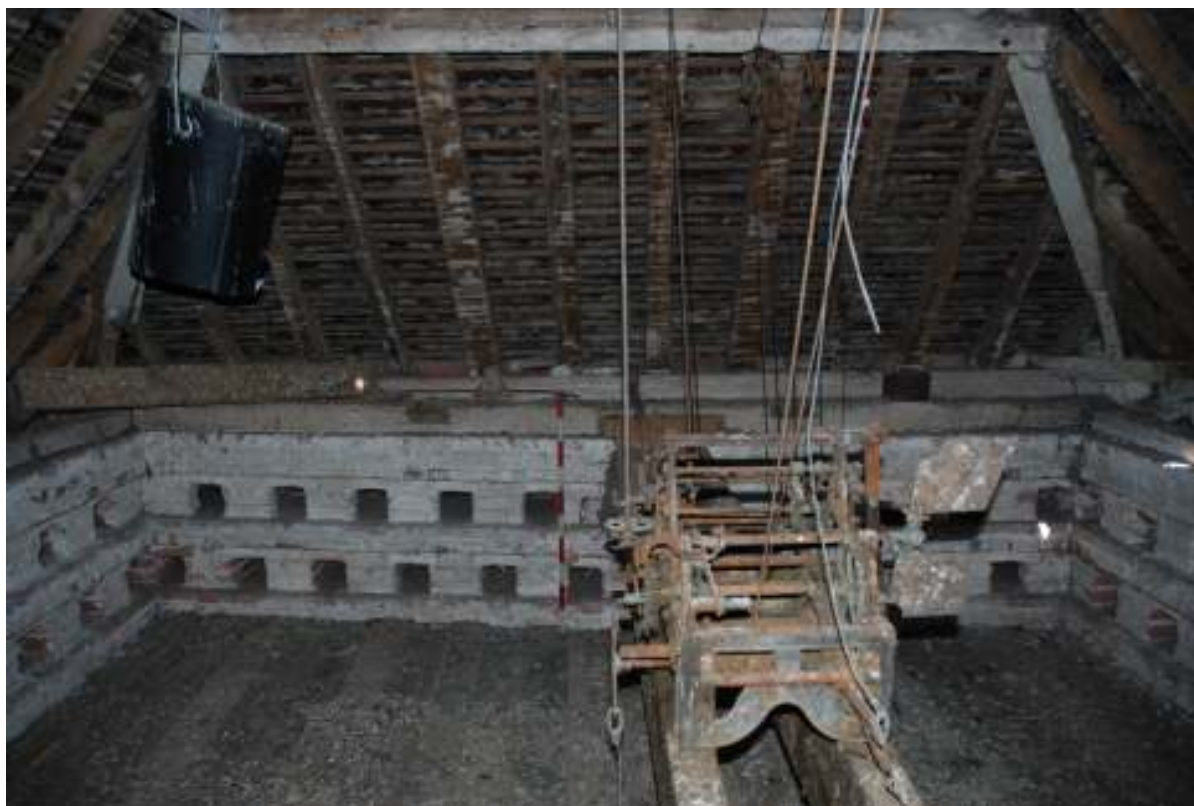
Fig. 58: Photograph of the interior northern wall – second floor. This is all part of the rebuild.

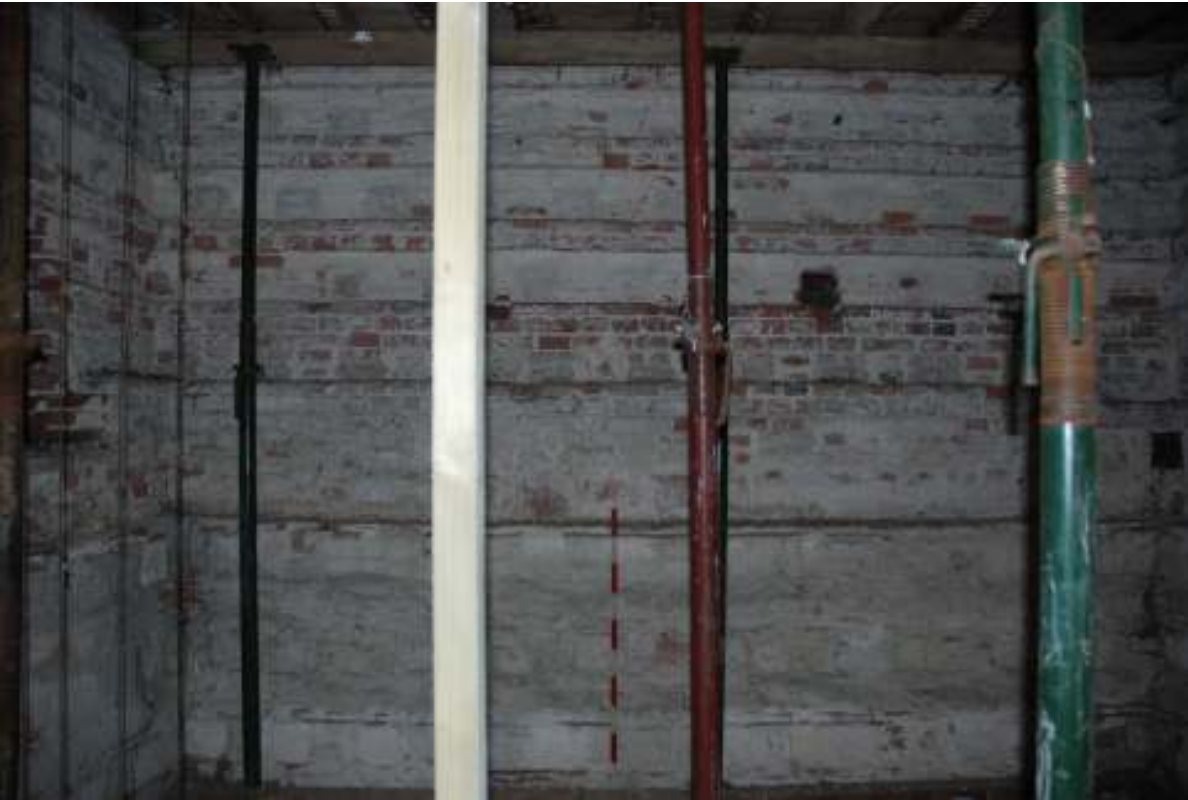
Fig. 59: Photograph of the interior eastern wall – first floor. The rebuild is from c.0.1m above the top of the scale, where the nesting holes are different.

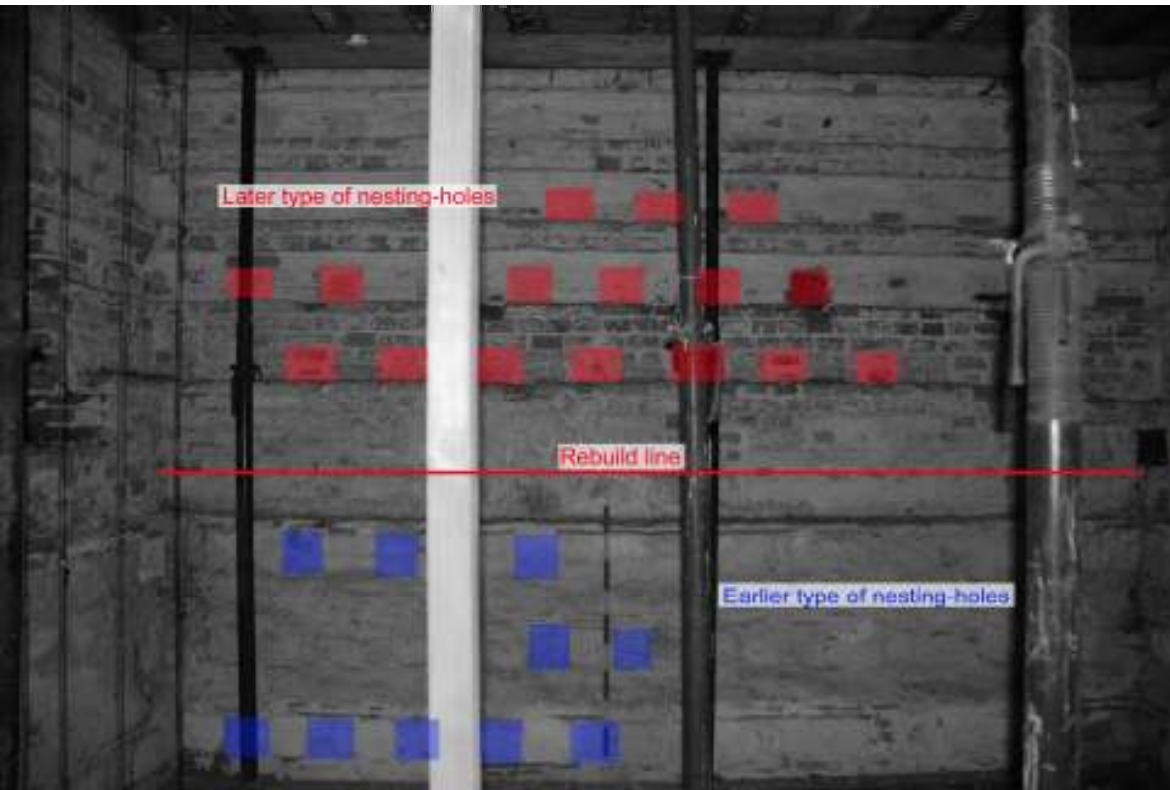
Fig. 60: Annotated photograph of the interior eastern wall – first floor. This shows the earlier construction (in blue); rebuild line and later construction (in red). The location of some of the blocked nesting-holes are highlighted.

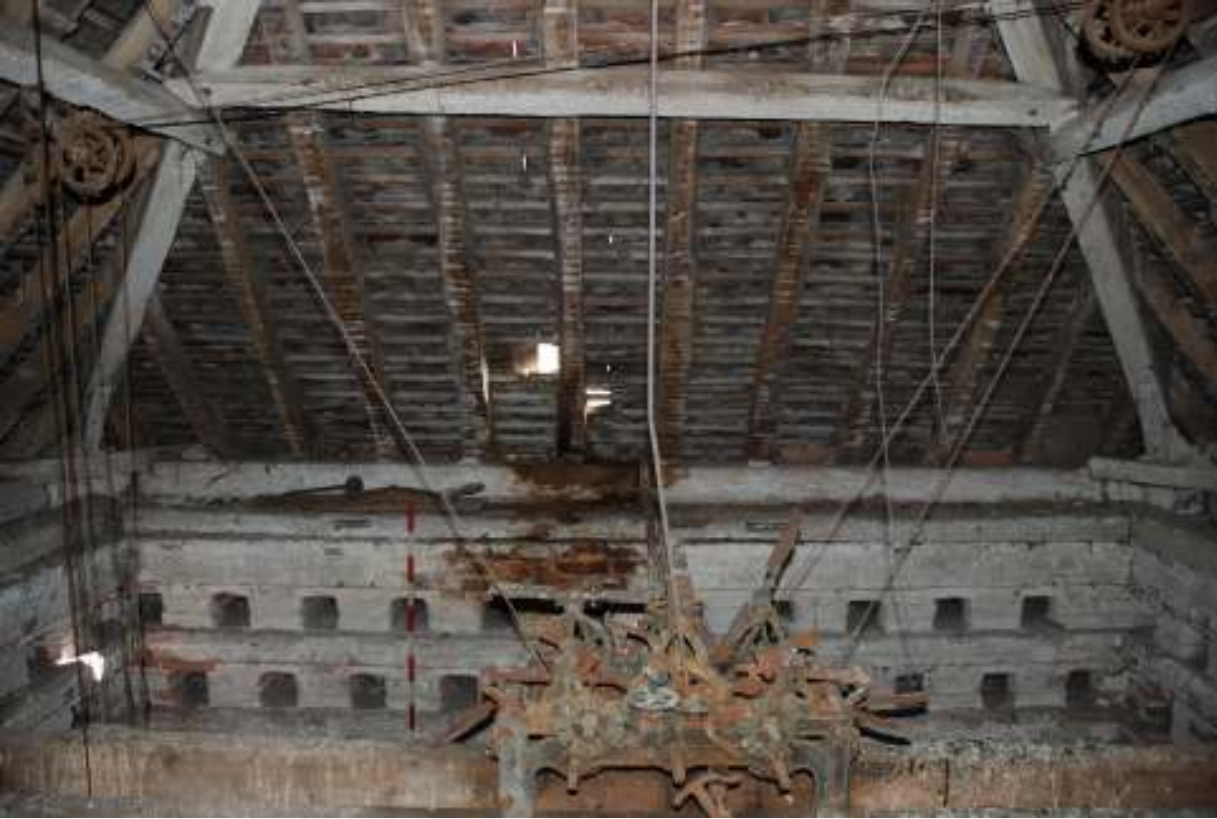
Fig. 61: Photograph of the interior eastern wall – second floor. This is all part of the rebuild.

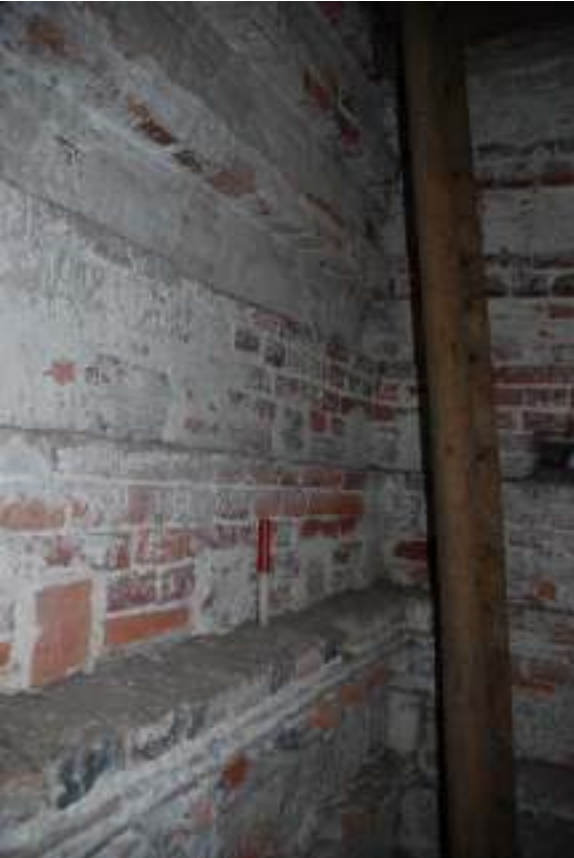
Fig. 62: Photograph of the nesting-holes in the south-west corner. The lower nesting-holes are part of the original build (tile and dentil courses), whereas the upper nesting-holes are part of the rebuild (brick ledges). The scale is standing at the rebuild level and the highest point of the original walls.

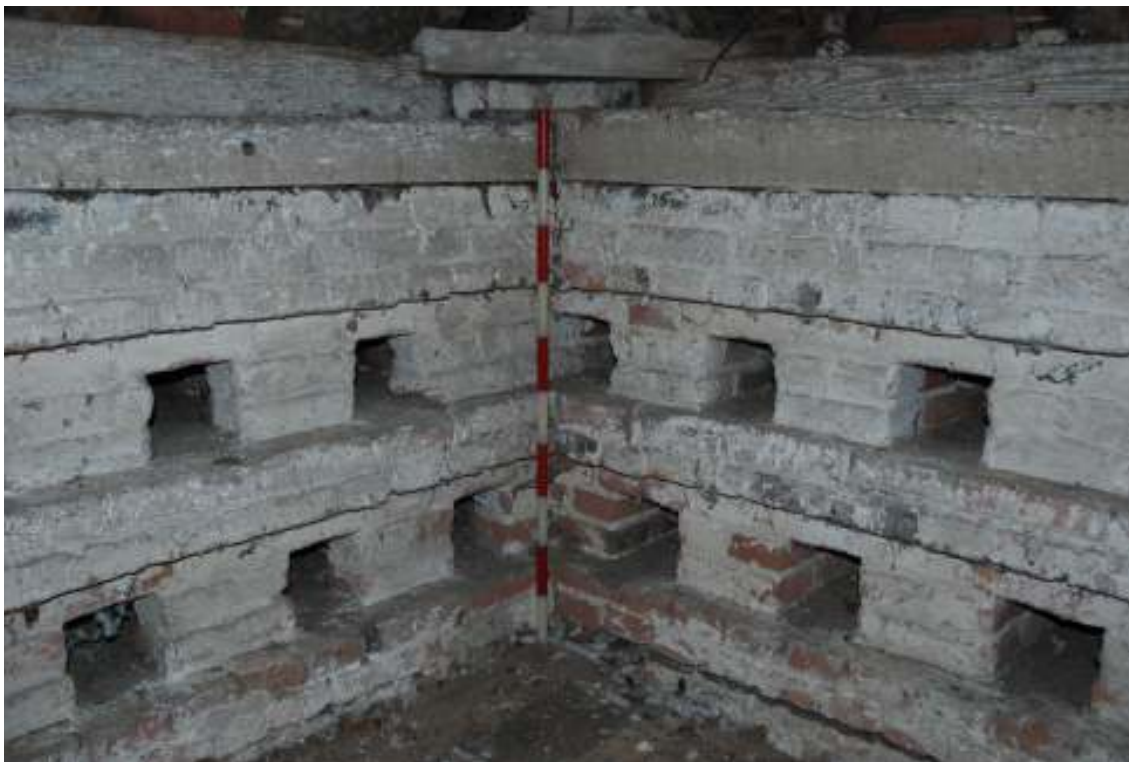
Fig. 63: Photograph of the nesting-holes in the south-eastern corner of the second floor. These are clearly the second type of nesting-holes (part of the rebuild) – with brick ledges.

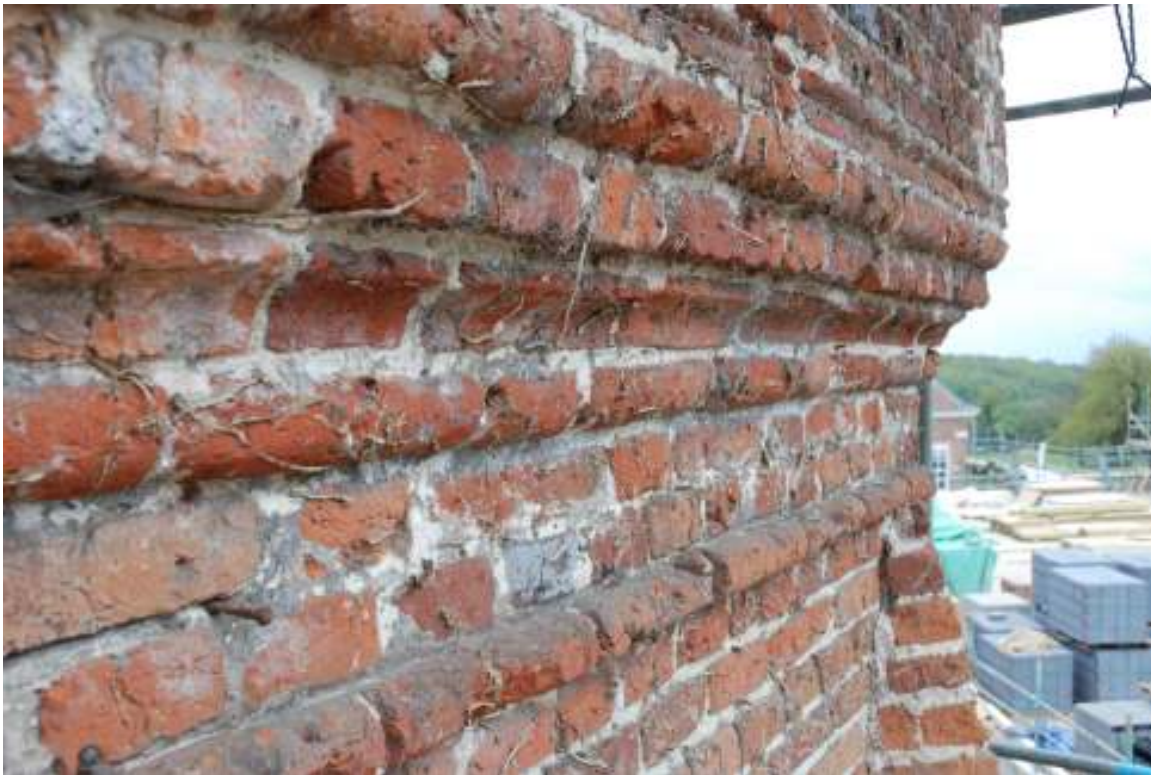
9.2.11.3 This moulded course was added onto the structure during its second phase of development, when the upper part of the dovecote was added. Presumably, it was constructed to enable the upper (new) brickwork to be added to the lower (older) parts, as well as enabling the dovecote to be widened at the upper levels. The decorative nature of it may also have added to it as a status symbol.

Fig. 65: Photograph of the moulded courses of brickwork, at the southern corner of the western wall.

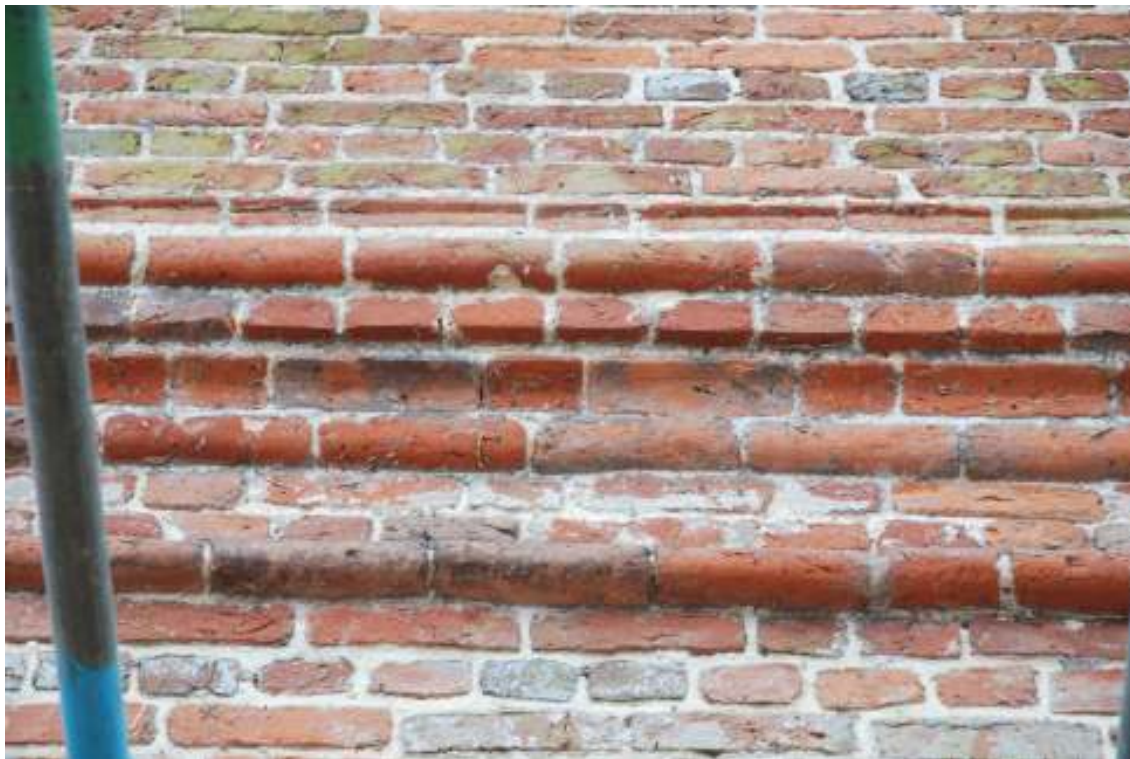
Fig. 66: Photograph of the moulded course of brickwork, along the southern wall.

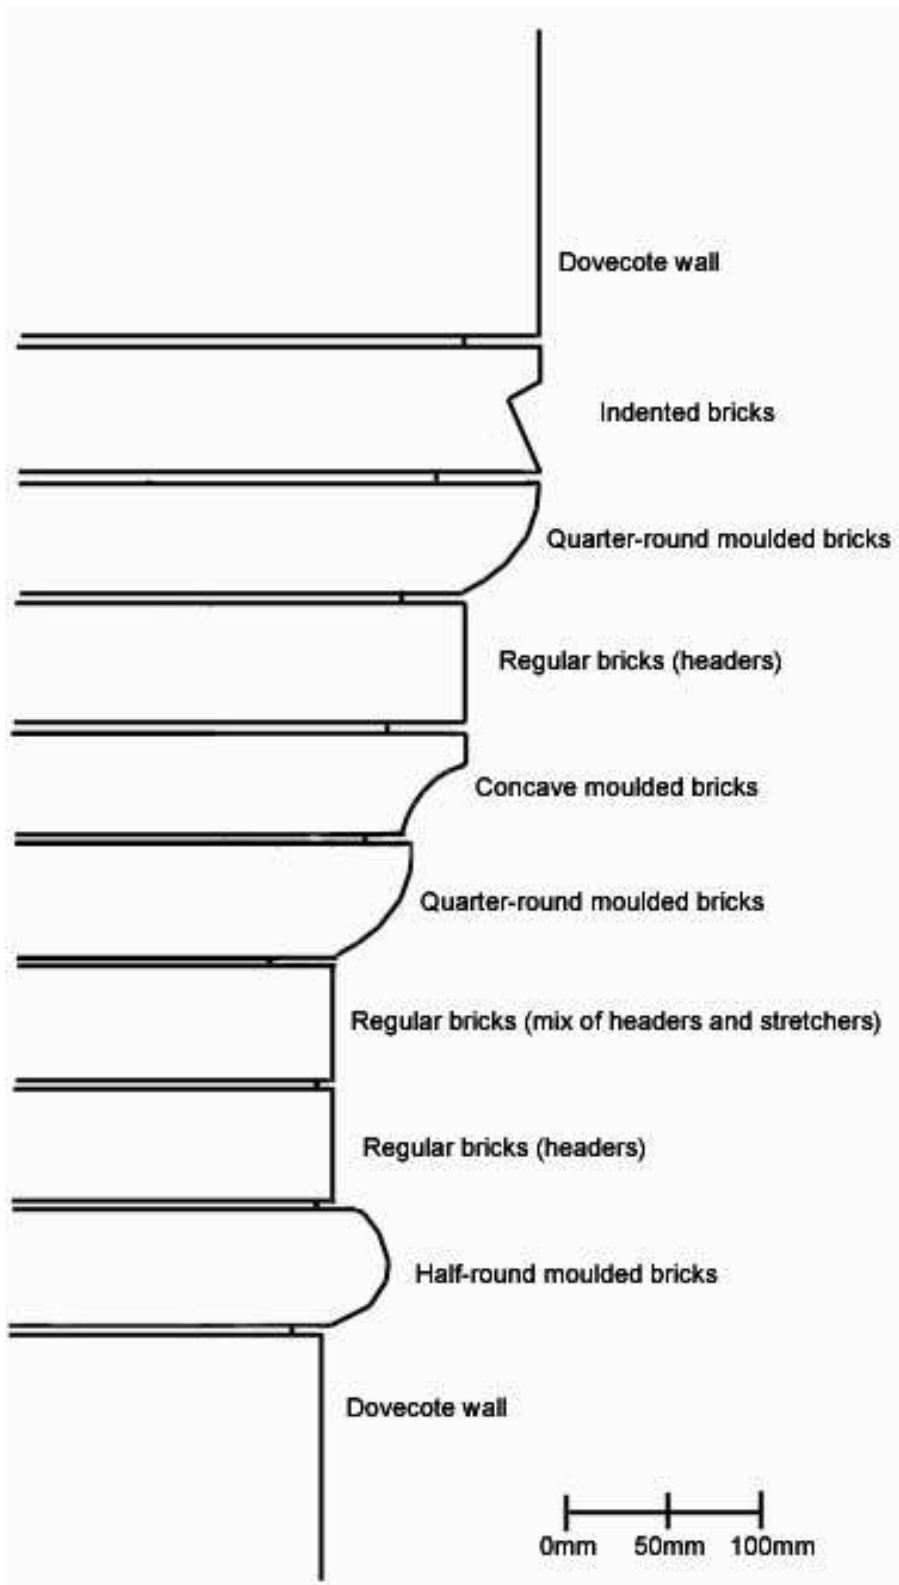
Fig. 67: Section of the moulded courses of brickwork.

9.2.11.2 The moulded courses enabled the brick walls of the dovecote to be 'stepped out' at the upper levels, by *c.*0.4-0.6m (according to internal dimensions). This is over the course of the moulding, by *c.*0.13m (external dimensions). The apparent larger 'step out' on the interior may be accounted for because of differing thickness of the walls, etc.

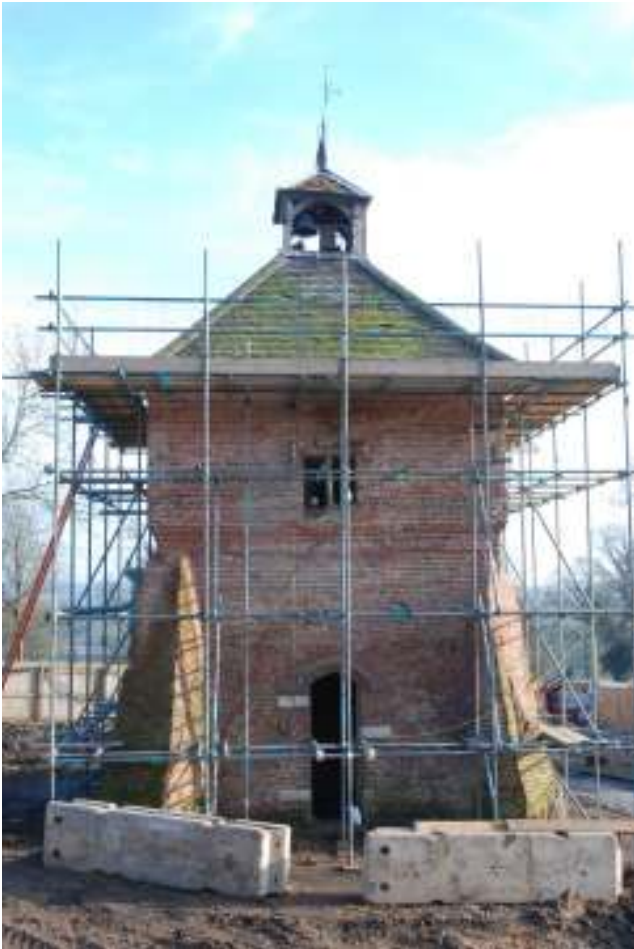
9.3.2 The exterior of the whole of this western wall, however, looks different from the lower levels of the other three walls, particularly in terms of its bond, but very similar to their upper levels. It consists of red bricks, etc, within a cream mortar. It is in a predominantly English bond (headers over stretchers), but with the occasional double row of stretchers and / or headers. There is also quite a bit of patching and repair at the ground floor level.

Fig. 68: Photograph of the exterior of the western wall of the dovecote. This is all part of the rebuild, excluding the later doorway.

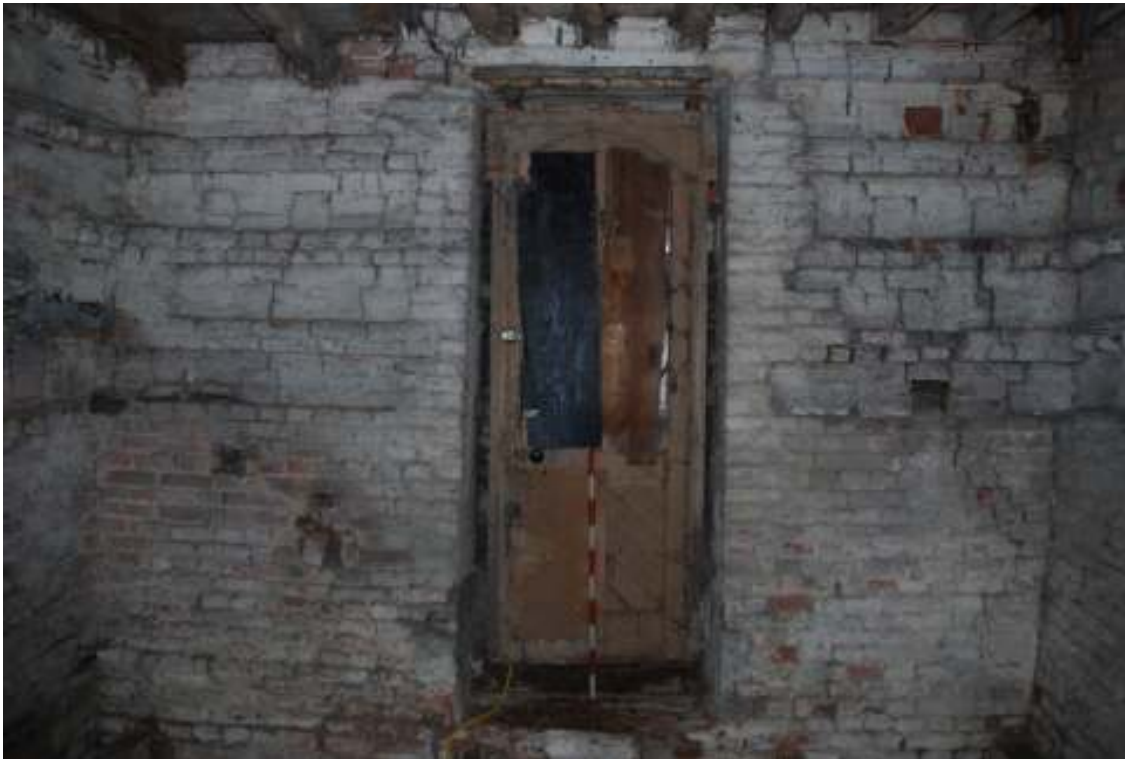
Fig. 69: Photograph of the interior western wall of the dovecote – ground floor. This is all part of the rebuild.

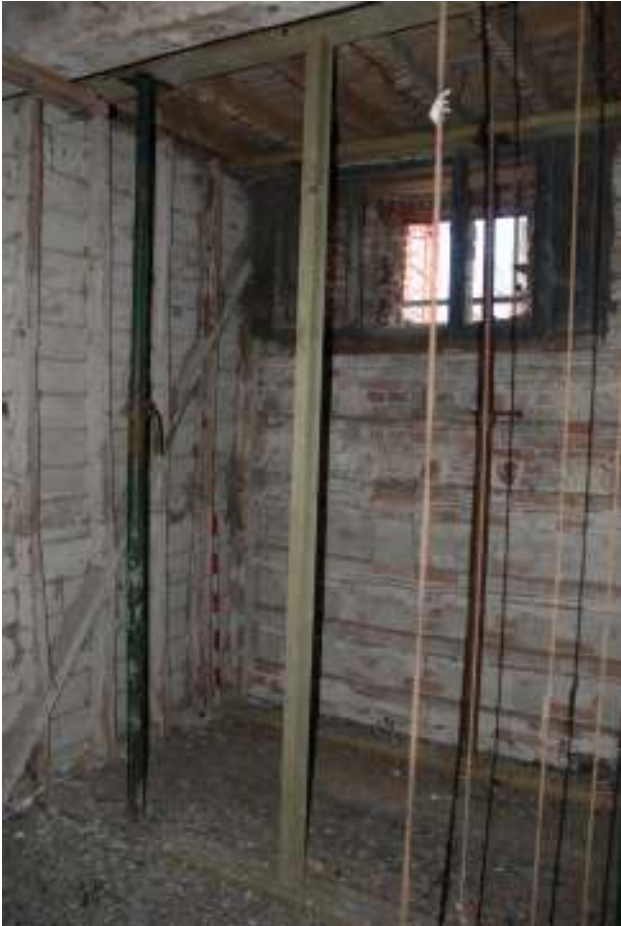
Fig. 70: Photograph of the interior western wall of the dovecote – first floor. This is all part of the rebuild.

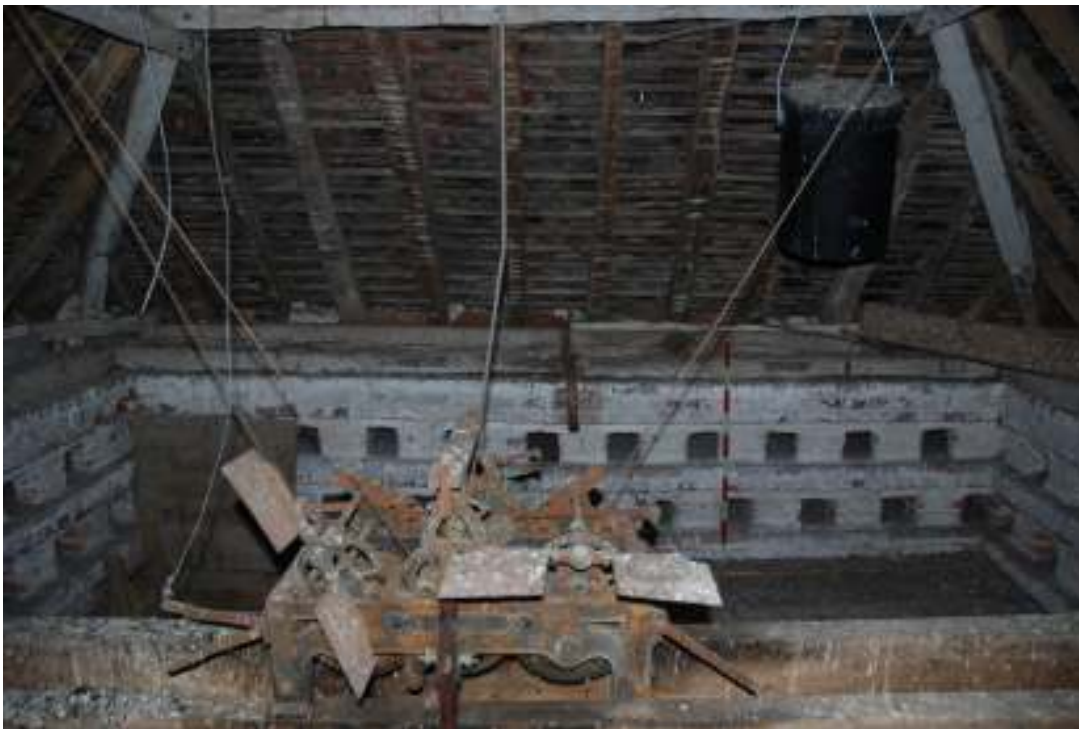
Fig. 71: Photograph of the interior western wall of the dovecote – second floor. This is all part of the rebuild.

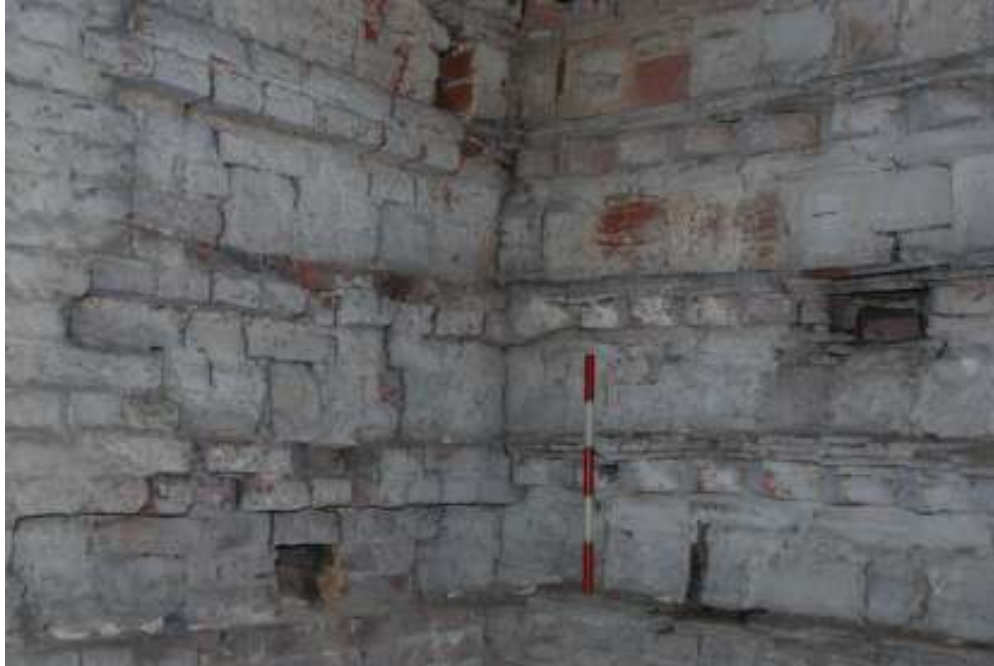
9.3.3 The nesting-holes on the western wall of the dovecote are all of the same type as those in the upper part of the other three walls (i.e. two courses of brickwork forming a ledge, with the hole above it). This is distinctly different from the tile / dentil course type of nesting-holes observed in the lower part of the other three walls.

Fig. 72: Photograph of the nesting-holes on the western wall (ground floor) (left side of photo), in comparison with those on the northern wall (right side of photo).

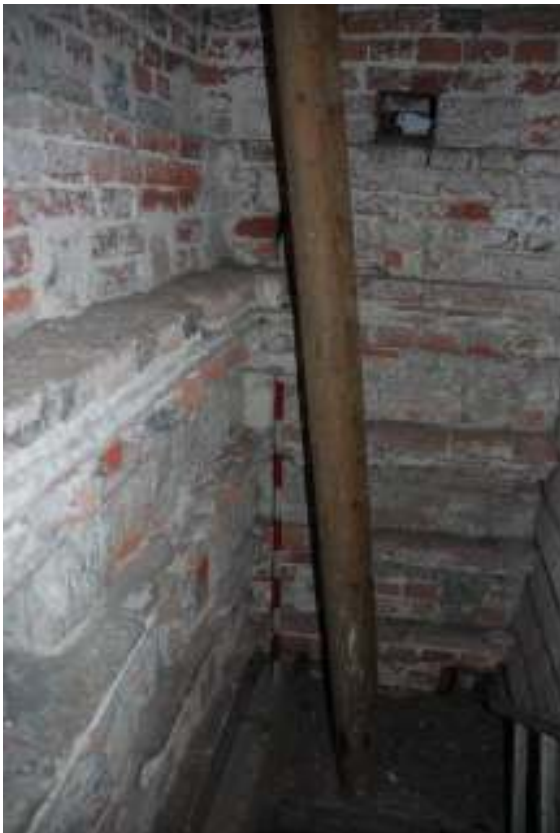
Fig. 73: Photograph of the nesting-holes on the western wall (first floor) (right side of photo), in comparison with those on the southern wall (left side of photo).

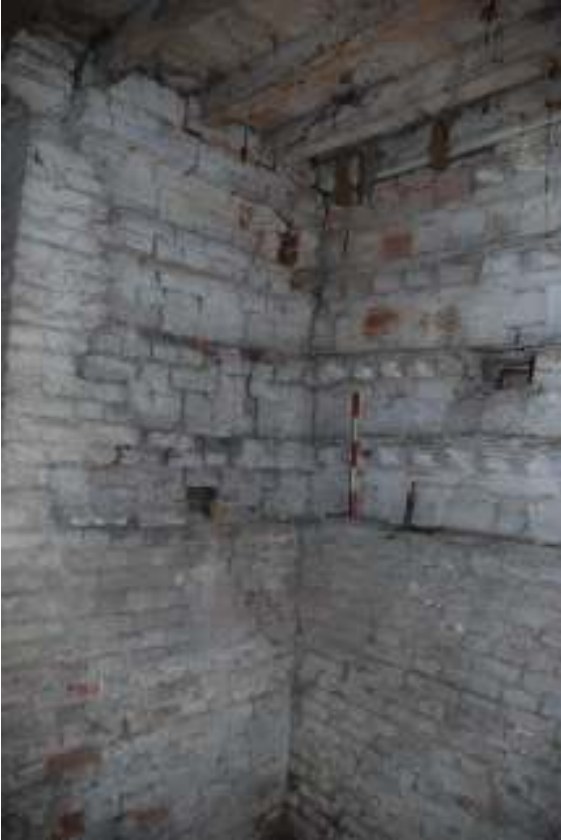
9.3.4 The clearest indication that the western wall was later in date than the lower part of the other three walls was seen at the north-west and south-west corners, where the western wall butted up against the other walls. On both the ground floor and lower first floor there was a roughly broken line between the two builds, and in a few areas the northern and southern walls retained evidence for the original corner and return along the western wall.

Fig. 74: Photograph of the north-west corner of the dovecote (ground floor). This shows how the northern wall is butted up against the western wall.

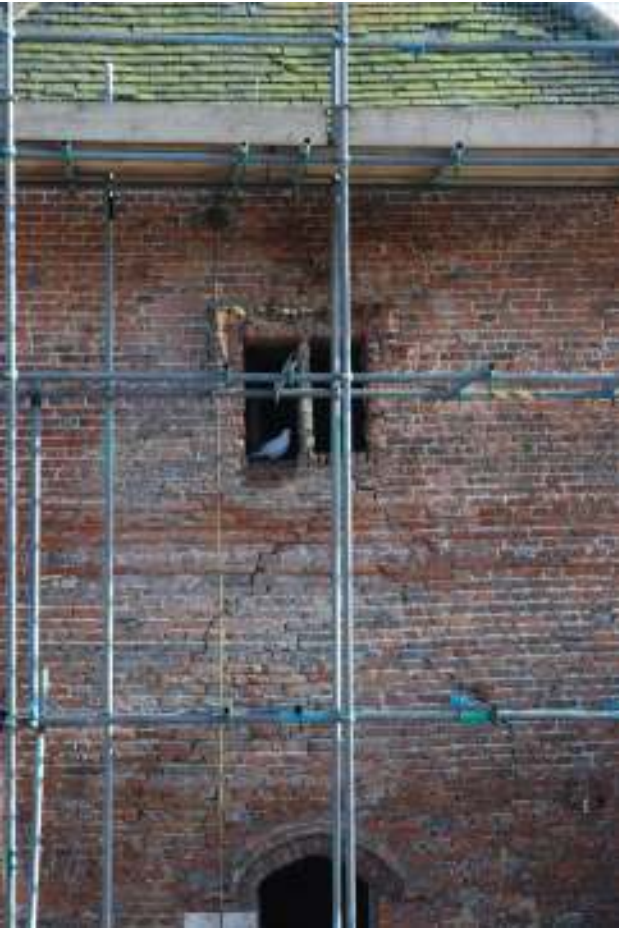
Fig. 75: Photograph of the window in the western wall (from the outside).

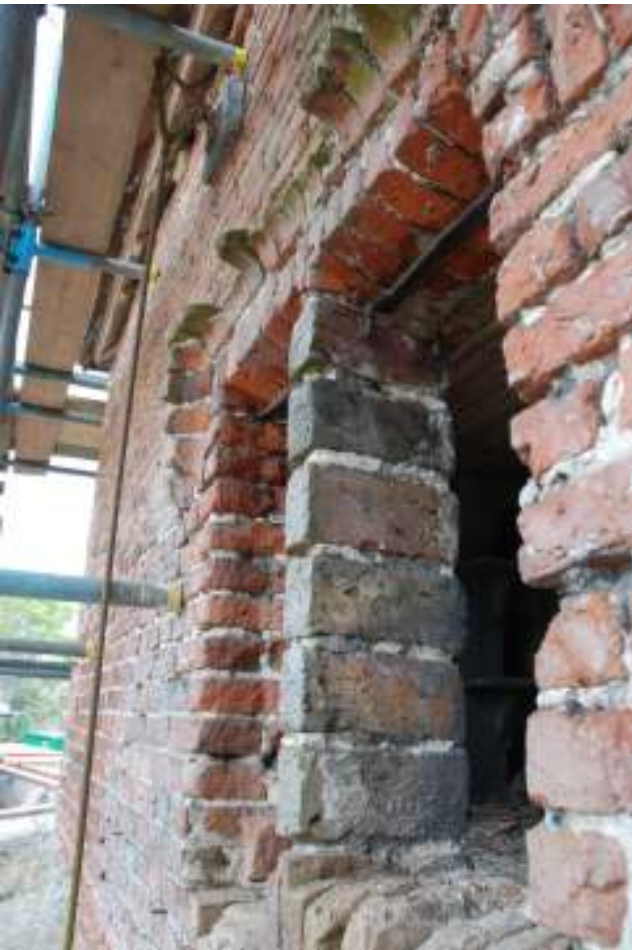
- 9.4.3** There is no evidence, either on the interior or exterior of the dovecote, that the window was inserted in at a later date. It therefore seems likely that it was constructed at the same time as the construction of the western wall itself. This is unusual, to have two windows in a dovecote, although it may also have enabled doves to enter the structure, with probable timber slats preventing larger predators from getting in.

Fig. 76: Photograph of the window in the western wall (from the outside). This clearly shows the hood around the top of the window, the later mullion down the centre of it, and the chamfered bricks surrounding the window.

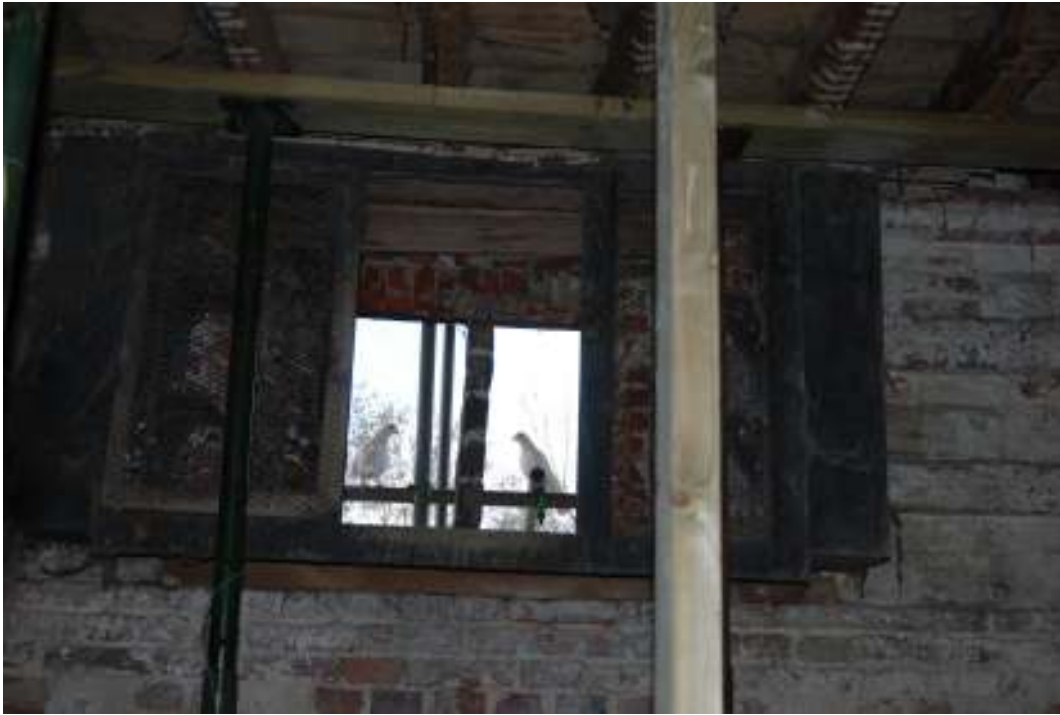
Fig. 77: Photograph of the window in the western wall (from the inside). Two doves are perched on the scaffolding outside this window.
